MINERALS PROGRAM INSPECTION REPORT
PHONE: (303) 866-3567

MINE NAME: Mineral County Pit	MINE/PROSPECTING ID#: M-1984-097	MINERAL: Sand and gravel	COUNTY: Mineral
INSPECTION TYPE: Monitoring	WEATHER: Clear	INSP. DATE: July 20, 2023	INSP. TIME: 09:00
OPERATOR: Mineral County	OPERATOR REPRESENTATIVE: Dannie Rogers	TYPE OF OPERATION: 112c - Construction Regular Operation	
REASON FOR INSPECTION: Normal I&E Program	BOND CALCULATION TYPE: None	BOND AMOUNT: \$0.00	
DATE OF COMPLAINT: NA	POST INSP. CONTACTS: None	JOINT INSP. AGENCY: None	
INSPECTOR(S): Todd Jesse	INSPECTOR'S SIGNATURE:

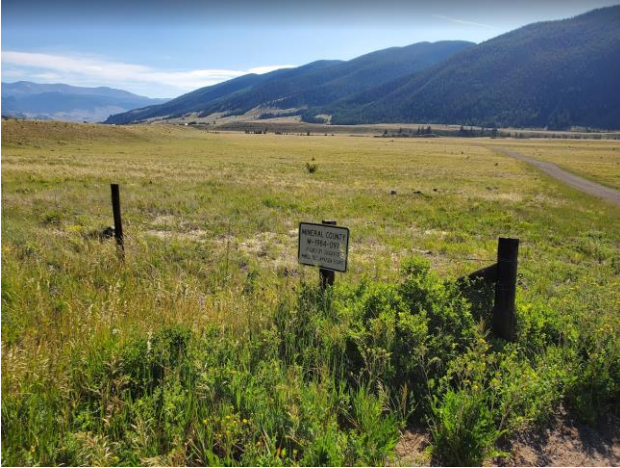
View to the east showing proper Mine ID signage posted at the entrance to the site.

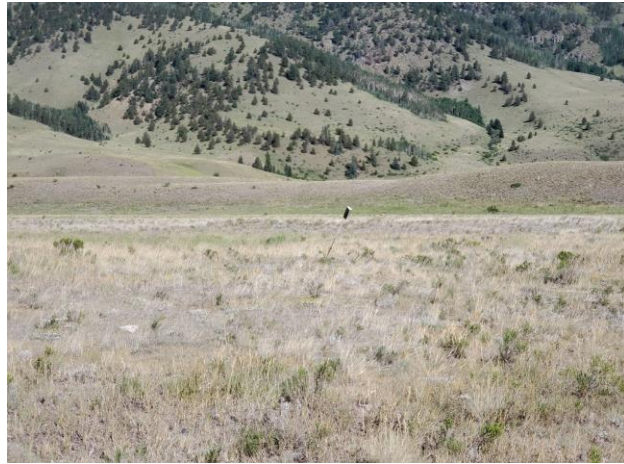
View to the west showing example of post that marks the permit boundary.

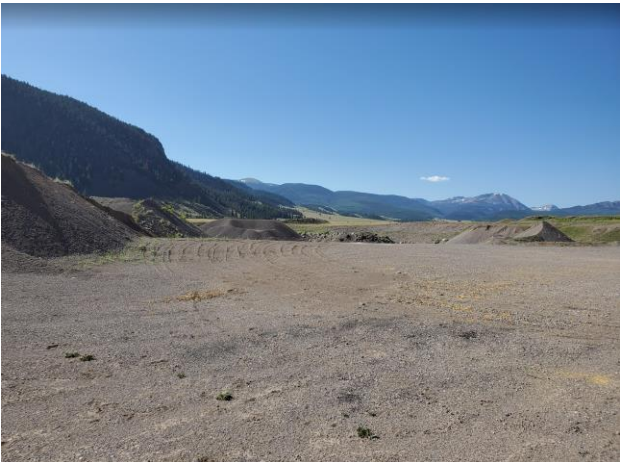
View to the southeast showing processing area on the pit floor.

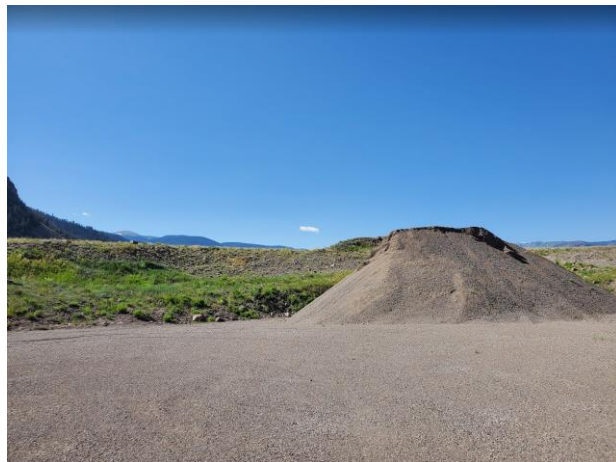
Mining has been conducted according to the submitted plan. Material was extracted at approximately reclamation grade resulting in no highwall on site. The side slopes of the pit are stable and well vegetated with volunteer species - showing no signs of erosion or slumping. The pit floor has multiple stockpiles of various sized materials ranging from sand to boulders. In addition to product stockpiles there is also a topsoil pile on site. There appears to be an adequate amount of topsoil stockpiled for the permitted reclamation plan. Topsoil stockpile is protected by vegetation. No state listed invasive species were identified on site during the inspection. No water was present on site at the time of the inspection.

View to the southeast showing reclamation grade on pit slopes

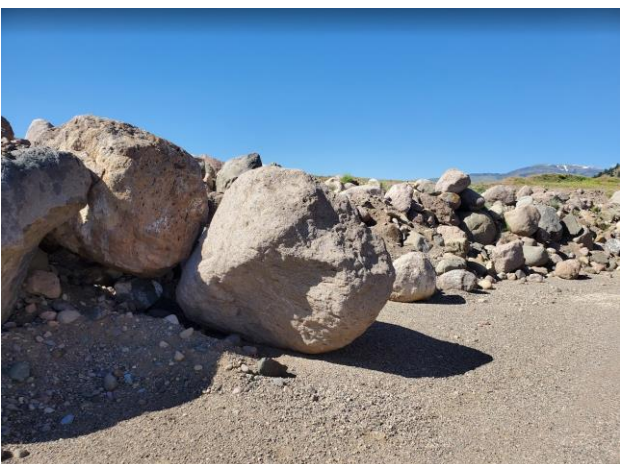
View to the west of oversized material. Boulders are as large as 3 foot diameter.

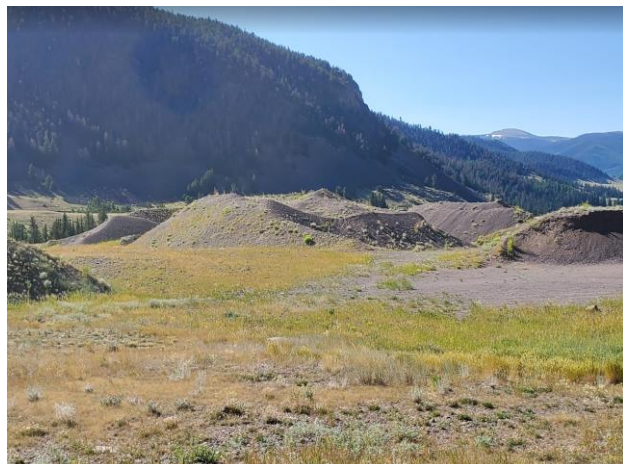
View to the east showing product stockpiles on site
