MINERALS PROGRAM INSPECTION REPORT
PHONE: (303) 866-3567

MINE NAME: Shale Core 2020-03	MINE/PROSPECTING ID#: P-2021-003	MINERAL: Oil shale	COUNTY: Rio Blanco
INSPECTION TYPE: Monitoring	WEATHER: Clear	INSP. DATE: August 9, 2023	INSP. TIME: 10:00
OPERATOR: Mahogany Energy Resources, LLC	OPERATOR REPRESENTATIVE: Justin Bilyeu	TYPE OF OPERATION: MP - Mineral Prospecting	
REASON FOR INSPECTION: Normal I&E Program	BOND CALCULATION TYPE: Complete Bond	BOND AMOUNT: \$8,517.00	
DATE OF COMPLAINT: NA	POST INSP. CONTACTS: None	JOINT INSP. AGENCY: None	
INSPECTOR(S): Amy Yeldell	INSPECTOR'S SIGNATURE:

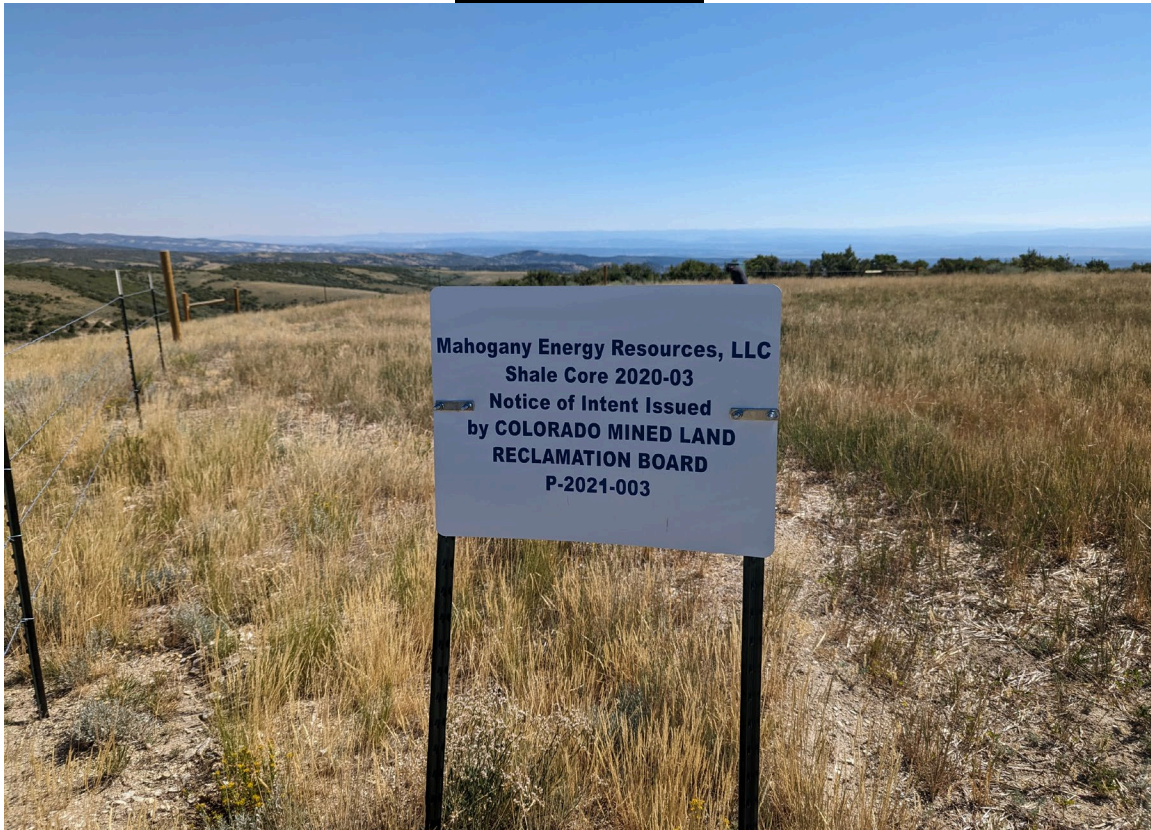
The mine identification sign and affected area boundary markers are in place and in compliance with Rule 3.1.12. A sign is posted as you enter the permit boundary. The permit boundary is delineated by a wire fence.

Photo One: Mine sign posted at permit entrance

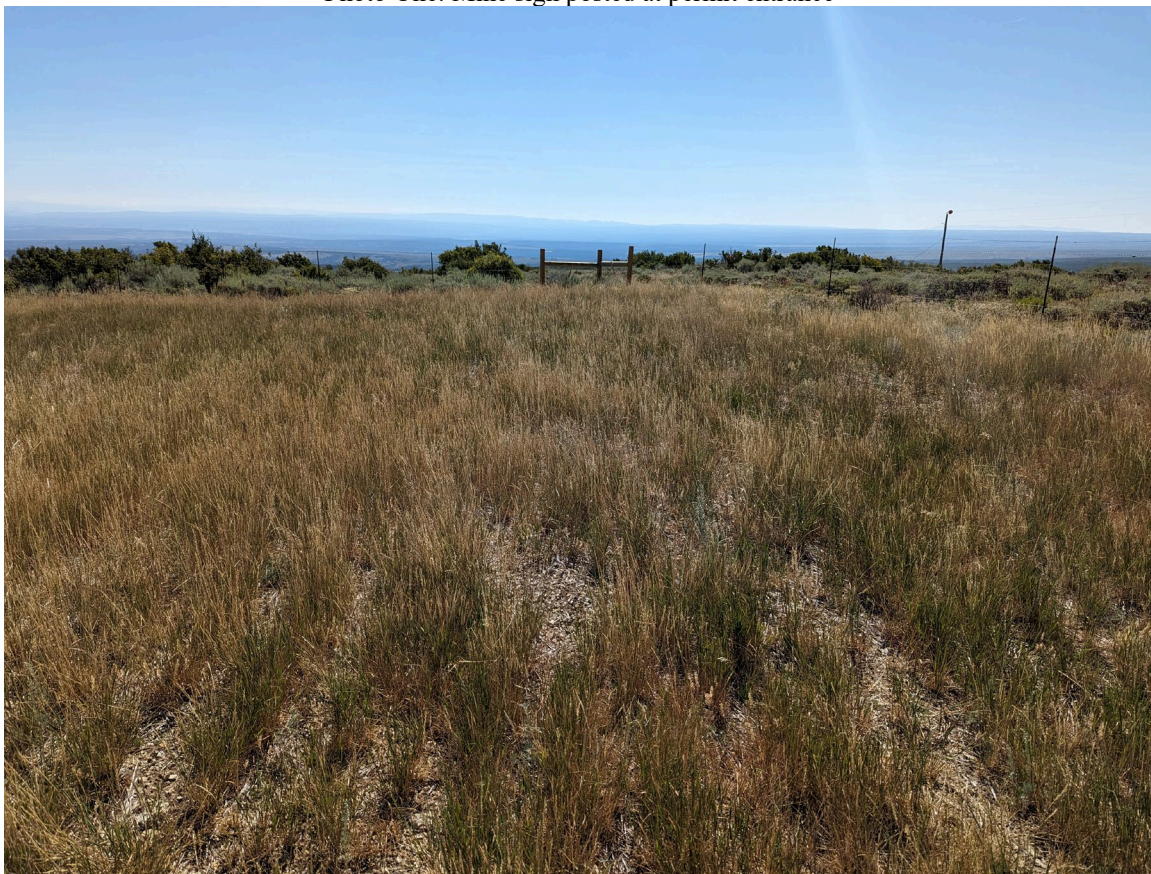
Phot Two: overview of established grasses

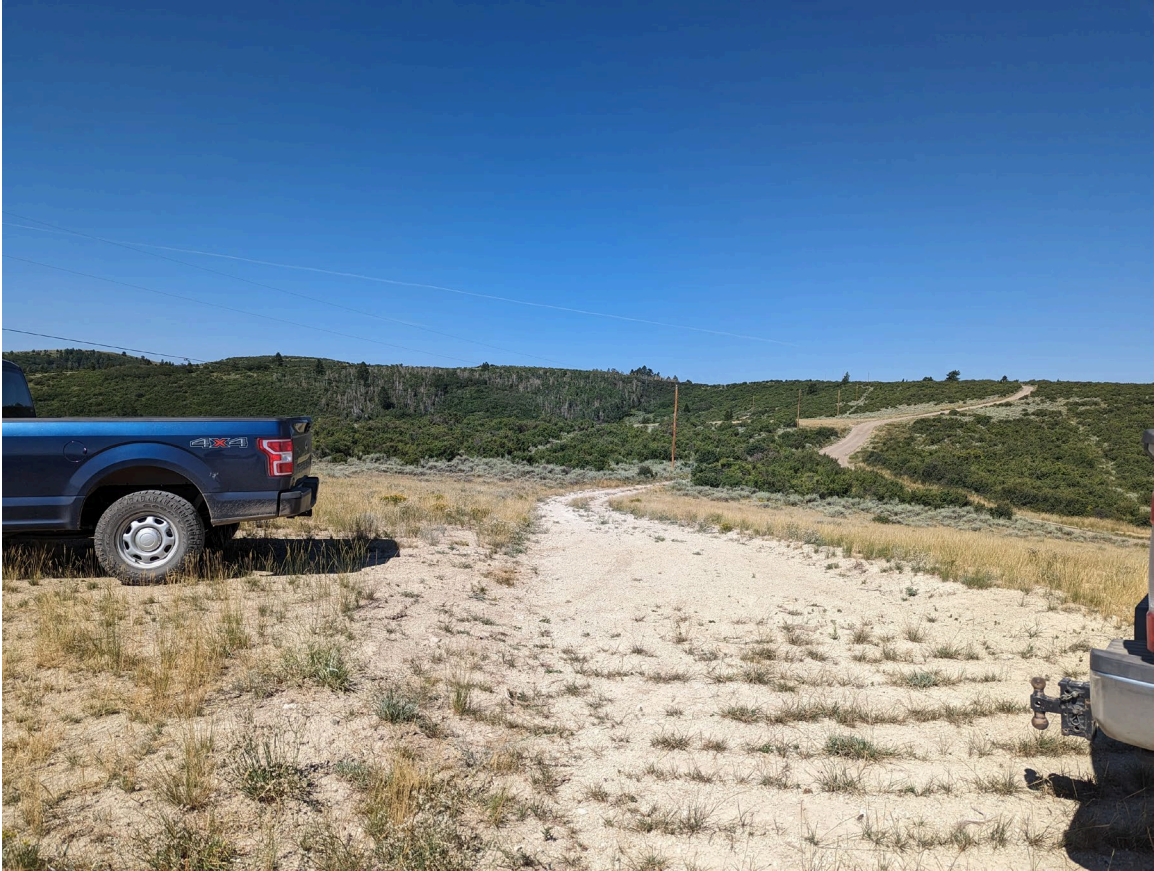
Photo Three: access road to pad, revegetated two track

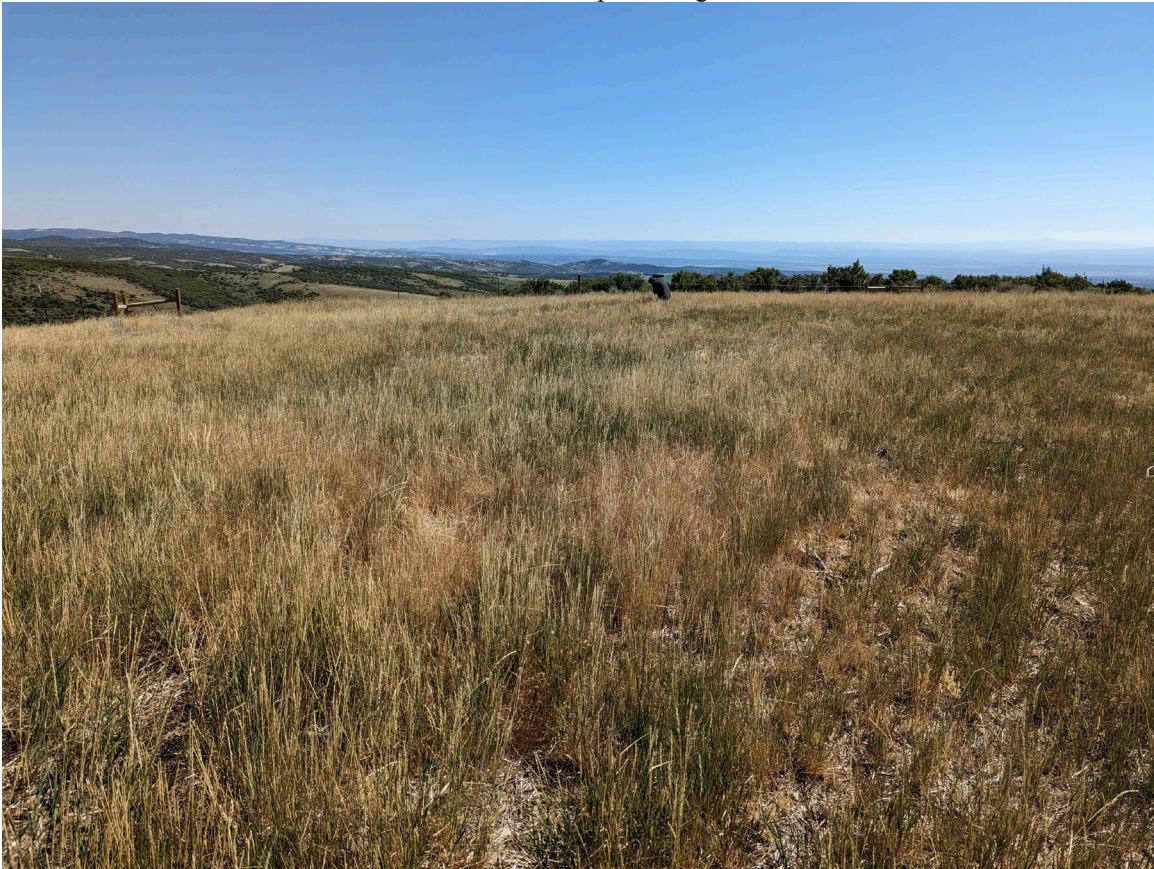
The site is now in final reclamation (fall 2022). Both of the wells have been permanently abandoned (plugged). The final report was received on June 30, 2023, as required per Rule 5.7. All abandonment related equipment has been removed from site. No other equipment, buildings, fuel or mining related debris remains on site. All pits have been reclaimed. The site is contoured, topsoil applied, seeded and exclusion fence installed. The pad is stable with no storm water or erosion concerns. The site was watered twice weekly in the spring of 2023 to get the initial vegetation established, but future or ongoing watering is not anticipated. Very few noxious weeds were observed. A few alyssum and Cheatgrass were present and should be treated to avoid spreading. Overall the reclaimed vegetation appears well established and dense in most places. Vegetation consists mostly of grasses with only a few small sparse forbs or shrubs. In general established vegetation appears diverse and should be monitored for continued improvement.

Photo Four: Pad overview, well established vegetation
