**MINERALS PROGRAM INSPECTION REPORT**  
**PHONE: (303) 866-3567**

<b>MINE NAME:</b> Shale Core 2020-01	<b>MINE/PROSPECTING ID#:</b> P-2021-002	<b>MINERAL:</b> Oil shale	<b>COUNTY:</b> Rio Blanco
<b>INSPECTION TYPE:</b> Monitoring	<b>WEATHER:</b> Clear	<b>INSP. DATE:</b> August 9, 2023	<b>INSP. TIME:</b> 11:00
<b>OPERATOR:</b> Mahogany Energy Resources, LLC	<b>OPERATOR REPRESENTATIVE:</b> Justin Bilyeu	<b>TYPE OF OPERATION:</b> MP - Mineral Prospecting	
<b>REASON FOR INSPECTION:</b> Normal I&E Program	<b>BOND CALCULATION TYPE:</b> Complete Bond	<b>BOND AMOUNT:</b> \$6,805.00	
<b>DATE OF COMPLAINT:</b> NA	<b>POST INSP. CONTACTS:</b> DRMS	<b>JOINT INSP. AGENCY:</b> None	
<b>INSPECTOR(S):</b> Amy Yeldell	<b>INSPECTOR'S SIGNATURE:</b>

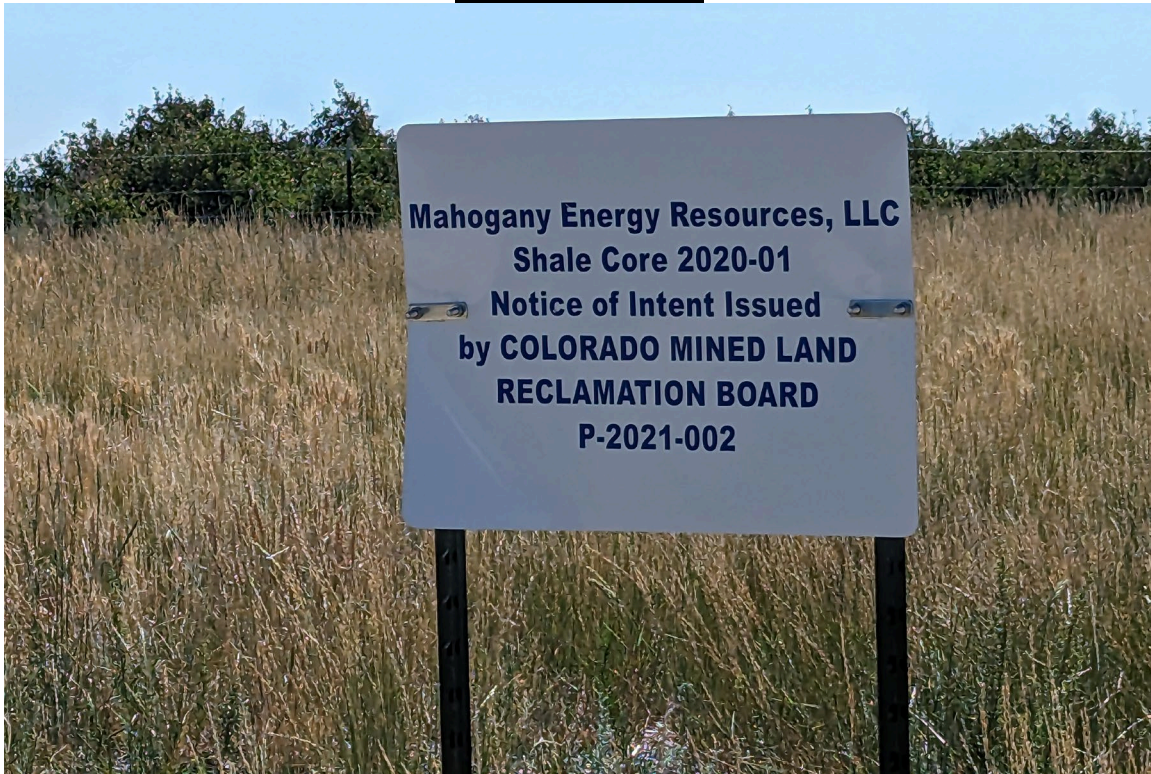
The mine identification sign and affected area boundary markers are in place and in compliance with Rule 3.1.12. A sign is posted as you enter the permit boundary. The permit boundary is delineated by a wire fence.

Photo One: Mine sign at entrance to site

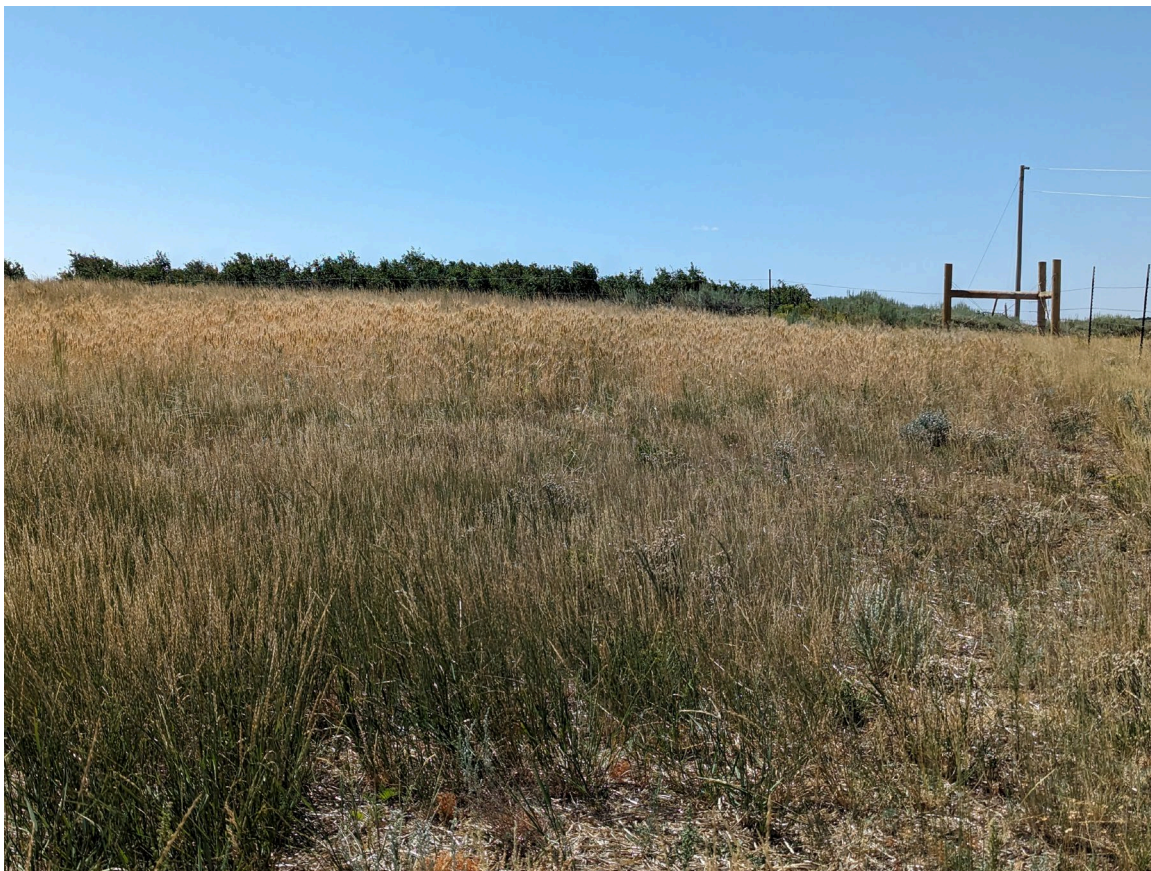
Photo Two: Dense patches of triticale

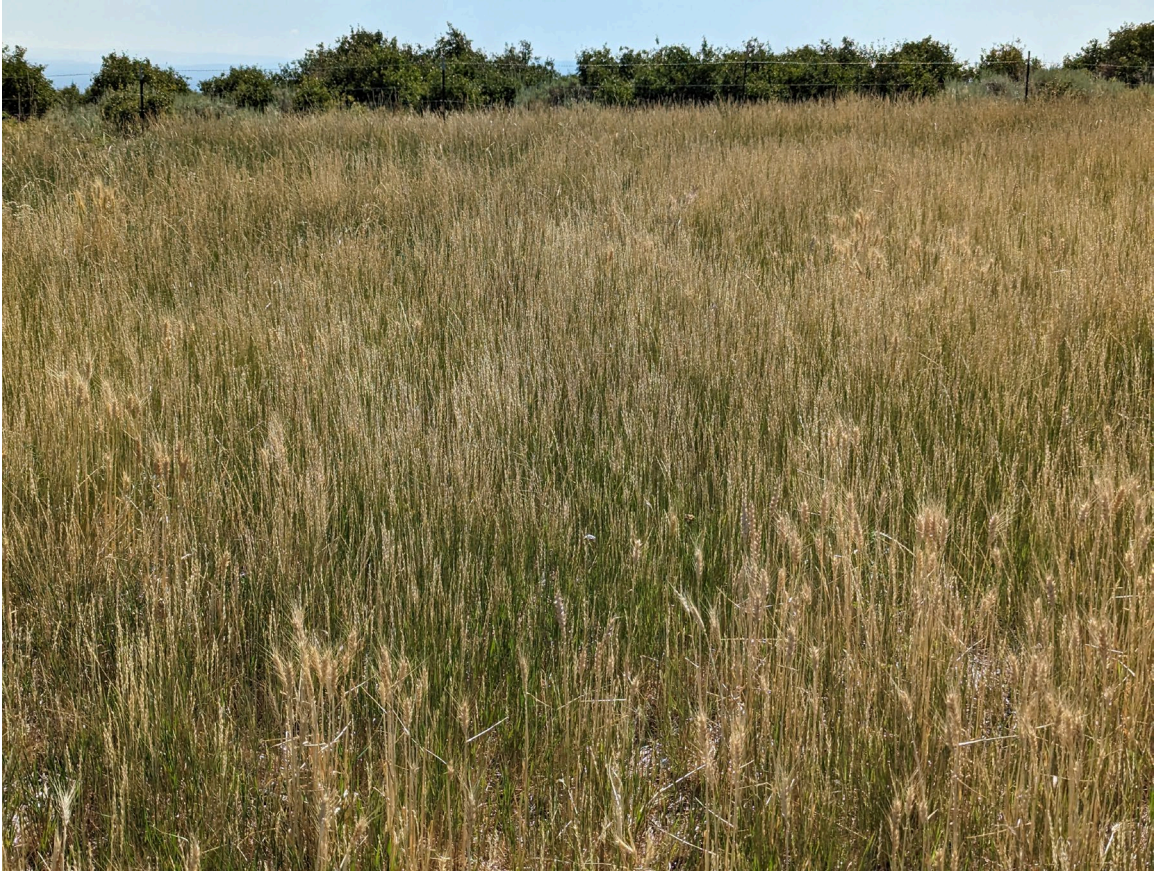
Photo Three: Dense and diverse cover of desirable grasses

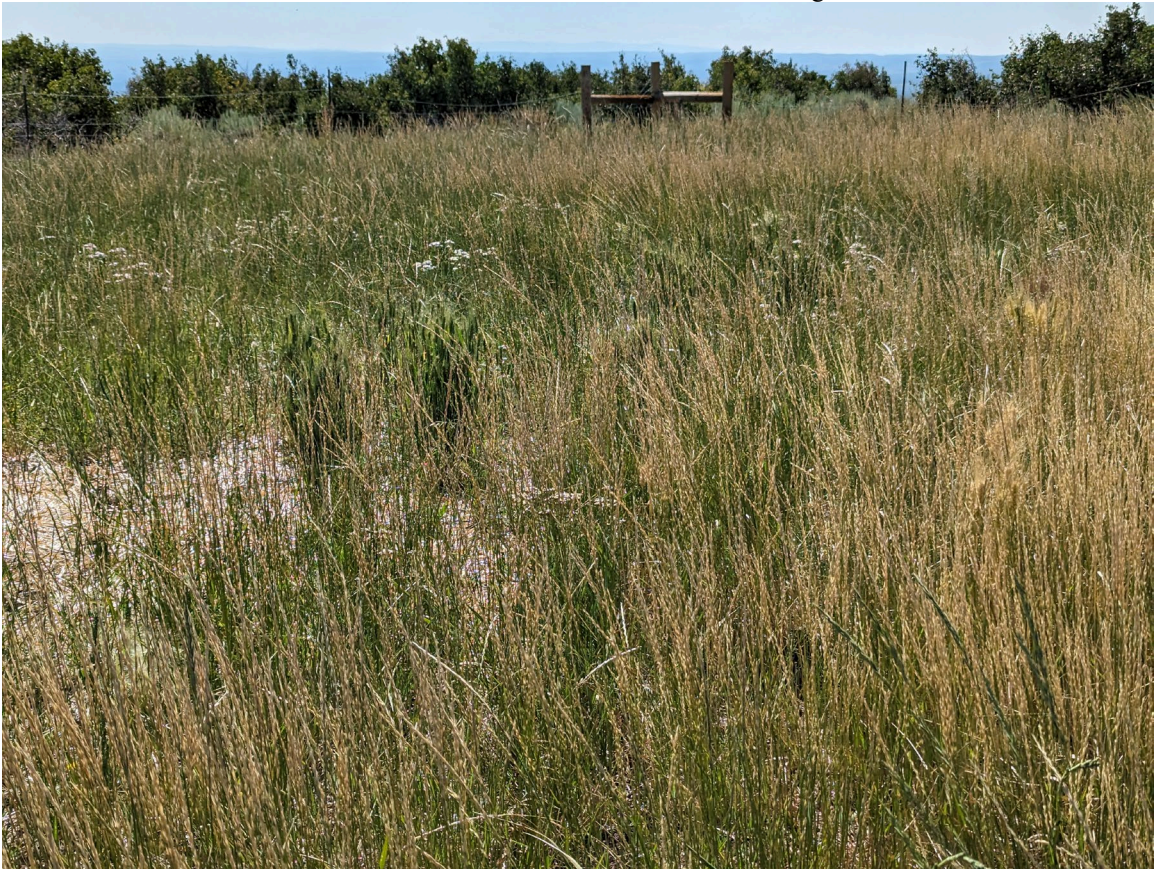
Photo Four: a few shrubs/ forbs beginning to establish.
