### MINERALS PROGRAM INSPECTION REPORT

<b>MINE NAME:</b> Hooper Pit	<b>MINE/PROSPECTING ID#:</b> M-2020-024	<b>MINERAL:</b> Sand and gravel	<b>COUNTY:</b> Saguache
<b>INSPECTION TYPE:</b> Monitoring	<b>WEATHER:</b> Clear	<b>INSP. DATE:</b> August 10, 2023	<b>INSP. TIME:</b> 07:50
<b>OPERATOR:</b> APC Southern Construction Co., LLC	<b>OPERATOR REPRESENTATIVE:</b> Jim MacDonald	<b>TYPE OF OPERATION:</b> 111 - Construction by Government Agency

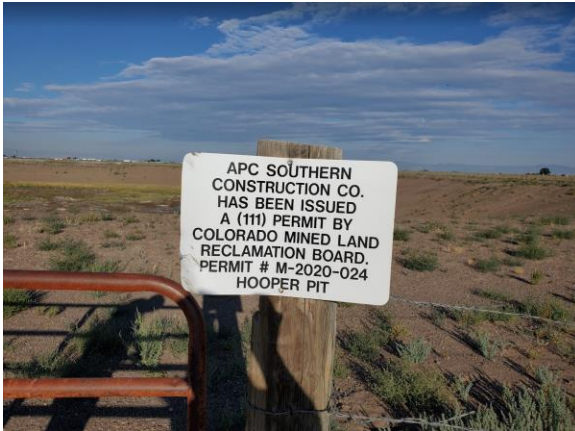
View to the west showing proper Mine ID signage posed at the entrance to the site.

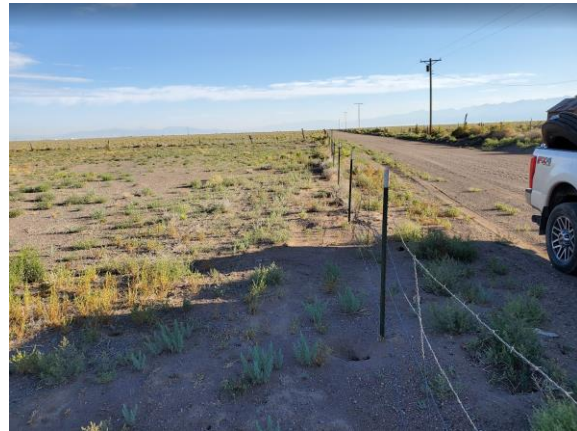
View to the north showing fence line that clearly marks permit boundary.

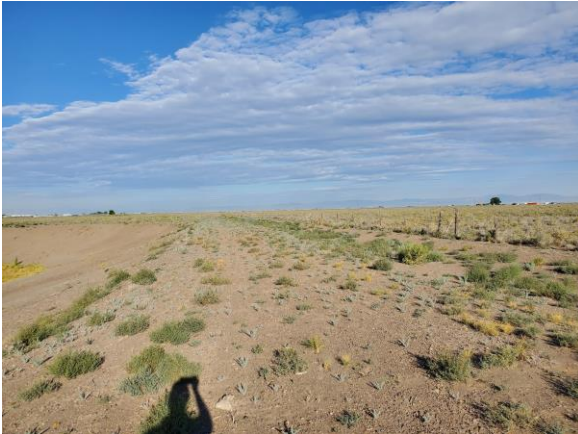
View to the west showing vegetation above the pit along the northern permit boundary

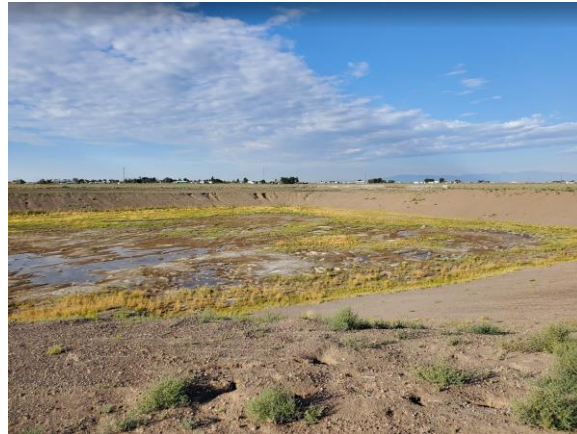
Groundwater was exposed at some point during the mining process which contradicts the approved Mine Plan. Water was observed at the bottom of the pit during this inspection and the previous inspection. This is noted as a problem. The permit application states that groundwater would not be exposed. Please contact the Colorado Division of Water Resources (DWR) to obtain a Gravel Well Pond Permit or other documentation that allows groundwater to be exposed on the pit floor. If permission from DWR cannot be obtained, the operator will need to backfill the pit to at least two feet above the groundwater surface.

Mining has been conducted at reclamation grade resulting in no high wall on the property. Slopes of the pit generally appear stable with minor erosional rills in the southwest corner of the pit. Revegetation attempts on the pit slopes were not successful – most likely due to poor quality of topsoil in the area. Before the permit could be released the Operator will need to obtain documentation from the land owner that they will accept the land in its current condition. The letter must contain statements that the land owner accepts exposed groundwater, vegetation, and erosion rills. If no documentation is provided that the land owner accepts the land in the current condition then the operator will be responsible for backfilling the pit to at least two feet above the groundwater surface, removing erosion features on the pit walls, and revegetating.

View to the south of erosion rills on the far side of the pit. Water can be seen on pit floor

**CORRECTIVE ACTIONS:** The operator shall demonstrate that the operation is in compliance with the Office of the State Engineer, show evidence that the operator is taking measures to bring the site into compliance with the SEO, or backfill the pits to at least two feet above the groundwater surface by the corrective action date specified.

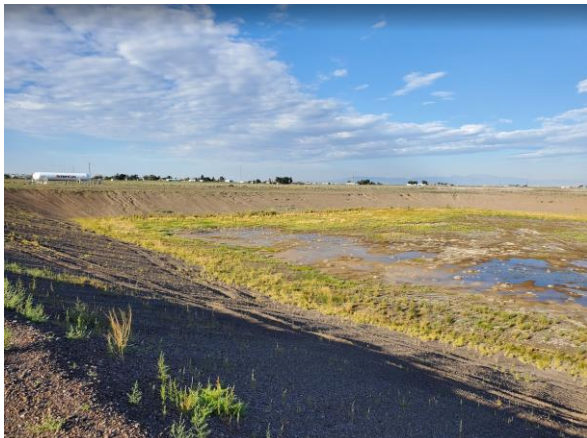
**PROBLEM/POSSIBLE VIOLATION:** Problem: The Division has no evidence that the operator has a valid well permit, substitute water supply plan, or approved water augmentation plan for the exposed groundwater at the site. This is a problem related to 34-32.5-116(4)(h) of the Colorado Revised Statutes and 3.1.6(1)(a) of the Construction Materials Rules and Regulations governing injury to existing water rights.

View to the southwest showing exposed groundwater, erosion rills on pit slopes and lack of revegetation.

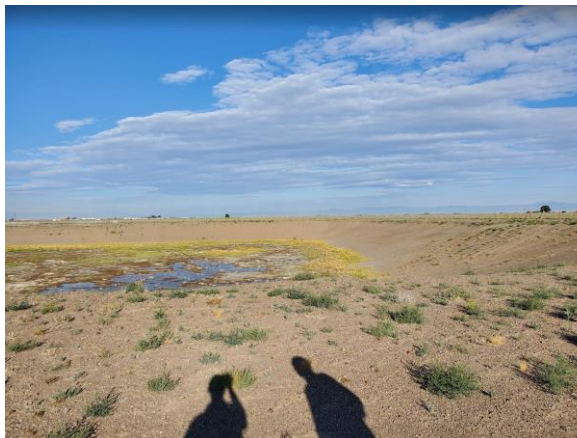
View to the west showing slopes of the pit walls. The pit was mined at reclamation grade, but limited vegetation is present on the slopes
