COLORADO
Division of Reclamation,
Mining and Safety
Department of Natural Resources

PERMIT INFORMATION

Permit Number: C-1994-082 Mine Name: Yeast Mine Operator Address: Seneca Property LLC Ms Miranda Kawcak 29515 Routt County Road No. 27 Oak Creek, CO 80467	County: Routt Operation Type: Surface Permit Status: Permanent Cessation Ownership: Private Operator Representative Present: Miranda Kawcak
Operator Representative Signature: (Field Issuance Only) This report was issued electronically from the Divisions' Denver Office.

Inspection Start Date: 17 Aug. 2023 Inspection Start Time: 16:00 p.m. Inspection End Date: 17 Aug. 2023 Inspection End Time: 16:15 p.m.	Inspection Type: Coal Partial Inspection Inspection Reason: Normal I&E Program Weather: Clear
Joint Inspection Agency: None	Joint Inspection Contacts:
Post Inspection Agency: None	Post Inspection Contacts:
Inspector(s): Robin Reilley, M.S. GISP	Inspector's Signature:

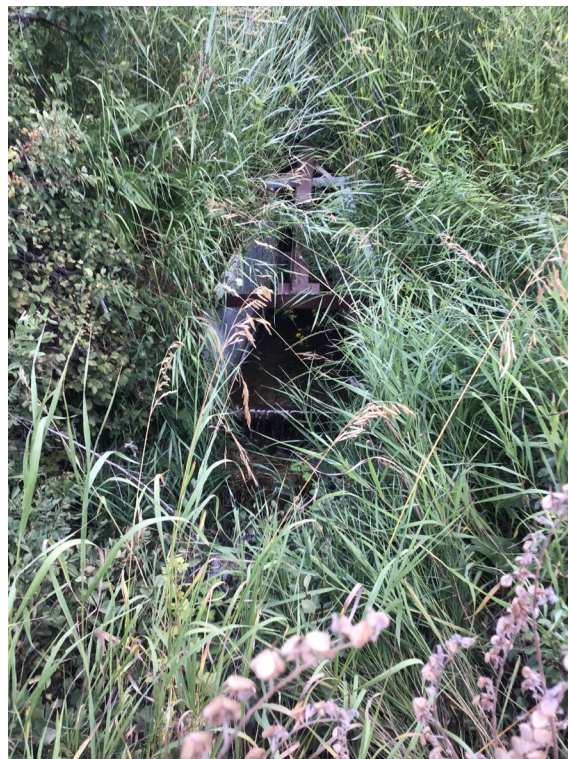
- Pond 12 was discharging clear water through flume at the time of inspection. The flume is encompassed by tall grasses.
- Pond 13 held water and was not discharging through its culvert. A white ring was apparent on the east and south edges of the pond from evaporation.
- Pond 14 held water and was not discharging. Some algae was present on the water surface.

Photo 1: Pond 12 flume discharging clear water.

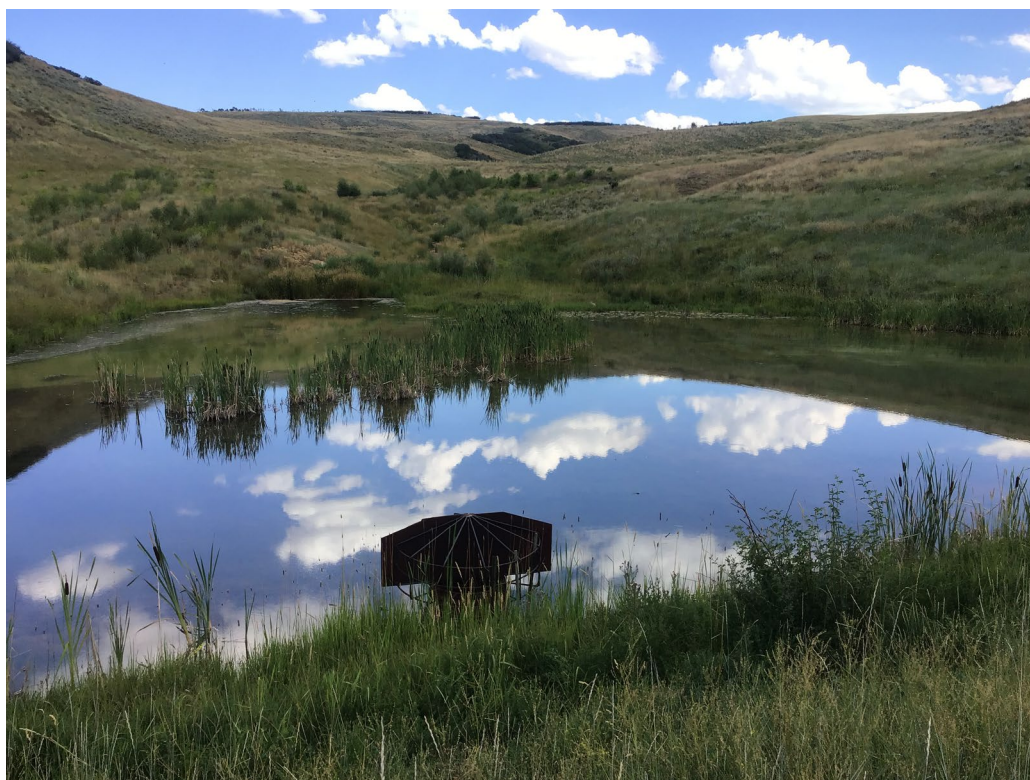
Reclamation has been completed at the site with the exception of the hillside above Pond 12.

- Vegetation on the slopes above Pond 12 appeared adequate and was beginning to dry out.

Photo 2: Pond 12, looking (east) up the slopes awaiting final bond release.

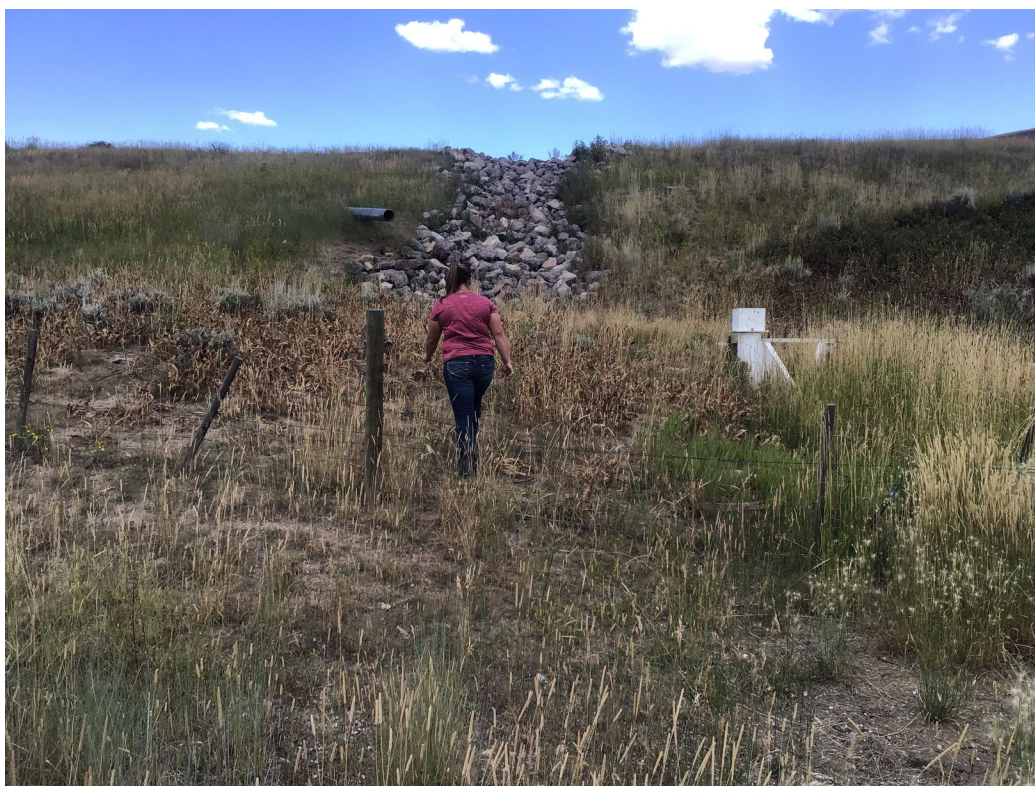
Photo 3: Pond 13 discharge structures viewed from the County road.

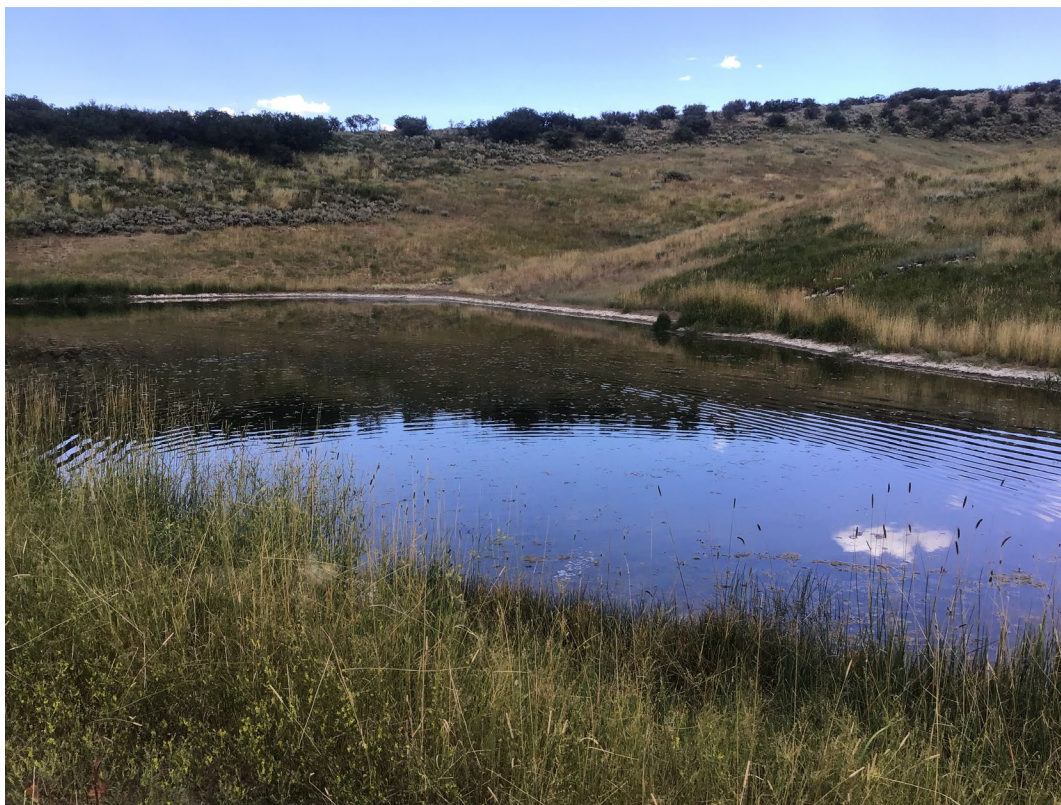
Photo 4: Pond 13 holding water.

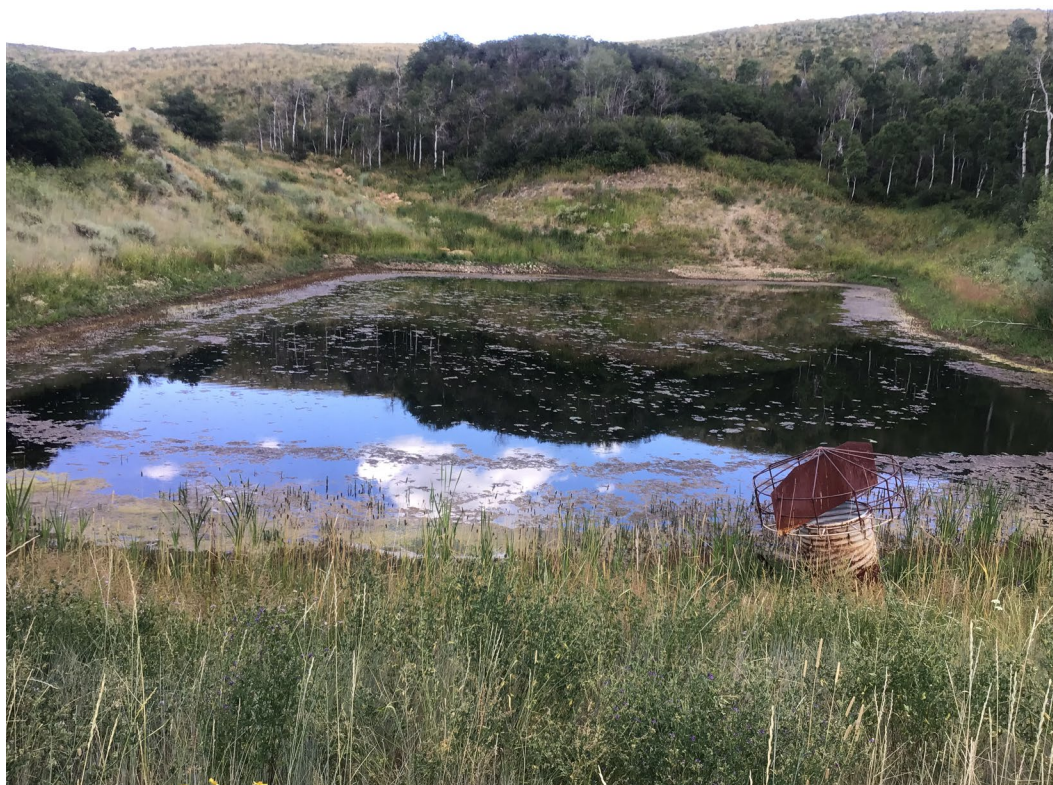
Pond 14 drop structure is cracked and water is flowing into structure. Structure requires sealing.

Photo 4: Pond 14 holding water.
