Division of Reclamation,
Mining and Safety

PERMIT INFORMATION

Permit Number: C-1982-057 Mine Name: Seneca II-W Mine Operator: Seneca Property LLC Operator Address: Ms. Miranda Kawcak 29515 Routt County Road 27 Oak Creek, CO 80467	County: Routt Operation Type: Surface Permit Status: Permanent Cessation Ownership: Private
	Operator Representative Present: Miranda Kawcak
Operator Representative Signature: (Field Issuance Only)

Inspection Start Date: 17 August, 2023 Inspection Start Time: 14:40 p.m. Inspection End Date: 17 August, 2023 Inspection End Time: 15:45 p.m.		Inspection Type: Coal Partial Inspection Inspection Reason: Normal I&E Program Weather: Partly Cloudy	
Joint Inspection Agency: None		Joint Inspection Contacts:	
Post Inspection Agency: None		Post Inspection Contacts:	
Inspector(s): Robin Reilley, GISP	Inspector's Signature:

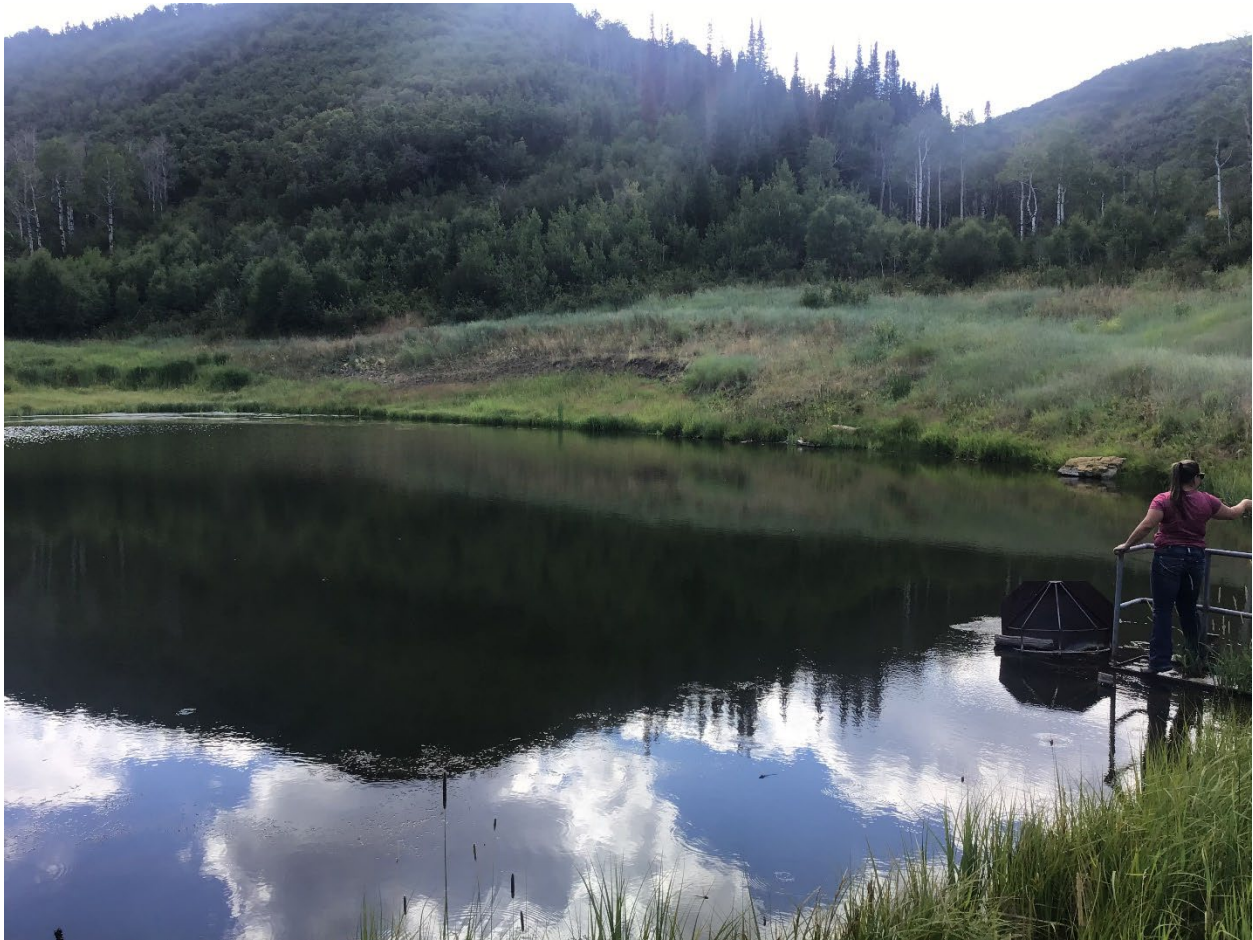
Photo 1: Pond 15.

Drop structure at Pond 15 had wood debris caught in the exterior enclosure. These were removed at the time of inspection.

- Pond 15 was discharging clear water through drop structure. Bottom vegetation was thriving in the pond. Tall grasses encompass the drainage to the flume. Water was flowing under the flume, requiring the flume to be reset.

1. Flume at Pond 15 requires resetting.

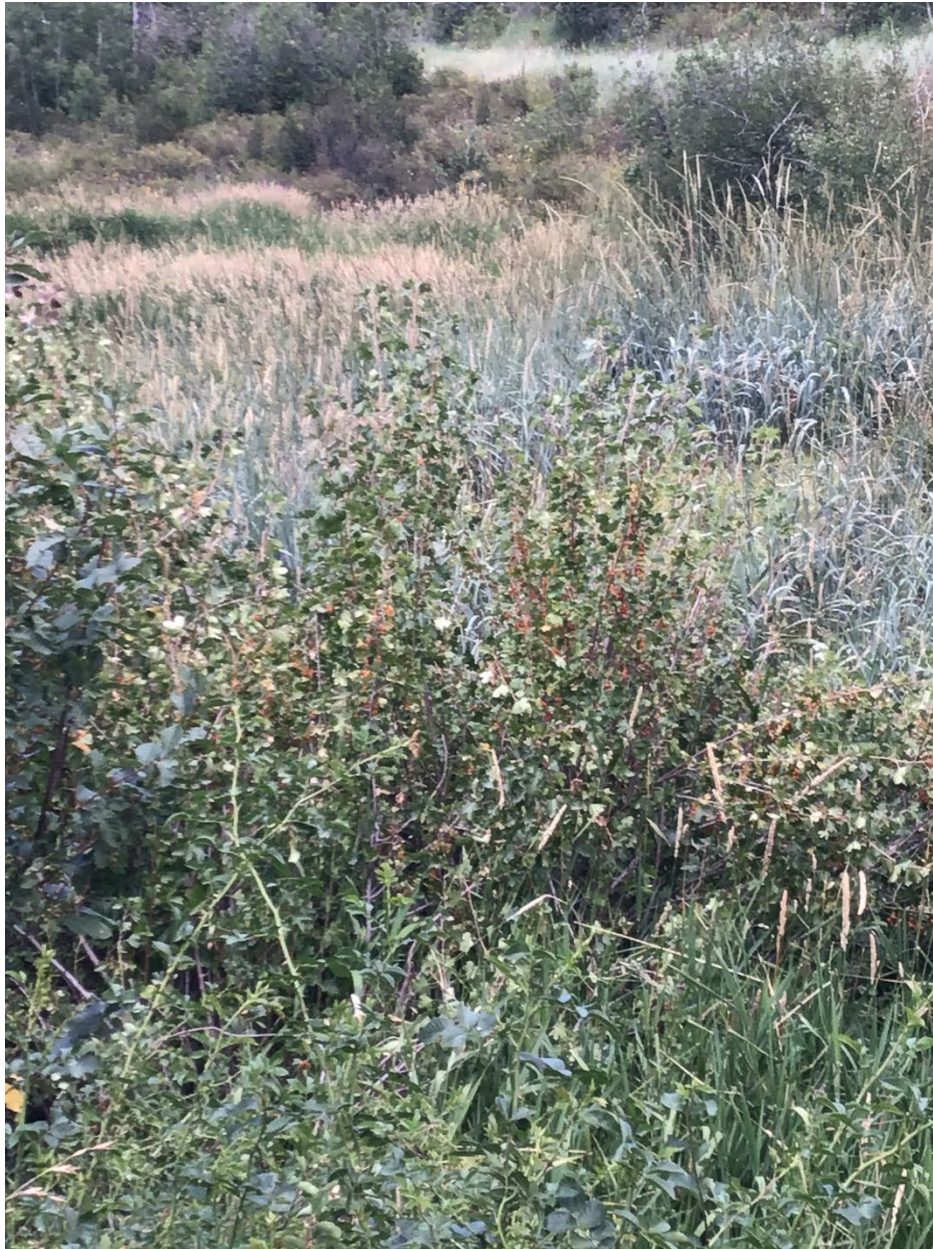
Photo 2: Golden current bushes laden with berries.

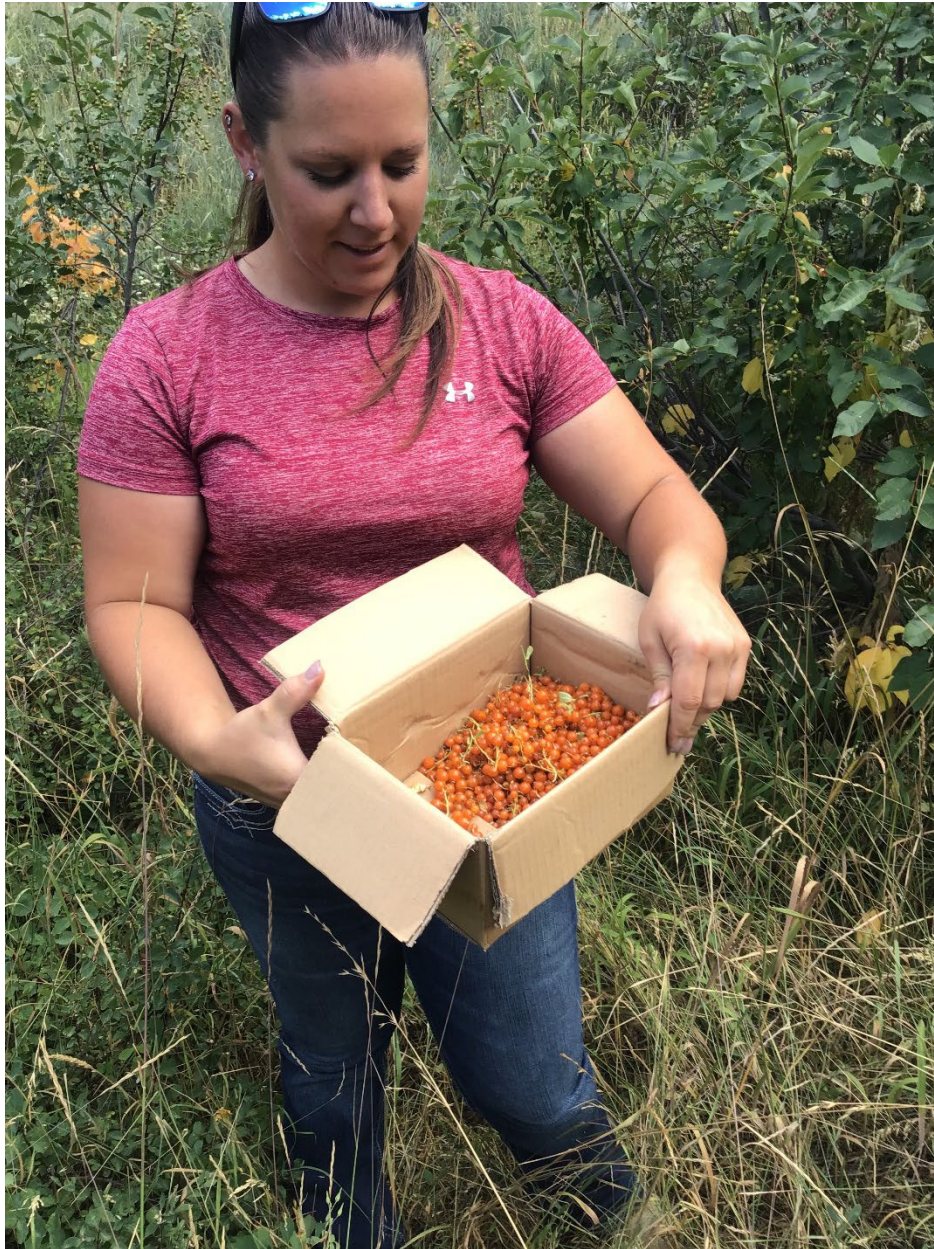
Photo 3: Harvest of golden currants.
