## 2023 August Complete Inspection Trapper Mine

**16 August 2023**

Permit Number: C1981010 Mine Name: Trapper Mine Operator: Trapper Mining, Inc. Operator Address:  Mr. Graham Roberts P.O. Box 187 Craig, CO 81626	County: Moffat Operation Type: Surface Permit Status: Active Ownership: Federal
	Operator Representative Present: Graham Roberts
This report was issued electronically from the Divisions' Denver Office.

Inspection Start Date: <b>16 August 2023</b> Inspection Start Time: 8:15 a.m. Inspection End Date: <b>16 August 2023</b> Inspection End Time: 5:30 p.m.	Inspection Type: <b>Coal Complete Inspection</b> Inspection Reason: Normal I&E Program Weather: Clear
Joint Inspection Agency:	Joint Inspection Contacts:
Post Inspection Agency: None	Post Inspection Contacts:
Inspector(s): Robin A. Reilley, M.S. GISP	Inspector's Signature:

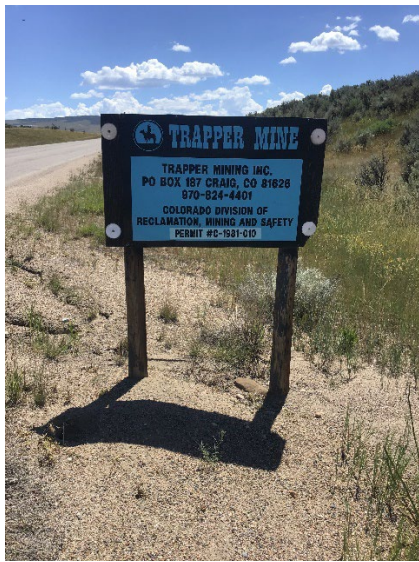
- The mine site identification signs observed at the main mine access point, (entrance from State Highway 13), was intact, displaying all required information: mine name, operator name, address, phone number, DRMS permit number and contact information.
- Blasting notification signs were placed at the entrances to the site.
- The new portion of the permit boundary (PR11), had not yet been delineated or fenced.
- Pond identification signs were prominently displayed in the vicinity of the ponds visited and were in adequate repair at the time of inspection.
- Topsoil stockpiles observed were clearly marked with identifying signs.

*Photo 1: Mine identification sign at main entrance.*

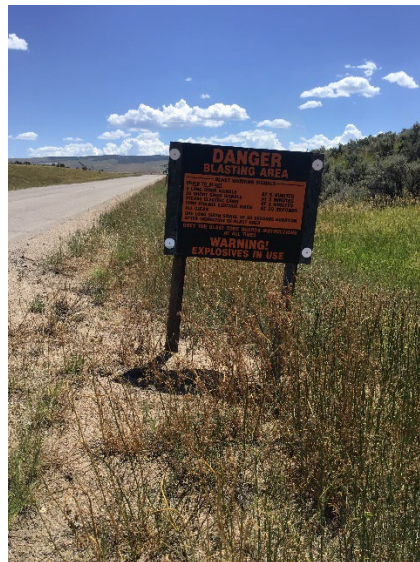
*Photo 2: Blasting information at main entrance.*

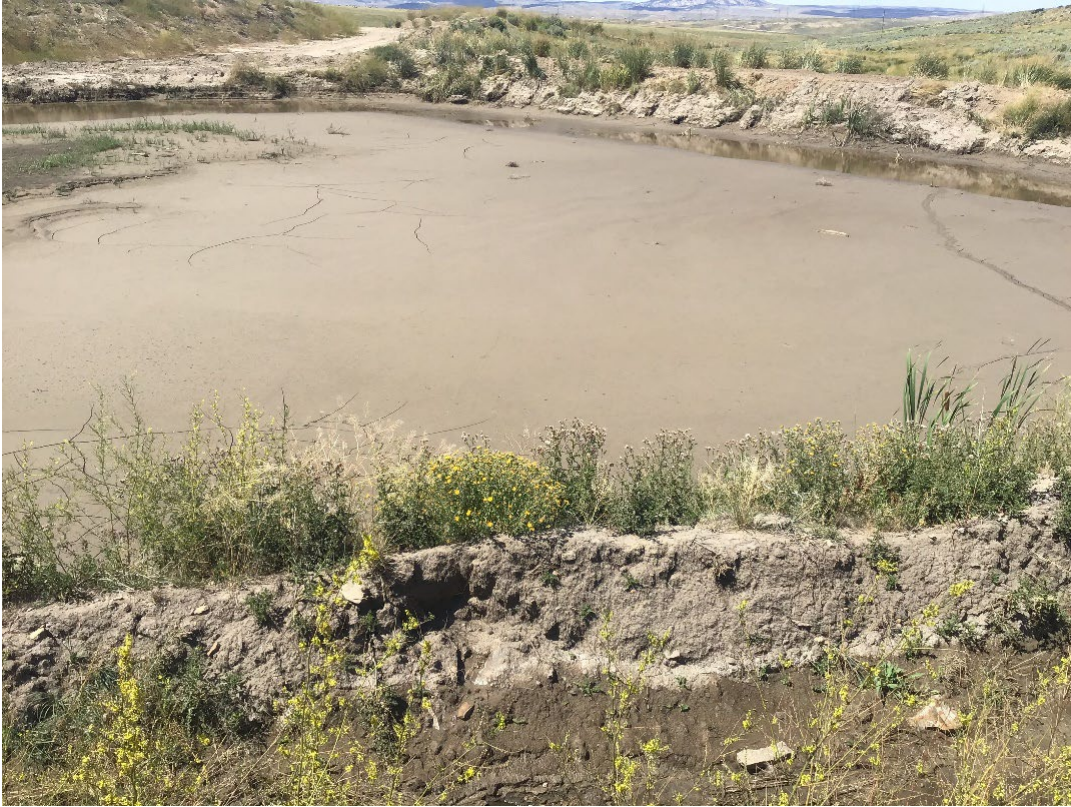
- East Pyeatt Pond #1 had been pumped down and water was being diverted downstream to next pond. The pond will be dredged once dredging of the dozer basin above Middle Flume #3 is complete.

*Photo 3: East Pyeatt #1 Pond, pumped down and slated for dredging.*

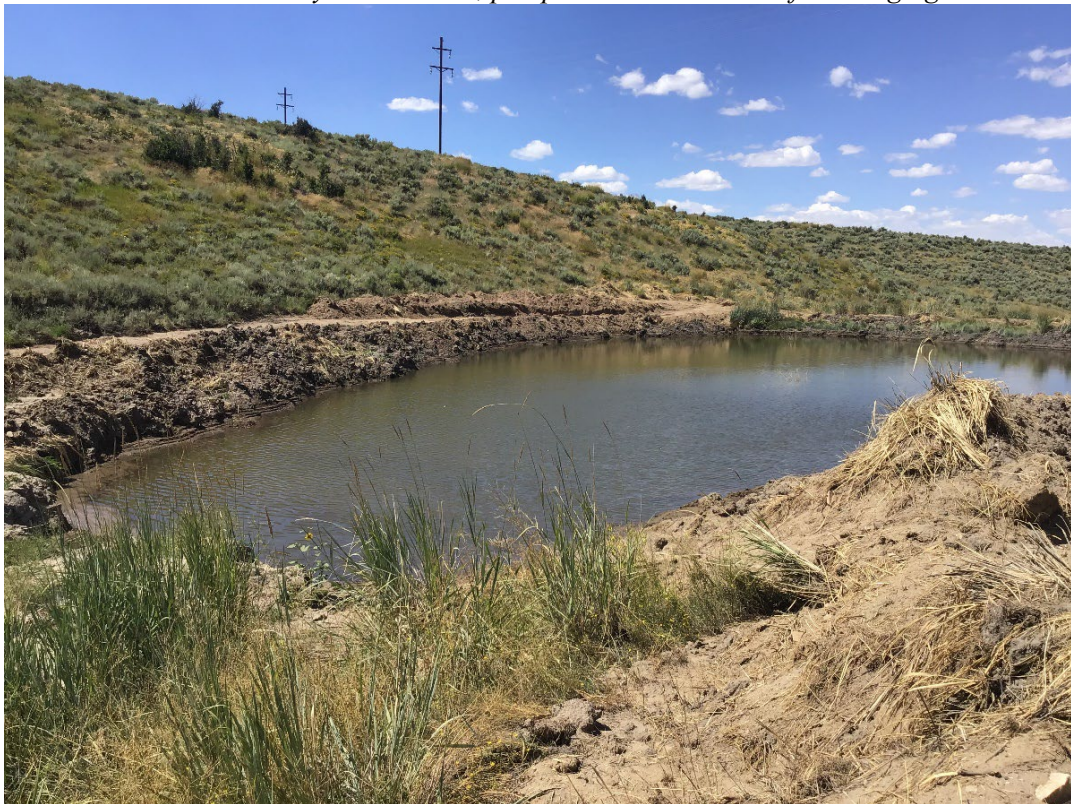
- Middle Pyeatt #1 was holding turbid water and had been dredged.
- East Flume #1 Pond held a puddle.

*Photo 4: Middle Pyeatt #1 Pond, recently dredged.*

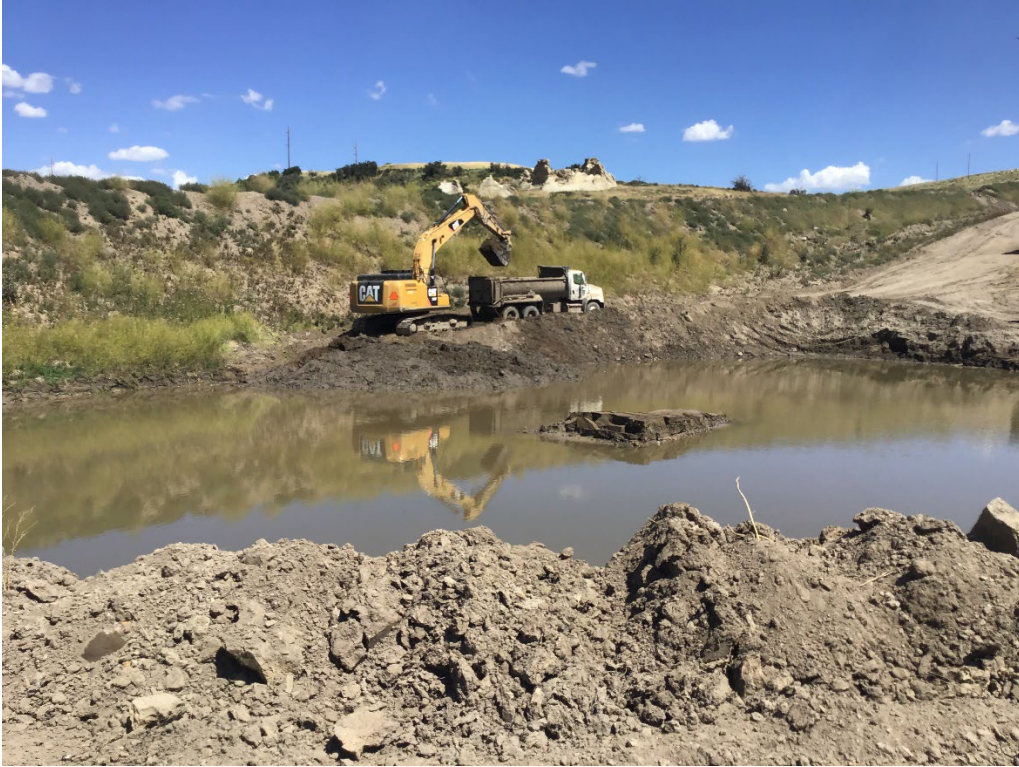
*Photo 5: Dozer basin along main haul road undergoing dredging.*

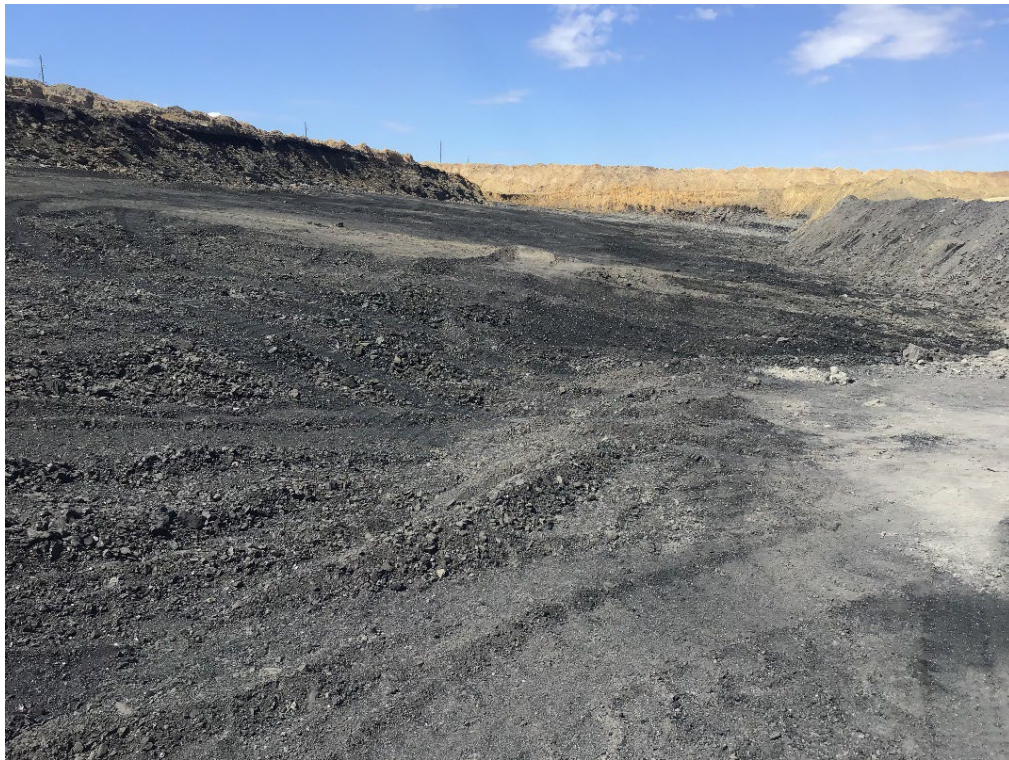
J Pit is still damp in areas. The pit has been dug down to coal and mining will begin soon. The coal dips severely to the north.

*Photo 6: J Pit floor looking west at significant dipping surface.*

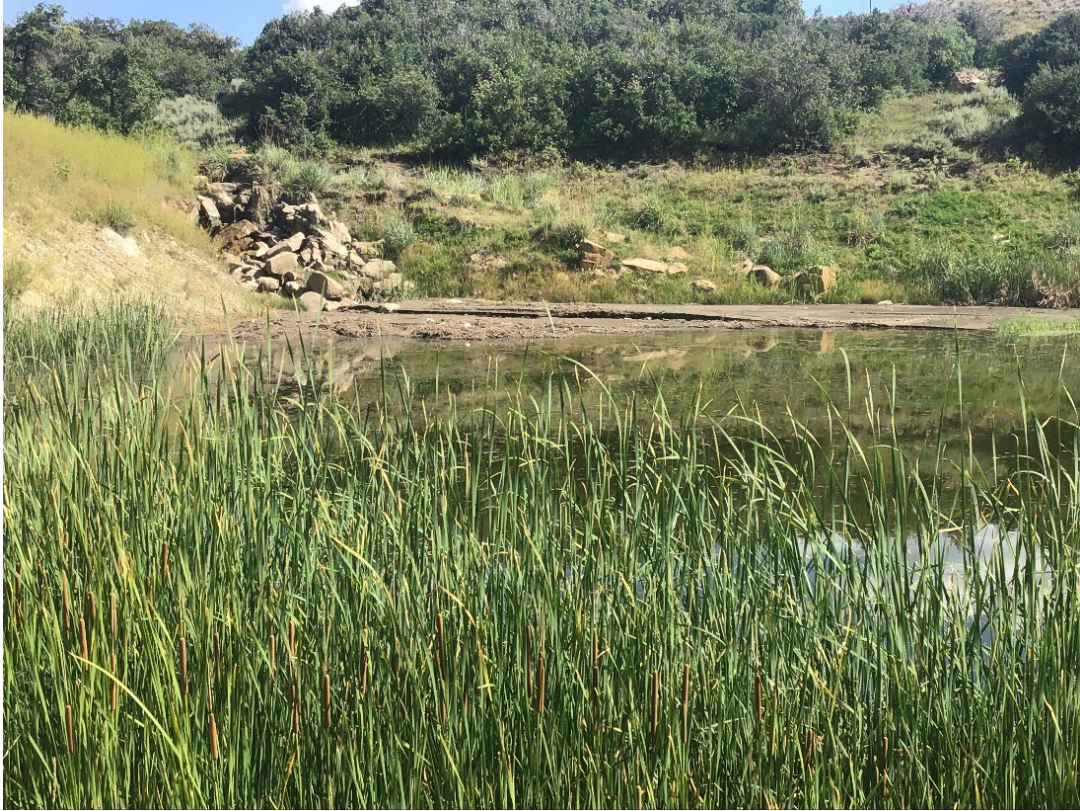
- East Middle Flume #1, located below the dragline stationed in L Pit was discharging through the primary spillway and was experiencing inflow from a spring. A sediment fan is present at the inflow.

*Photo 7: East Middle Flume Pond, exhibiting inflow from spring.*

- *Vegetation at spillway inlet at East Middle Flume Pond requires removal.*

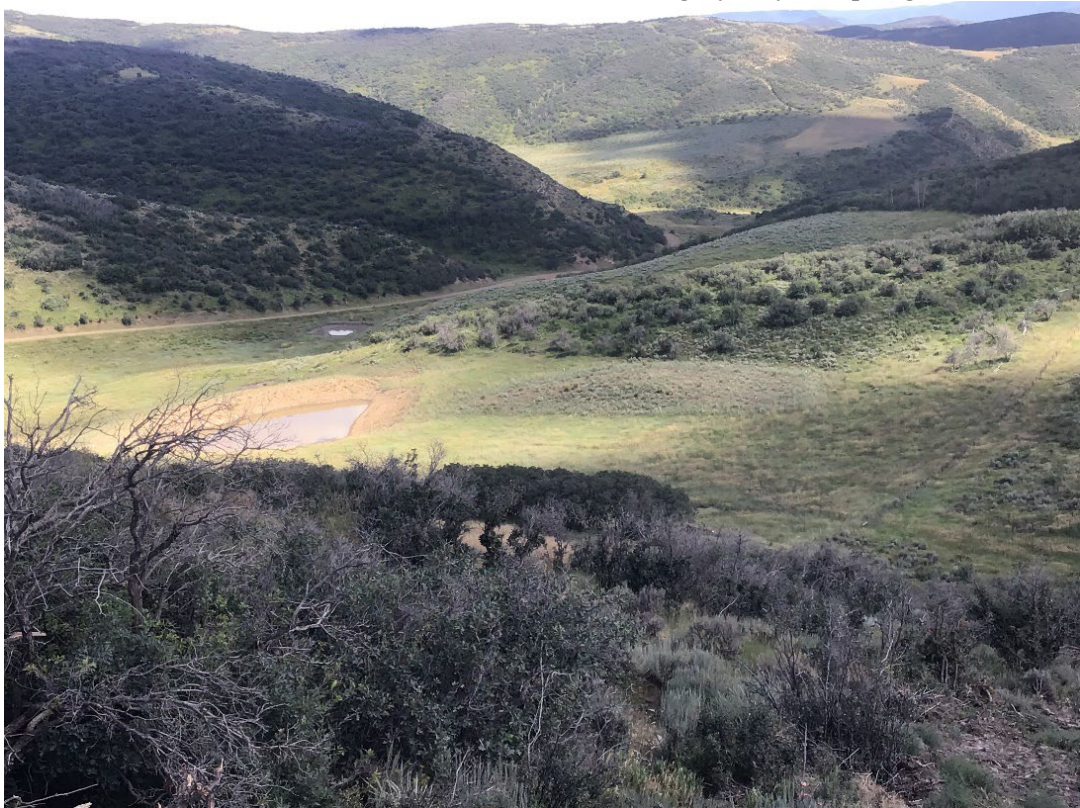
*Photo 8: Jeffway Pond from above looking east.*

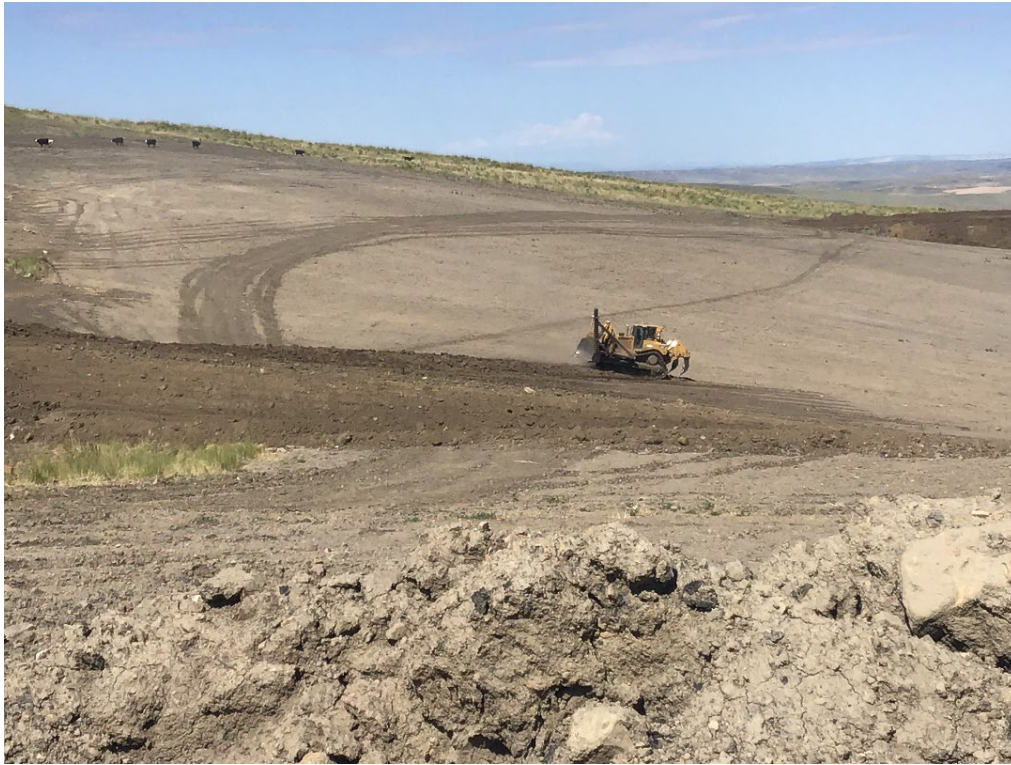
D pit work was underway on lower portion of the pit placing a constructed drainage to tie into an existing drainage to the west. Soil was being layed down along east edge at the terminus of D Pit to establish the channel. Ripping and grading the topsoil haul road at upper south area of D Pit used to transport topsoil to the pit was occurring at the time of inspection.

*Photo 9: D Pit ripping and grading topsoil haul road.*

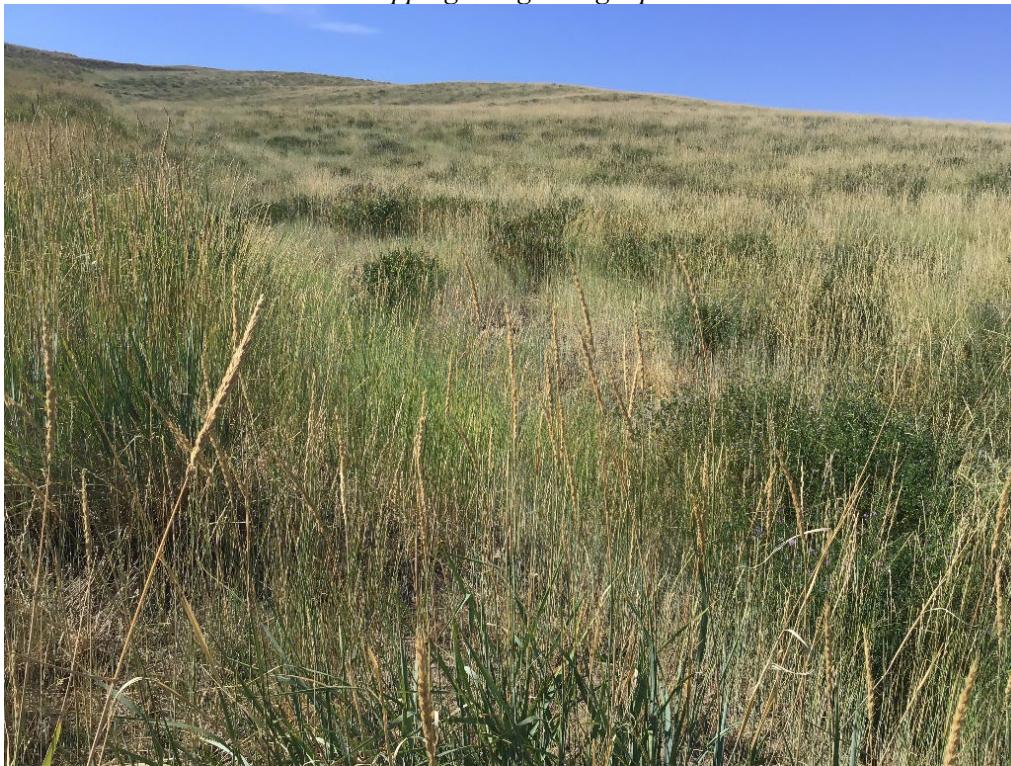
- Reclamation comprised of topsoil and seeding was not occurring at the time of inspection.
- Vegetation was beginning to dry out and loose its verdant green color. Chamisa was just beginning to bloom.
- A 40 acre area adjacent to D Pit was monitored for vegetation cover and diversity. The area abuts Phase III reclamation and appears of similar diversity exhibiting good cover. No erosional features were noted, ditches have stabilized with vegetation. A couple of dozer basins were noted and appeared stable with adequate vegetation. The area comprises mostly wheat grasses and alfalfa. Minimal weeds were present.

*Photo 10: Overview of vegetation comprising a 40 acre area east of D Pit grading and adjacent to phase III released acreage to the east.*

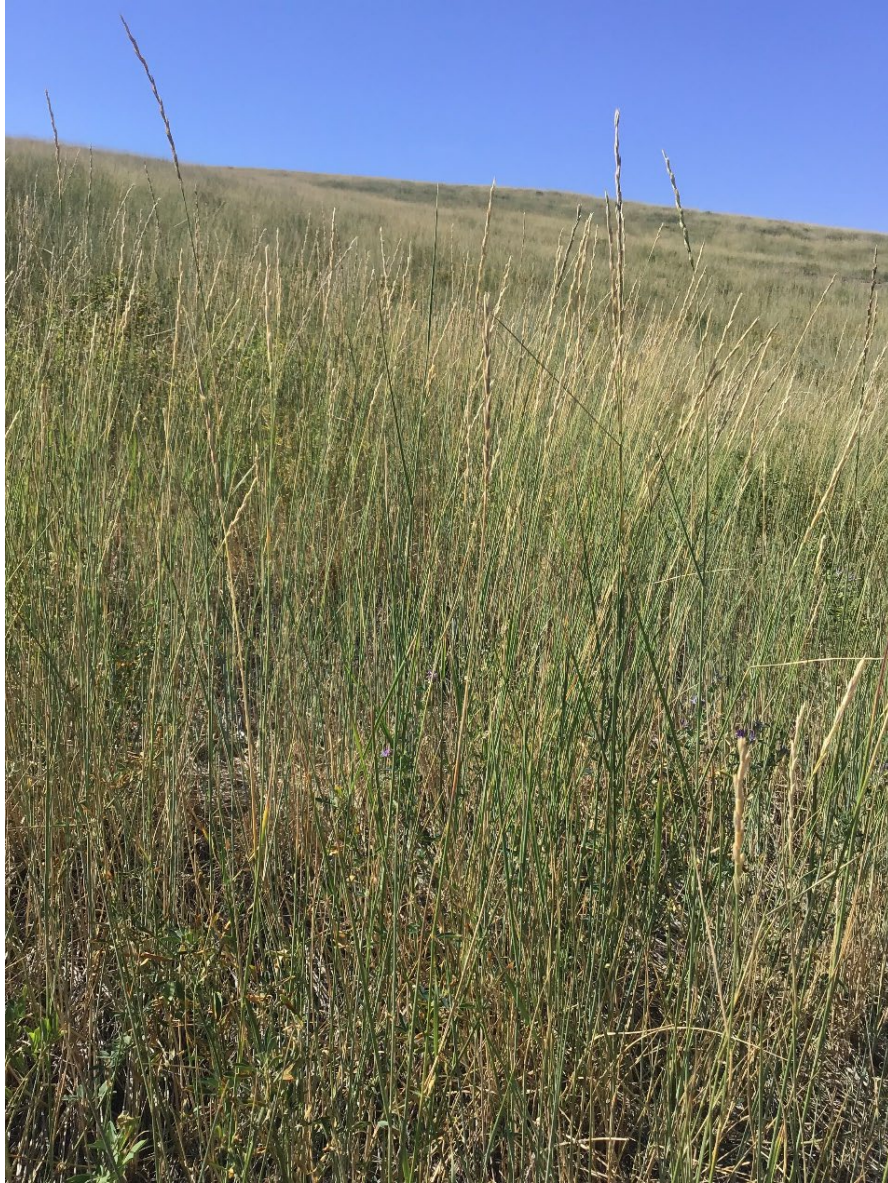
*Photo 11: Dense D Pit vegetation comprised mostly of wheat grasses and alfalfa.*

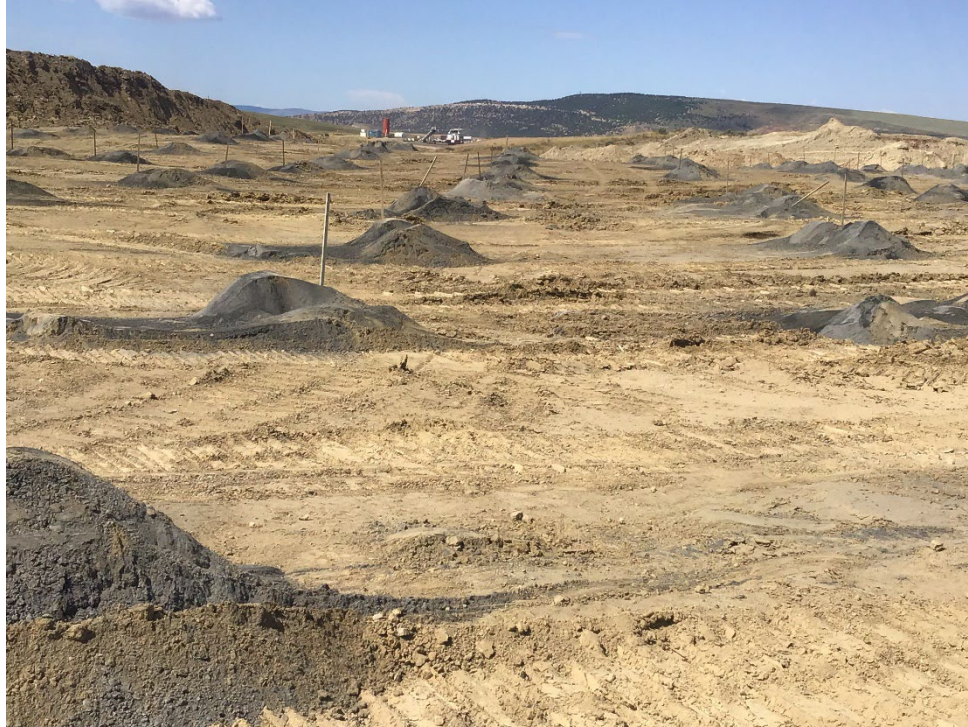
*Photo 12: Blast set up in I Pit Middle.*

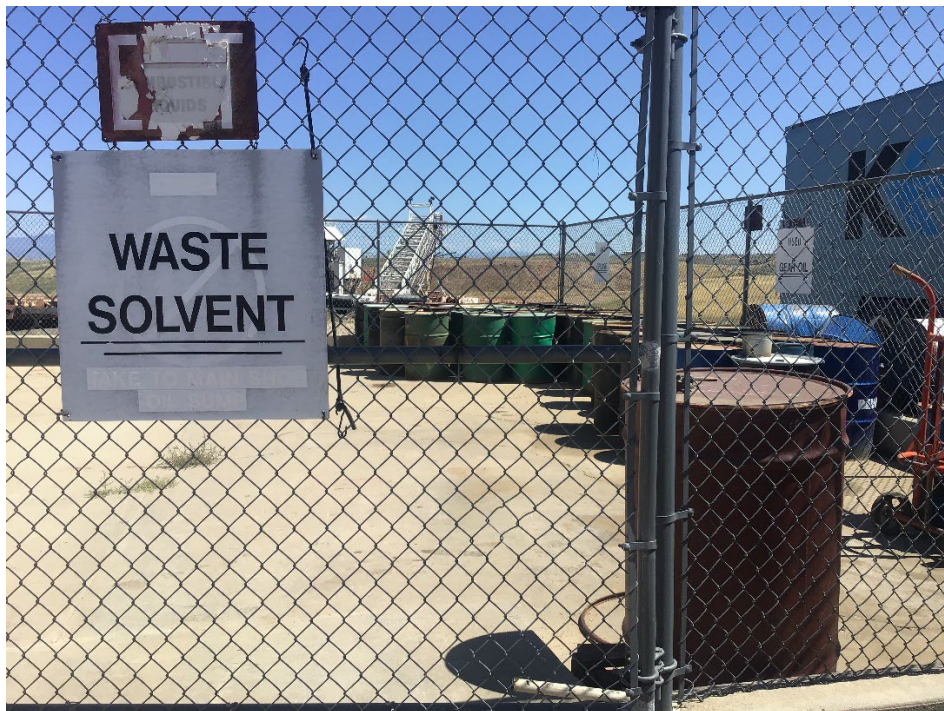
*Photo 13: Solvent storage area, with barrel lids sealed.*

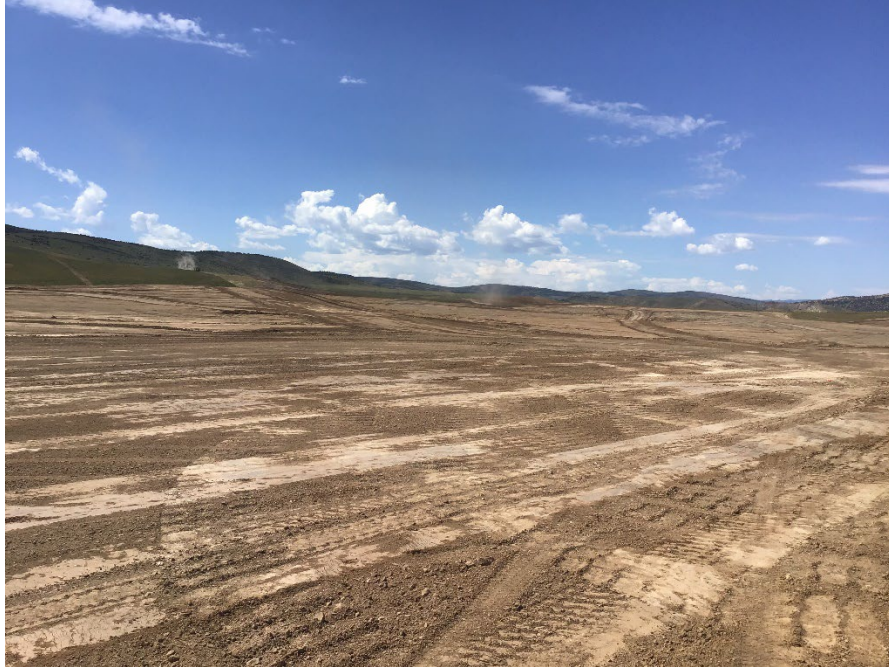
The lower north end of C Pit is partially stripped for placement of a spoil dump, haul roads and ramps. Stripping was occurring at the time of inspection. A portion of the required power line for C Pit operations has been relocated and is in place. Operations were raising dust at the time of inspection.

*Photo 14: C Pit stripping activities, looking southwest.*
