C-2010-089 New Horizon North August Partial Inspection Report

PERMIT INFORMATION

Permit Number: C-2010-089 Mine Name: New Horizon North Mine Operator: Elk Ridge Mining and Reclamation, LLC Operator Address: Mr Tony Tennyson P.O. Box 628 27646 West 5th Avenue Nucla, CO 81424	County: Montrose Operation Type: Surface Permit Status: Active Ownership: Private
	Operator Representative Present: Tony Tennyson
Operator Representative Signature: (Field Issuance Only)

Inspection Start Date: August 16, 2023 Inspection Start Time: 08:53 Inspection End Date: August 16, 2023 Inspection End Time: 09:10	Inspection Type: Coal Partial Inspection Inspection Reason: Normal I&E Program Weather: Clear
Joint Inspection Agency: None	Joint Inspection Contacts:
Post Inspection Agency: None	Post Inspection Contacts:
Inspector(s): Lucas West	Inspector's Signature:

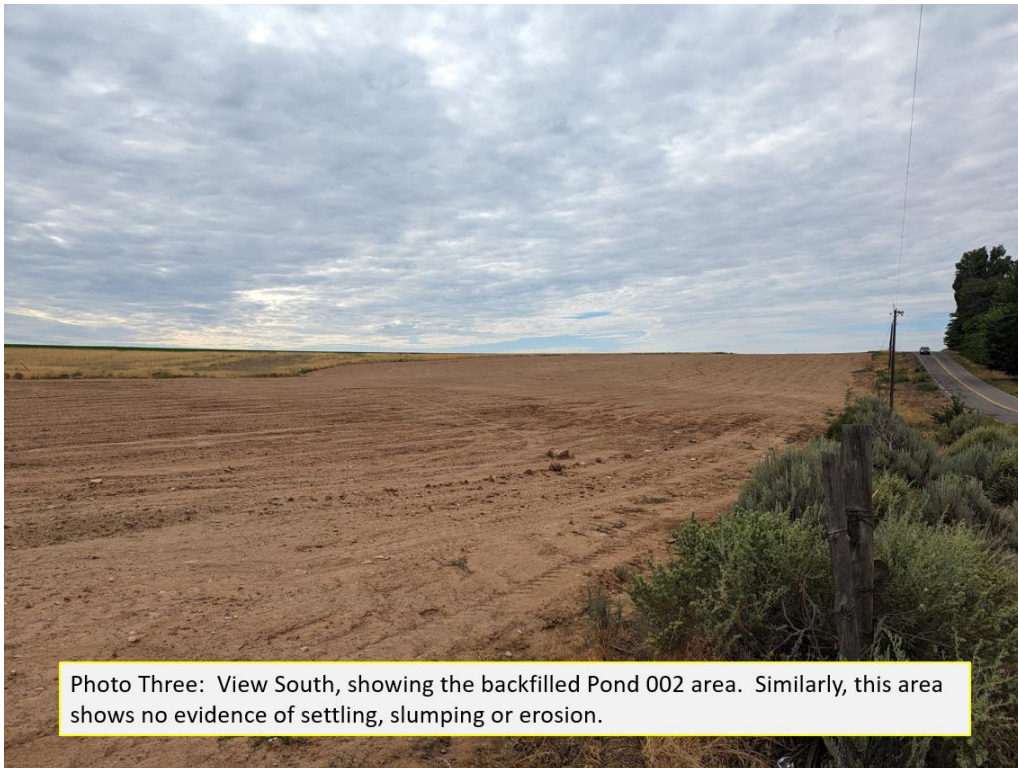
Photo Three: View South, showing the backfilled Pond 002 area. Similarly, this area shows no evidence of settling, slumping or erosion.

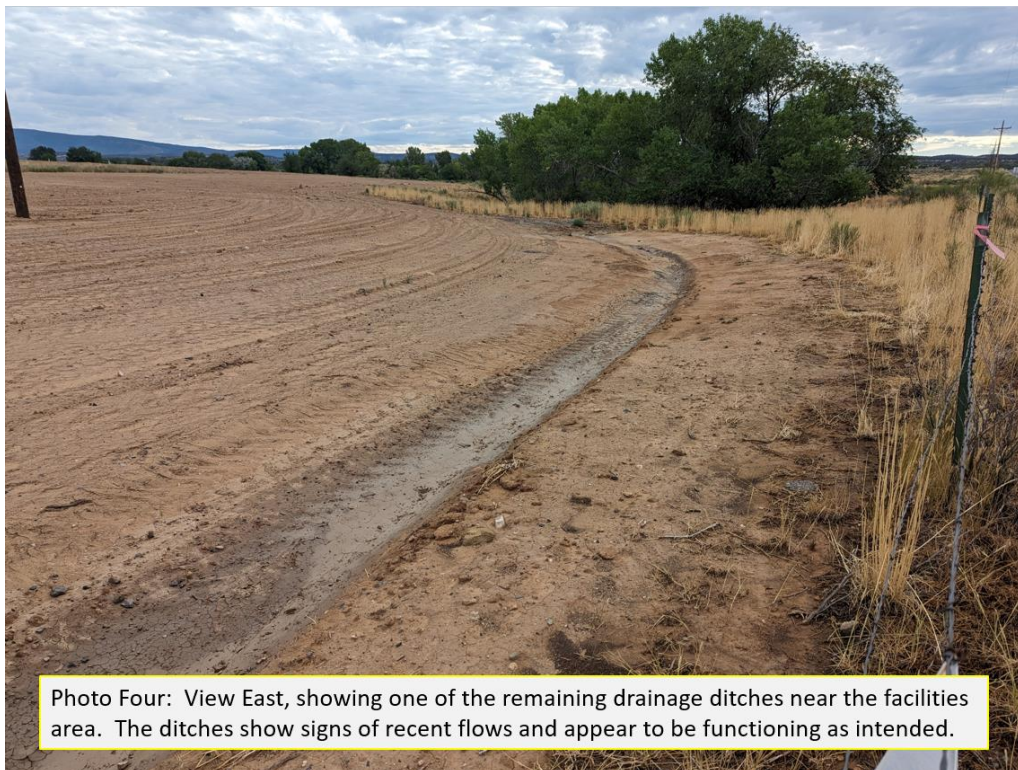
The remaining drainage ditches on site showed evidence of recent flows in response to precipitation events. An example of the ditches can be seen in Photo Four, and appear to be functioning as intended. The stock pond that remains on site can be seen in Photo Five, contained some standing water. Small erosional features have begun to form on the Banks of the pond and discussions with the Operator indicate they are being monitored and will be repaired when the seeding is conducted this fall. This is not considered a problem at this time. The former emergency discharge from Pond 001 that is permitted to remain post reclamation was observed and appears to be conveying storm water effectively and serving its intended purpose.

Photo Four: View East, showing one of the remaining drainage ditches near the facilities area. The ditches show signs of recent flows and appear to be functioning as intended.
