**MINERALS PROGRAM INSPECTION REPORT**  
**PHONE: (303) 866-3567**

<b>MINE NAME:</b> Duck Creek Mine	<b>MINE/PROSPECTING ID#:</b> M-2013-022	<b>MINERAL:</b> Oil shale	<b>COUNTY:</b> Rio Blanco
<b>INSPECTION TYPE:</b> Monitoring	<b>WEATHER:</b> Clear	<b>INSP. DATE:</b> August 9, 2023	<b>INSP. TIME:</b> 12:00
<b>OPERATOR:</b> Shale Tech International Services LLC	<b>OPERATOR REPRESENTATIVE:</b> Justin Bilyeu	<b>TYPE OF OPERATION:</b> 110(2) - Hard Rock Limited Impact	
<b>REASON FOR INSPECTION:</b> Normal I&E Program	<b>BOND CALCULATION TYPE:</b> Partial Bond	<b>BOND AMOUNT:</b> \$395,882.86	
<b>DATE OF COMPLAINT:</b> NA	<b>POST INSP. CONTACTS:</b> None	<b>JOINT INSP. AGENCY:</b> None	
<b>INSPECTOR(S):</b> Amy Yeldell	<b>INSPECTOR'S SIGNATURE:</b>

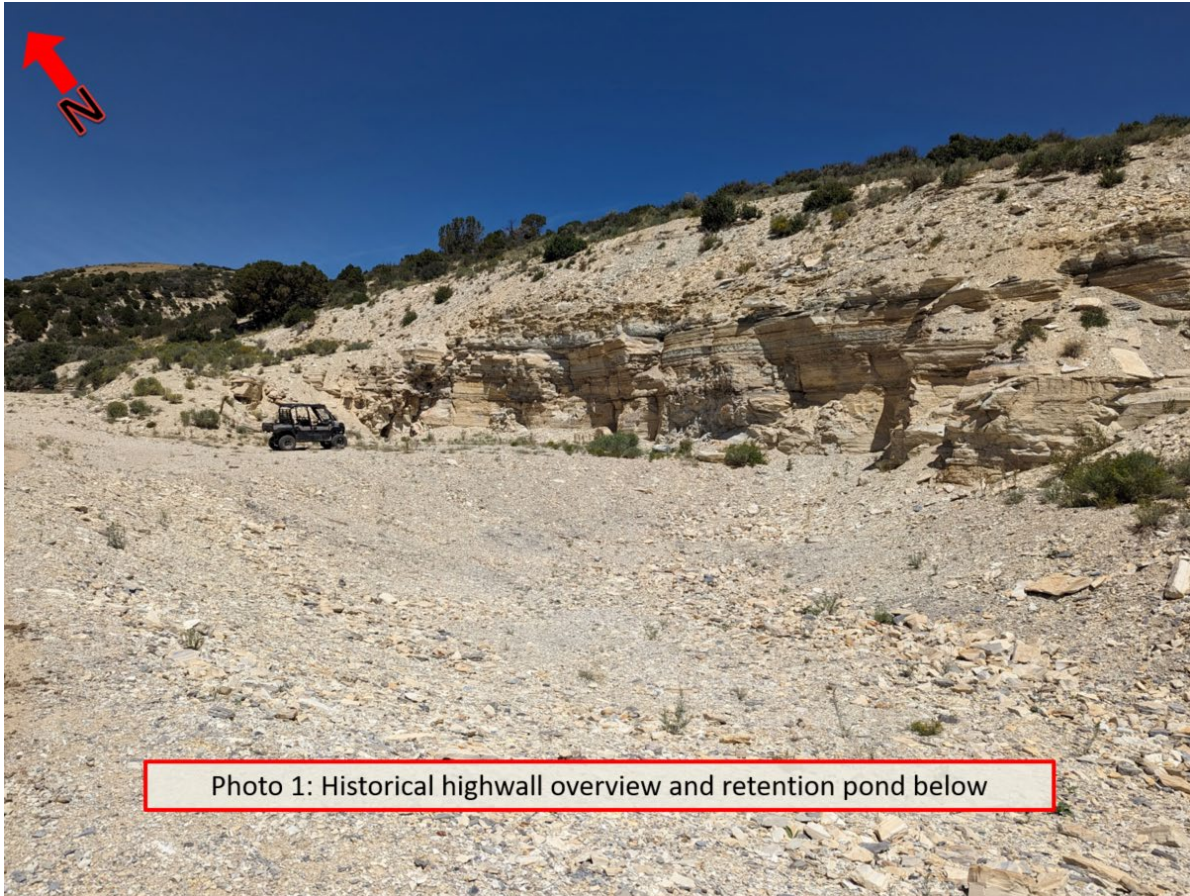
The site is permitted for 5 acres with a maximum disturbance of 3 acres. At this time its estimated that approximately 1.75 acres are disturbed. The site was inactive at the time of the inspection. This site was previously permitted under an NOI. No additional (new) disturbances have occurred since the mining permit was issued. No mining has taken place and all highwalls appear to be in a similar condition as compared to the previous inspection. The historical excavation is approximately 100 LF of vertical highwall at 20-30 ft. tall with pad below (see photos one and two). No fuel, equipment or buildings are located on site.

Photo 1: Historical highwall overview and retention pond below

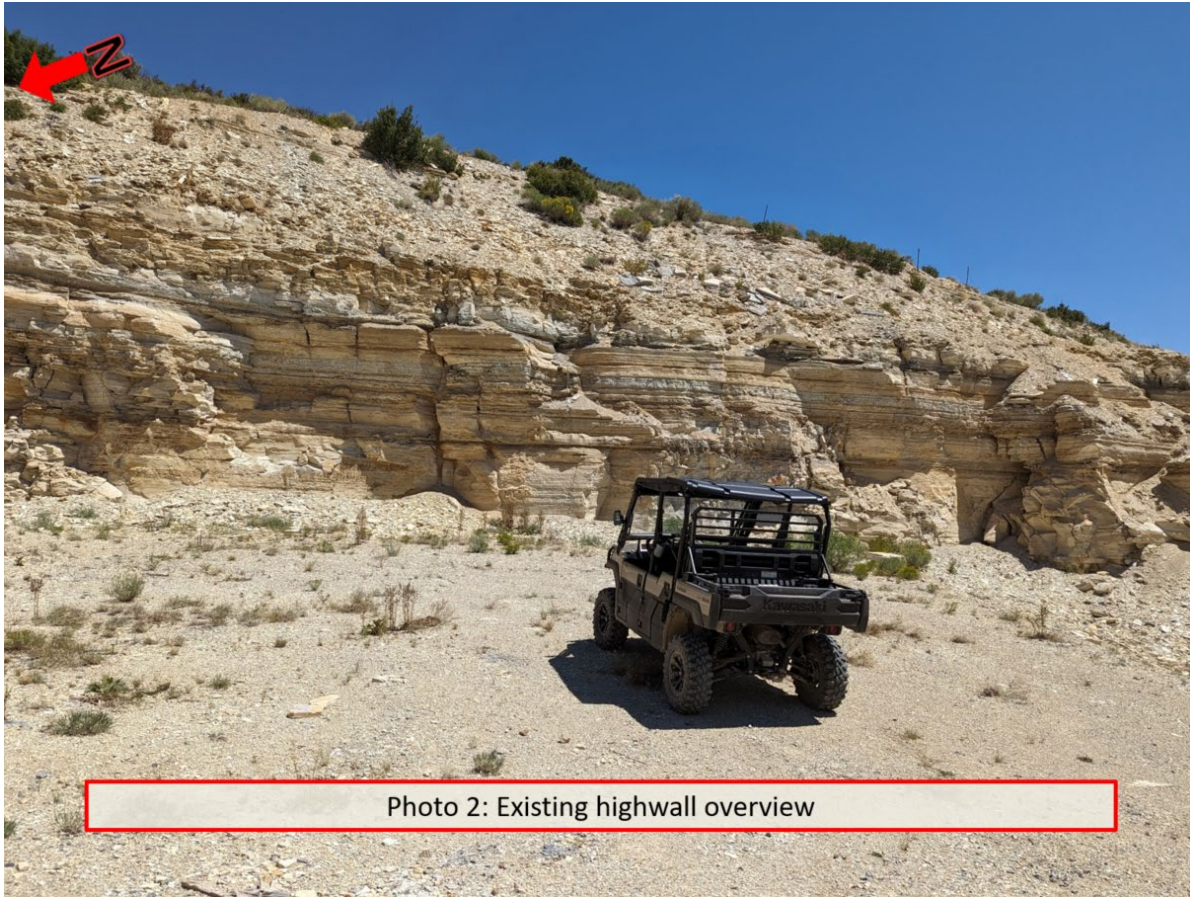
Photo 2: Existing highwall overview

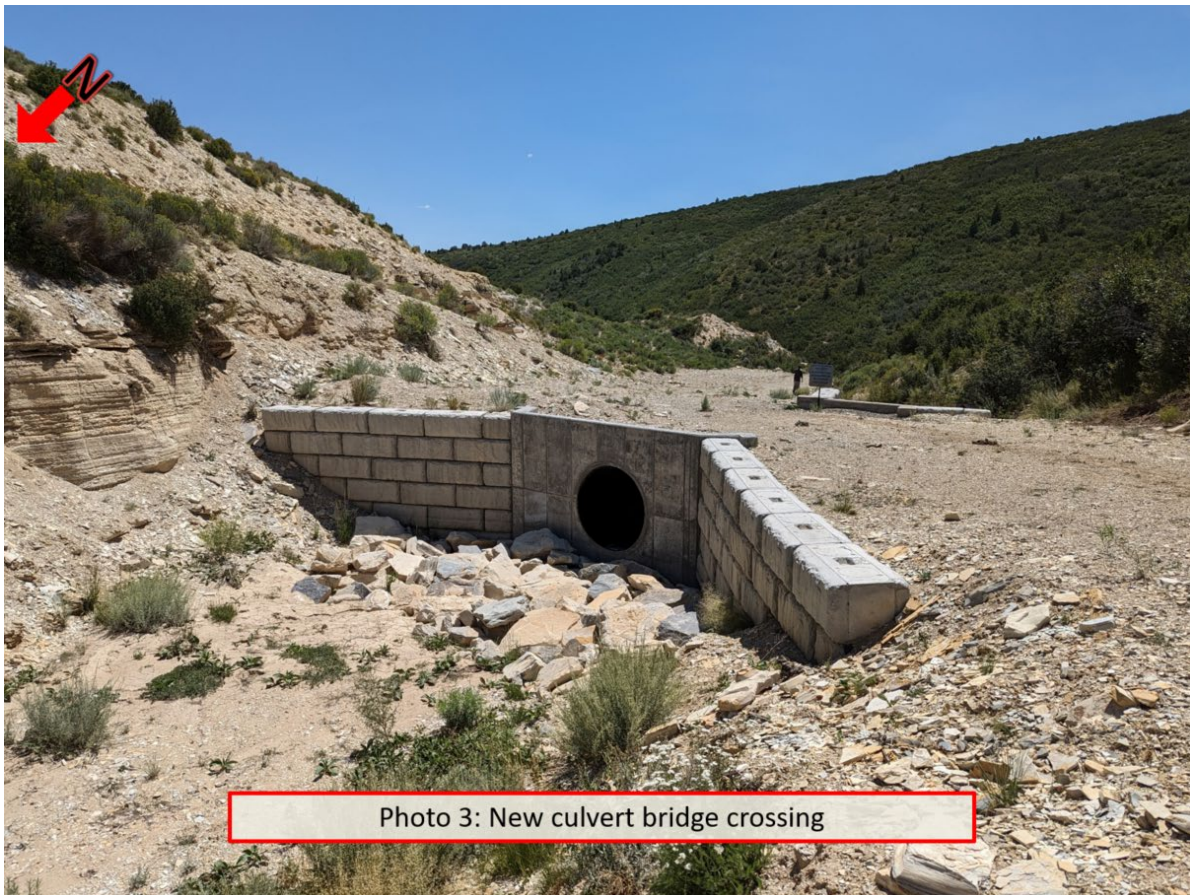
Overall the site appears stable and well maintained. A drainage bisects the access road to the mine. A new 48" stormwater culvert and bridge has been installed since the last inspection (See Photo Three). This feature was discussed in the mine plan however no design specifications were provided with the drainage report. The culvert is to be removed upon completion of mining. Additionally for stormwater control a small excavated pit on the south edge of the existing disturbed footprint has been installed (See Photo Four).

Photo 3: New culvert bridge crossing

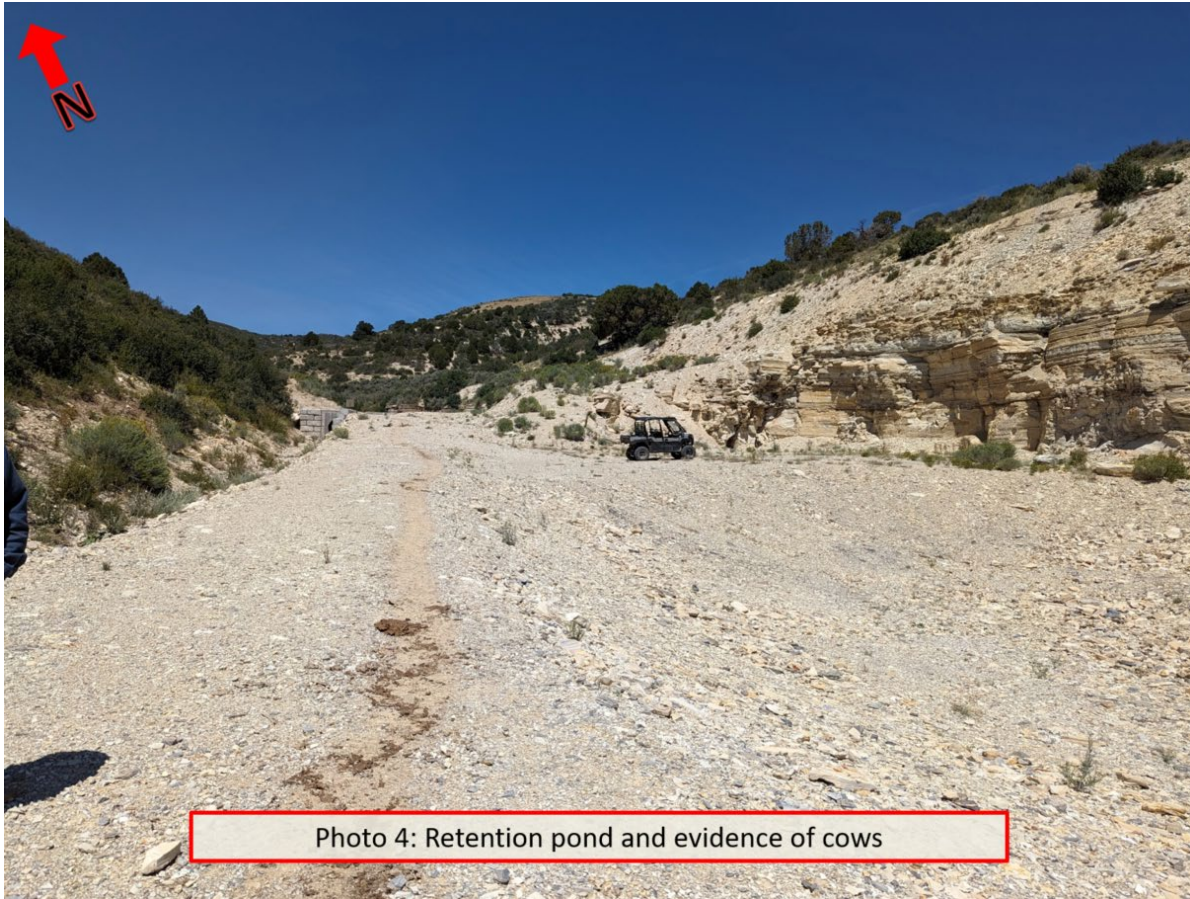
Evidence of cows was observed based on foot path and introduction of noxious weeds along their trail (See Photo Four). No noxious weeds were observed near the mining highwall. The operator is encouraged to manage noxious weeds introduced within the mine site to avoid the potential future reclamation delays if populations become established.

Photo 4: Retention pond and evidence of cows

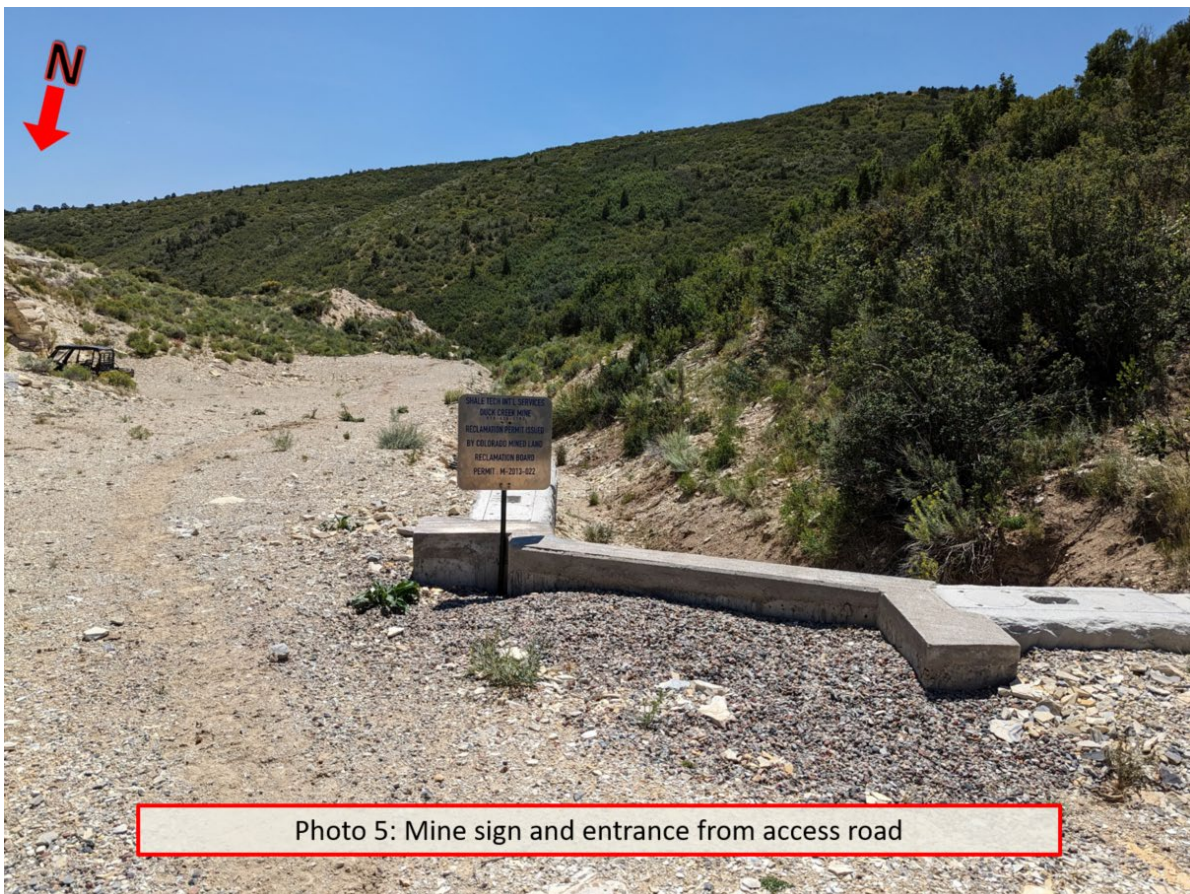
A mine sign was posted at the entrance to the mine site as required by Rule 3.1.12(1). The information depicted was correct/ up to date and the sign was of sufficient size (See Photo Five). The permit boundary of the affected land was clearly delineated pursuant to Rule 3.1.12(2).

Photo 5: Mine sign and entrance from access road
