## C-1981-035 August Partial Inspection Report and Cover Letter

**Re: King Coal Mine Permit No. C-1981-035**  
**August 2023 Post Inspection Outstanding Maintenance Items**

<b>Inspection Start Date:</b> August 16, 2023 <b>Inspection Start Time:</b> 13:34 <b>Inspection End Date:</b> August 16, 2023 <b>Inspection End Time:</b> 15:41	<b>Inspection Type:</b> Coal Partial Inspection <b>Inspection Reason:</b> Normal I&E Program <b>Weather:</b> Clear
<b>Joint Inspection Agency:</b>  None	<b>Joint Inspection Contacts:</b>  None
<b>Post Inspection Agency:</b>  None	<b>Post Inspection Contacts:</b>  None
<b>Inspector(s):</b>  Lucas West	<b>Inspector's Signature:</b>

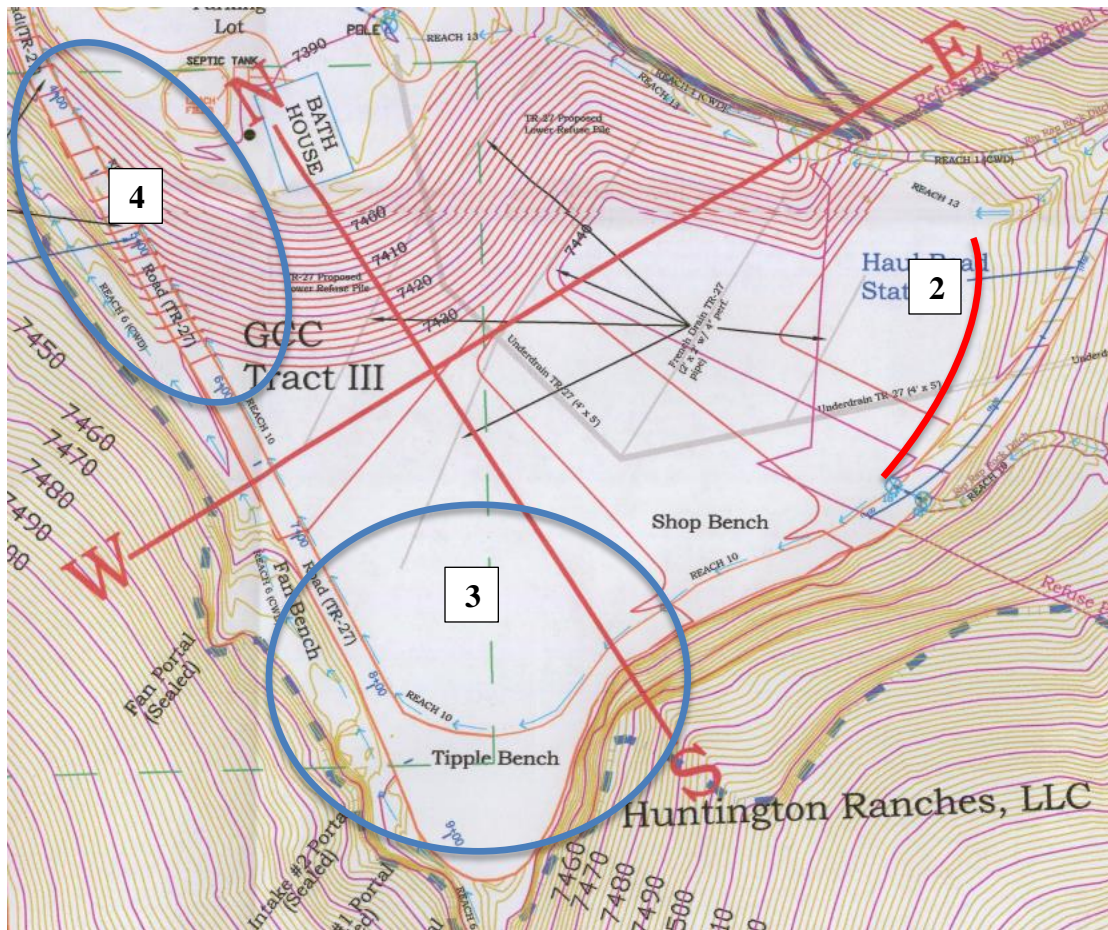
Attachment 1:

Upon completion of the Division's August 16, 2023 inspection Six (6) required outstanding maintenance items were identified. These past due maintenance items are located in the King I Refuse Disposal Area. Please see the items listed below. **Corrective actions 1, 2, 3 and 5 must be completed by Tuesday September 5, 2023. Photographs and documentation must be submitted to the Division in order for the outstanding maintenance items to be considered resolved. If the outstanding maintenance items are not completed by September 5, 2023, The Division will pursue enforcement action. Maintenance Items 2, 3 and 4 are located on an excerpt of the King I Map 007 included at the end of this document as Attachment 1.**

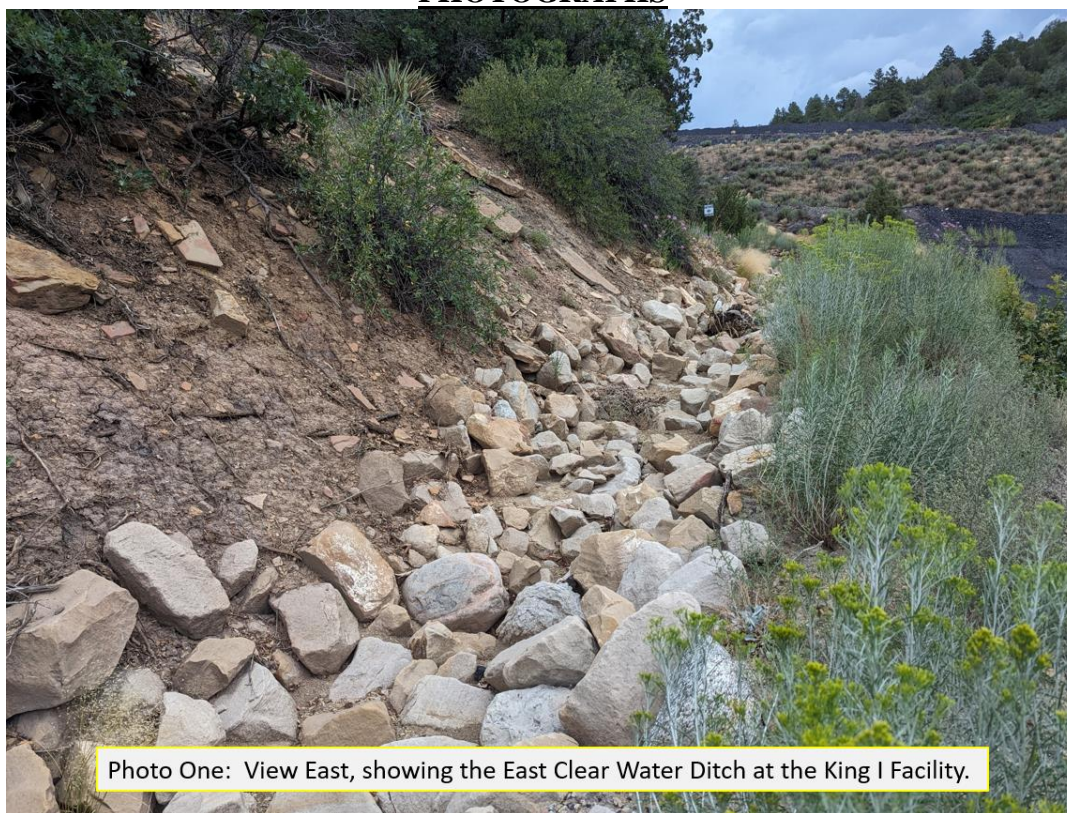
During the inspection both the East and the West Clear Water Ditches were observed. Both ditches were free from obstruction and appeared to be able to function as designed. No evidence of recent flow was noted, however the area has been experiencing recent precipitation events and no evidence of erosion or altered flow was noted. The two Clear Water Ditches can be seen in Photos One and Two.

Photo One: View East, showing the East Clear Water Ditch at the King I Facility.

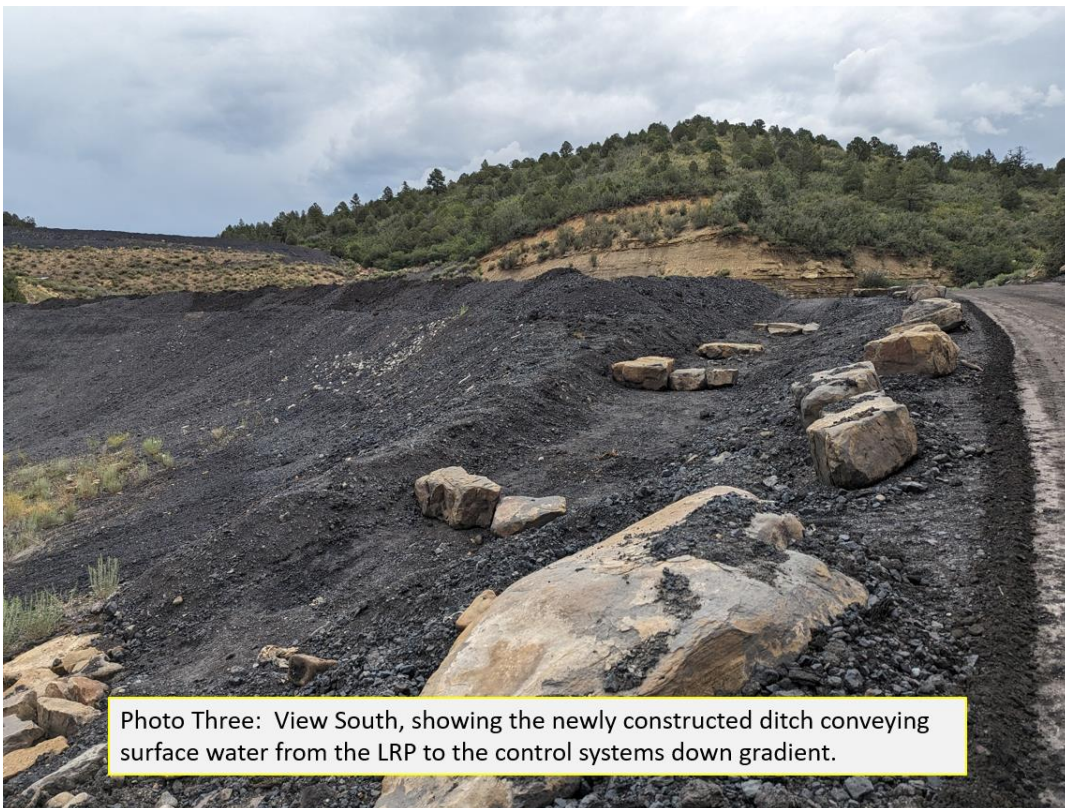
The newly construction section of Reach 10 that conveys water from the Lower Refuse Pile (LRP) was noted to be in good condition and free from obstruction. The ditch can be seen in Photo Three. As noted in the cover letter the new location and design of ditch will be more effective, however is not consistent with the approved design. This will need to be handled through the Technical Revision Process. Additionally, The approved design for water conveyances around the LRP include Reaches 10 and 13. Reach 10 is supposed to flow from the lowest culvert along the access road, along the South and West sides of the LRP, however currently there is no established ditch to convey the water as noted in Photos Four and Five. Surface water is conveyed by way of sheet flow across the graded top of the LRP eventually joining the newly constructed ditch as shown in Photo Three. The Operator should re-establish the design and location that is approved for Reach 10, controlling the flow around the LRP. Similarly, Reach 13 is designed to convey surface flows from the hillside between the LRP and the Upper Refuse Pile (URP) down a constructed slope to the culvert system below the LRP. This ditch and constructed slope has been consumed by waste placement, leaving no conveyance to control the surface flows as seen in Photos Six and Seven. The Division recommends establishing a temporary conveyance that connects Reach 13 with Reach 10 as noted as Item 2, of Attachment 1 to the cover letter included with this report. The establishment of these conveyances is considered a maintenance item that requires immediate attention. The Operator should establish the conveyances in their intended or temporary location, to their approved design specifications and provide photo documentation of completion via email to the Division no later than Tuesday September 5, 2023.

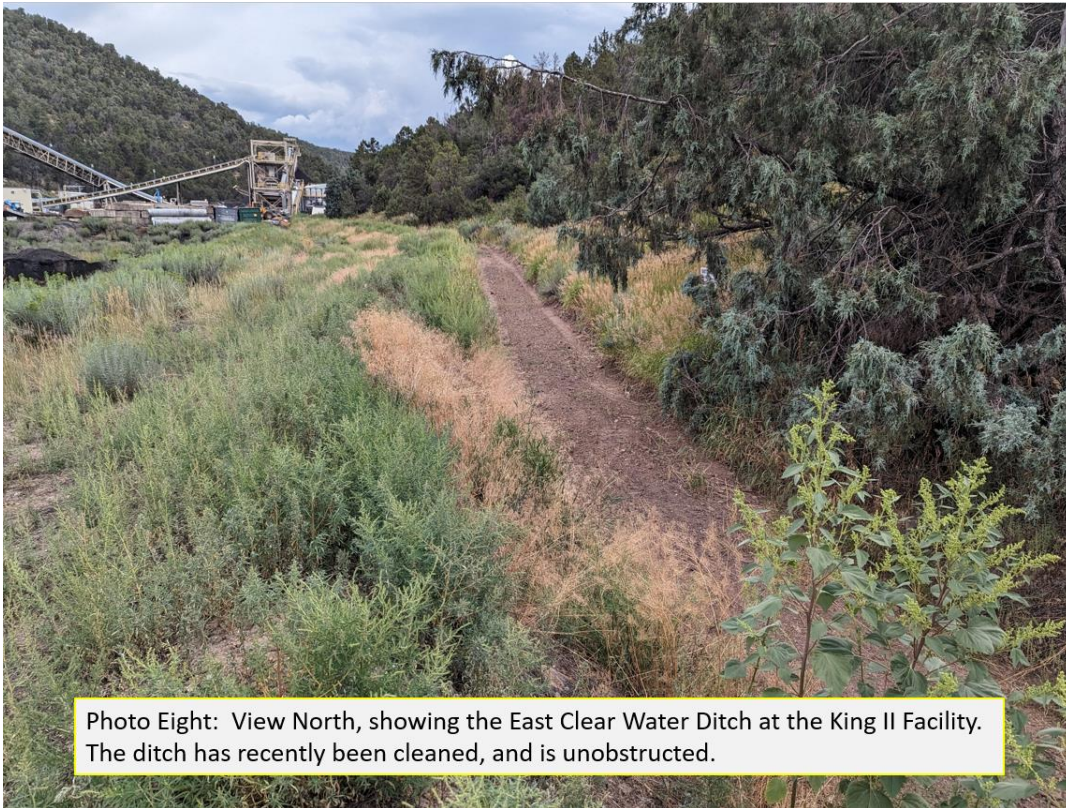
At the King II Area both the East and West Clear Water Ditches were observed. The ditches have been recently cleared of volunteer vegetation and were free from any other obstruction. The ditches appear to be able to function as designed and can be seen in Photos Eight and Nine. At the time of the inspection, the main sediment pond at the King II facility was actively being cleaned out as seen in Photo Ten. Inflow water has been routed into a trench along the east side of the sediment pond and conveyed to the south end of pond. This allows the sediment pond to still function during the cleanout efforts. The cleanout is approximately 75% complete and all material excavated is being trucked to the LRP at the King I facility to be blended with more coarse waste and placed in the

Photo Eight: View North, showing the East Clear Water Ditch at the King II Facility. The ditch has recently been cleaned, and is unobstructed.

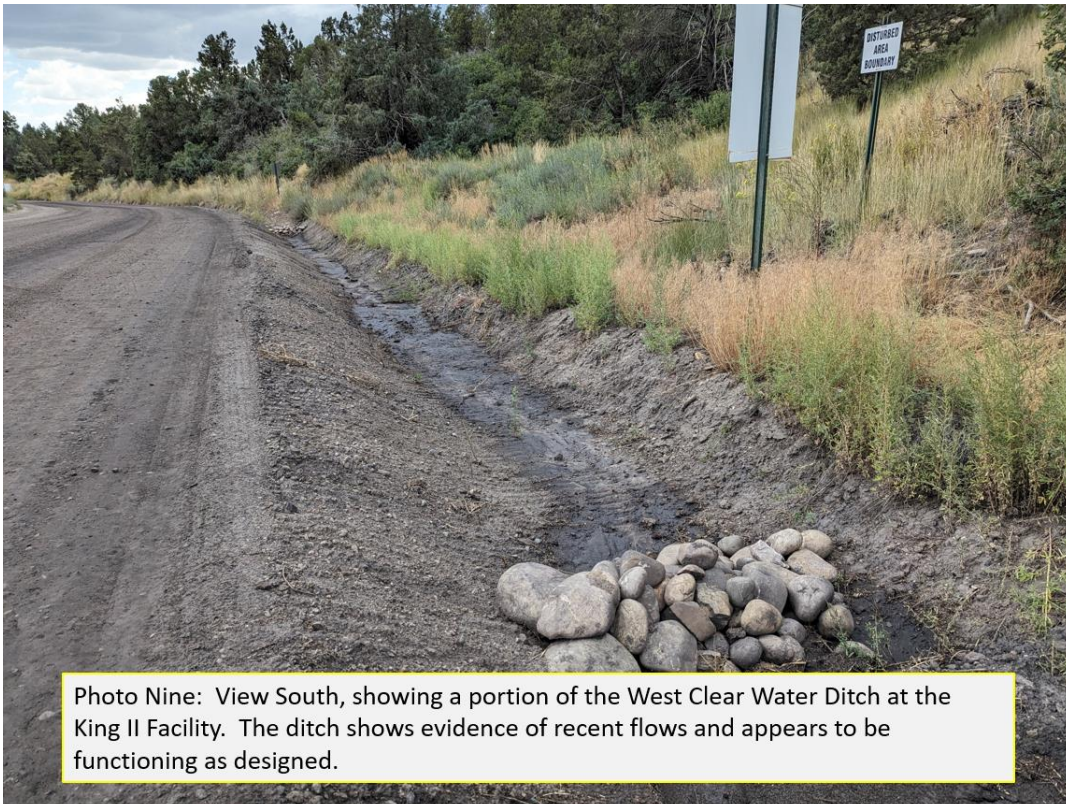
Photo Nine: View South, showing a portion of the West Clear Water Ditch at the King II Facility. The ditch shows evidence of recent flows and appears to be functioning as designed.
