**MINERALS PROGRAM INSPECTION REPORT**  
**PHONE: (303) 866-3567**

| <b>MINE NAME:</b><br>Cresson Project | <b>MINE/PROSPECTING ID#:</b><br>M-1980-244 | <b>MINERAL:</b><br>Gold and silver | <b>COUNTY:</b><br>Teller |
| <b>INSPECTION TYPE:</b><br>Monitoring | <b>WEATHER:</b> Clear | <b>INSP. DATE:</b><br>July 10, 2023 | <b>INSP. TIME:</b><br>09:00 |

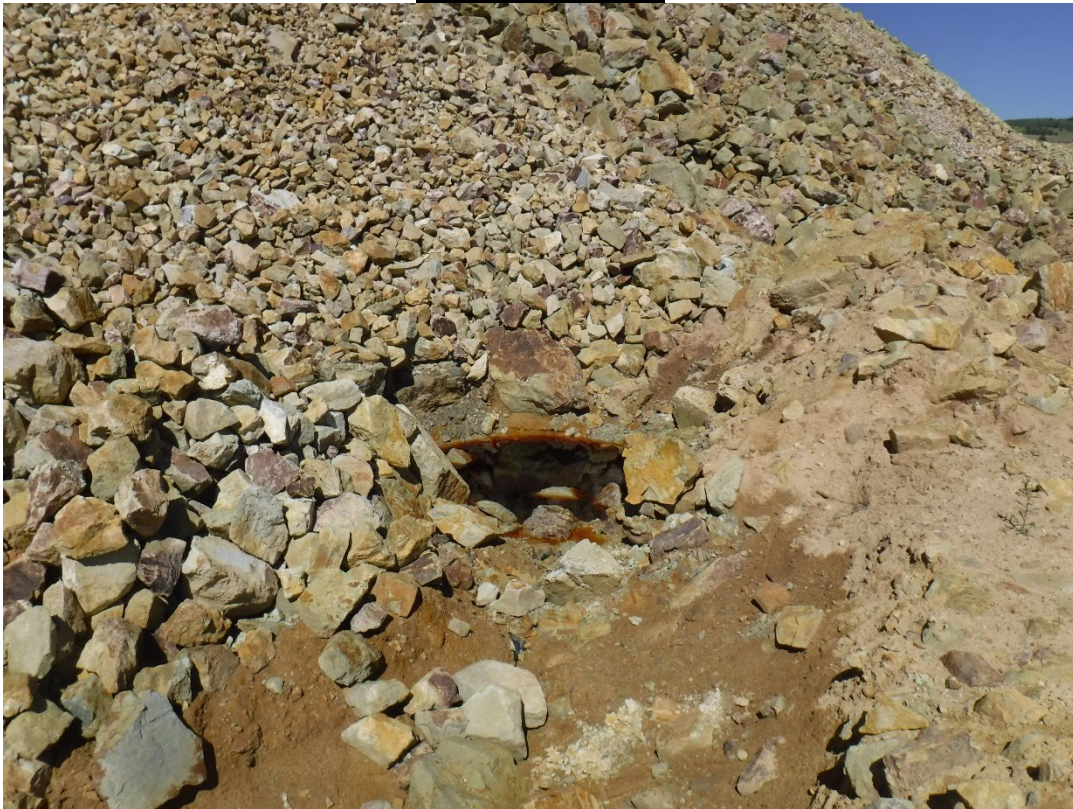
The Division inspected the seep areas located along the eastern toe of the East Cresson Overburden Storage Area (ECOSA). Both seep locations were holding water. The water was reddish-brown in color at both locations and for the north location, Seep 2, it was difficult to determine the depth of water. The southern seep, Seep 1, configuration has a capacity of 2,305 cubic feet or 17,200 gallons. The staff gauge that was present indicated there was approximately  $\frac{1}{2}$  to  $\frac{3}{4}$  foot of water in the basin. Water was observed flowing into the trench from the south/southeast. After the inspection the Operator informed the Division that the last time the seeps were pumped out was on June 15. Water removed from the seeps is transported and dumped onto a lined facility

**Photo 1:** Northern portion of Seep2, looking north

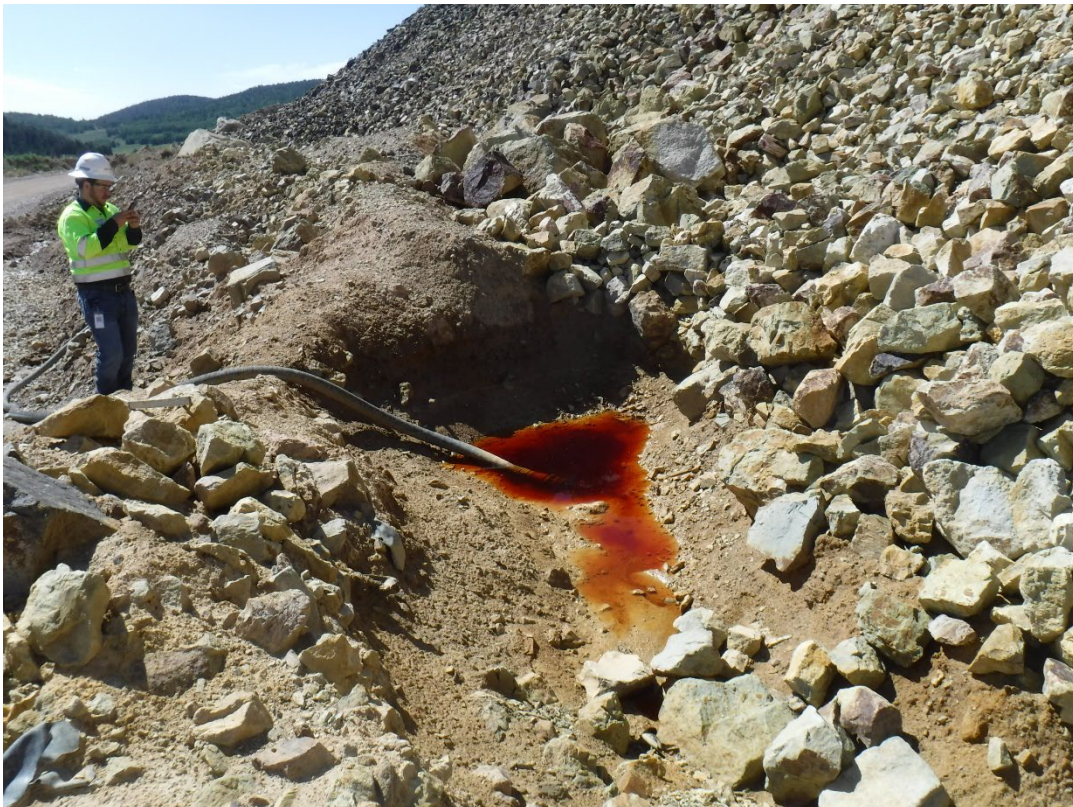
**Photo 2:** Northern portion of Seep2 that is then piped to the southern portion for pumping into truck

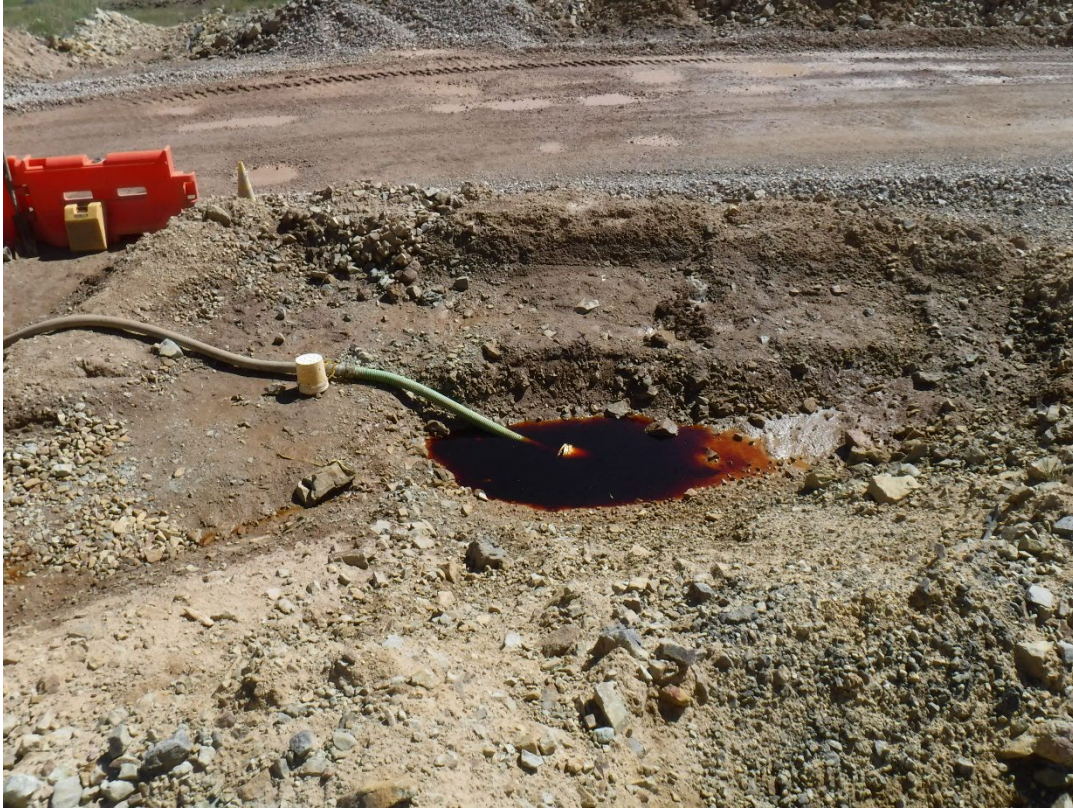
**Photo 3:** Southern portion of Seep2 that is then pumped into a truck for transport for disposal, looking east

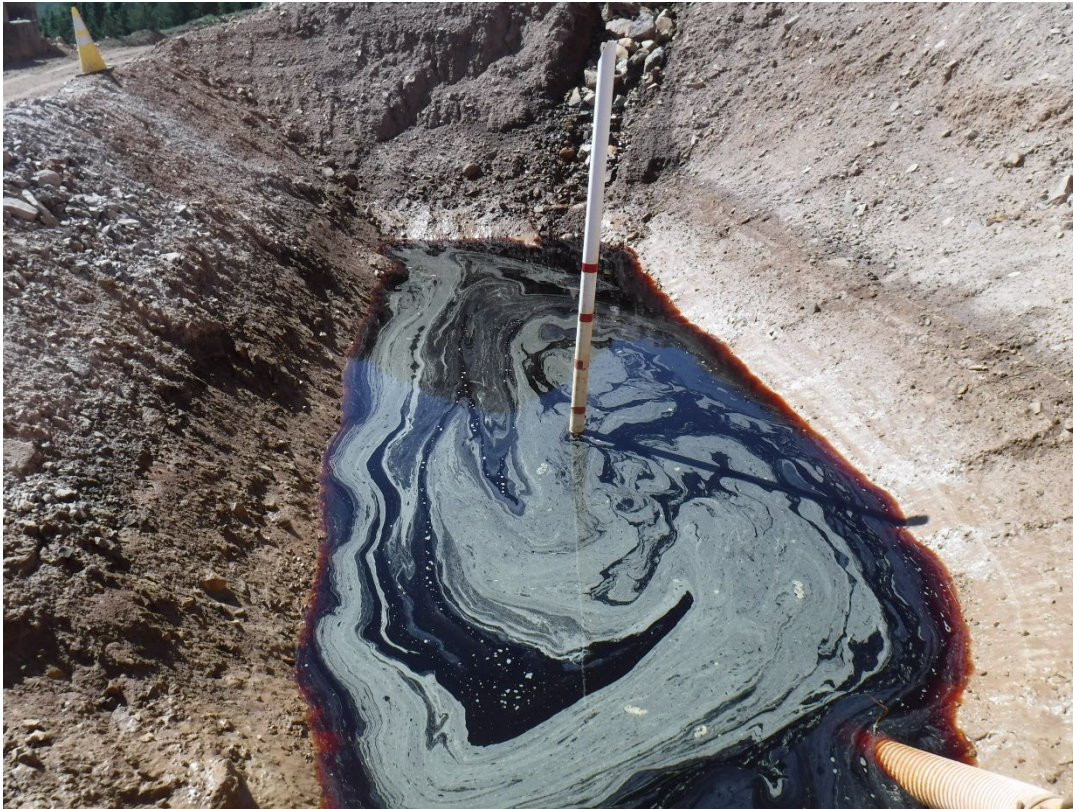
**Photo 4:** Main collection point of Seep1 located south of Seep2, looking south

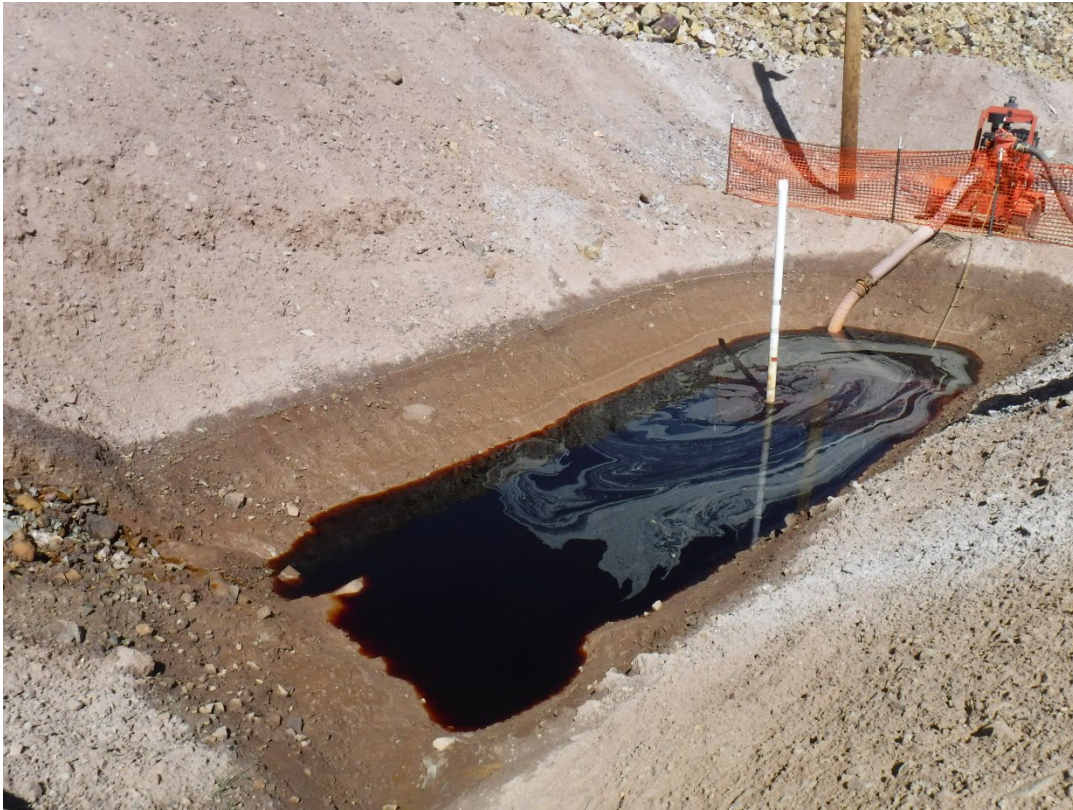
**Photo 5:** Seep1 located south of Seep2, looking northwest

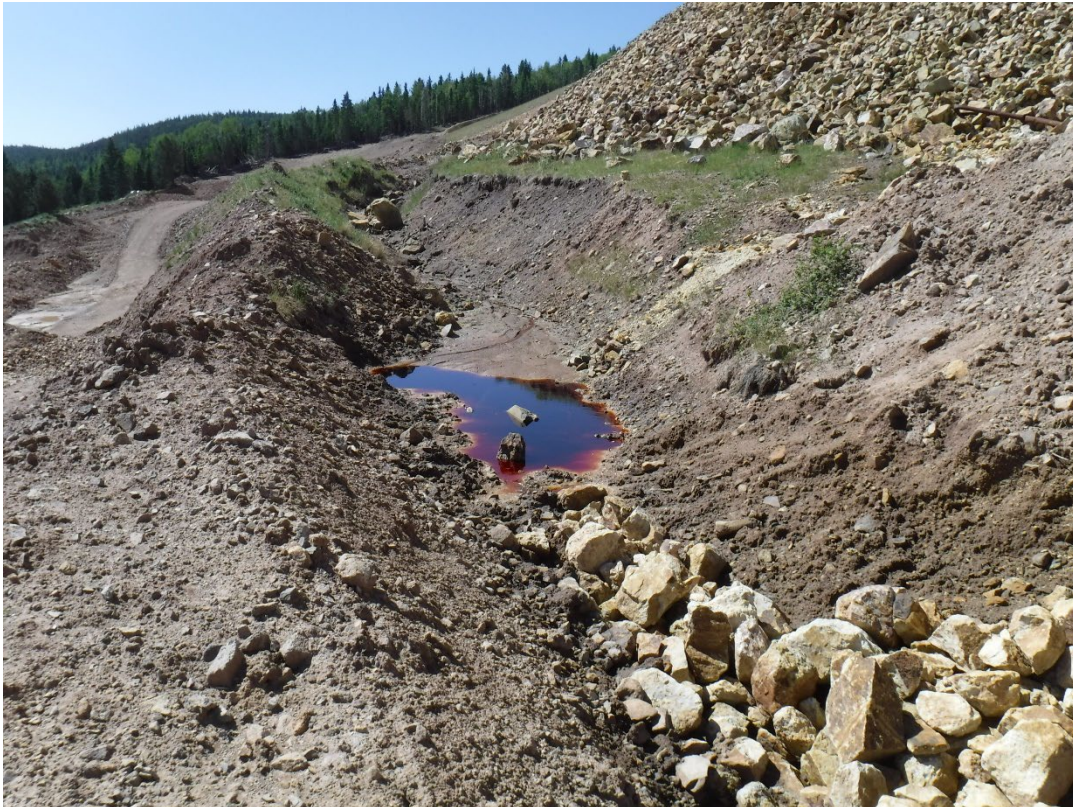
**Photo 6:** Looking south at the drainage ditch that is flowing north to Seep1

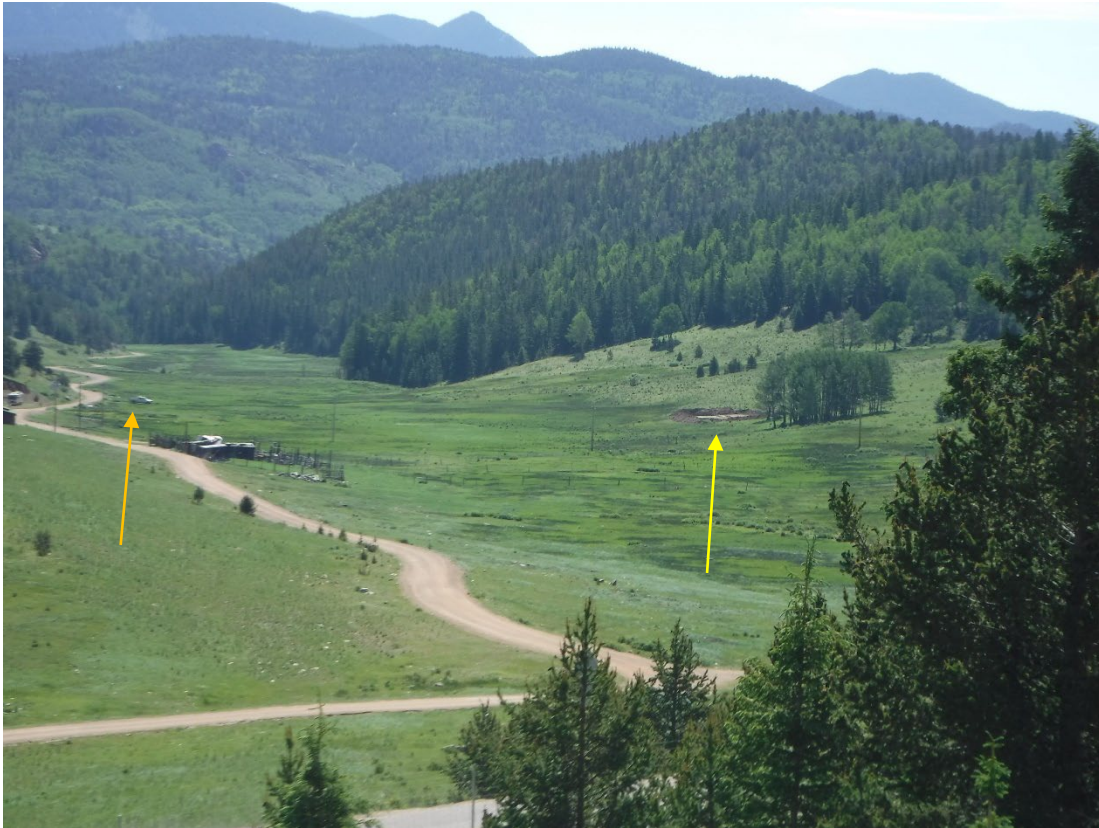
The purpose of the Grassy Valley inspection was to view the drilling operations related to the point-of-compliance (POC) monitoring wells installation, GVMW-26A and B. Installation of GVMW-26 was approved through Technical Revision 129. Contained in TR-129 was commitment to sample the well(s) no later than the end of second quarter 2023. The Operator stated that they were having difficulty mobilizing the drill rig to the GVMW-26 location. The reason given was since the drill rig is dedicated to the CC&V site it is not currently registered and approved to travel over the road. Because of this the only way to get the drill rig to the drilling location was to transport it via semi track and trailer. The contractor that was supposed to do the transporting was having undefined problems and could not transport the drill rig. The Division had approved an extension for to the due date for installation to the first week in July but staffing issues prevented the well from being installed at that time. The Operator stated that the well would be installed later that week. The Division was informed on Monday July 17 that the wells had been installed. During TR129 the Operator committed to submitting a POC well installation report to the Division no later than 45 days from the date the last well was installed, which would be **August 31, 2023**.

**Photo 7:** Looking southeast towards the well pad for GVMW-26 (yellow arrow) and the location of GVMW-22 (orange arrow)

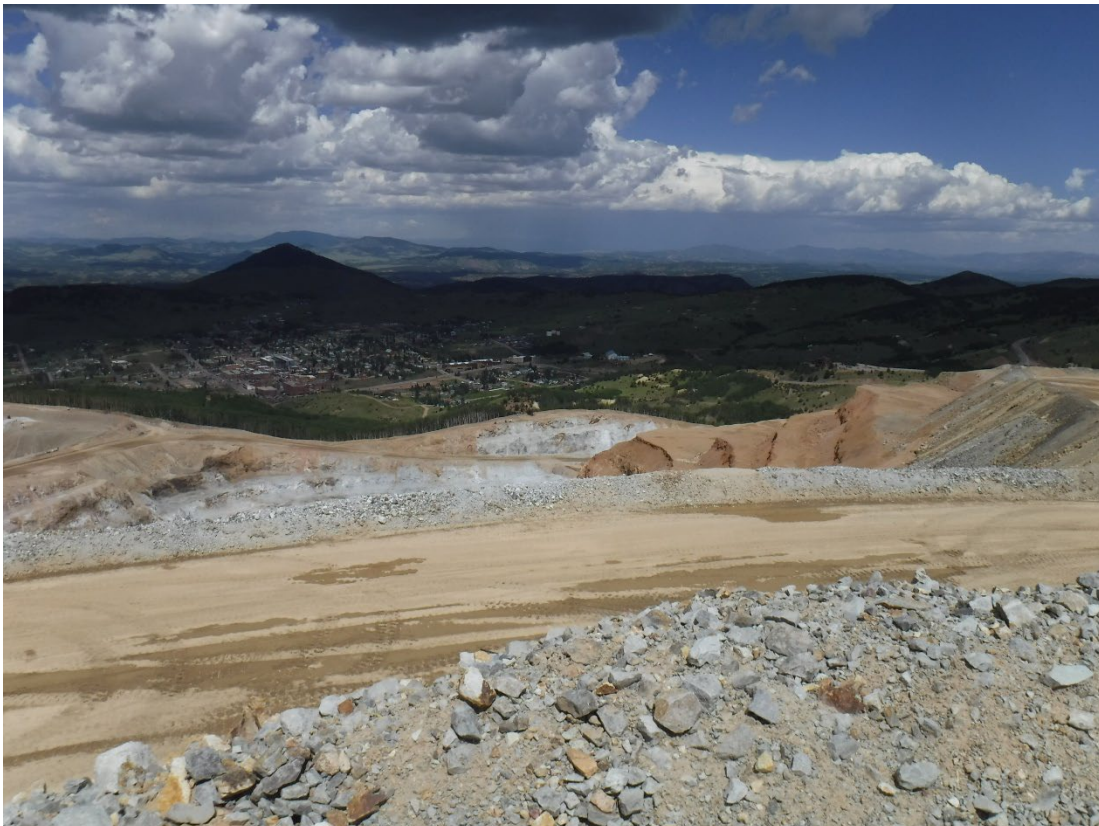
**Photo 8:** Mining activities at Globe Hill

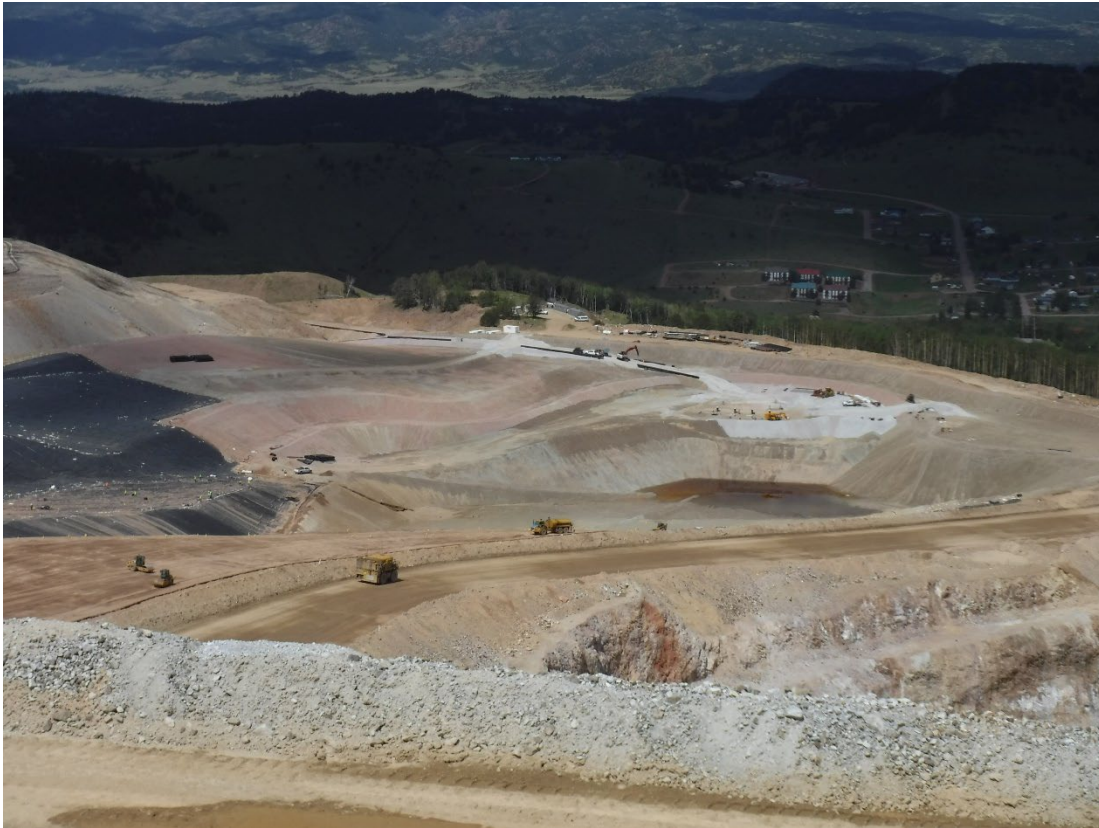
The Division observed, from a distance, the VLF2 Phase III Process Solution Storage Area (PSSA). At the time of inspection the contractors were working on installing piping, plumbing and electrical for the pumping of the PSSA. The contractors were also working on placing drain cover fill over areas. In other areas the contractors were deploying and welding 80 mil liner panels and placing soil fill (clay) material in preparation for liner deployment. The Division is currently reviewing TR-136 which is the Valley Leach Facility 2 Phase 3 Stage A.1 Record of Construction Report. Construction within VLF2 Phase 3 Stage A.1 was completed on December 12, 2022.

**Photo 9:** Construction activities near the PSSA

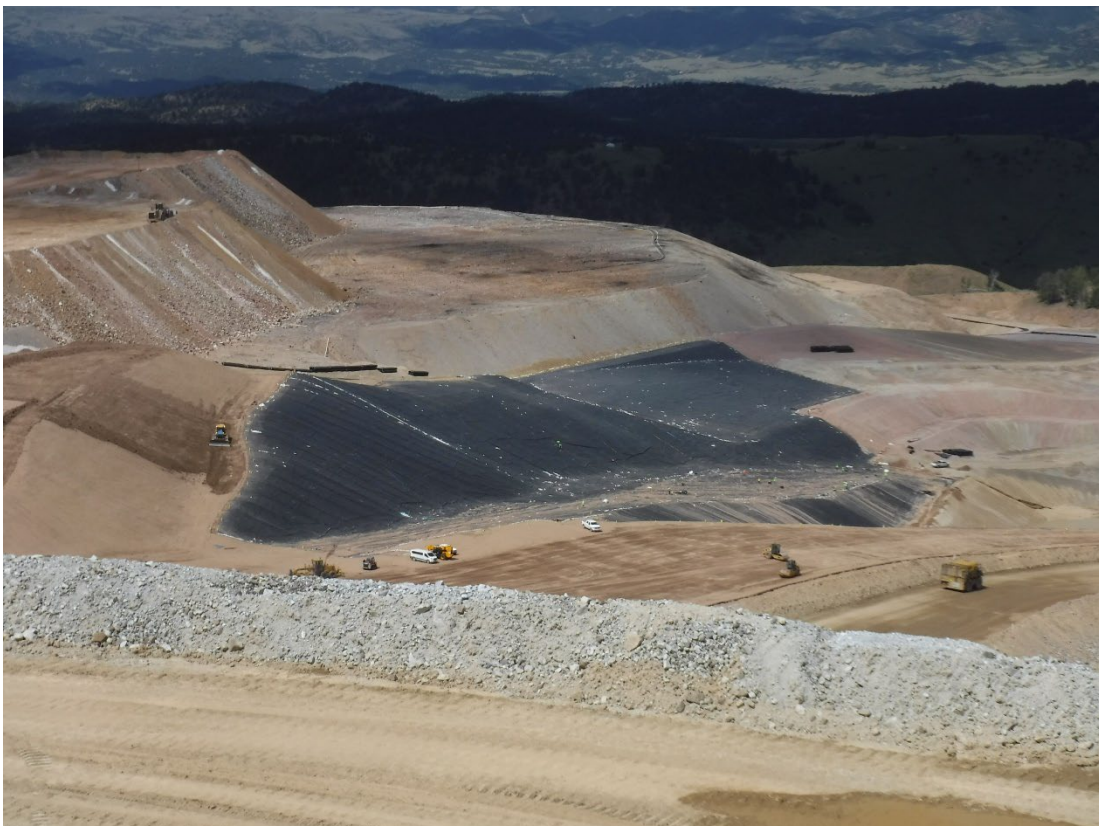
**Photo 10:** Geomembrane panel welding

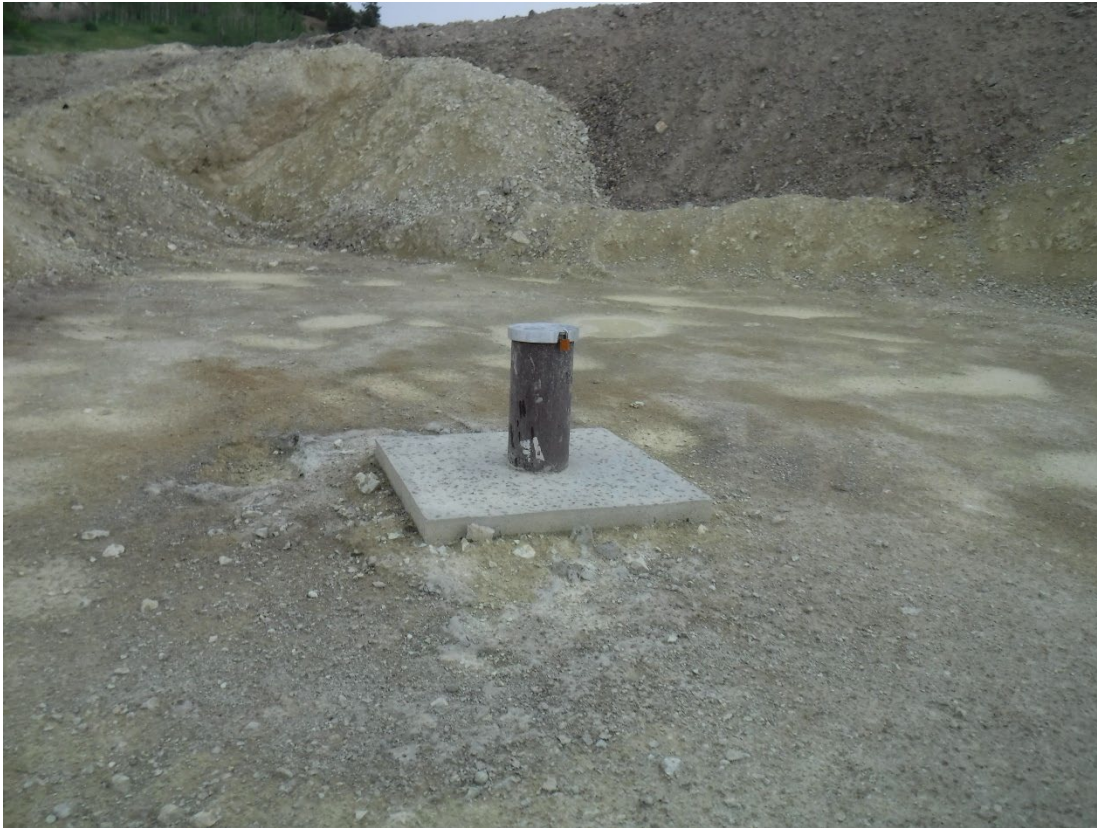
The Division viewed the recently installed POC wells in Poverty and Maize Gulches. The POC well in Poverty Gulch is PGMW-5. This well is a 4-inch PVC well that was first sampled during the second quarter 2023. In Maize Gulch the POC well is SGMW-8 which is also a 4-inch PVC well. Initially this well was drilled and installed as a dry well but overtime groundwater has been detected in the well. This well is also being routinely monitored.

**Photo 11:** Newly installed Poverty Gulch POC well PGMW-5

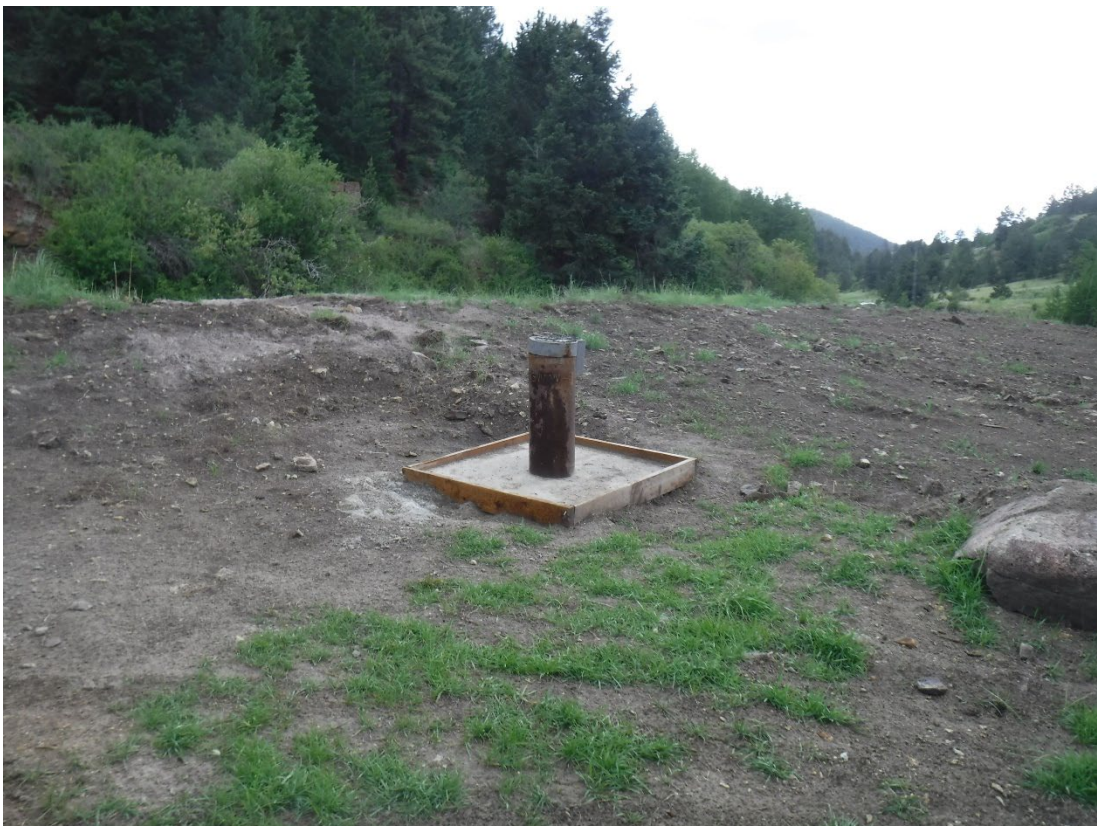
**Photo 12:** Newly installed Maize Gulch POC well SGMW-8
