**PERMIT INFORMATION**

| <b>Permit Number:</b> C1981033<br><b>Mine Name:</b> Bear Mine<br><b>Operator:</b> N/A<br><b>Operator Address:</b><br>N/A | <b>County:</b> Gunnison<br><b>Operation Type:</b> Underground<br><b>Permit Status:</b> Revoked<br><b>Ownership:</b> Private |

**INSPECTION INFORMATION**

| <b>Inspection Start Date:</b> August 15, 2023<br><b>Inspection Start Time:</b> 14:00<br><b>Inspection End Date:</b><br><b>Inspection End Time:</b> | <b>Inspection Type:</b> Coal Complete Inspection<br><b>Inspection Reason:</b> Normal I&E Program<br><b>Weather:</b> Clear |

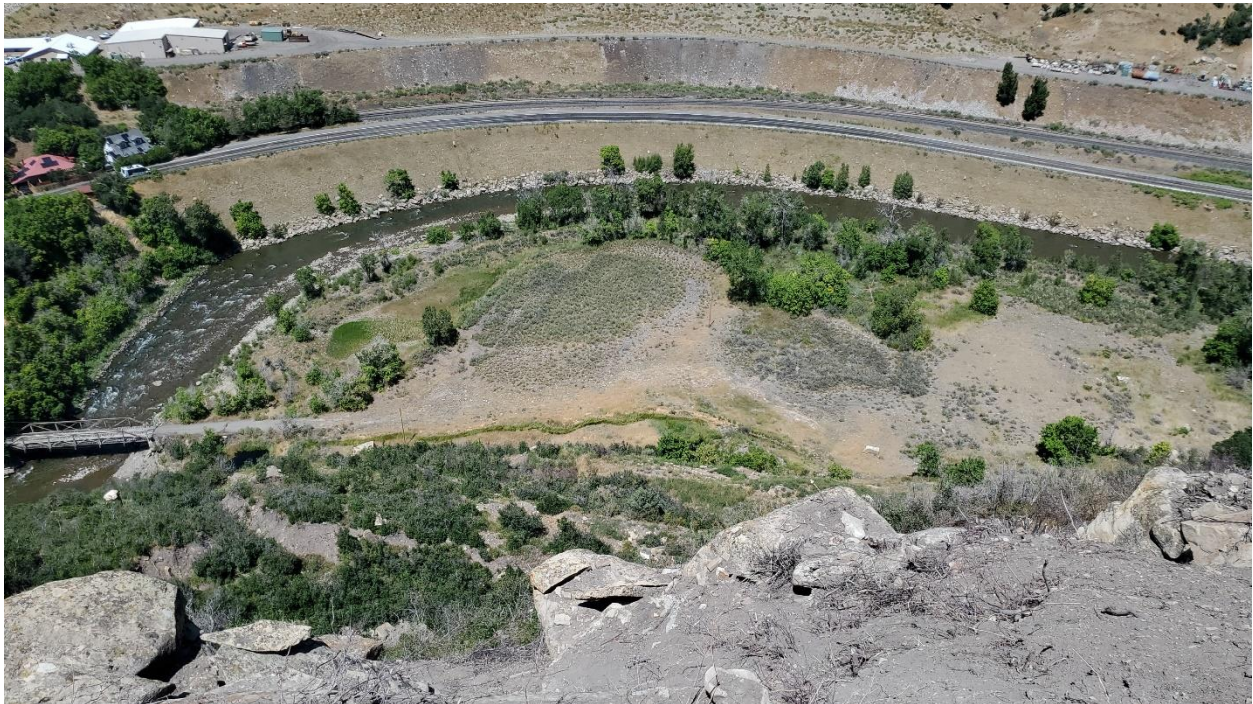
*Figure 1: Overview of site from bench above slide*

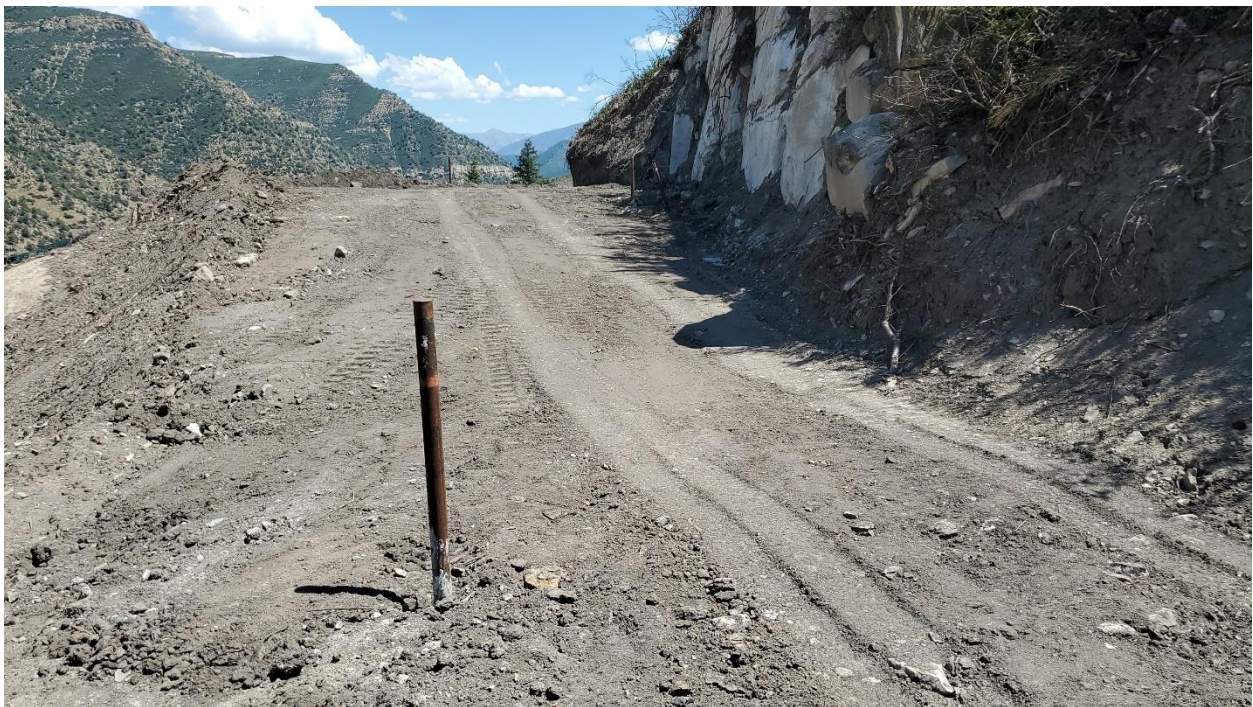
Staff from the Inactive Mines Program and their contractors had begun to access the site with a view to resuming their investigation of the underground coal fire. No new drilling had begun by the time of the inspection.

*Figure 2: Bench above slide*

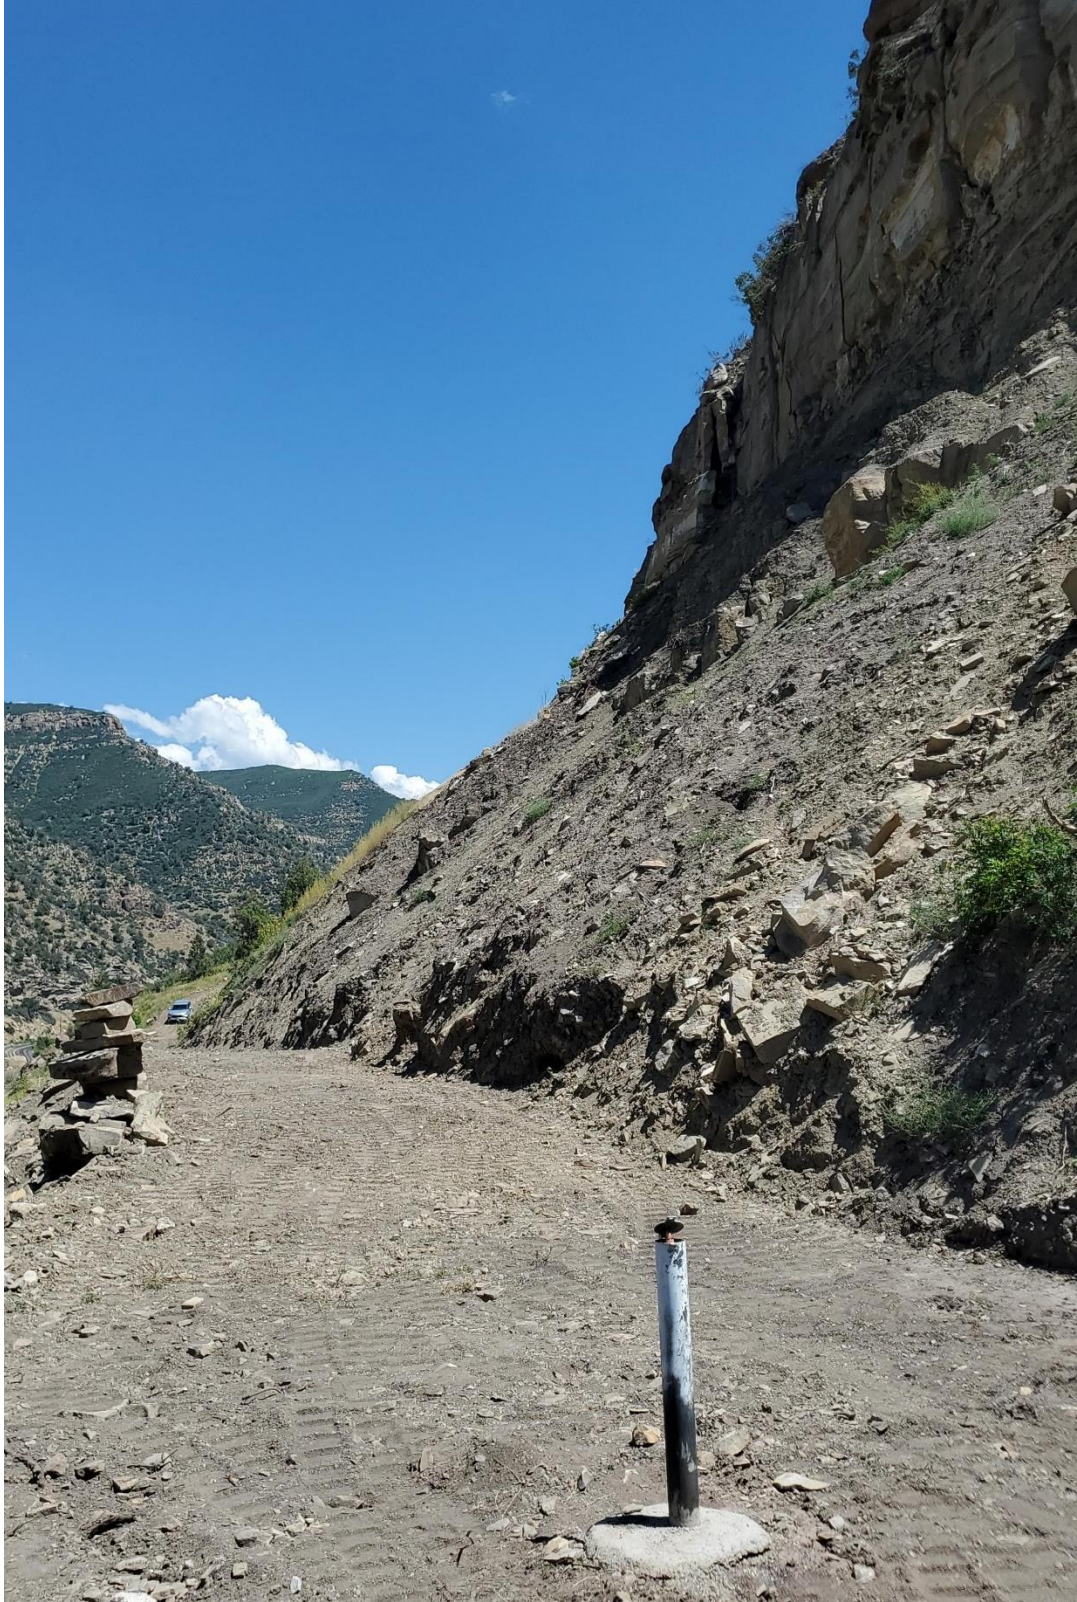
*Figure 3: Bench below slide*

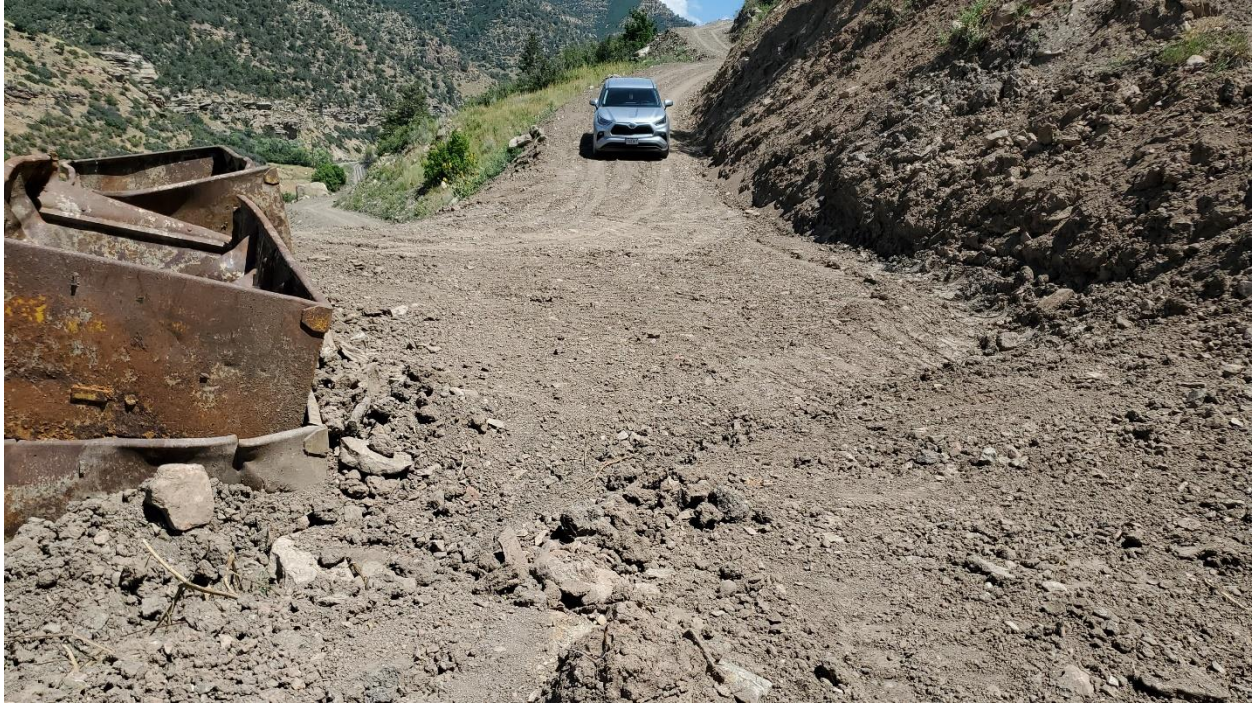
The temporary road that was constructed in order to mitigate and investigate the underground fire had been repaired, and it was possible to drive to the bench where the investigation holes had been drilled. Some surface water control structures (water bars and a small diversion ditch) had been built along the road in an attempt to control run-off and minimize the impact of the road disturbance.

*Figure 4: Surface water diversion at first hairpin*
