## M1980136, Chambers Pit, Inspection Report

**MINERALS PROGRAM INSPECTION REPORT**  
**PHONE: (303) 866-3567**

| <b>MINE NAME:</b><br>Chambers Pit | <b>MINE/PROSPECTING ID#:</b><br>M-1980-136 | <b>MINERAL:</b><br>Sand and gravel | <b>COUNTY:</b><br>Eagle |
| <b>INSPECTION TYPE:</b><br>Monitoring | <b>WEATHER:</b> Clear | <b>INSP. DATE:</b><br>August 14, 2023 | <b>INSP. TIME:</b><br>13:00 |

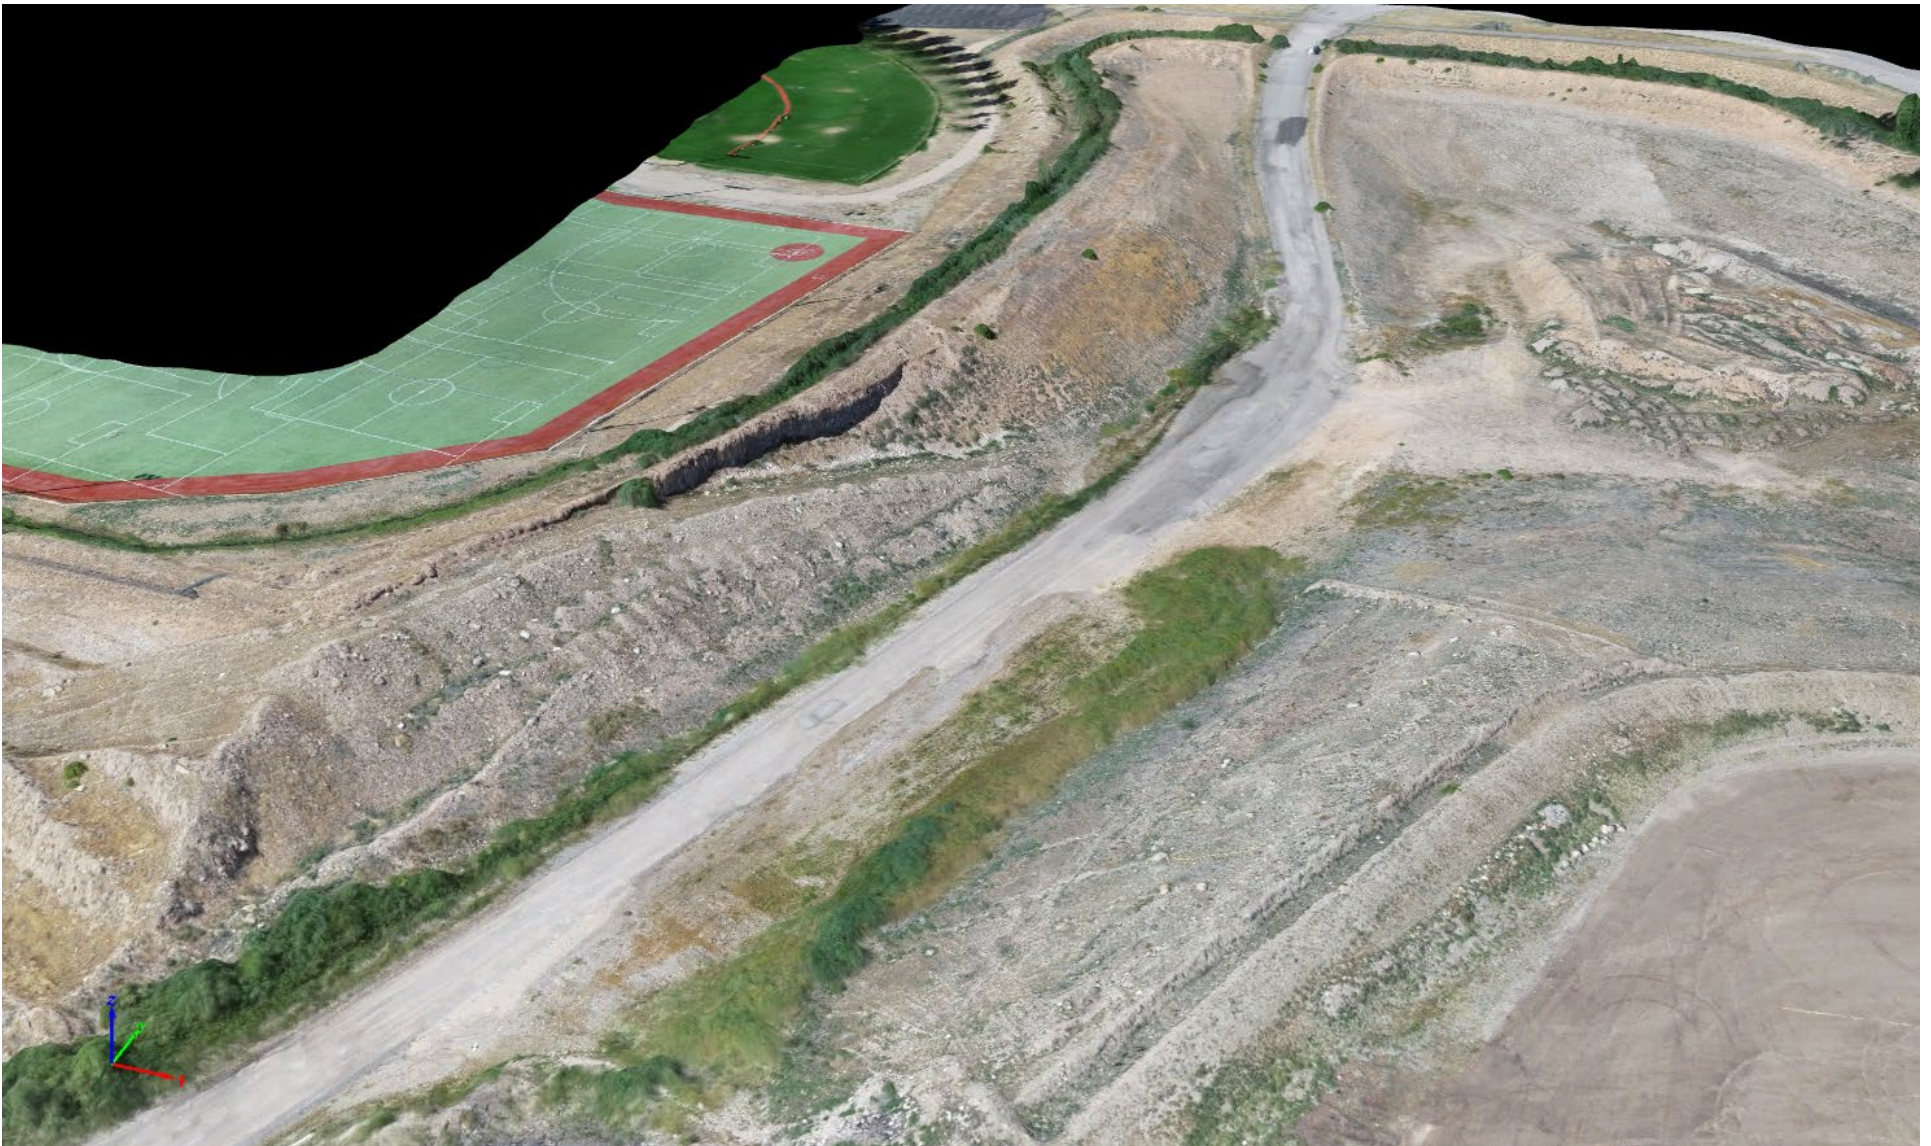
- The embankment to the west of the East Access Road (Figures 2, 5, 6 and 7) is much steeper than 3H:1V, and includes a sheer section (presumably an old high-wall)
- Slopes to the north and west of the disc golf parking area (Figures 5, 6 and 7) are steeper than 3H:1V. As the contours in Figure 7 show, this area has been graded quite differently to the surface shown on Exhibit F
- Parts of the embankments to the west of the West Access Road, and to the north of the light use road to the north west of it (Figures 3, 5, 8 and 9) are steeper than 3H:1V
- The slope to the south west of the ball fields is also slightly steeper than 3H:1V (Figure 5)

Figure 2: Screenshot from Pix4D showing triangle mesh of north eastern portion of surveyed area

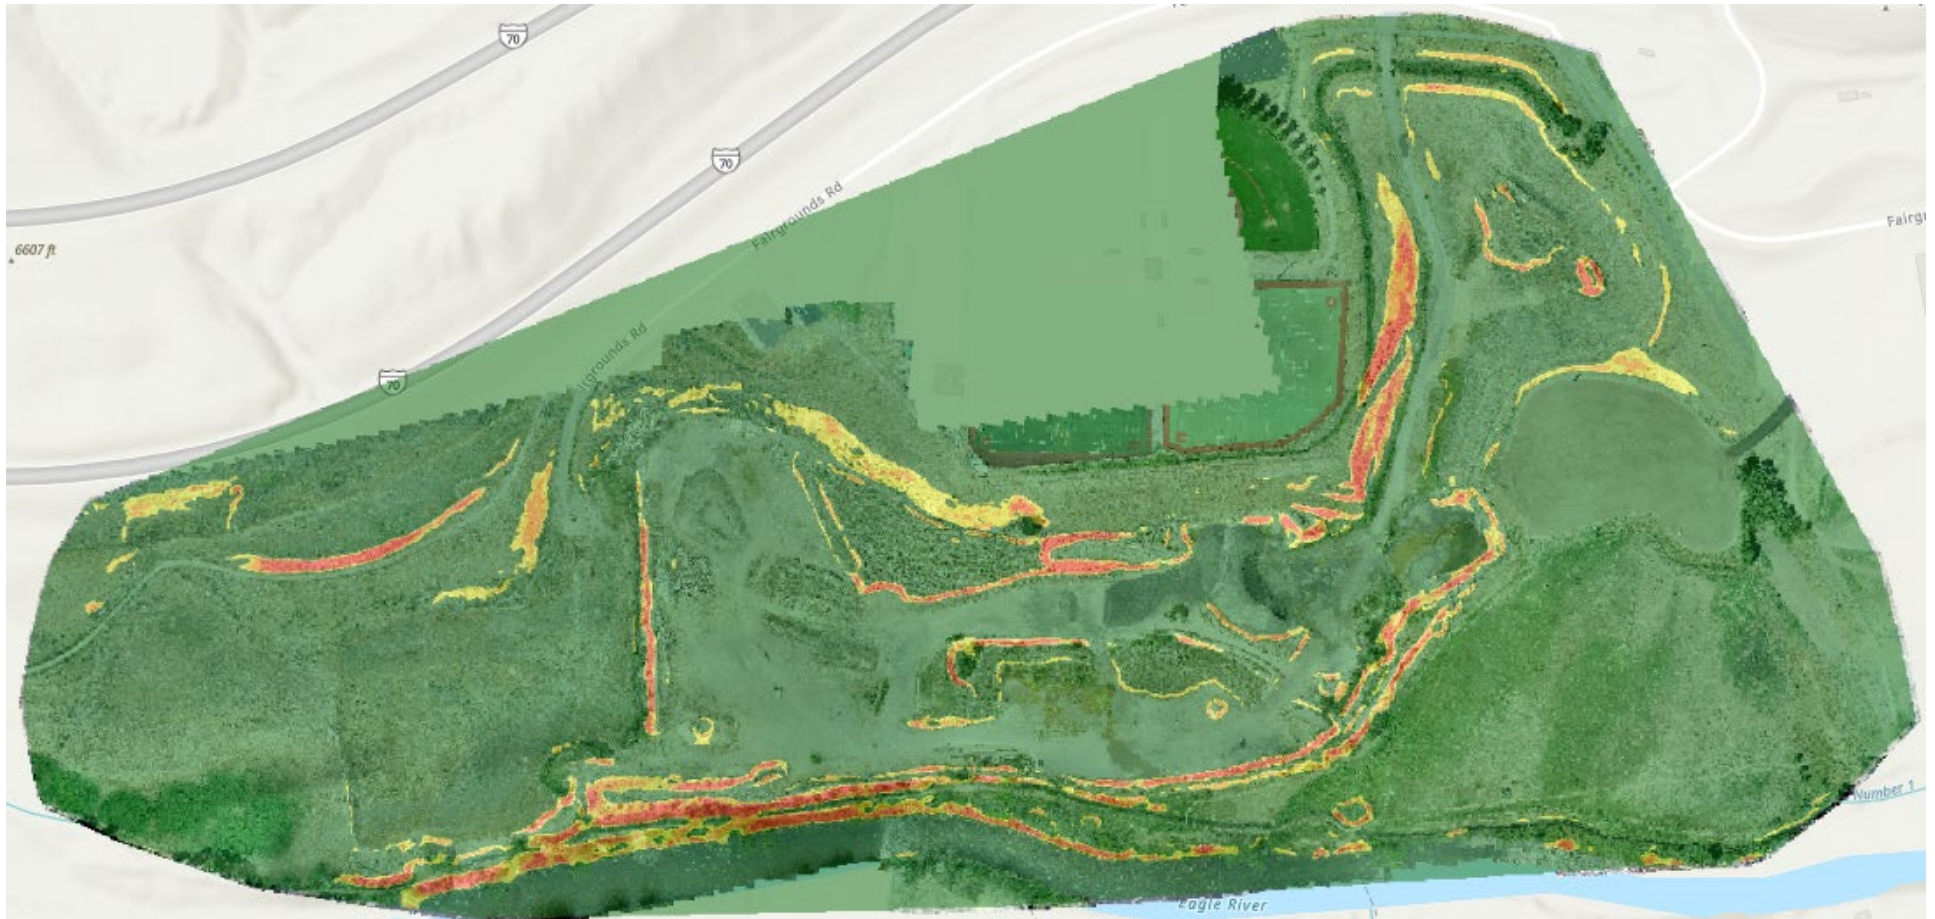
Figure 5 (below) shows that there are several areas where the slope is steeper than 3H:1V (yellow, orange and red areas). Some of these areas are associated with ditches, berms or stockpiled topsoil, and could reasonably be expected to be graded out as the site is disc harrowed and topsoil is spread, however there are several areas where more extensive grading work would be necessary to achieve a 3H:1V slope:

Figure 5: Screenshot from ArcGIS Online showing orthomosaic of whole of surveyed area, overlaid with slope raster.

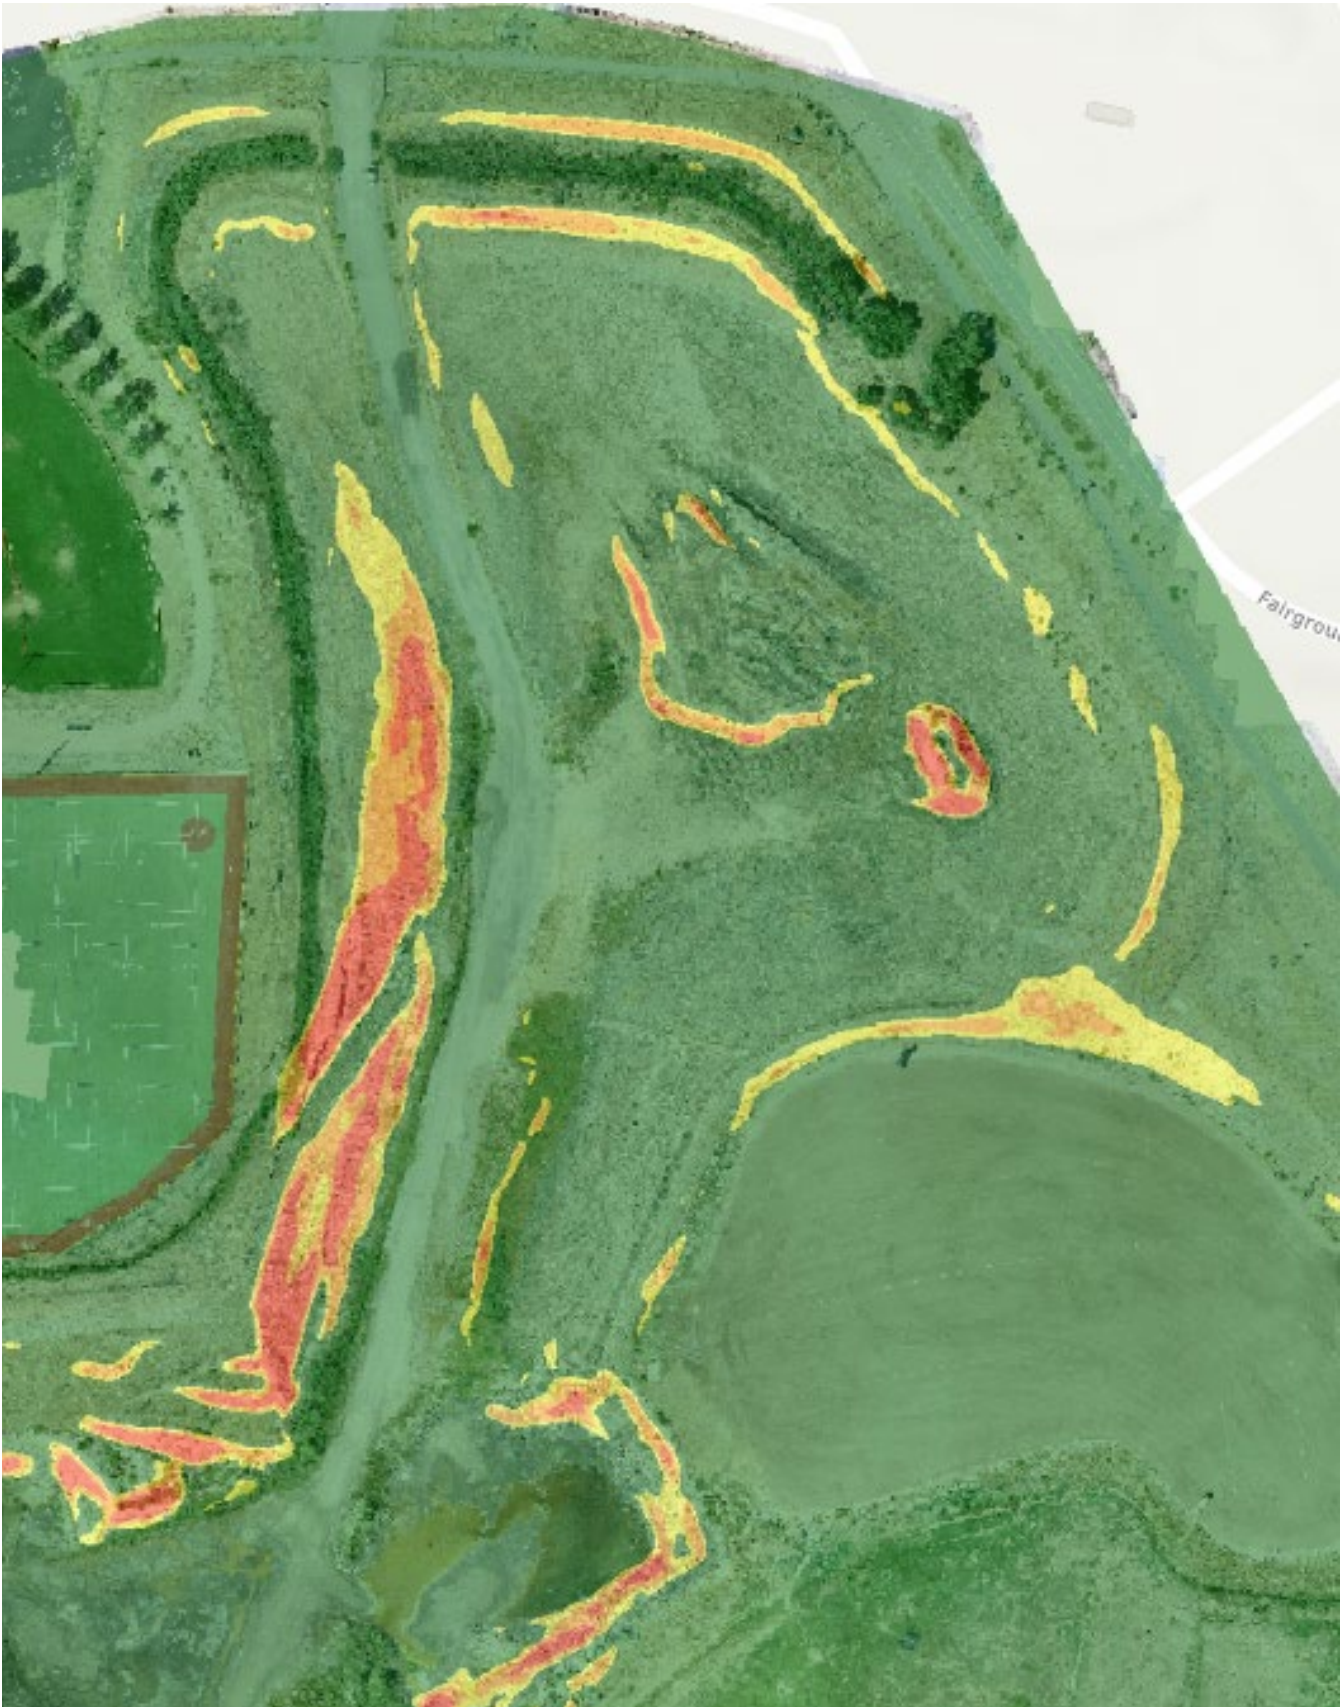
Figure 6: North eastern portion of surveyed area; Orthomosaic overlaid with slope raster

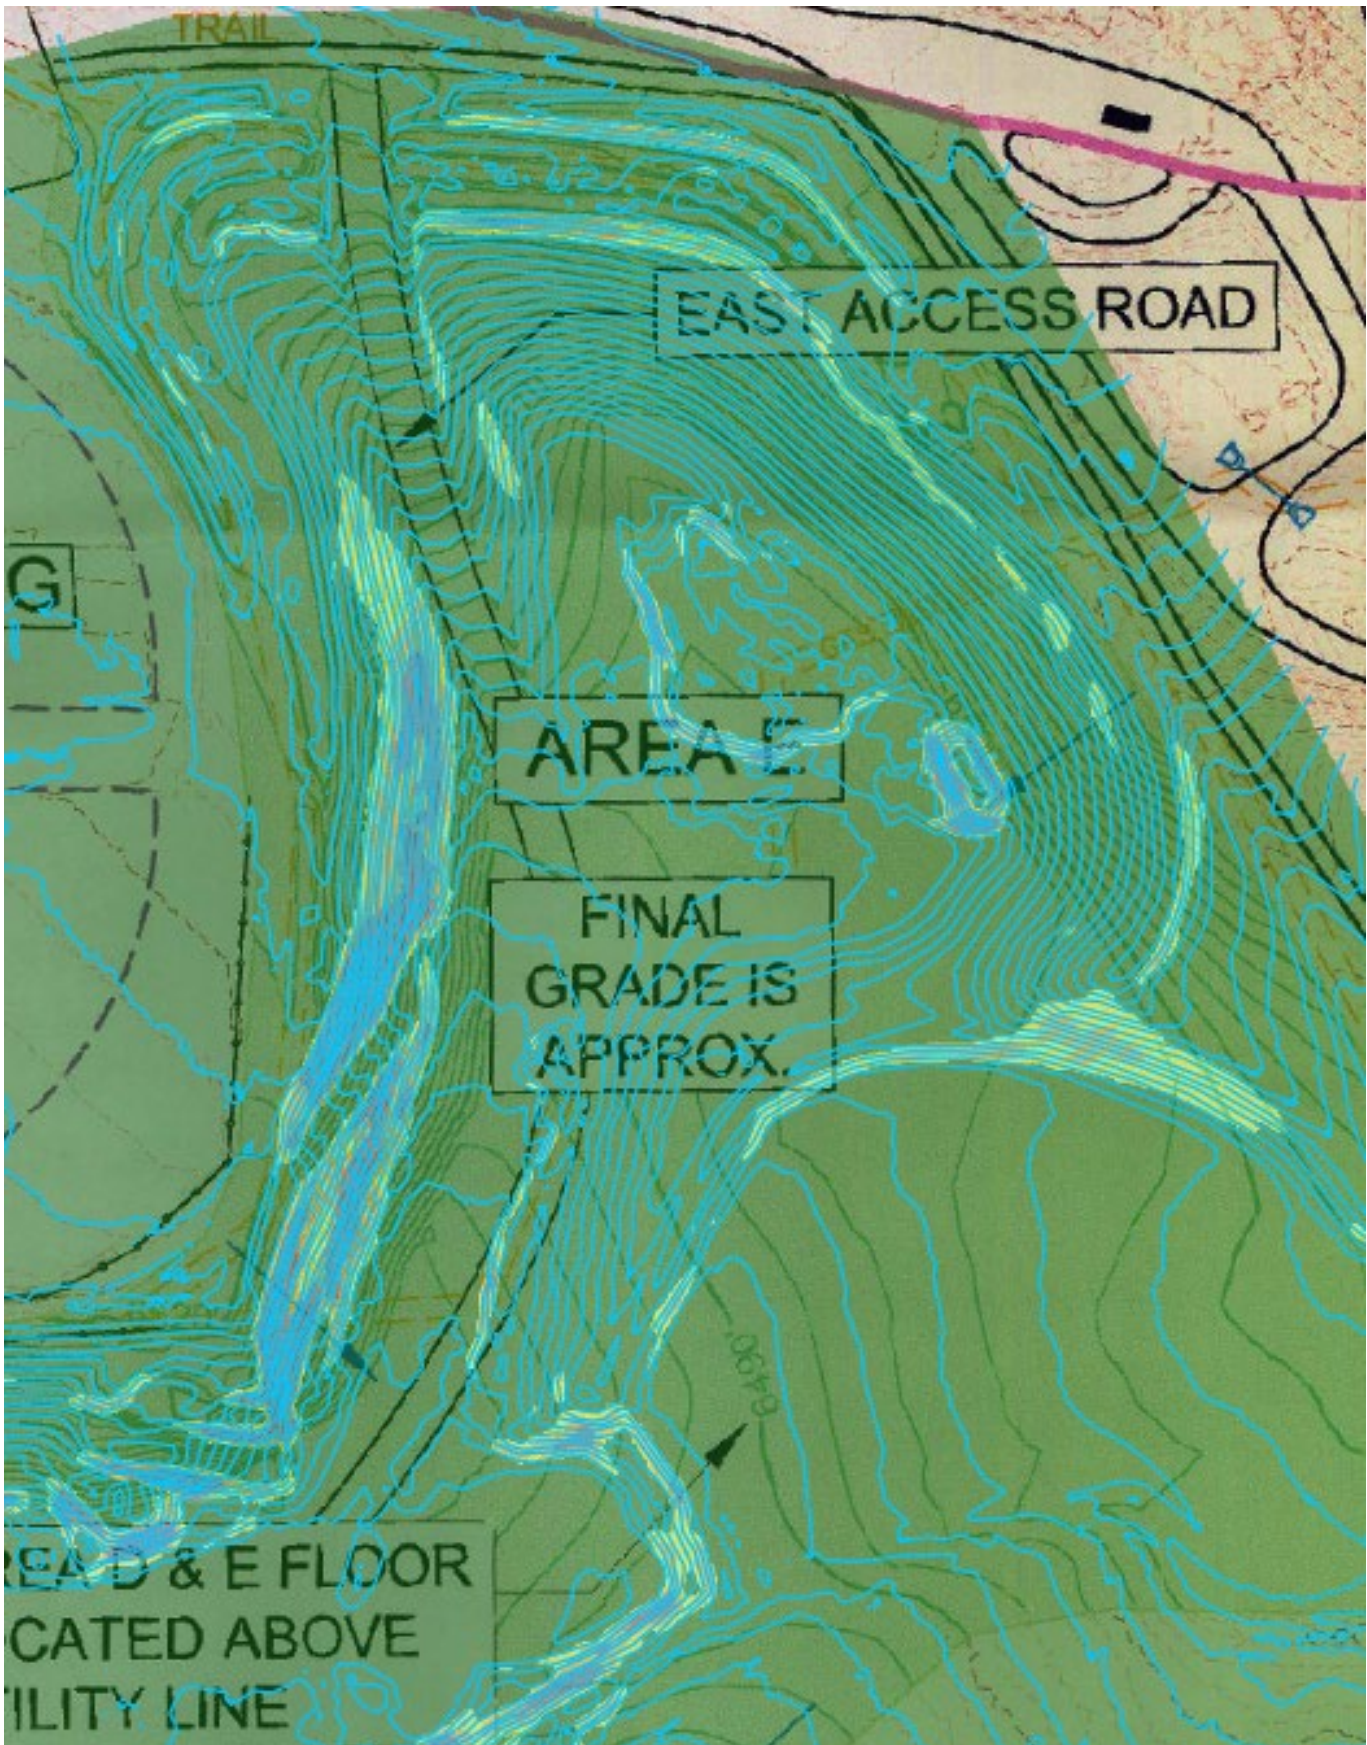
Figure 7: North eastern portion of surveyed area; Exhibit F overlaid with slope raster and generated 2ft contours (blue)

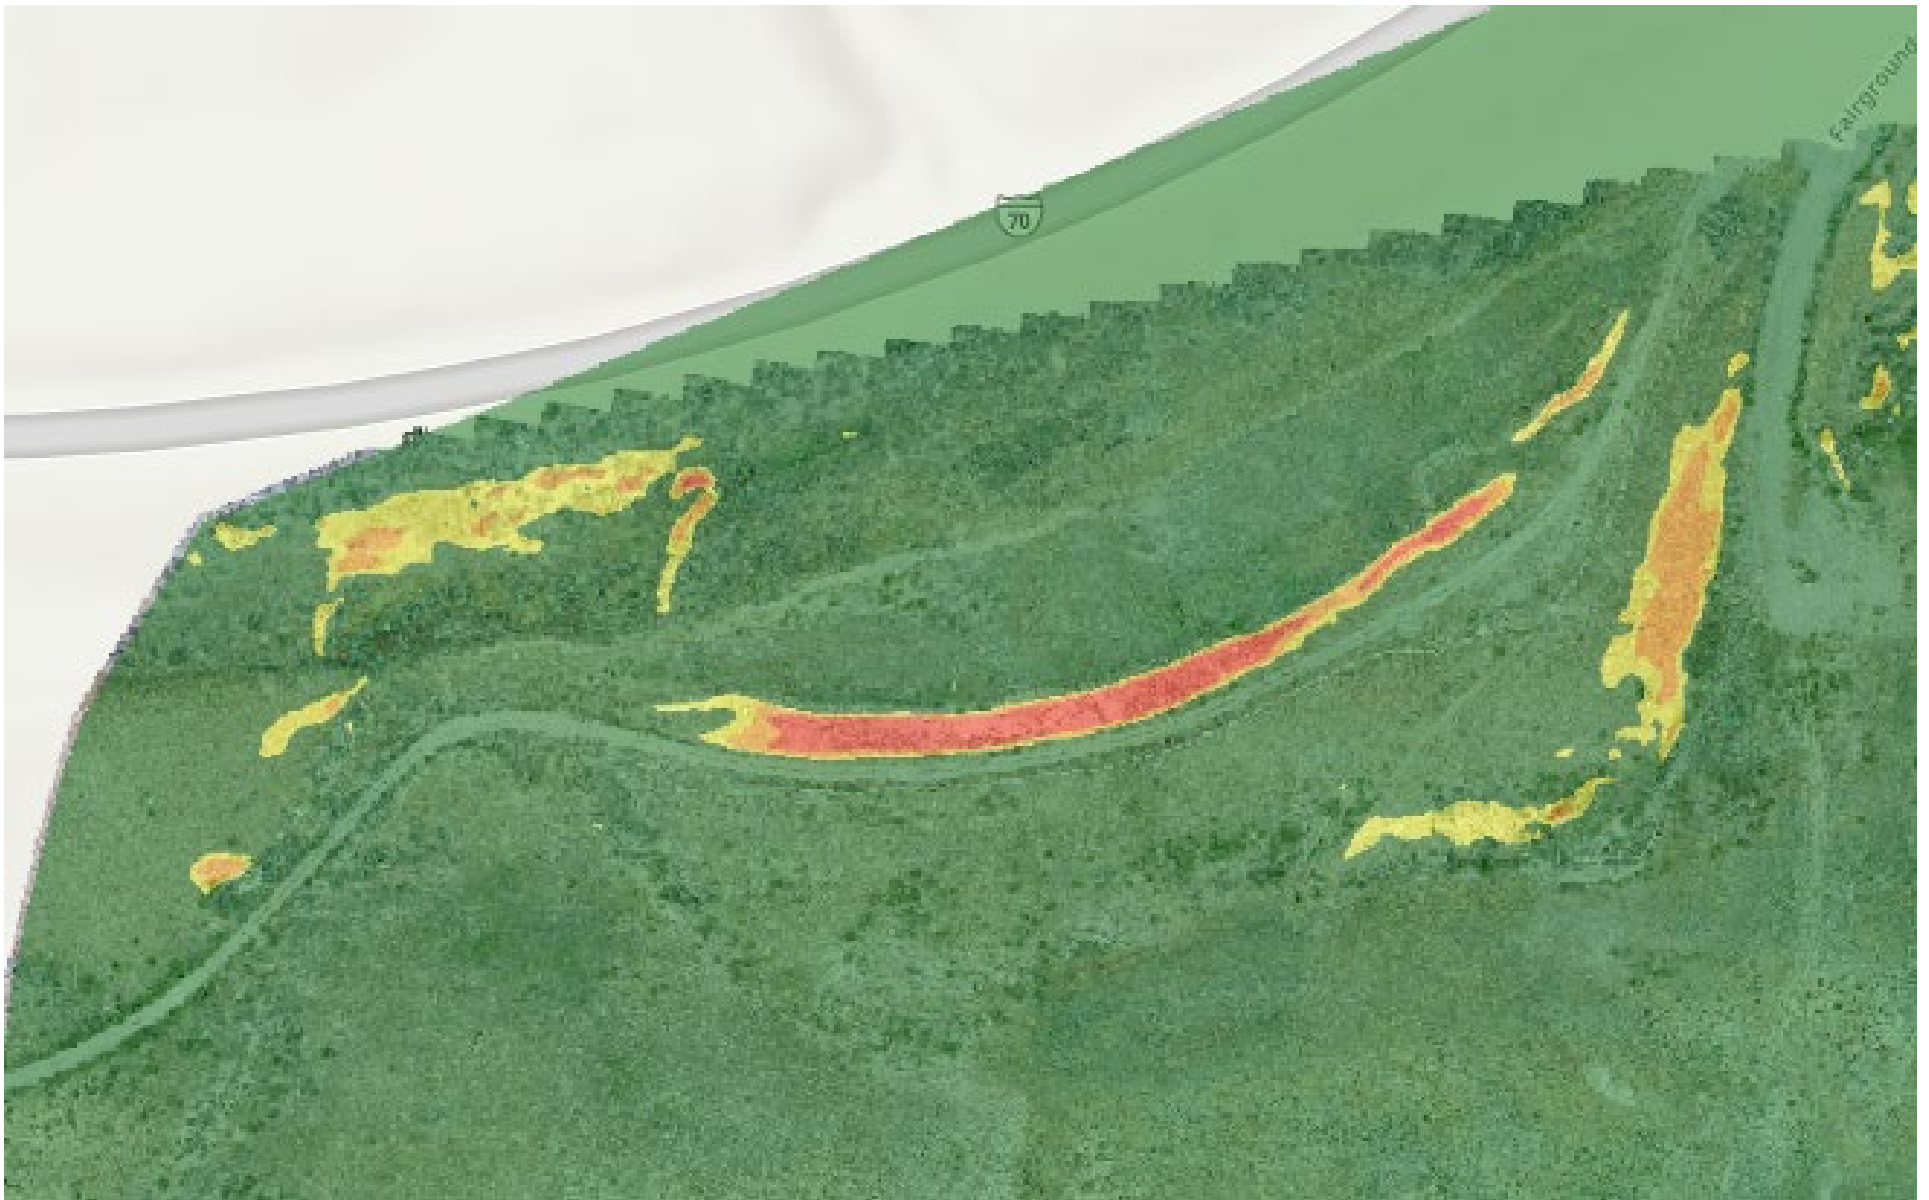
Figure 8: Western portion of surveyed area; Orthomosaic overlaid with slope raster

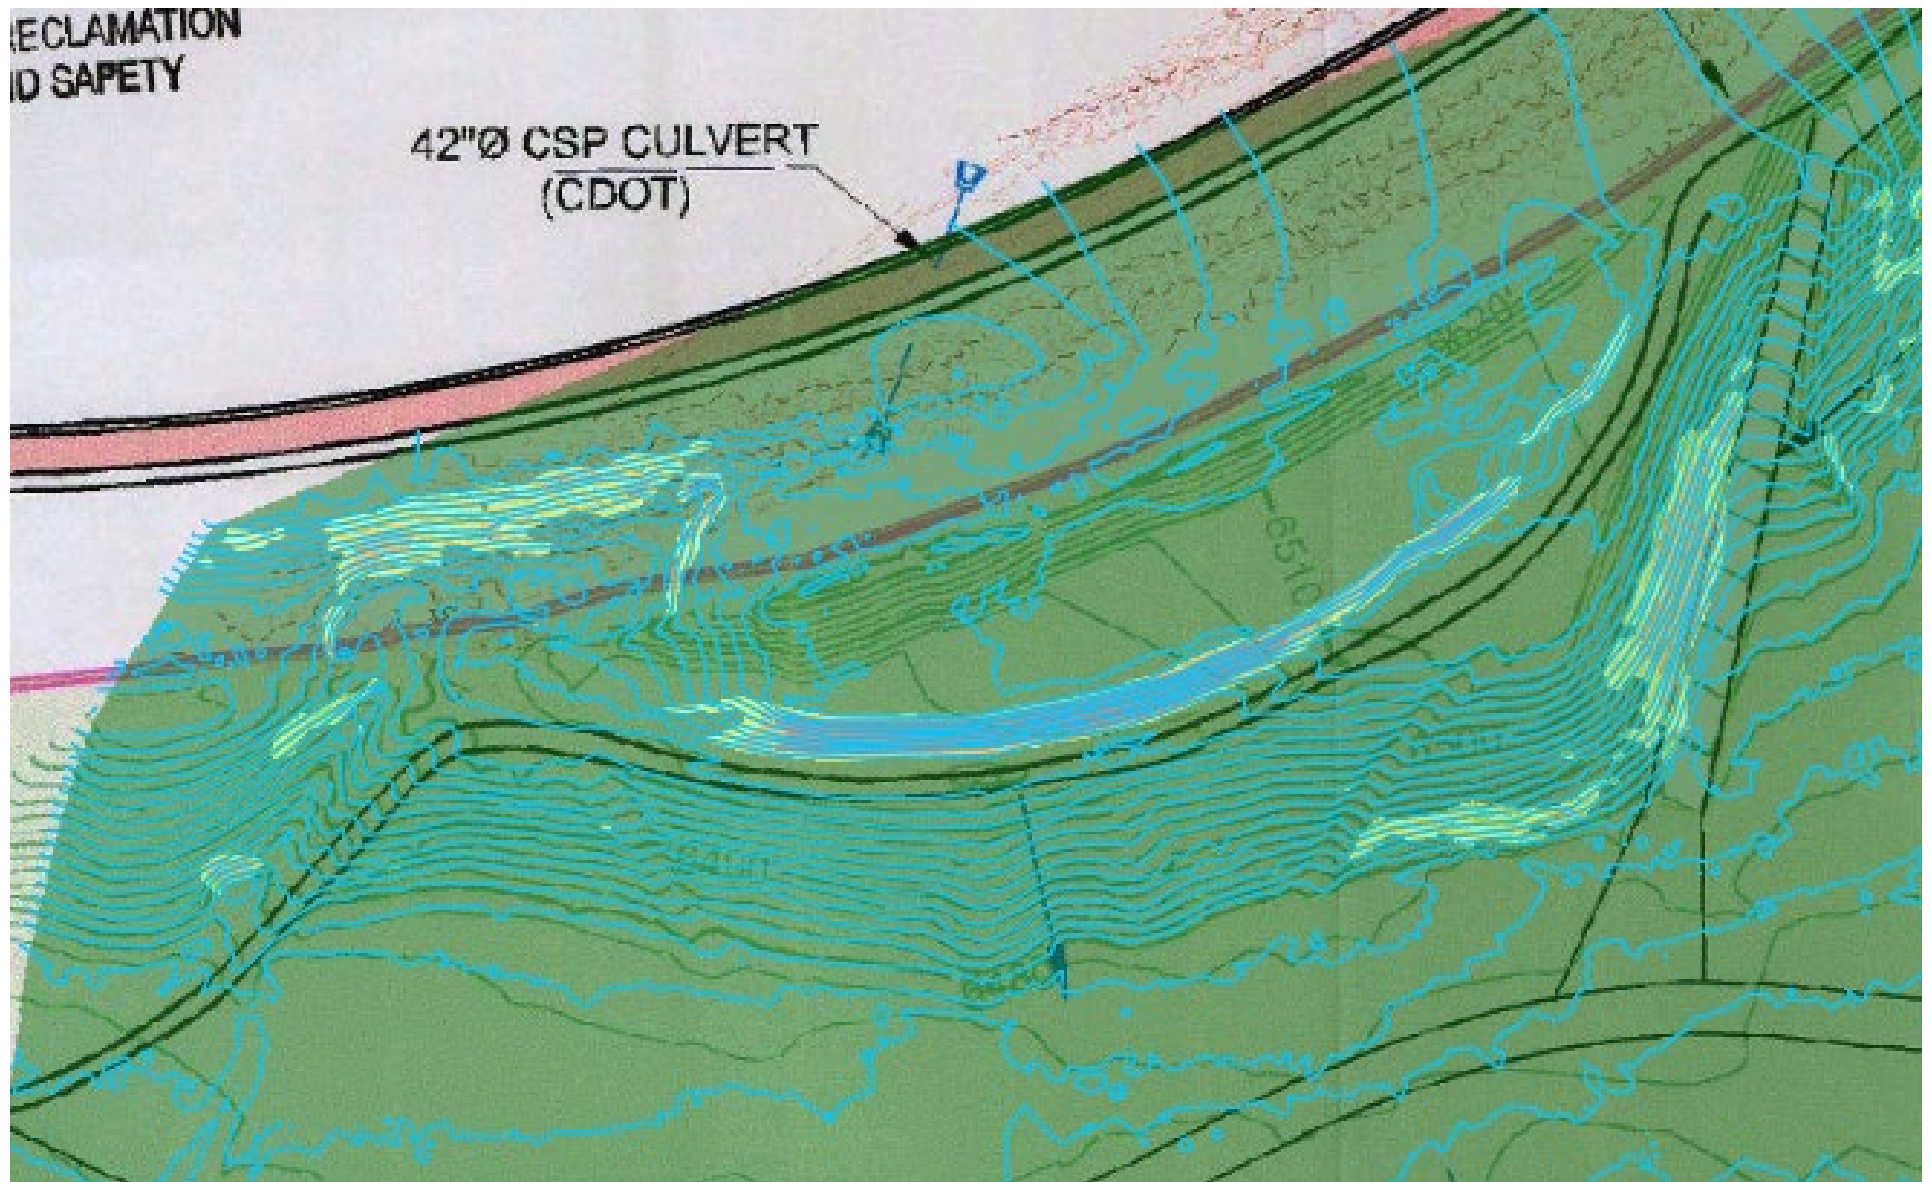
Figure 9: Western portion of surveyed area; Exhibit F overlaid with slope raster and generated 2ft contours (blue)
