## Bowie #1 inspection report

<b>Permit Number:</b> C-1981-038 <b>Mine Name:</b> Bowie No. 1 Mine <b>Operator:</b> Bowie Resources, LLC <b>Operator Address:</b> Mr. Basil R Bear P.O. Box 1488 Paonia, CO 81428	<b>County:</b> Delta <b>Operation Type:</b> Underground <b>Permit Status:</b> Active <b>Ownership:</b> Private
	<b>Operator Representative Present:</b>  Basil Bear
<b>Operator Representative Signature:</b> (Field Issuance Only)

<b>Inspection Start Date:</b> August 23, 2023 <b>Inspection Start Time:</b> 07:20 <b>Inspection End Date:</b> August 24, 2023 <b>Inspection End Time:</b> 08:00		<b>Inspection Type:</b> Coal Complete Inspection <b>Inspection Reason:</b> Normal I&E Program <b>Weather:</b> Clear	
<b>Joint Inspection Agency:</b>  None		<b>Joint Inspection Contacts:</b>	
<b>Post Inspection Agency:</b>  None		<b>Post Inspection Contacts:</b>	
<b>Inspector(s):</b>  Robert Zuber, P.E.	<b>Inspector's Signature:</b>

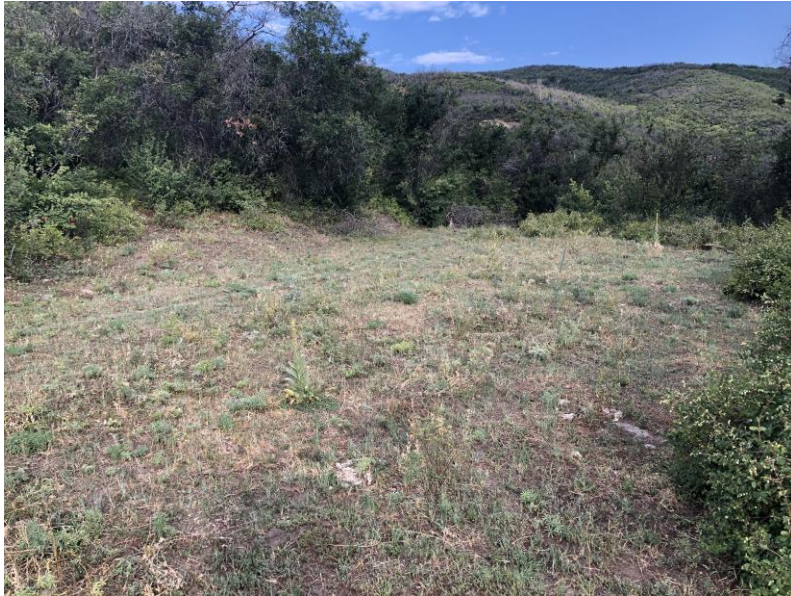
Only small numbers of weeds were seen on the drill hole pads, including a small amount of thistle and a small amount of mullein at DH-67 and a small amount of knapweed at DH-47.

**Pad for drill hole DH-67**

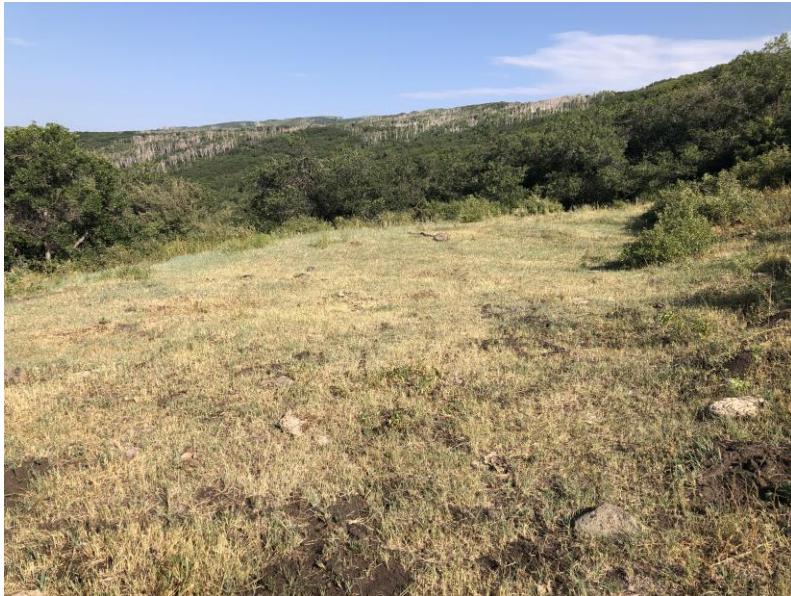
**Pad for drill hole DH-55**

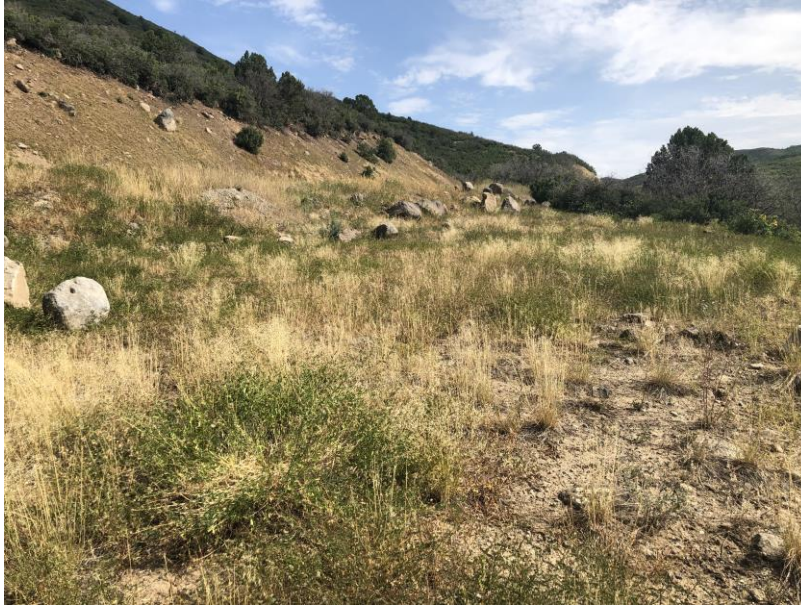
**Pad for drill hole DH-92**

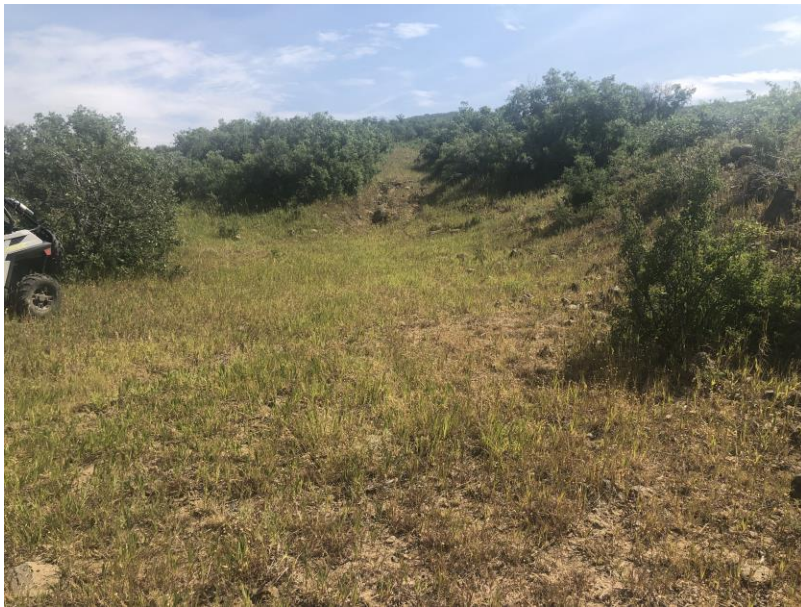
**Pad for drill hole DH-41**

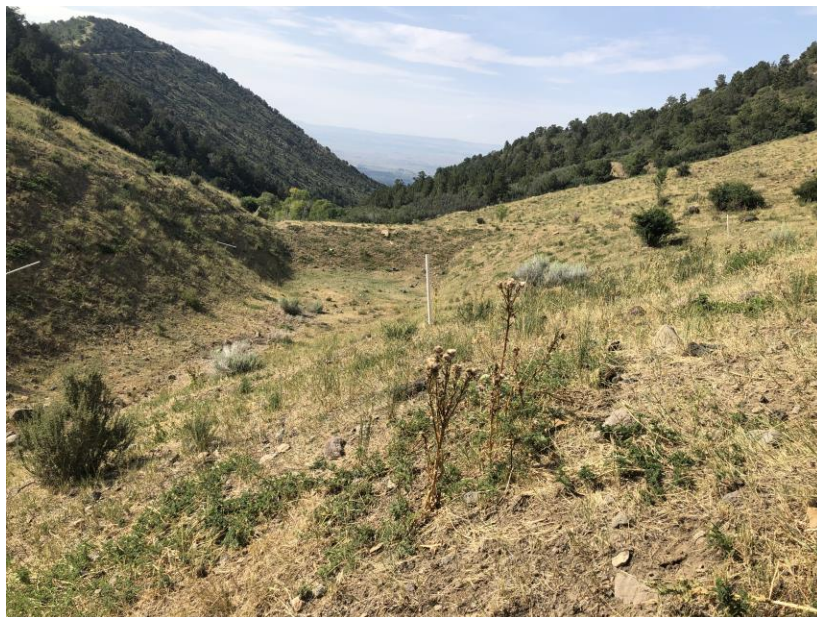
The ponds at the loadout, the Coal Storage Area (near Black Bridge Road), and the West Mine were dry, and no problems were identified with these ponds.

At the West Mine, no yellow starthistle was seen. Dead thistle near the West Mine ponds suggests that BRL has been spraying weeds.

**Upper pond at West Mine (note sprayed thistle)**

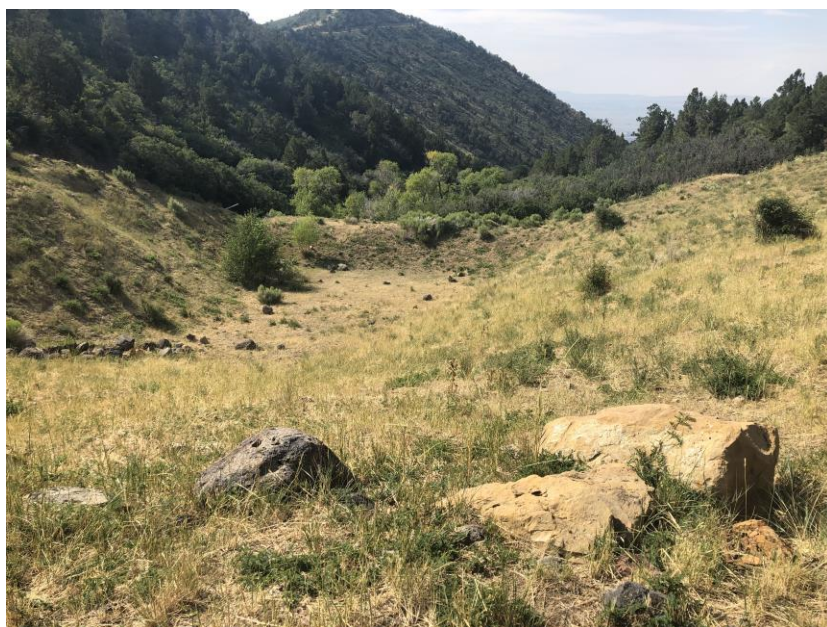
**Lower pond at West Mine**

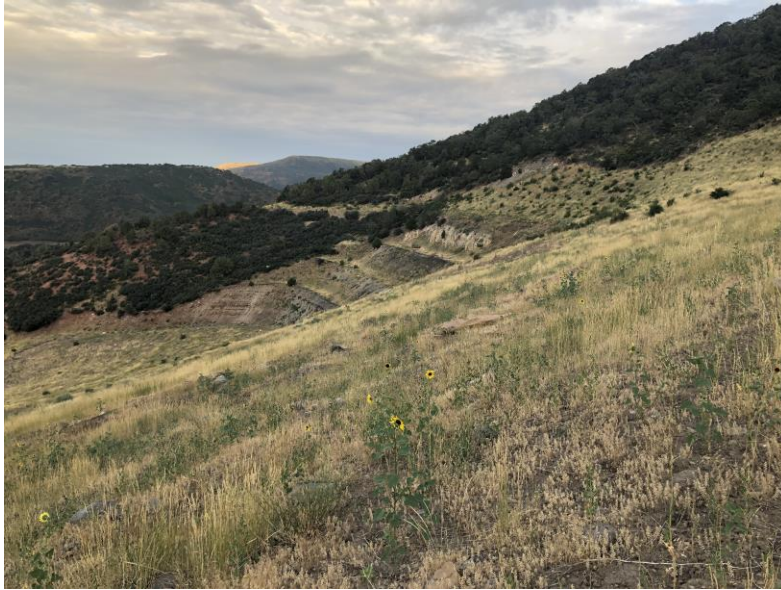
**Steep slope on upper part of East Mine**

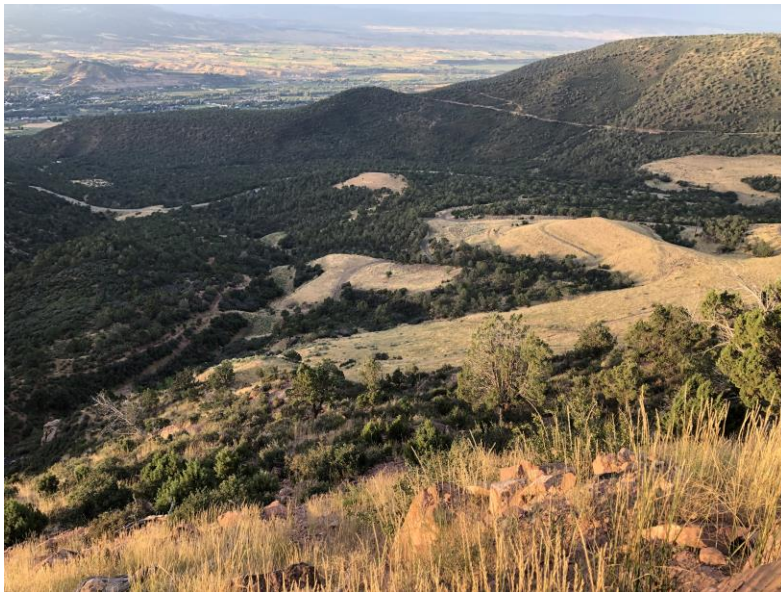
No erosion was seen at the reclaimed areas of the East Mine, including:

**Lower East Mine – RDA, Old Waste Disposal Area, and drainage below**

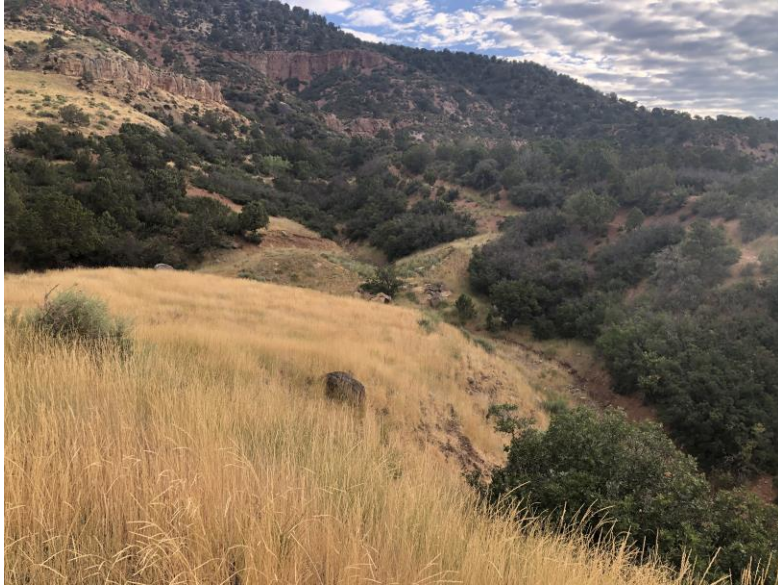
**Old Waste Disposal Area, and drainage above**

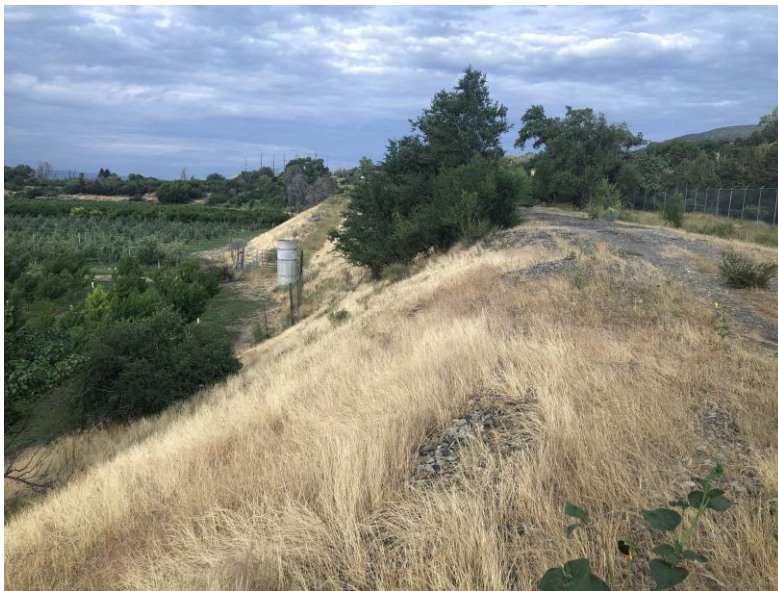
No erosion was seen at the loadout, including the steep slope between the loadout and the orchard below. The trestle across the river appears stable.

**Hillside below the loadout**
