File: July 2023 Monitoring Summary

Date: August 31, 2023

Reference: July 2023 Geotechnical Monitoring Summary Pikeview Quarry

PIKEVIEW QUARRY SLOPE
MONITORING

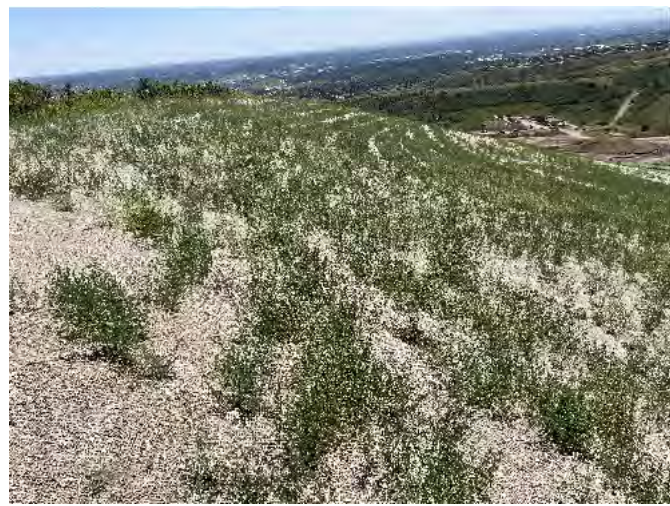
6. Vegetation growing within erosion blanket.

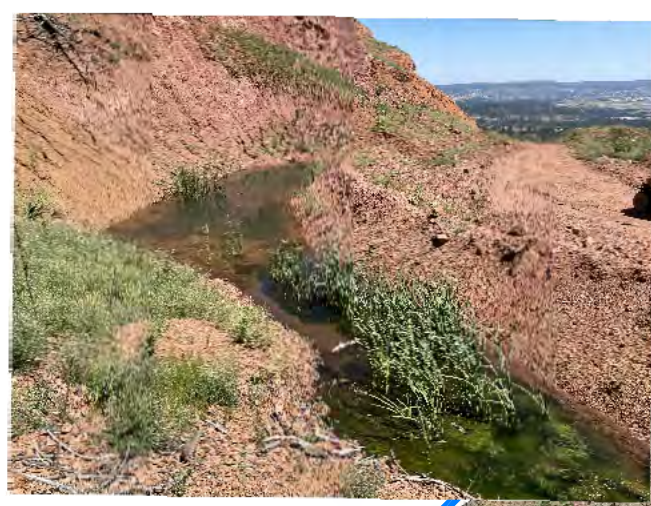
5. Sheep water hole.

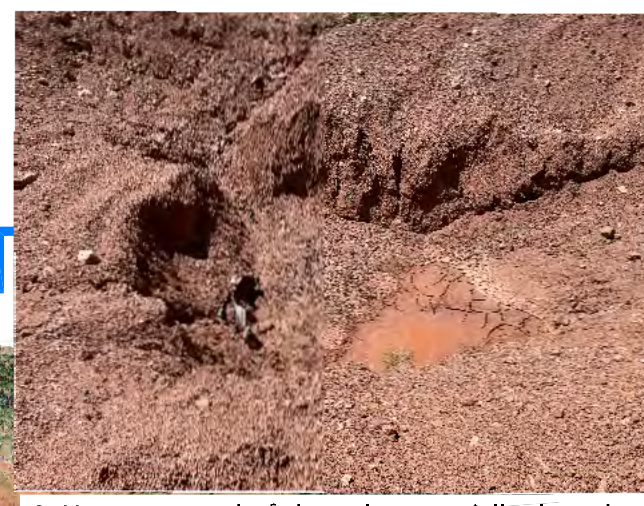
- The culvert remains cleared but mostly blocked inside. Riverbend has partially cleared the debris, but access limitations and supports within the culvert inhibit clearing all the debris. Riverbend has procured a pump and will begin pumping operations if any water collects behind the culvert. Riverbend inspects the culvert for ponded water following rain events, and should any water be observed, it will be removed using pumps.

4. Upstream end of the culvert partially cleared.

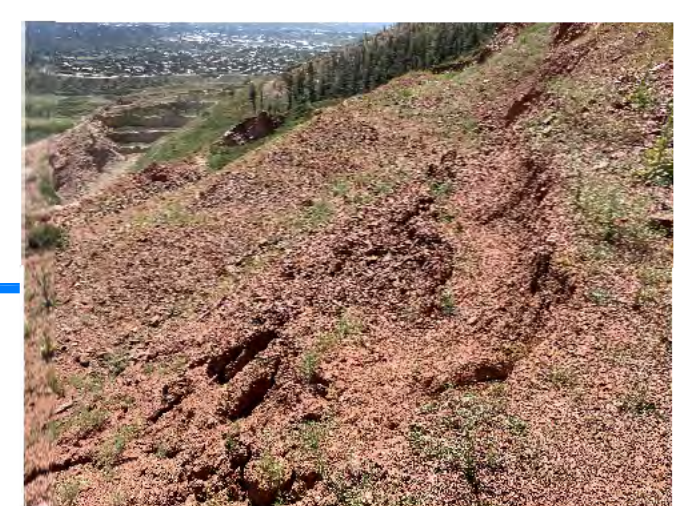
- Known cracks were monitored for changes. Currently the cracks are not growing in any of the areas on the slopes of the site. The hummocky field in the area immediately above the southern extent of the slide shows evidence of cracking, but they are not fresh or active. No new or open cracks were found immediately inside or next to the slide area.

3. No continued signs of cracking or slumping

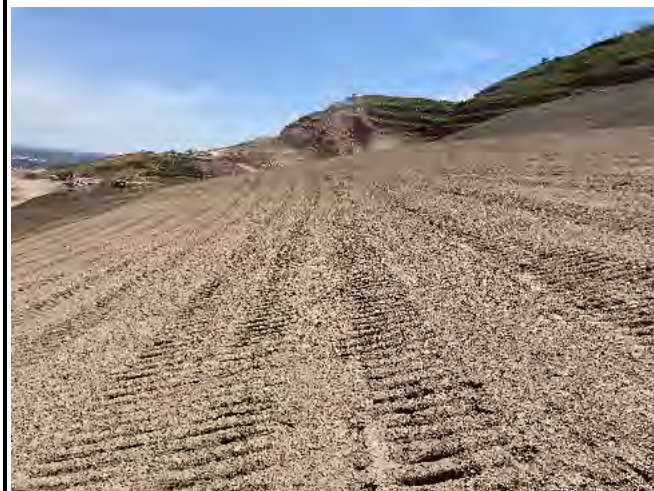
- The slope below the first bench has been placed to the final grade, and this slope was traversed on foot and examined for cracks or signs of instability by Stantec engineers. No cracks or signs of instability were identified.

7. No cracking or slumping on bench slope.

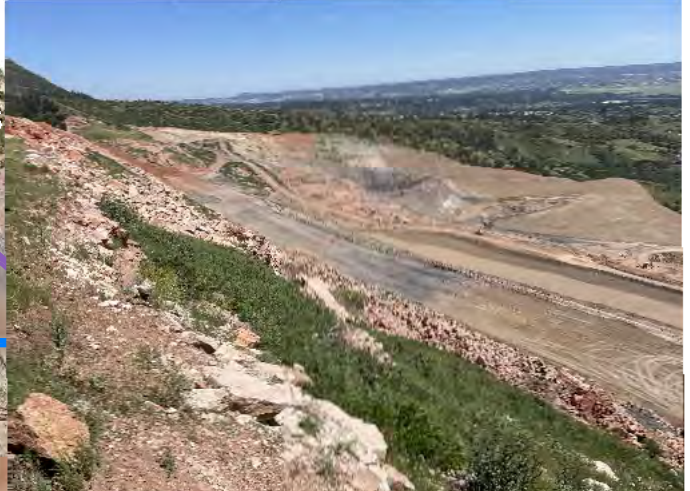
2. Compacted floor of first bench.

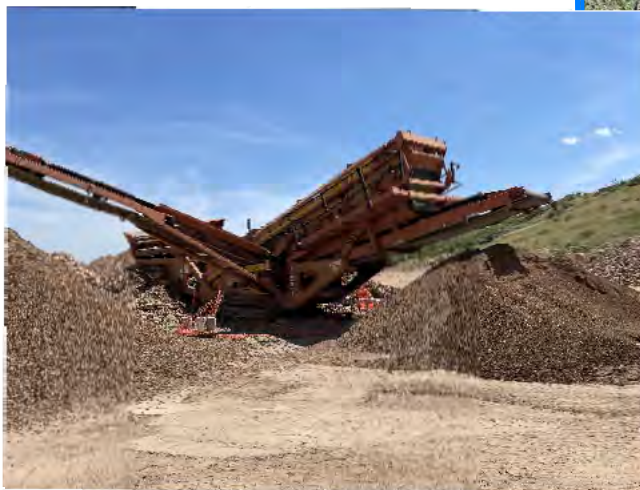
8. Astec near pit floor processing riprap.

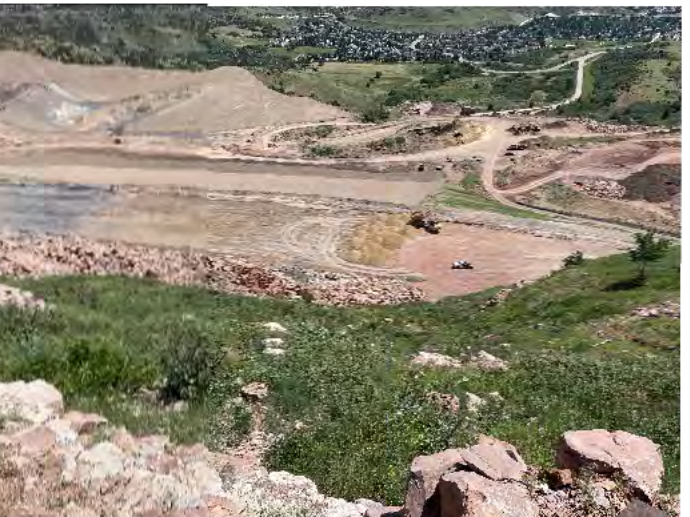
1. Offsite material placed and waiting for compaction.

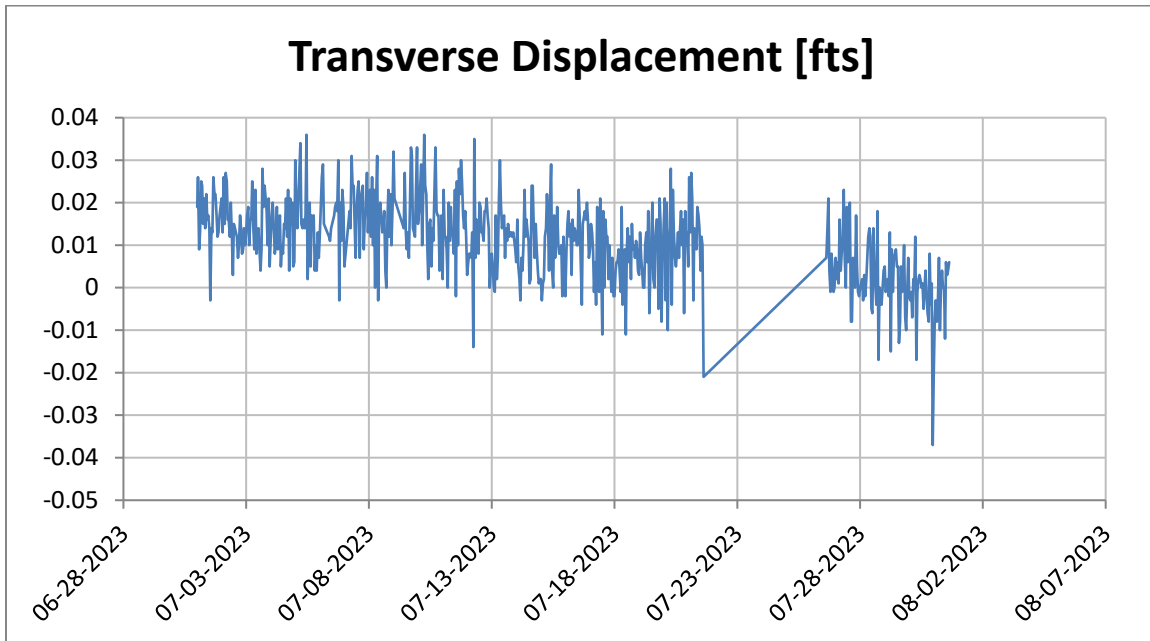
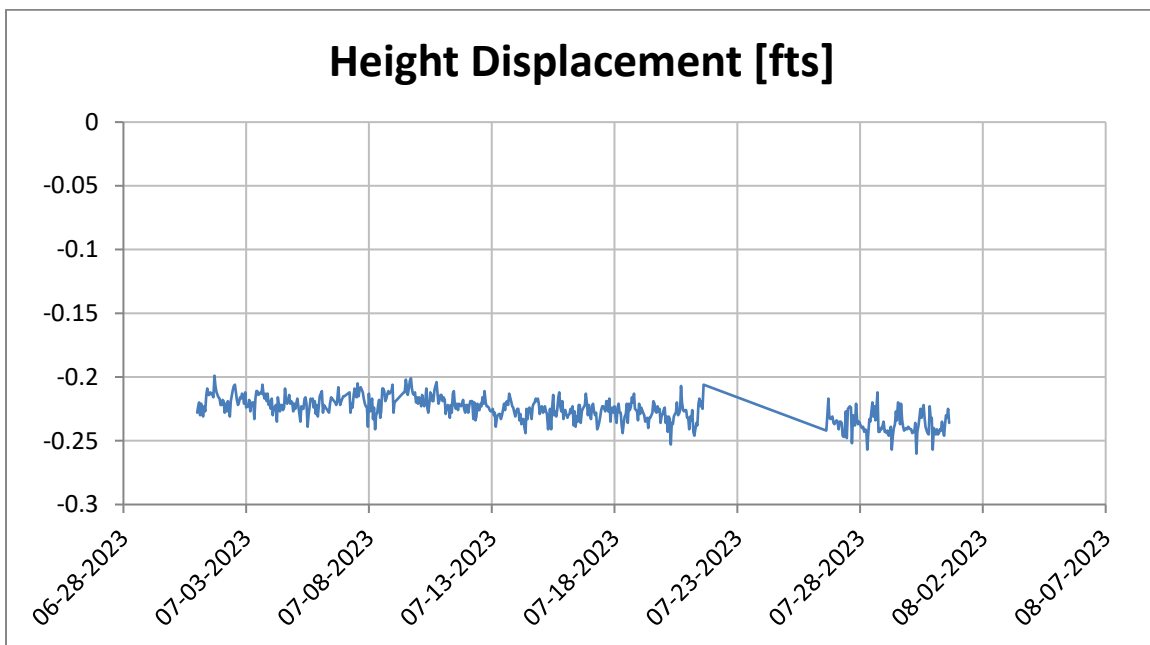
Prism BR1

The data show stable conditions with no movements at 15 of 20 prisms with recorded displacements limited to data scatter and not actual movements. Prisms BR1, BR2, NP3, NP66 and P69A are located above the landslide, and these prisms recorded slope creep movements at slow velocity. This settlement was likely related to the landslide material consolidating under its own weight with the addition of excess water. These prisms were placed in areas where slope creep movements are likely to occur; therefore, movements being recorded at more locations is expected. The prisms placed in the buttress fill area show small amounts of movement; these apparent movements are believed to be the result of topsoil placement around prism. Plots of the transverse and height displacements for each prism are included in Appendix B.

1. Survey accuracy is ± 0.016 feet.
2. Alert threshold is ± 0.35 feet.
3. Transverse displacement is in the horizontal direction. Positive direction means closer to the robotic station.
4. Height displacement is in the vertical direction. Positive direction means higher in elevation.
5. Prism records slope creep movements.

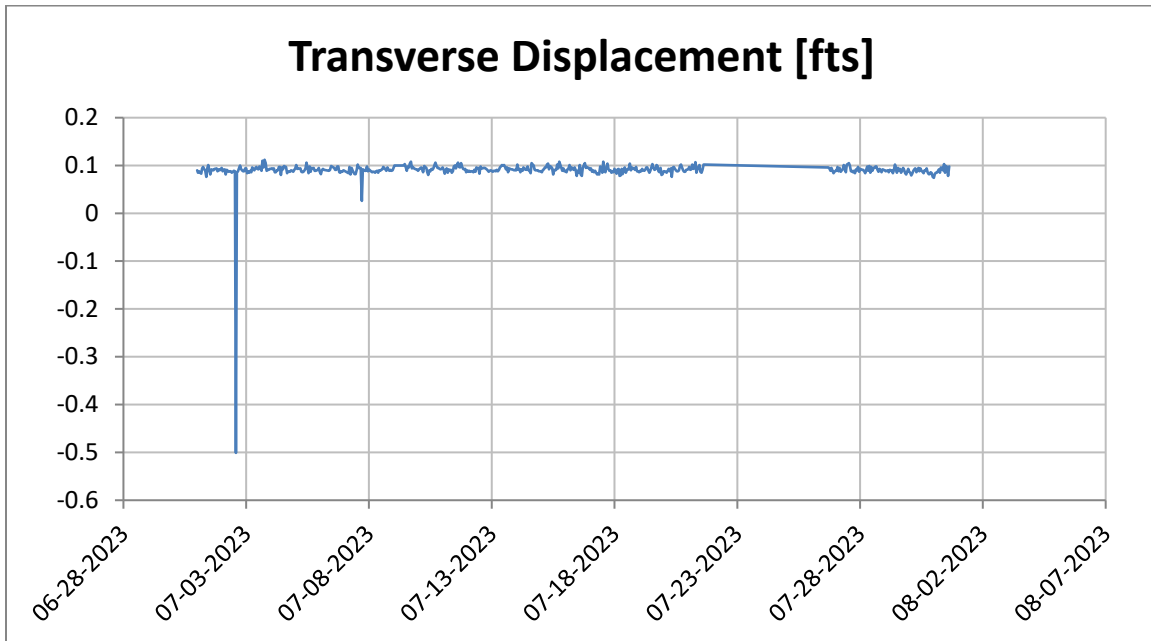
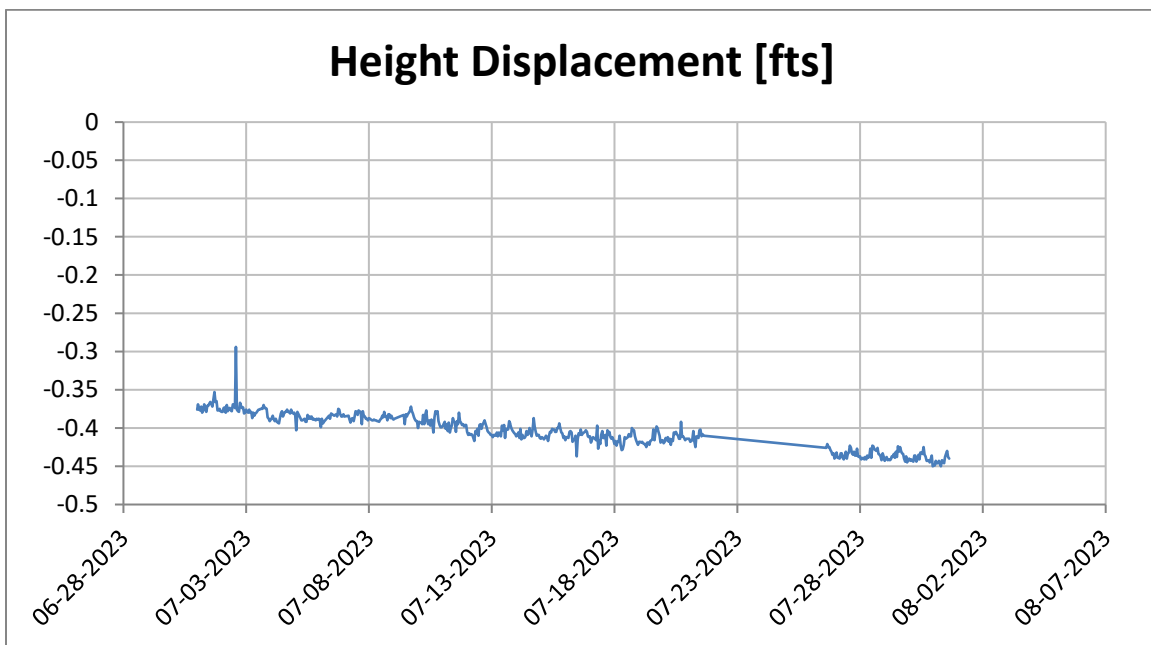
Prism BR2

1. Survey accuracy is ± 0.016 feet.
2. Alert threshold is ± 0.35 feet.
3. Transverse displacement is in the horizontal direction. Positive direction means closer to the robotic station.
4. Height displacement is in the vertical direction. Positive direction means higher in elevation.
5. Prism records slope creep movements.

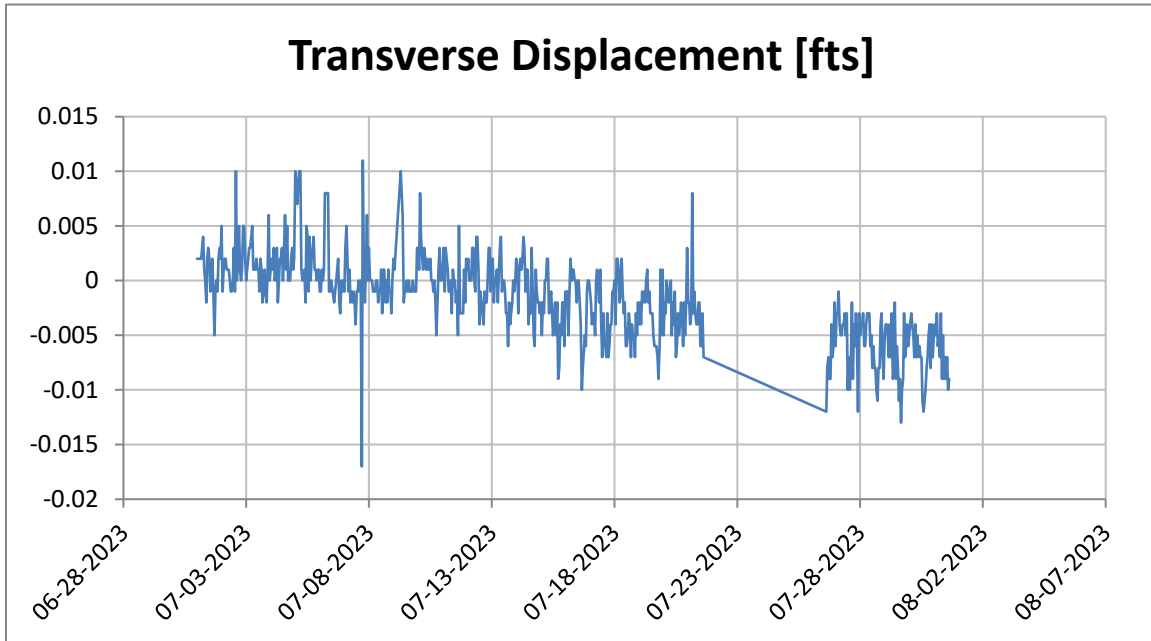
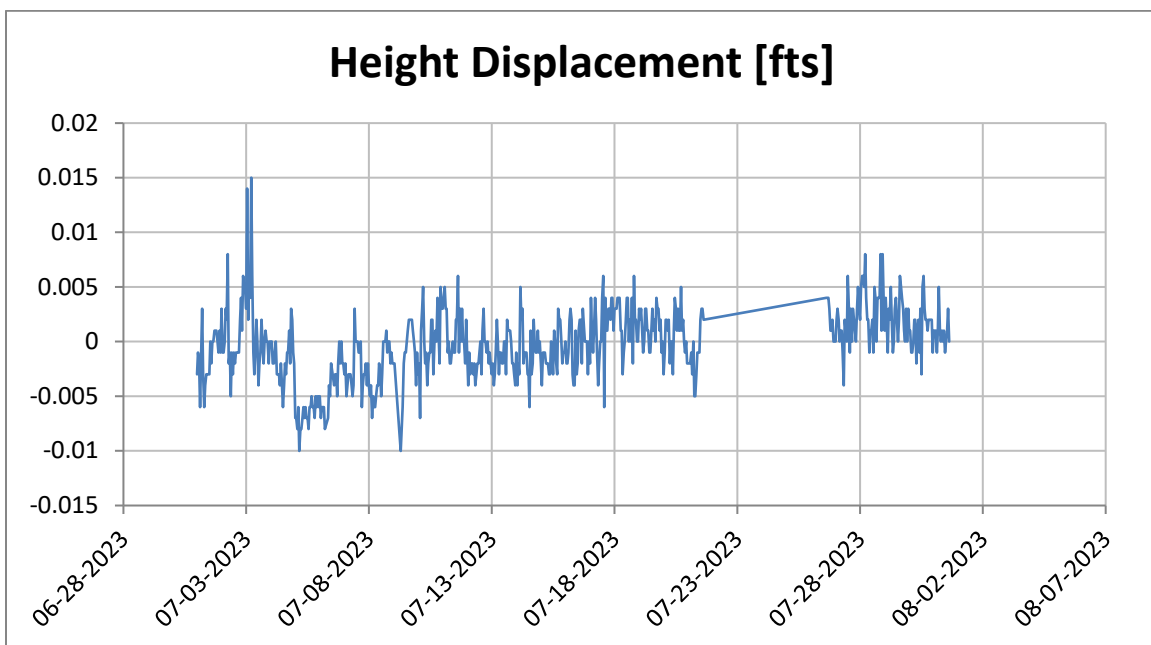
Prism B7200-1

1. Survey accuracy is +/-0.016 feet.
2. Alert threshold is +/-0.35 feet.
3. Transverse displacement is in the horizontal direction. Positive direction means closer to the robotic station.
4. Height displacement is in the vertical direction. Positive direction means higher in elevation.
5. Apparent movements believed to be the result of topsoil placement around prism.

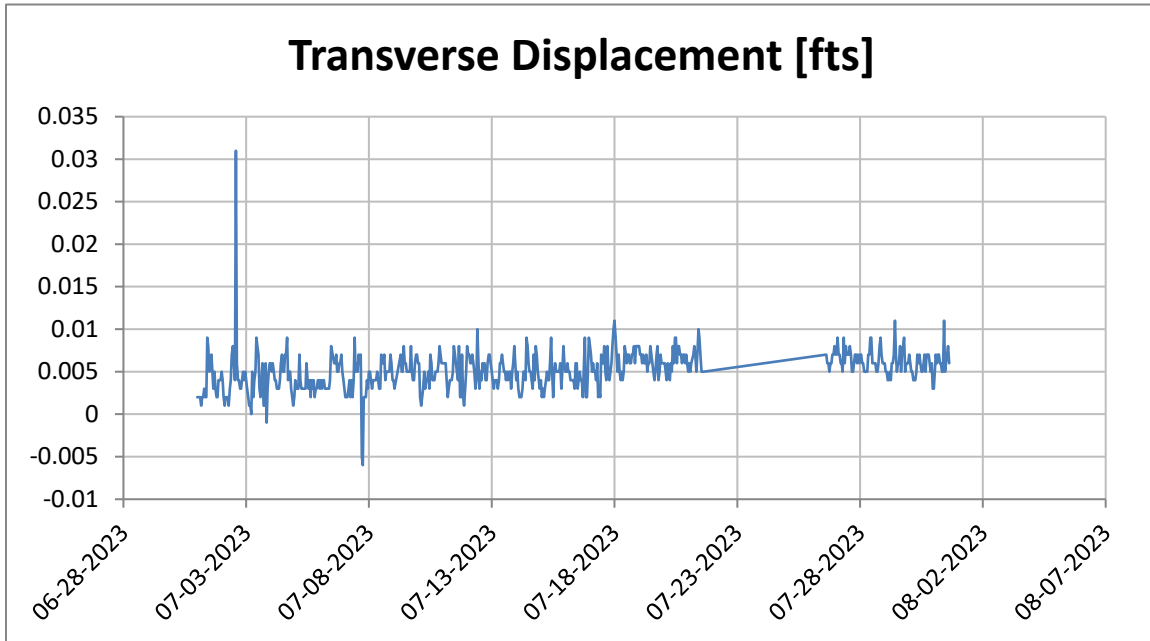
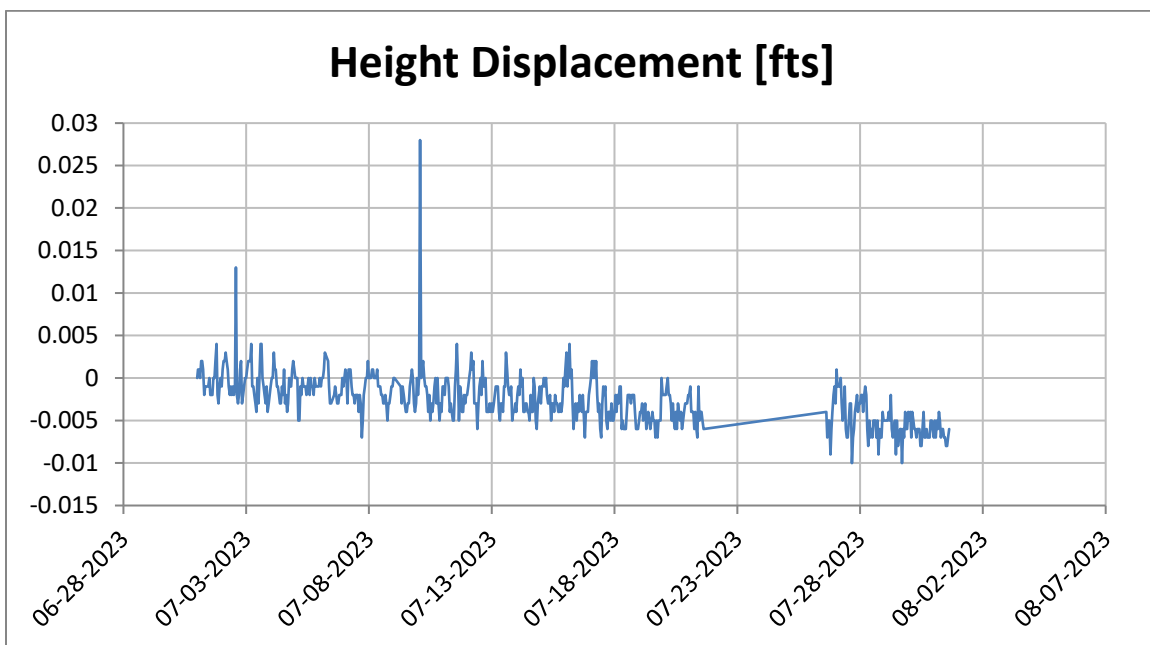
Prism B7200-2

1. Survey accuracy is ± 0.016 feet.
2. Alert threshold is ± 0.35 feet.
3. Transverse displacement is in the horizontal direction. Positive direction means closer to the robotic station.
4. Height displacement is in the vertical direction. Positive direction means higher in elevation.
5. Apparent movements believed to be the result of topsoil placement around prism.

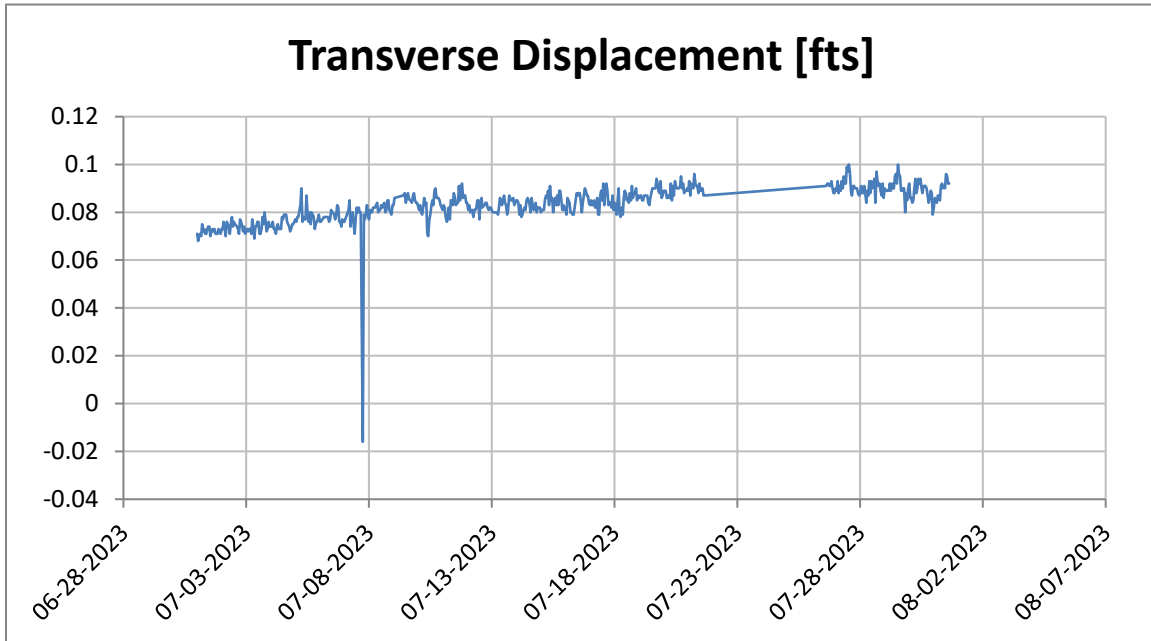
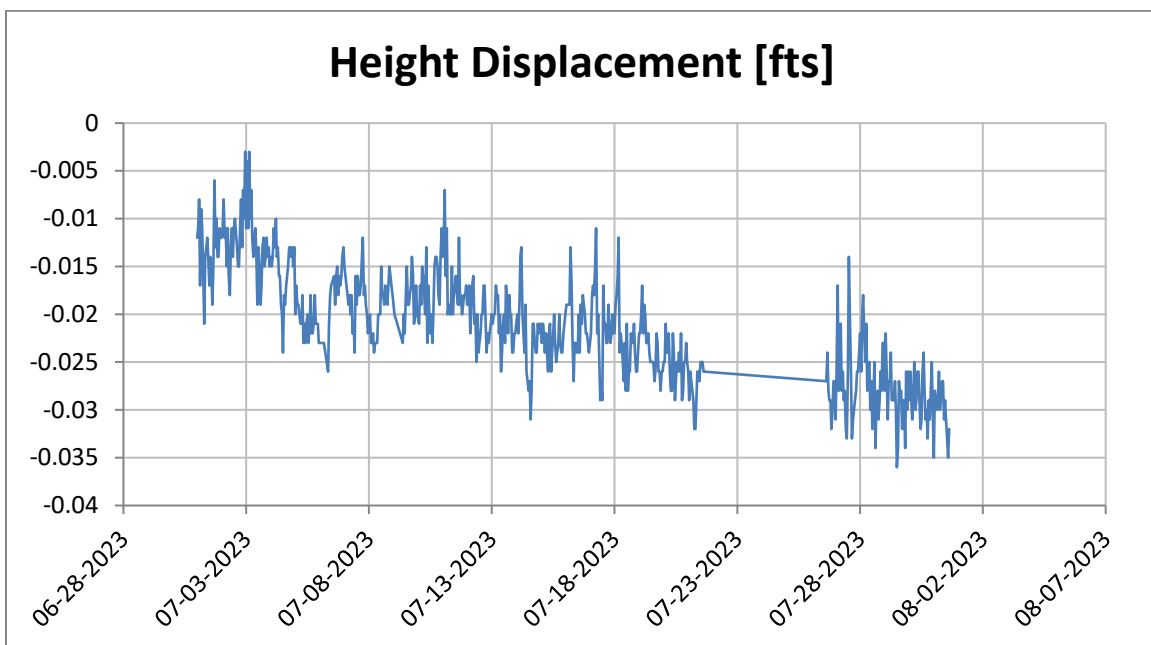
Prism B7200-3

1. Survey accuracy is +/-0.016 feet.
2. Alert threshold is +/-0.35 feet.
3. Transverse displacement is in the horizontal direction. Positive direction means closer to the robotic station.
4. Height displacement is in the vertical direction. Positive direction means higher in elevation.
5. Apparent movements believed to be the result of topsoil placement around prism.

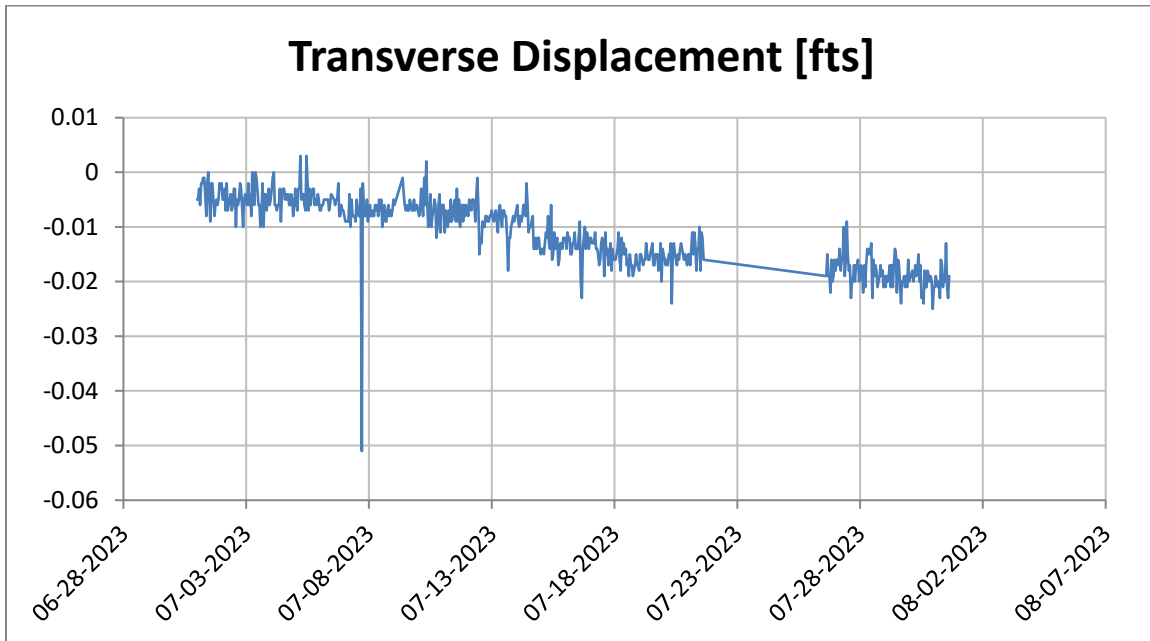
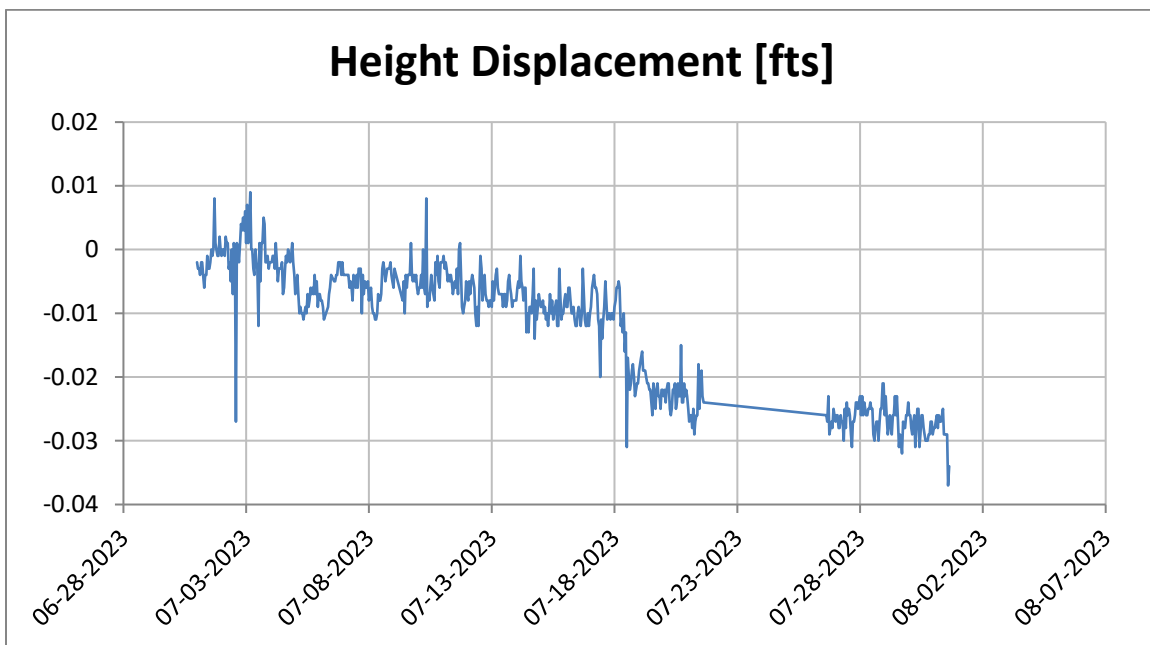
Prism B7300-1

1. Survey accuracy is ± 0.016 feet.
2. Alert threshold is ± 0.35 feet.
3. Transverse displacement is in the horizontal direction. Positive direction means closer to the robotic station.
4. Height displacement is in the vertical direction. Positive direction means higher in elevation.
5. Apparent movements believed to be the result of topsoil placement around prism.

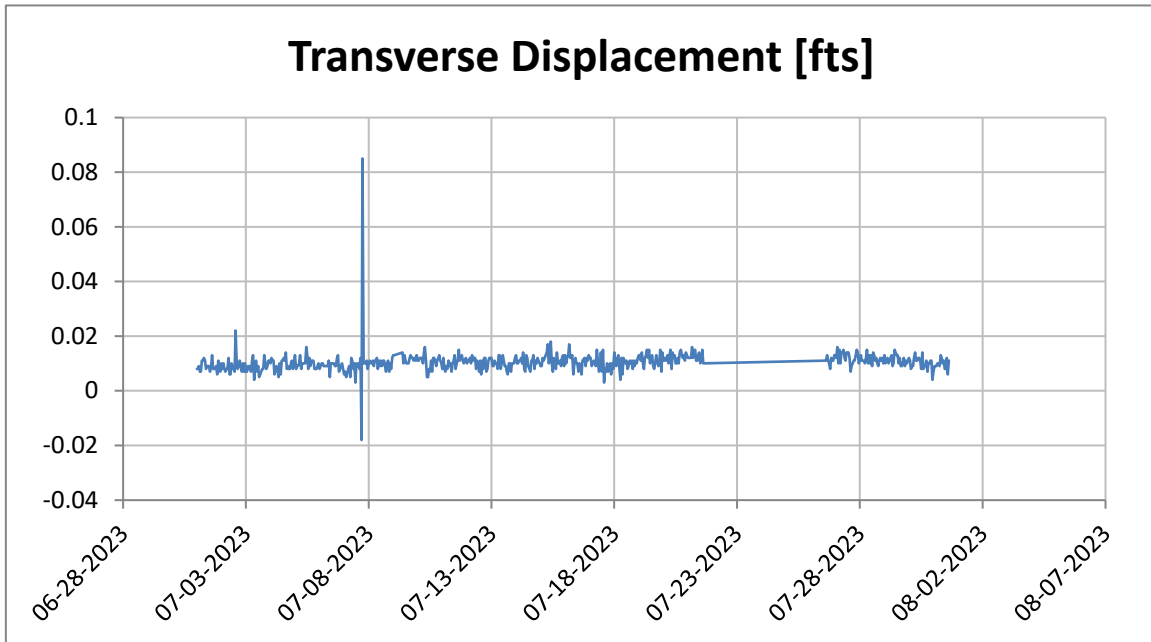
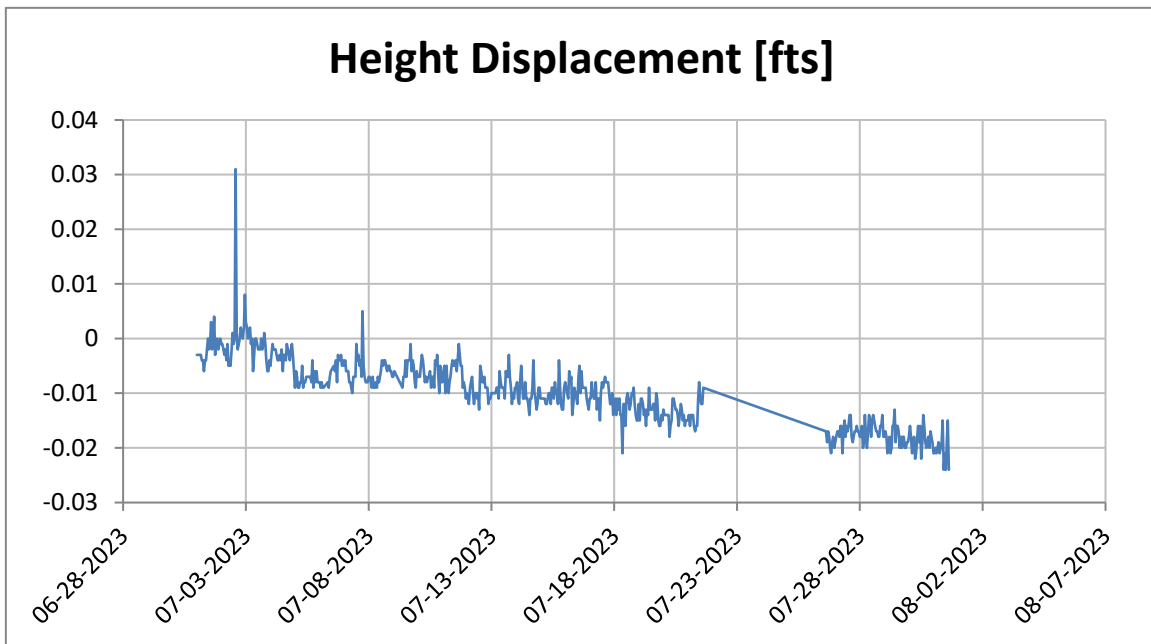
Prism B7300-2

1. Survey accuracy is ± 0.016 feet.
2. Alert threshold is ± 0.35 feet.
3. Transverse displacement is in the horizontal direction. Positive direction means closer to the robotic station.
4. Height displacement is in the vertical direction. Positive direction means higher in elevation.
5. Apparent movements believed to be the result of topsoil placement around prism.

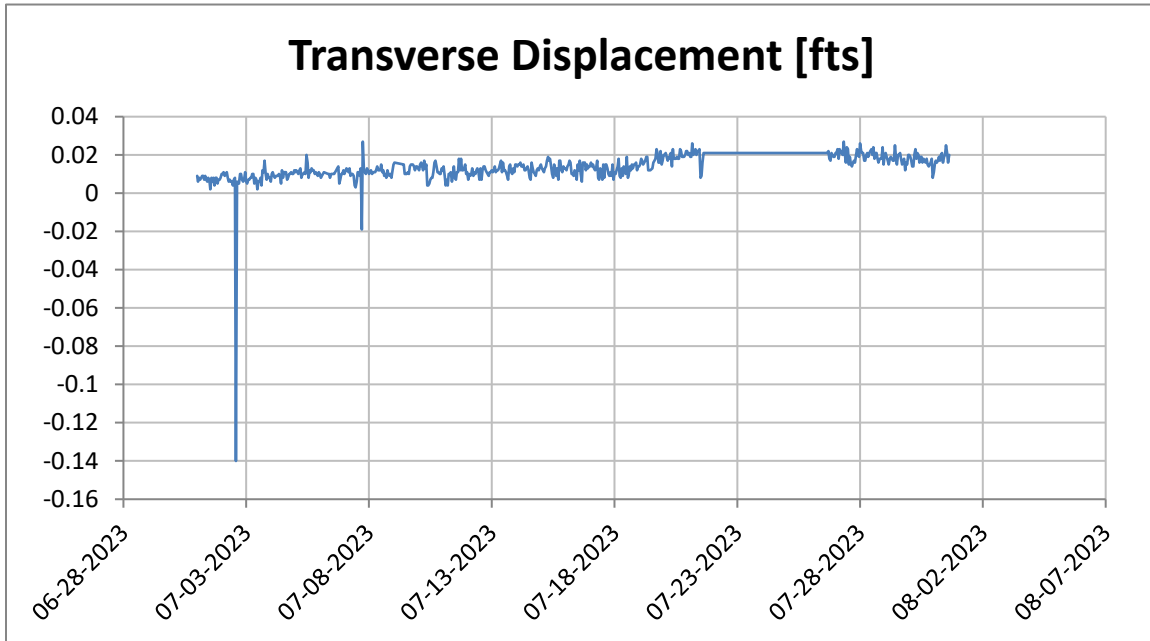
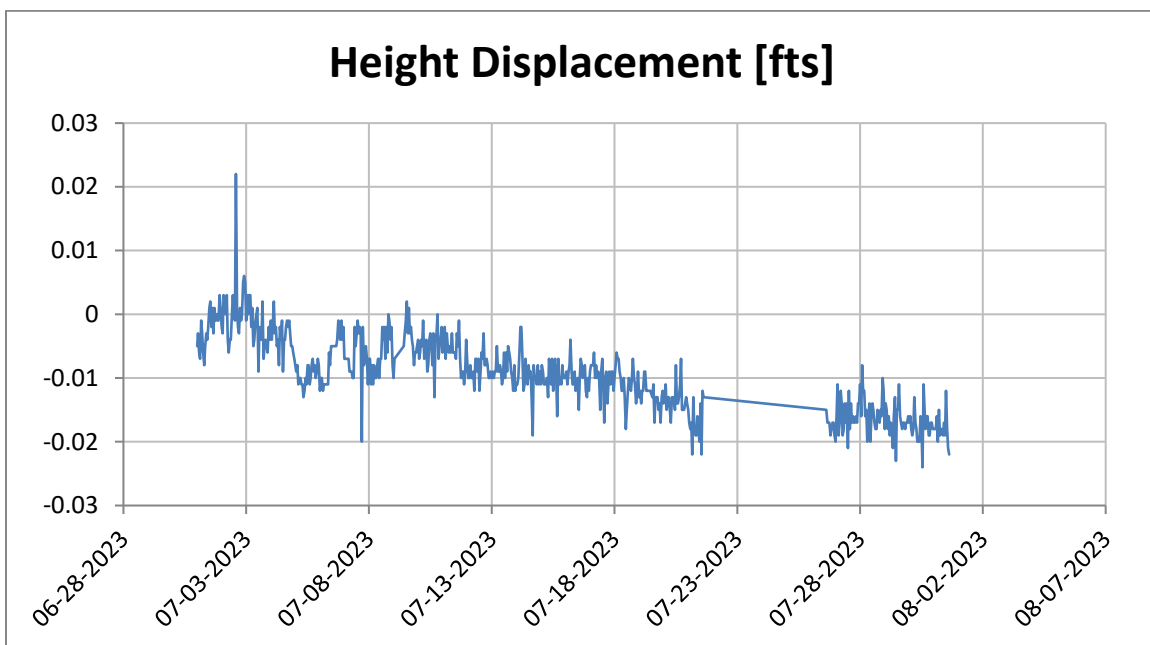
Prism B7300-3

1. Survey accuracy is +/-0.016 feet.
2. Alert threshold is +/-0.35 feet.
3. Transverse displacement is in the horizontal direction. Positive direction means closer to the robotic station.
4. Height displacement is in the vertical direction. Positive direction means higher in elevation.
5. Apparent movements believed to be the result of topsoil placement around prism.

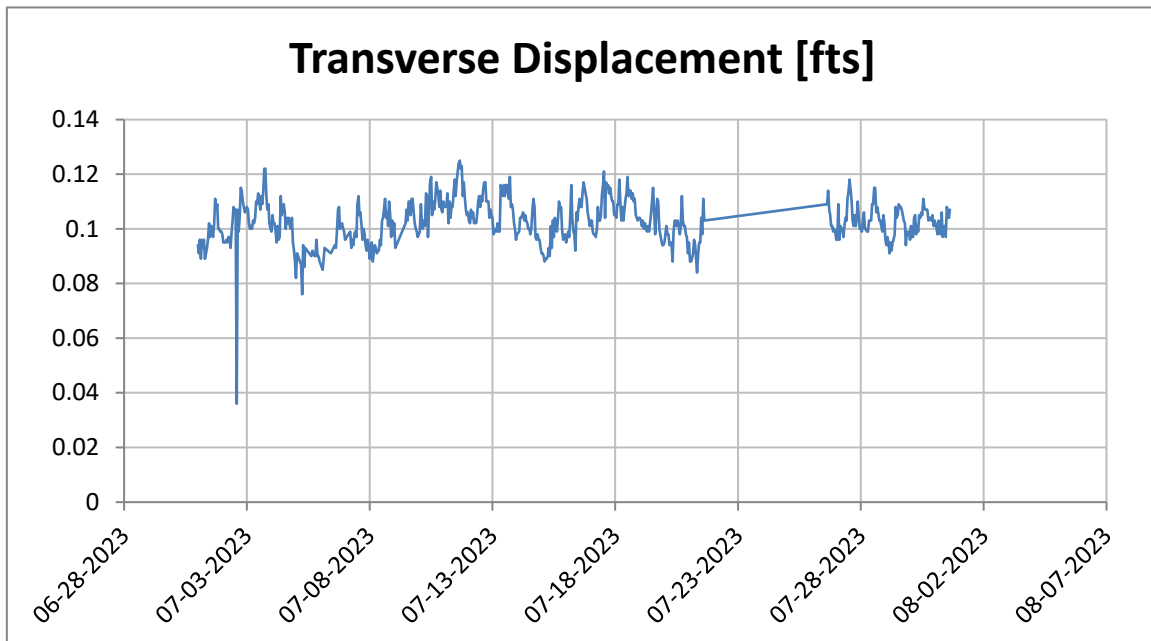
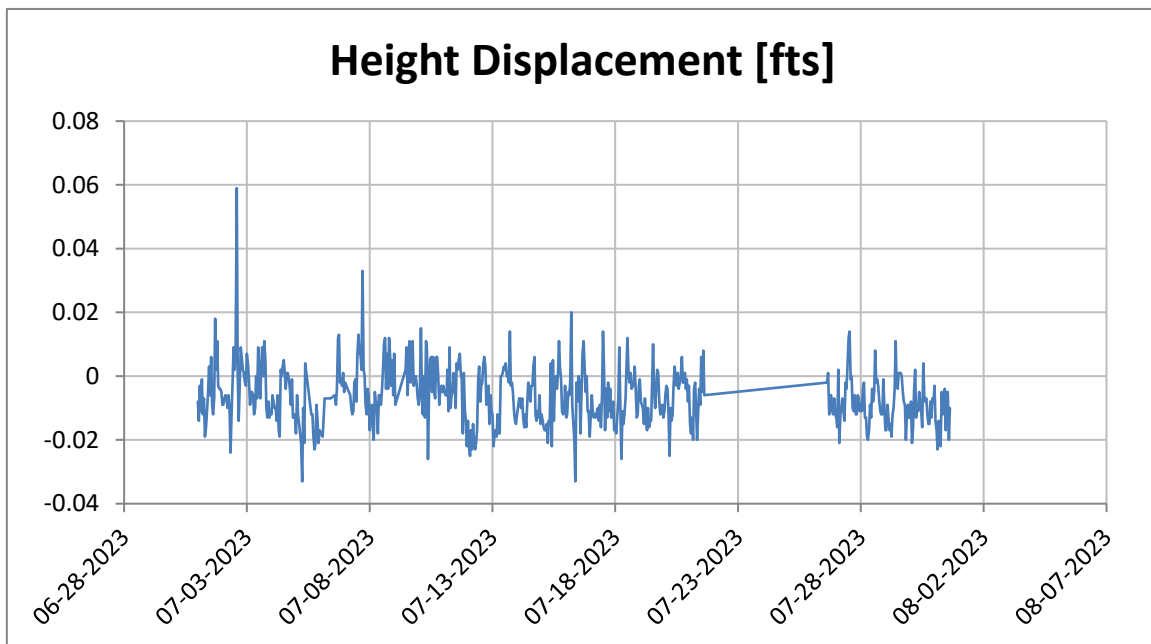
Prism P33

1. Survey accuracy is ± 0.016 feet.
2. Alert threshold is ± 0.35 feet.
3. Transverse displacement is in the horizontal direction. Positive direction means closer to the robotic station.
4. Height displacement is in the vertical direction. Positive direction means higher in elevation.
5. Regression limit alerts received on July 2.

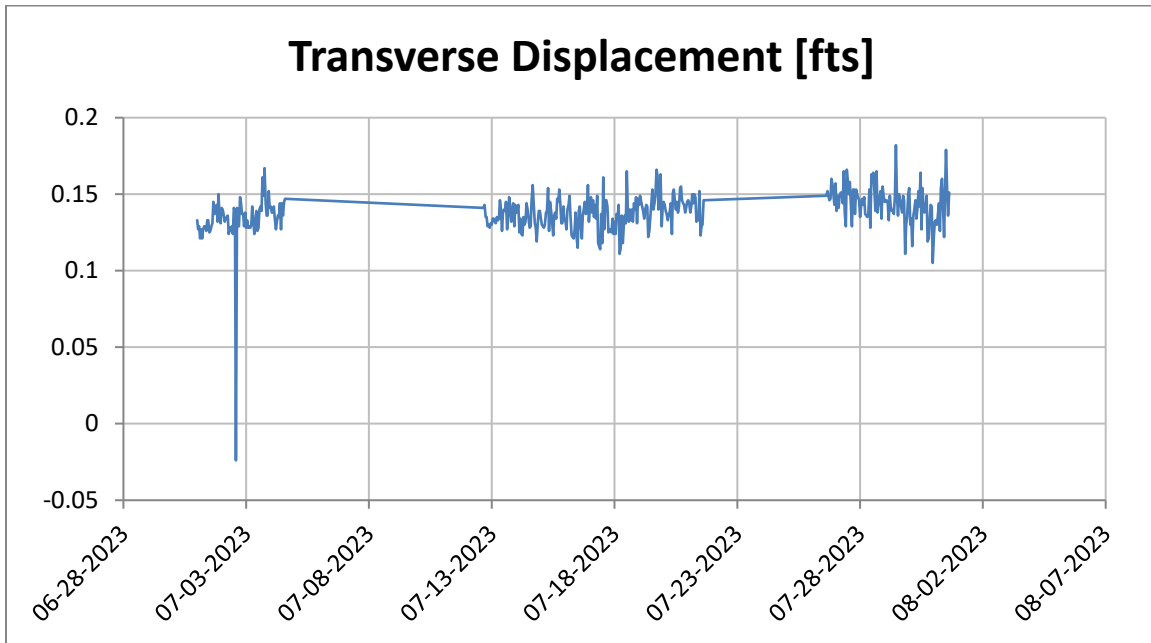
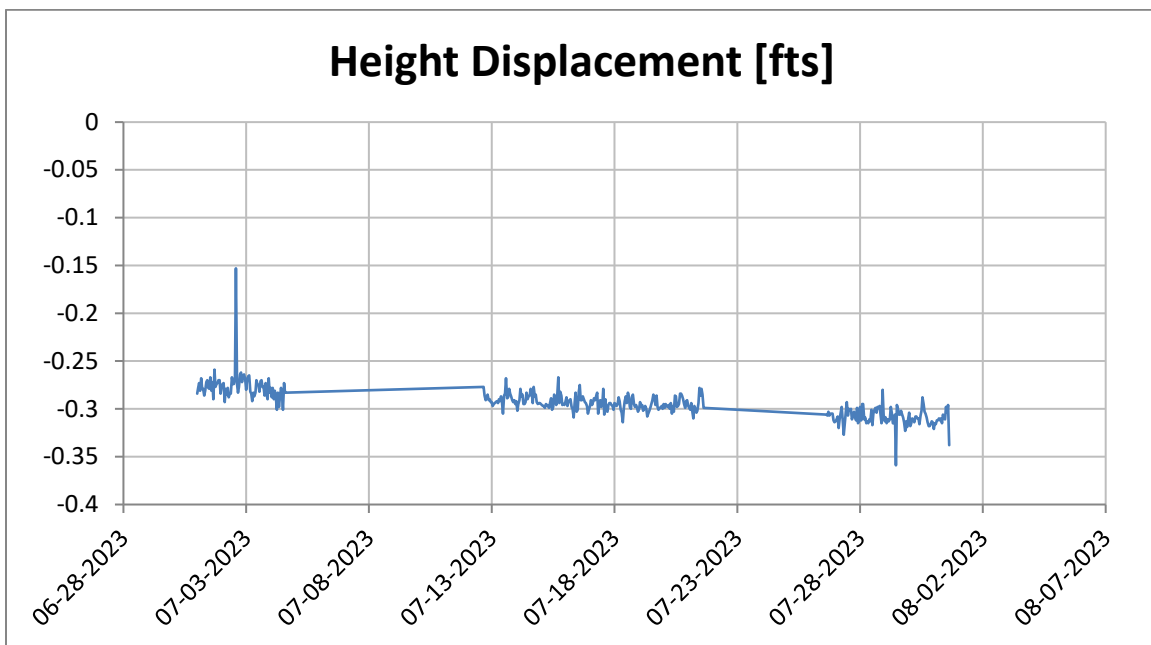
NP3

1. Survey accuracy is ± 0.016 feet.
2. Alert threshold is ± 0.35 feet.
3. Transverse displacement is in the horizontal direction. Positive direction means closer to the robotic station.
4. Height displacement is in the vertical direction. Positive direction means higher in elevation.
5. Prism records slope creep movements.

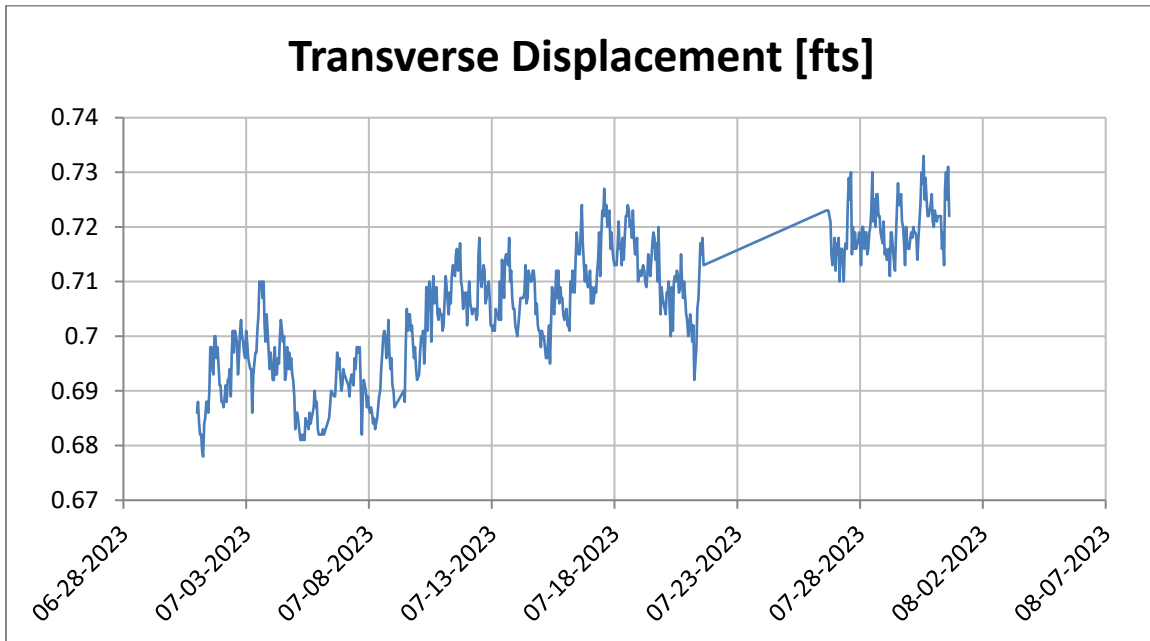
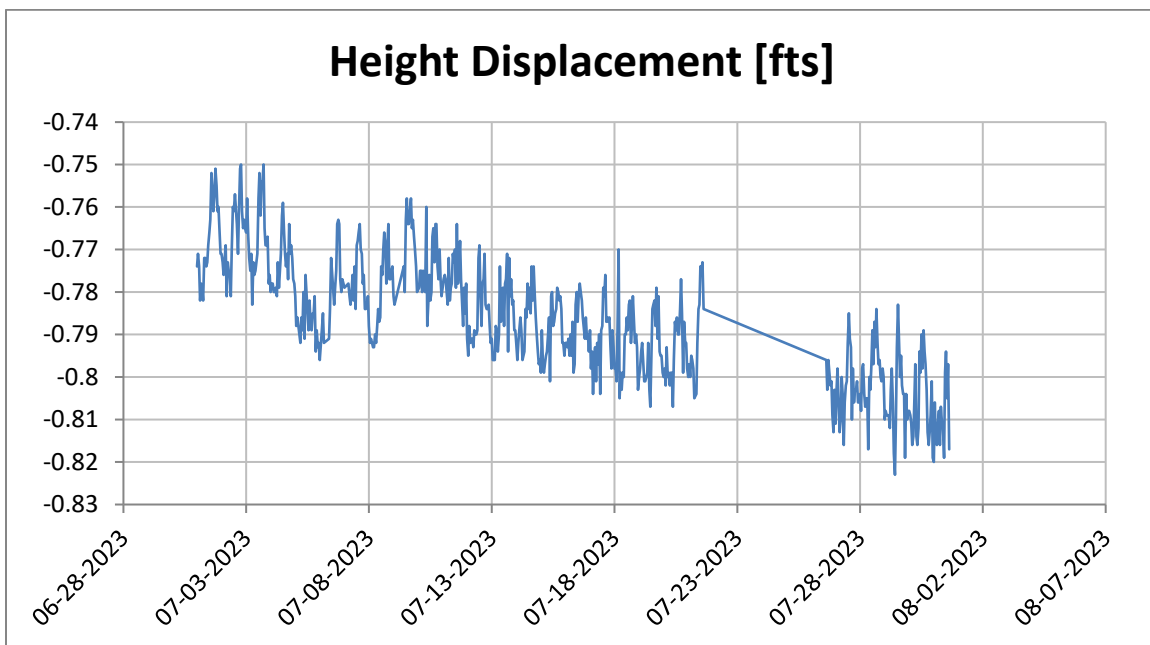
NP66

1. Survey accuracy is ± 0.016 feet.
2. Alert threshold is ± 0.35 feet.
3. Transverse displacement is in the horizontal direction. Positive direction means closer to the robotic station.
4. Height displacement is in the vertical direction. Positive direction means higher in elevation.
5. Prism records slope creep movements.

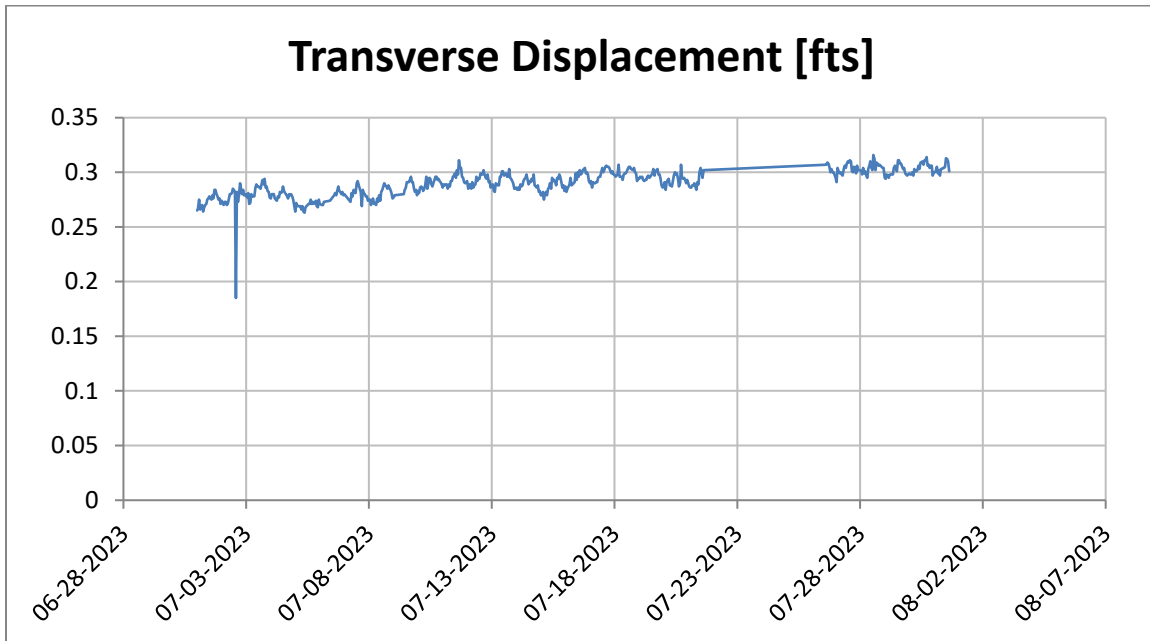
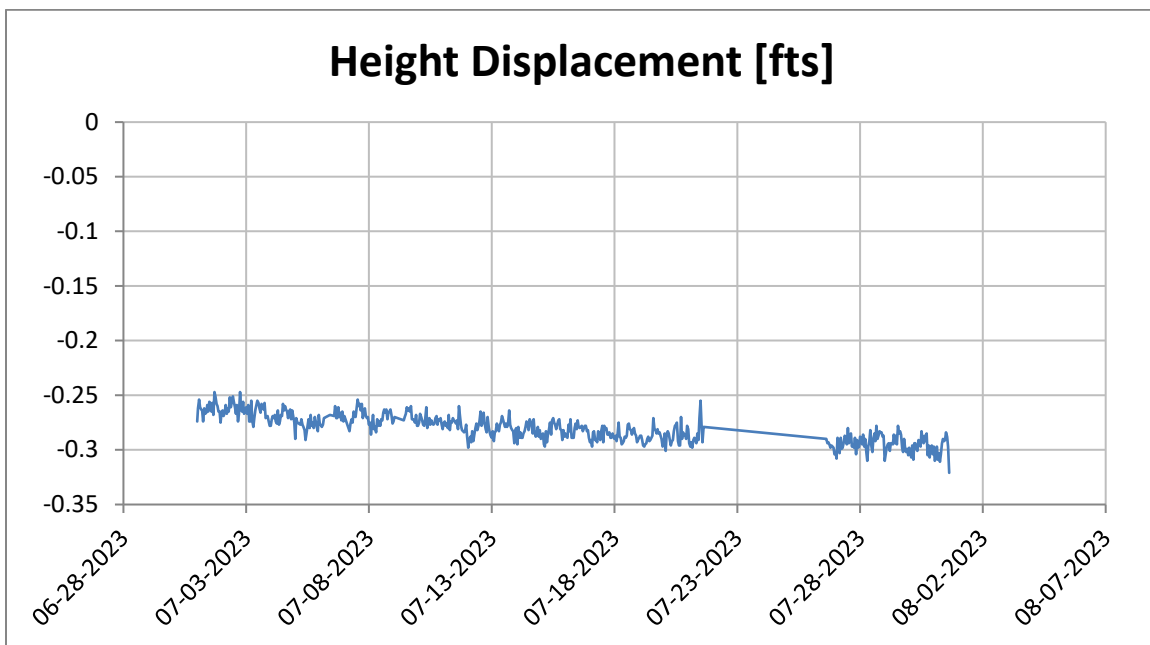
P69A

1. Survey accuracy is ± 0.016 feet.
2. Alert threshold is ± 0.35 feet.
3. Transverse displacement is in the horizontal direction. Positive direction means closer to the robotic station.
4. Height displacement is in the vertical direction. Positive direction means higher in elevation.
5. Prism records slope creep movements.
