File: July 2023 Monitoring Summary

Date: August 31, 2023

Reference: July 2023 Geotechnical Monitoring Summary Pikeview Quarry

PIKEVIEW QUARRY SLOPE
MONITORING

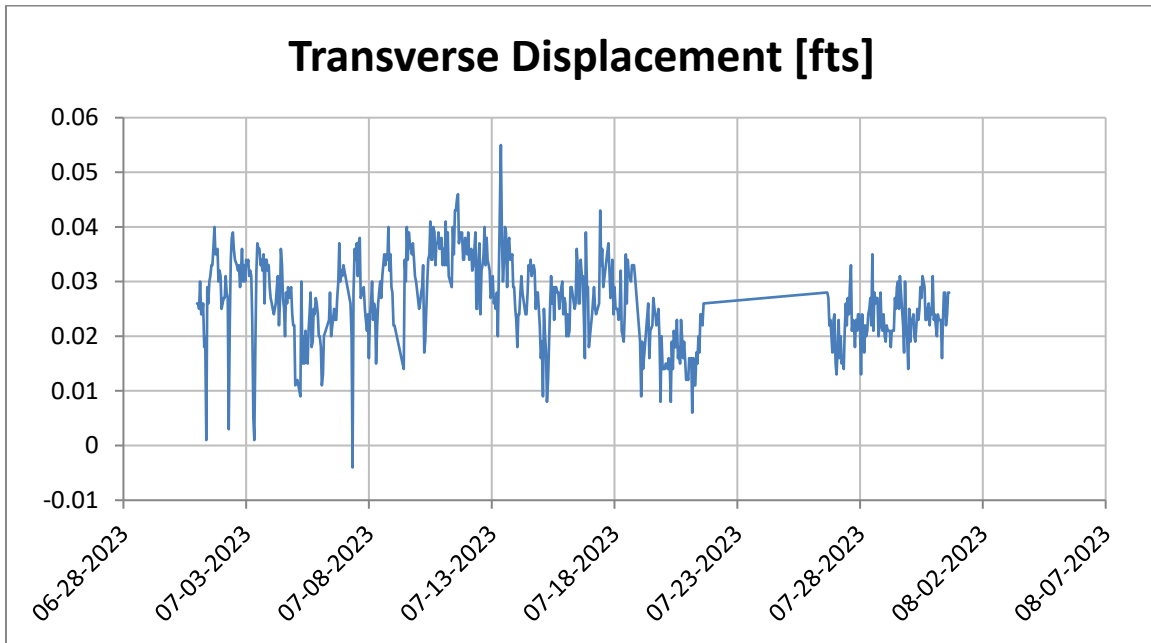
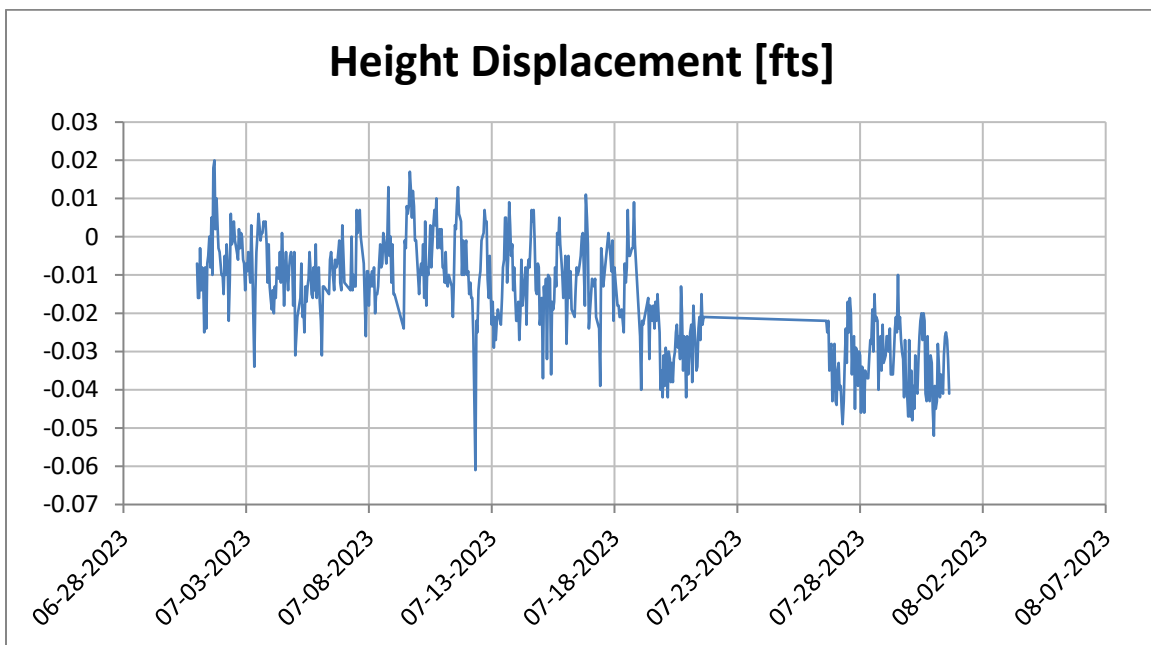
Prism P70

1. Survey accuracy is ± 0.016 feet.
2. Alert threshold is ± 0.35 feet.
3. Transverse displacement is in the horizontal direction. Positive direction means closer to the robotic station.
4. Height displacement is in the vertical direction. Positive direction means higher in elevation.
5. Regression limit alerts received on July 2.

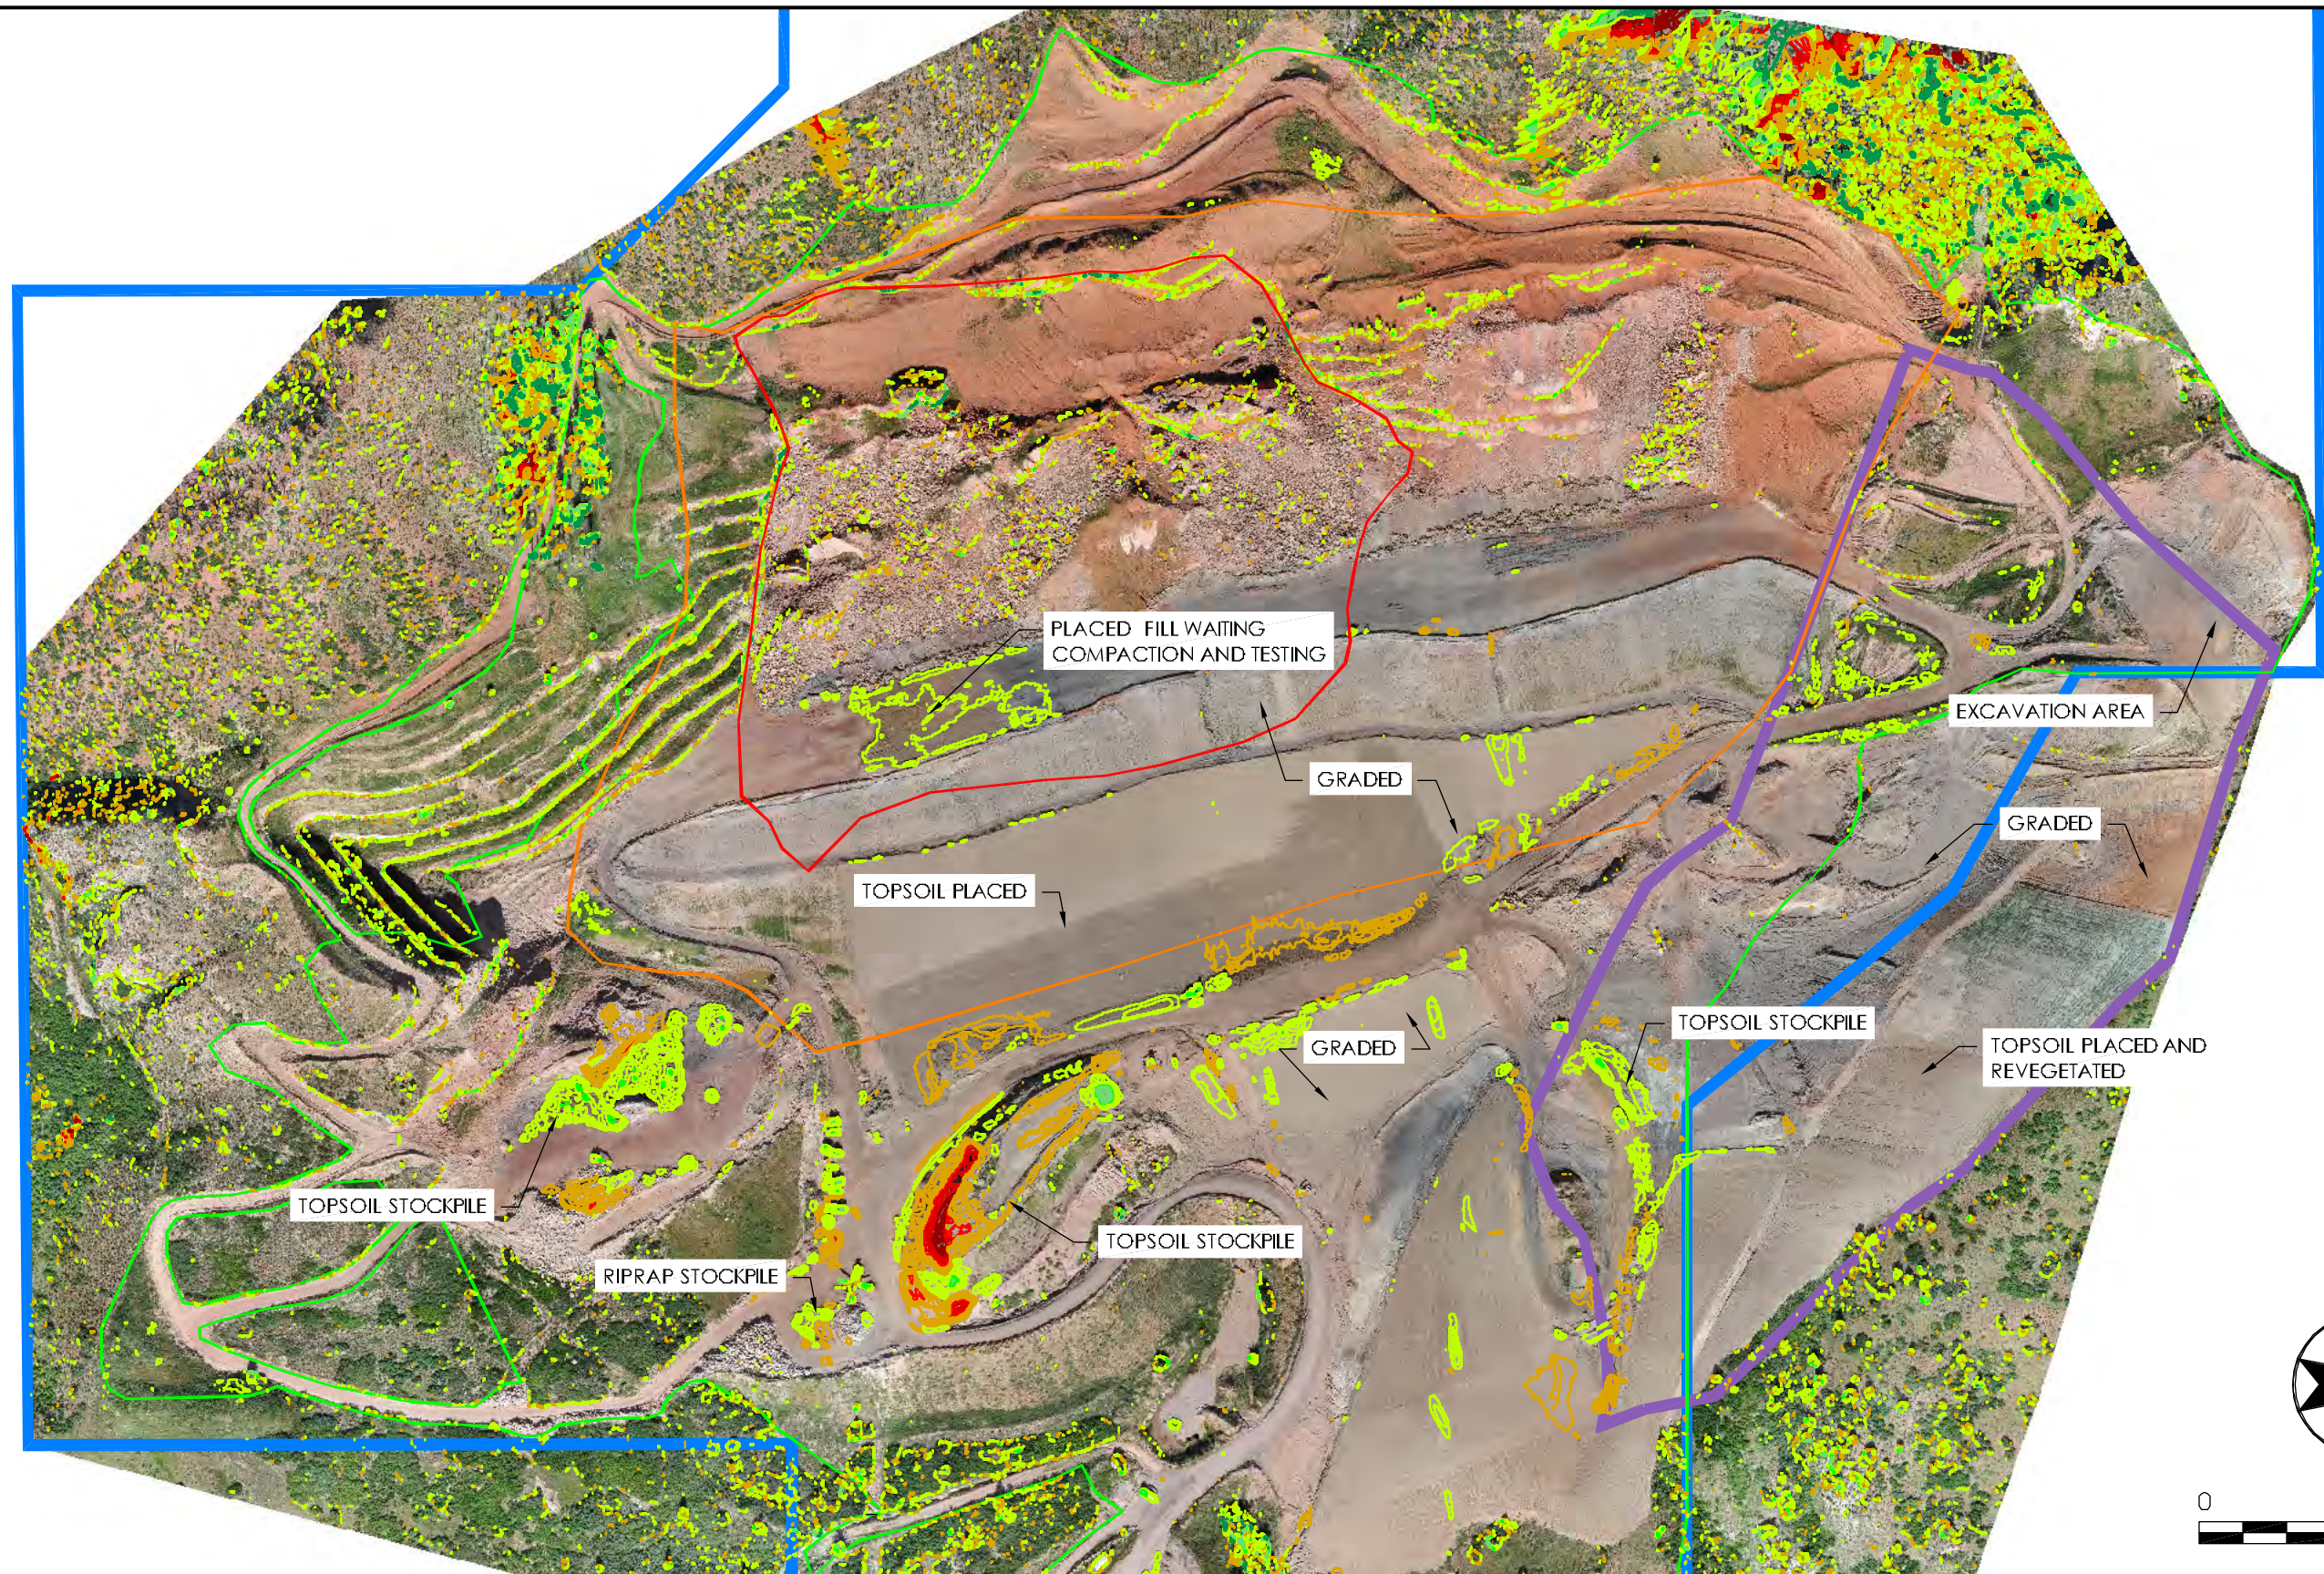
Revision #	Date
1	2023.08.31
Drawn By PK	Figure No. 5

The July topography was also compared to the June topography to identify changes in the site topography. Comparison of the two surveys showed the placement of the fill material at the toe of the landslide. Fill material is excavated from the North and South Borrow Areas or imported from offsite projects. No slope

movements or other changes in topography were identified. The current imagery and topography are included in Figures 1 and 3, and the comparison surface is included as Figure 5 in Appendix C.
