JONES FINE SAND - SAND CREEK MINE - M-1992-088

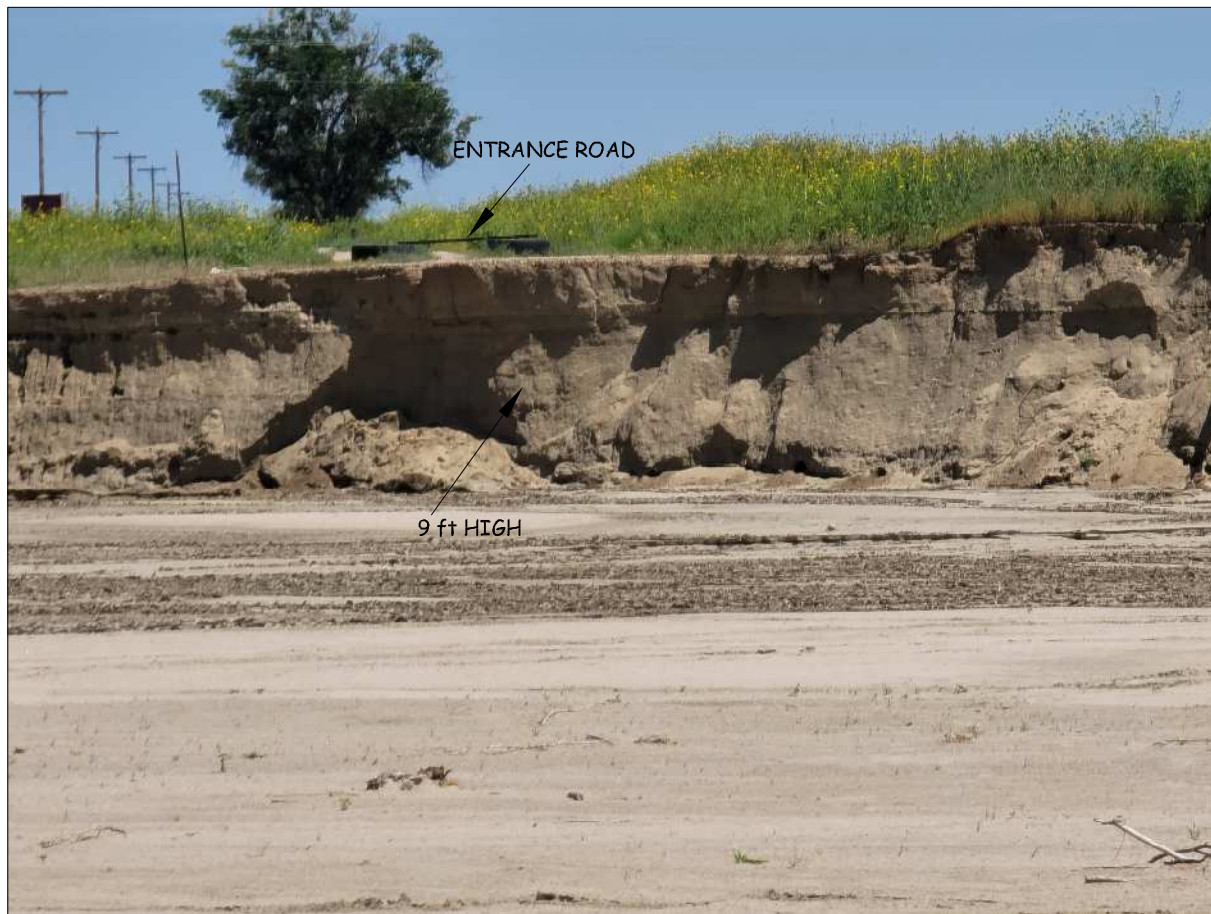
Photo 1 - 8-10-2023
Entrance Road

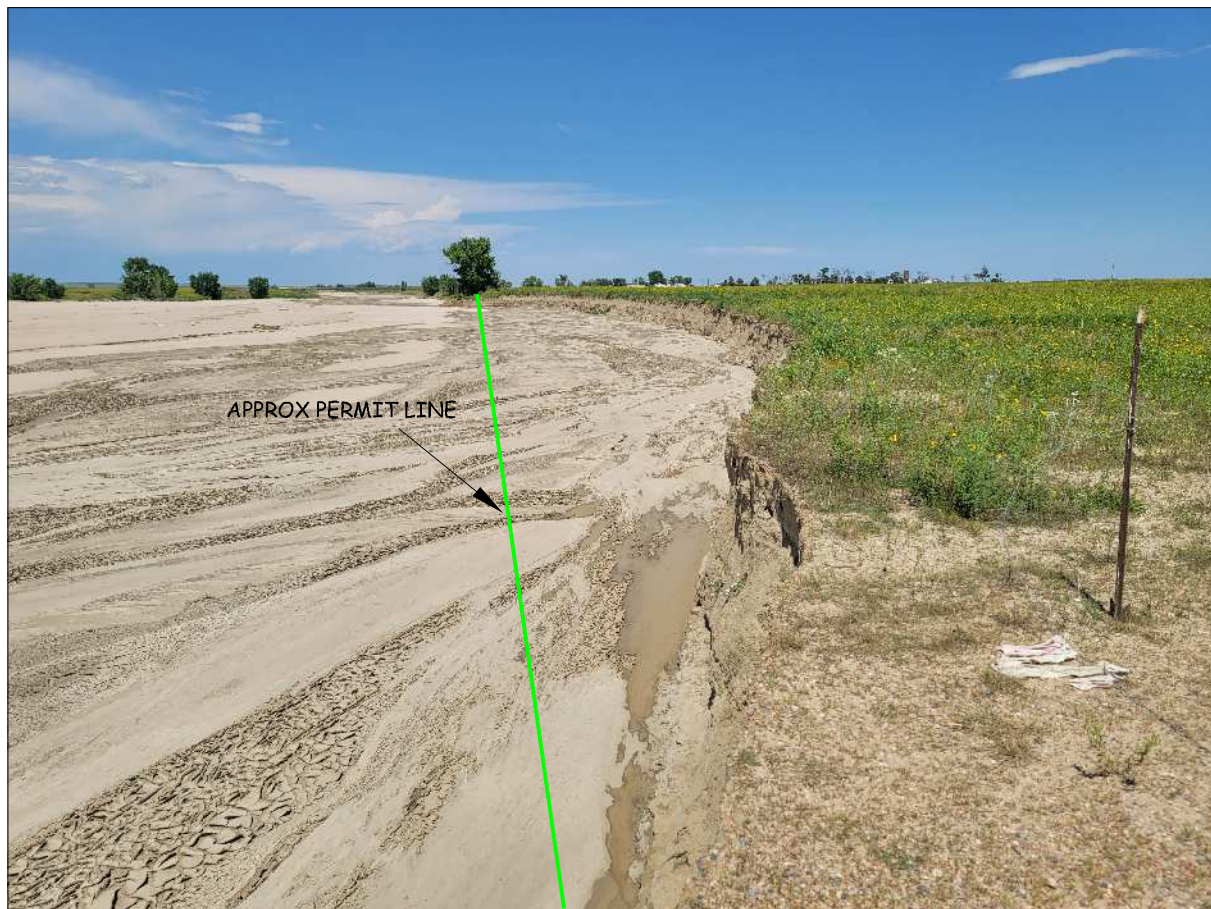
Photo 2 - 8-10-2023
Looking north along east bank from Entrance Road

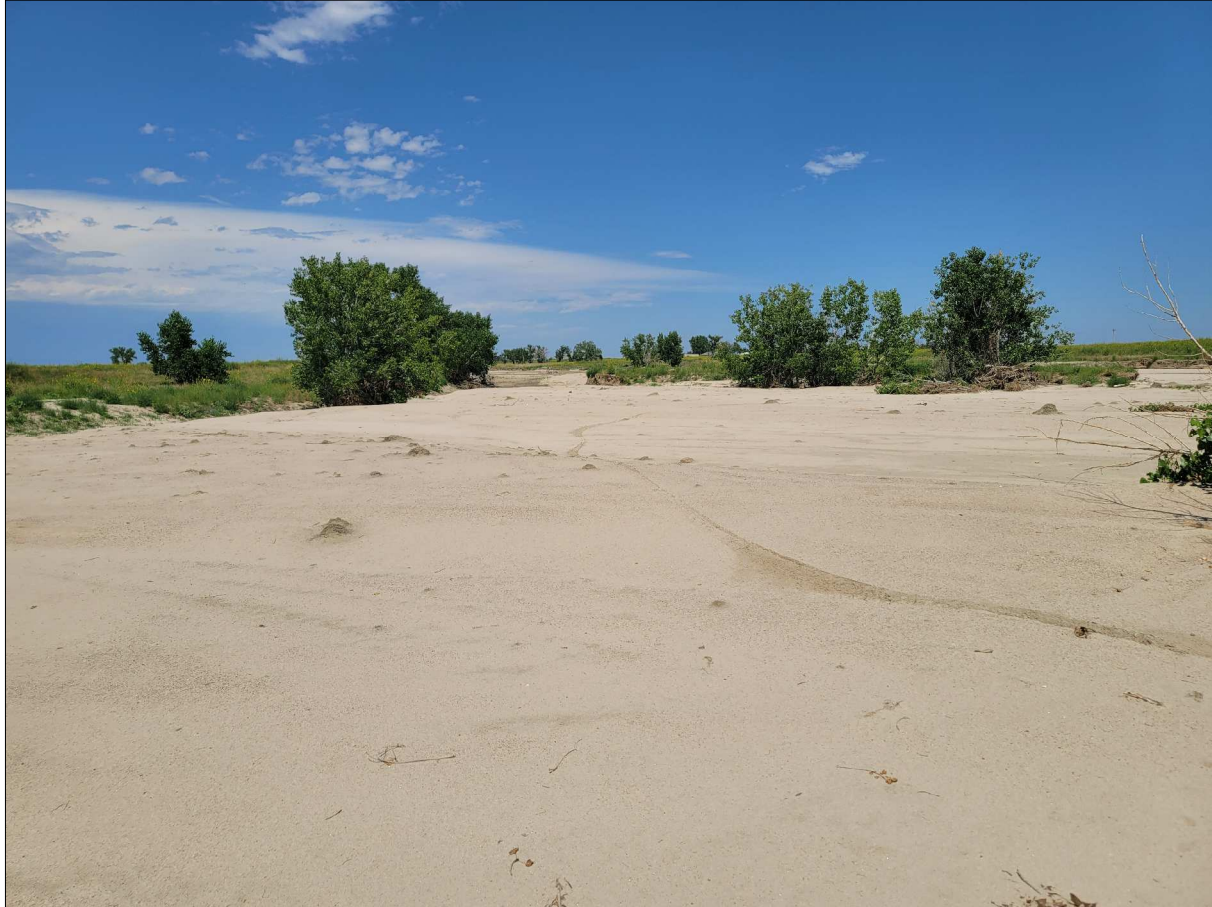
Photo 3 - 8-10-2023
Filled north backfill area

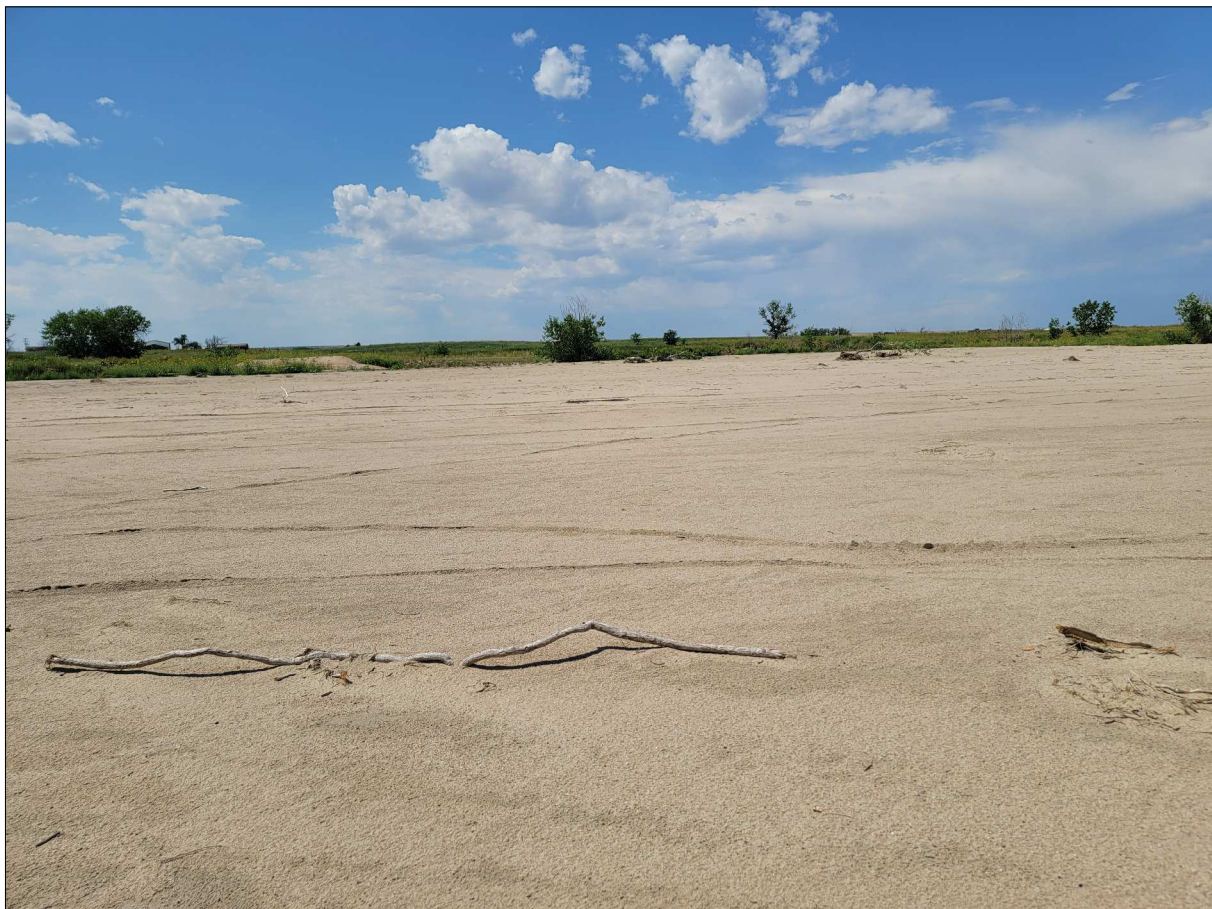
Due to the heavy rains this spring we had water running thru the mine area along the historic drainage for the first time since 2014. The runoff event was large enough to change the river bottom and banks. Along the east side approximately 0.21 acres was eroded from within the permit area leaving a 9 foot high cut where the road entered the permit area and removed all of the voluntary bank sloping done in the past (photo 1 & 2). On the west side it refilled approximately 3.93 acres (yellow) on the north end of the area previously mined (photo 3). The active mining area (blue) was refilled as well. There is no evidence that mining has occurred within the channel area at this time. (photos 4).

Photo 4 - 8-10-2023
Active mining area looking northwest
