Inspection Report, Foidel Creek Mine, C-1982-056

Permit Number: C-1982-056 Mine Name: Foidel Creek Mine Operator: Twentymile Coal, LLC Operator Address: Ms Miranda Kawcak 29515 Routt County Road No. 27 Oak Creek, CO 80467	County: Routt Operation Type: Underground Permit Status: Active Ownership: Private
	Operator Representative Present: Miranda Kawcak
Operator Representative Signature: (Field Issuance Only) Miranda Kawcak

Inspection Start Date: August 23, 2023 Inspection Start Time: 8:30 AM Inspection End Date: August 23, 2023 Inspection End Time: 11:30 AM		Inspection Type: Coal Partial Inspection Inspection Reason: Normal I&E Program Weather: Clear	
Joint Inspection Agency:		Joint Inspection Contacts:	
Post Inspection Agency: None		Post Inspection Contacts:	
Inspector(s): Hunter Ridley	Inspector's Signature:

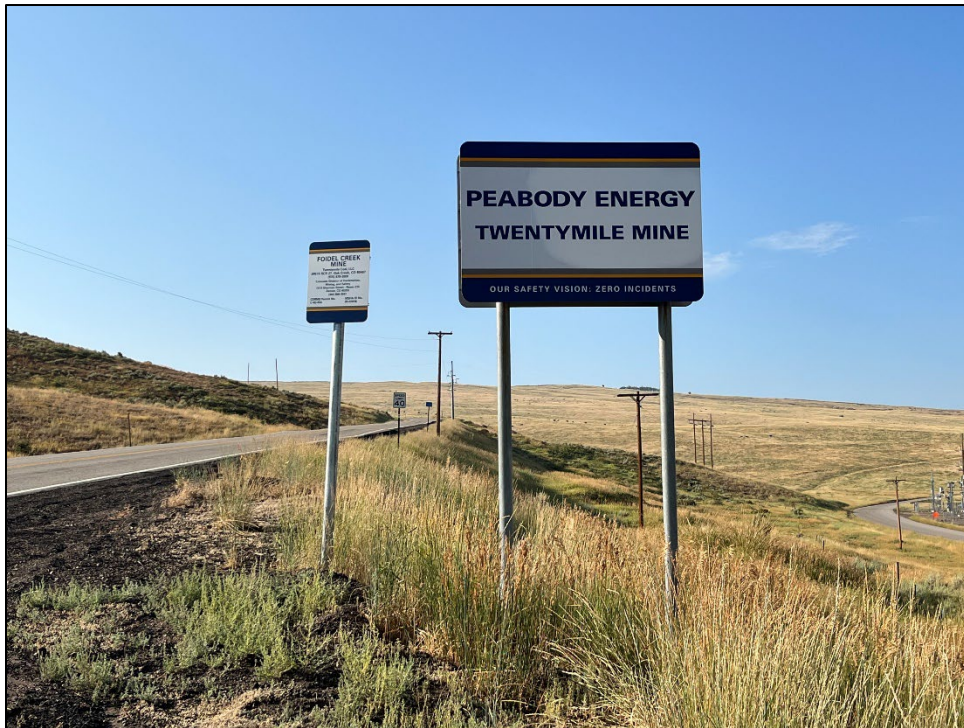
Mine identification markers were observed throughout the site (Photo 1). All information for compliance was present.

Photo 1: Mine sign identification at site entrance.

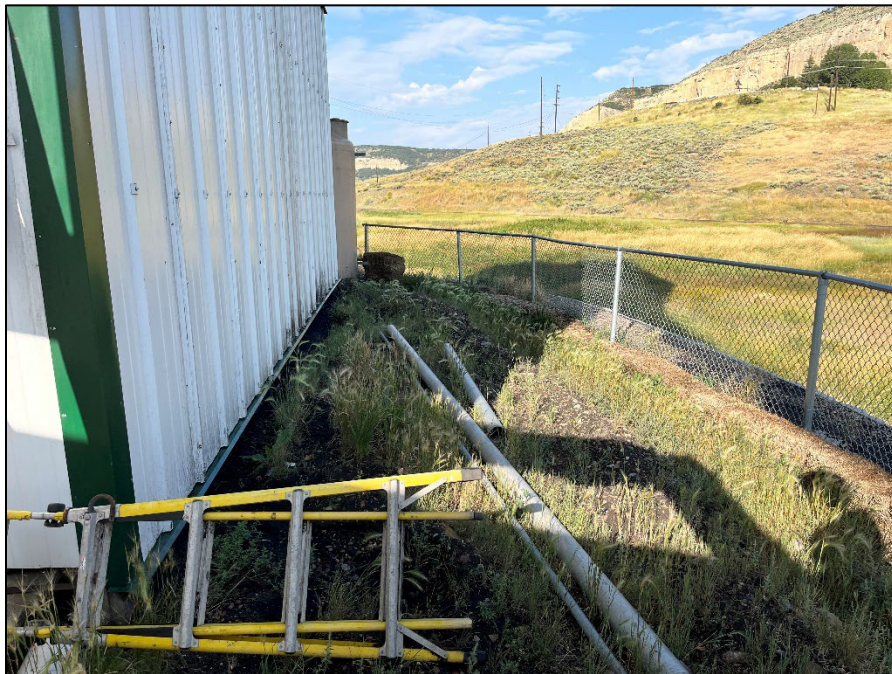
The stoker coal loadout facility has not yet been sealed following a note made in a DRMS inspection report last Fall which pointed out that this wash plant facility was leaking water and causing sediment erosion behind the building (Photos 2). The Operator stated that as of the date of this inspection the building is scheduled to be sealed. The Division's jurisdiction on this item lies in the protection of nearby Foidel Creek. Therefore, the Division is most concerned with the proper use of best management practices (BMPs) in this area. Straw bales and ditches are currently being utilized behind the stoker loadout building to control leaking water. However, the downhill silt fence will need to be replaced (Photo 3) and erosion on the southwestern side of the stoker loadout facility area will need to be addressed with an appropriate BMP (Photo 4). **The Division has given until September 30, 2023 for TC to accomplish the installation and maintenance of BMPs in this area. Please provide the Division with photo documentation that this has been completed. Failure to complete this corrective action by the deadline will result in enforcement action.**

Photo 2: Three ditches and hay bales capture water and sediment leaking from the stoker loadout building to avoid runoff into Foidel Creek.

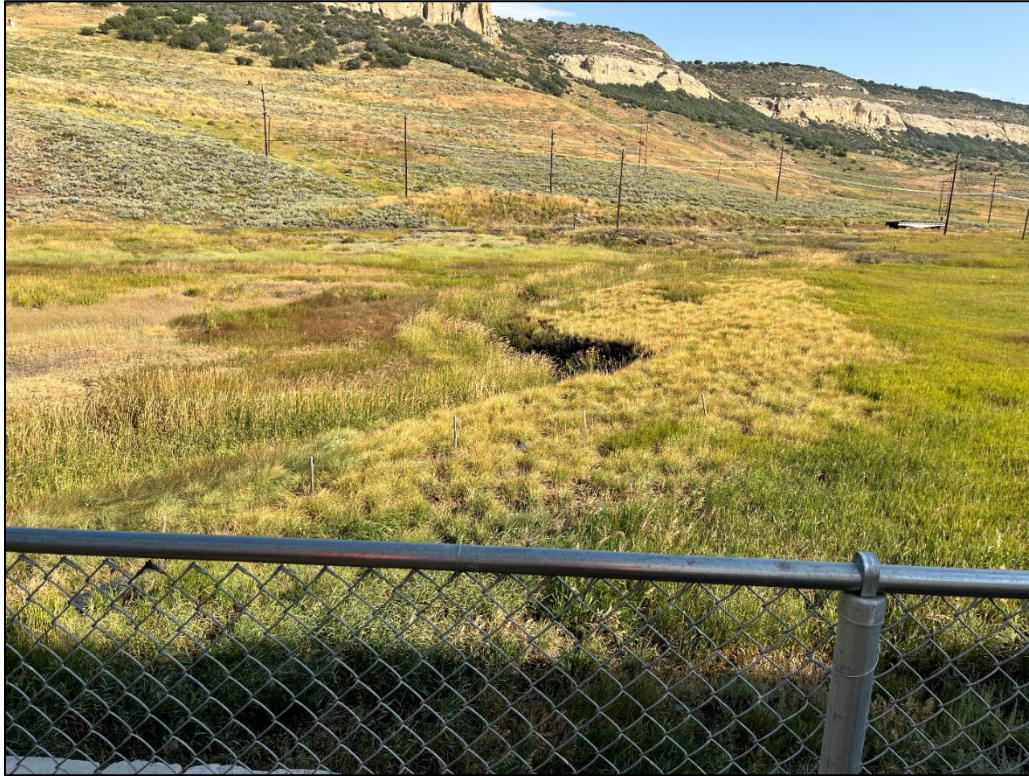
Photo 3: Silt fence behind the stoker loadout building which is in need of repair.

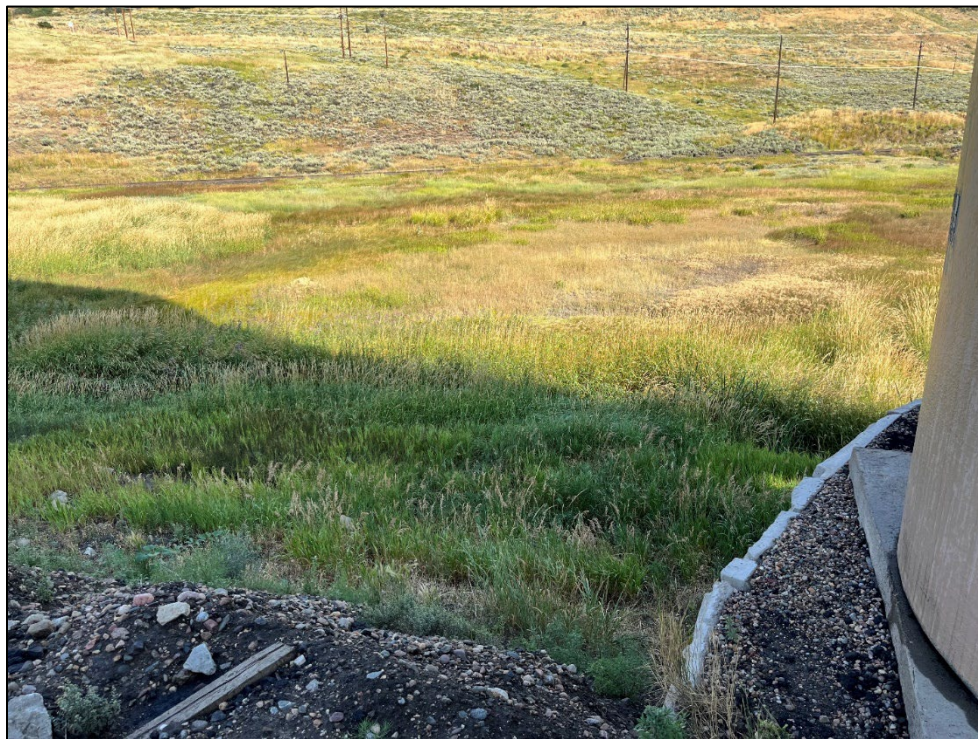
Photo 4: Sediment on the SW side of the stoker loadout facility is eroding towards Foidel Creek. This area requires additional BMPs to be in compliance.

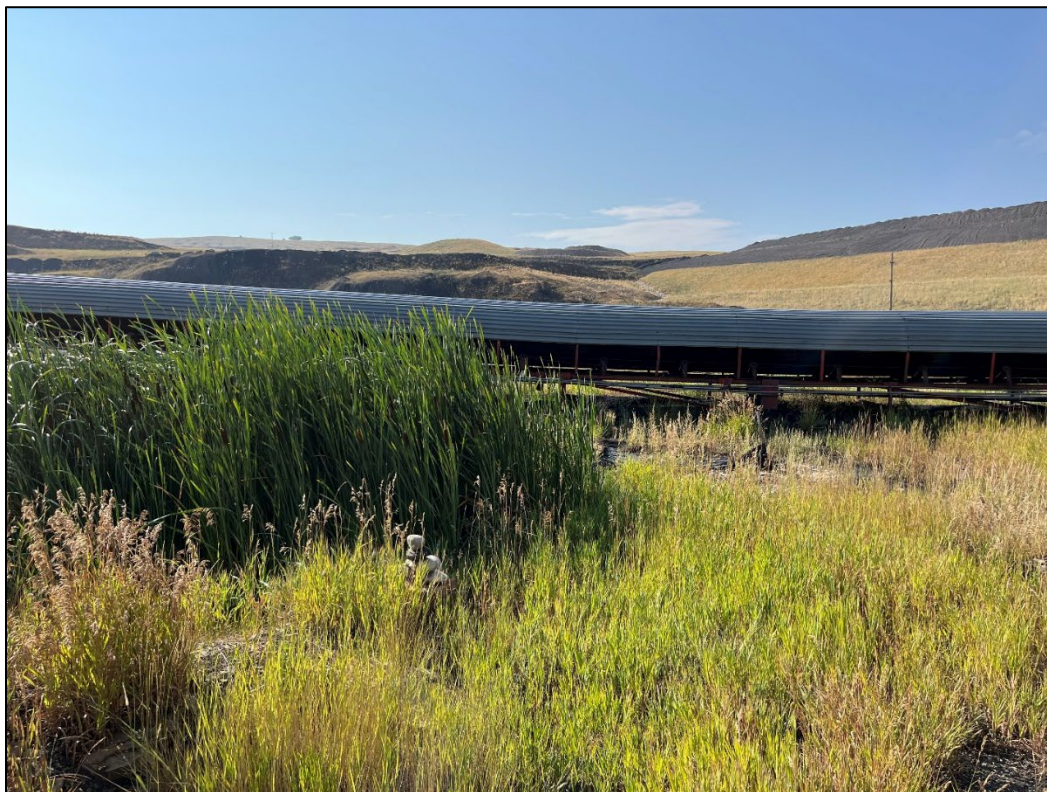
Underground pumps at Pond D were currently shut off. Thus, water levels at this pond system were low (Photos 10 and 11). Main facilities ponds were checked for discharge and culverts were inspected for function (Photos 5-

Photo 5: View SE of the refuse pile, coal conveyor belt, and Pond D discharge.

7). Continue to clean out culverts when vegetation and sediment hinders function. Buffer zone signs for Foidel Creek were in place throughout the main facilities area (Photo 9).

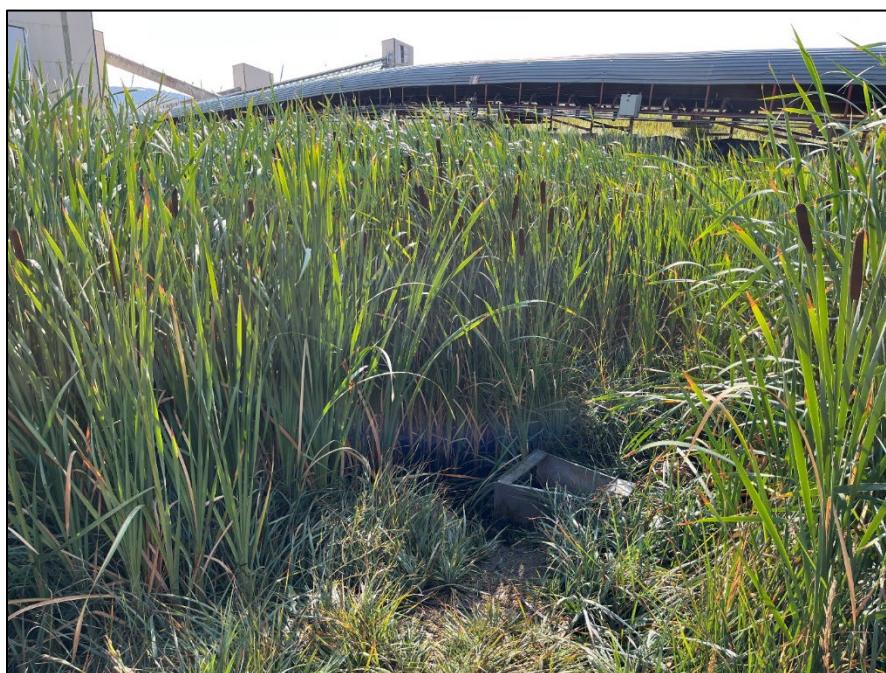
Photo 6: Weir at Pond D discharge, cattails provide additional water filtration.

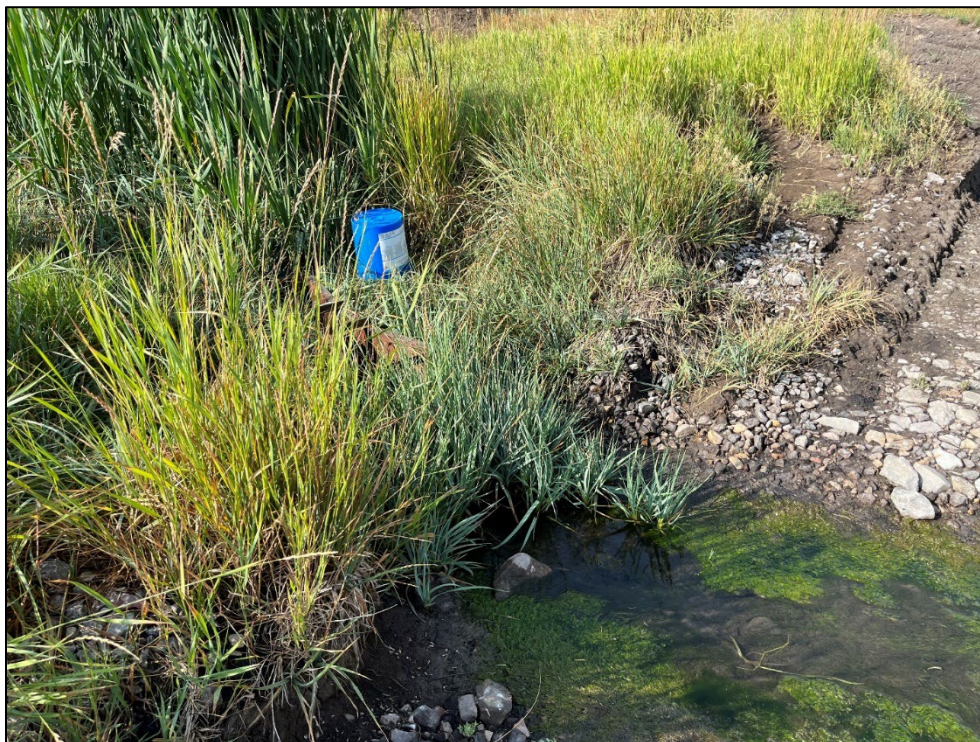
Photo 7: Discharge and water sample collection point for Ponds B.

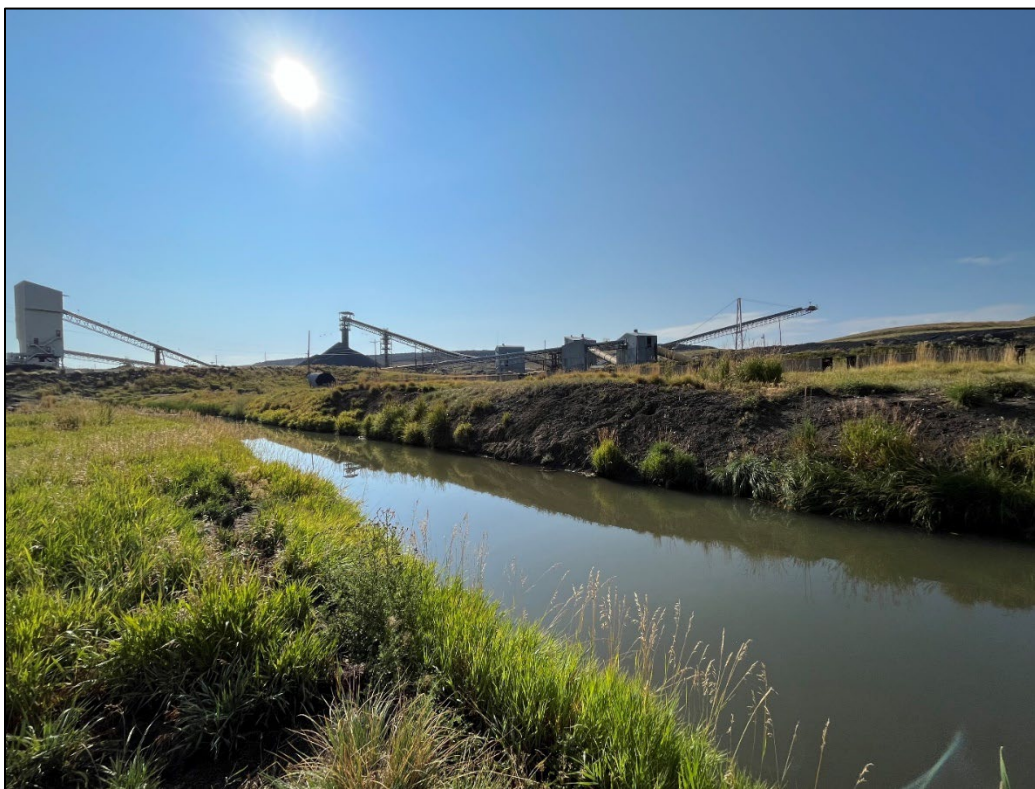
Photo 8: Northernmost pond at Ponds B.

All ponds across the site are still scheduled to be cleaned this year. Several ponds around the main facilities area will need to be included in this annual cleaning to maintain proper function (Photo 8).

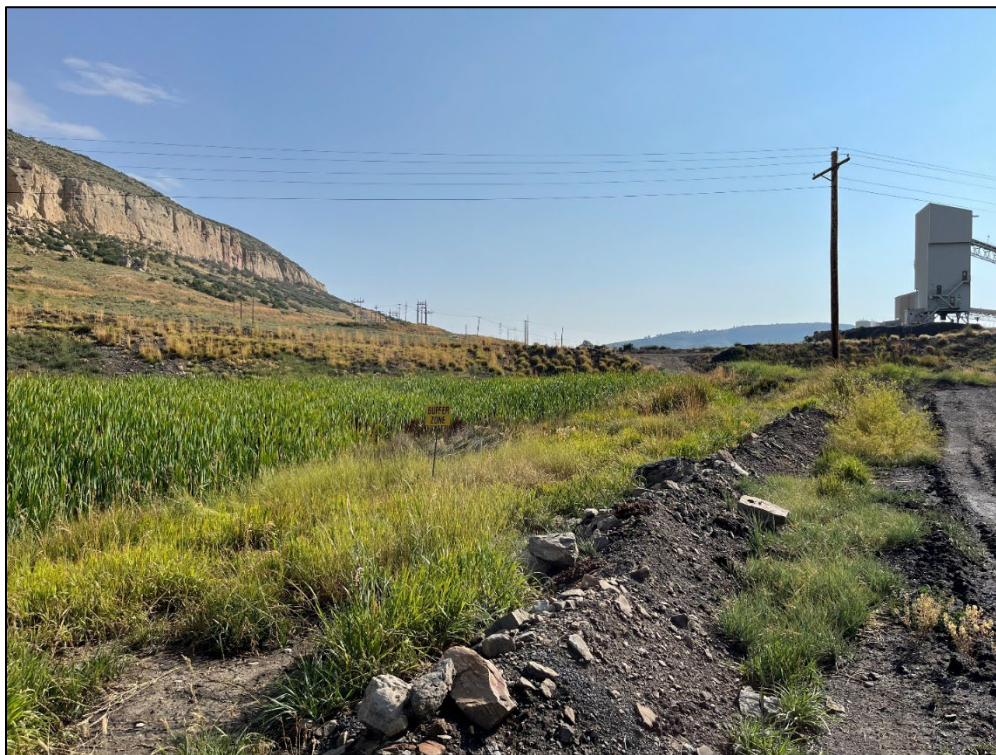
Photo 9: Buffer zone signs are in place for Foidel Creek near Ponds B.

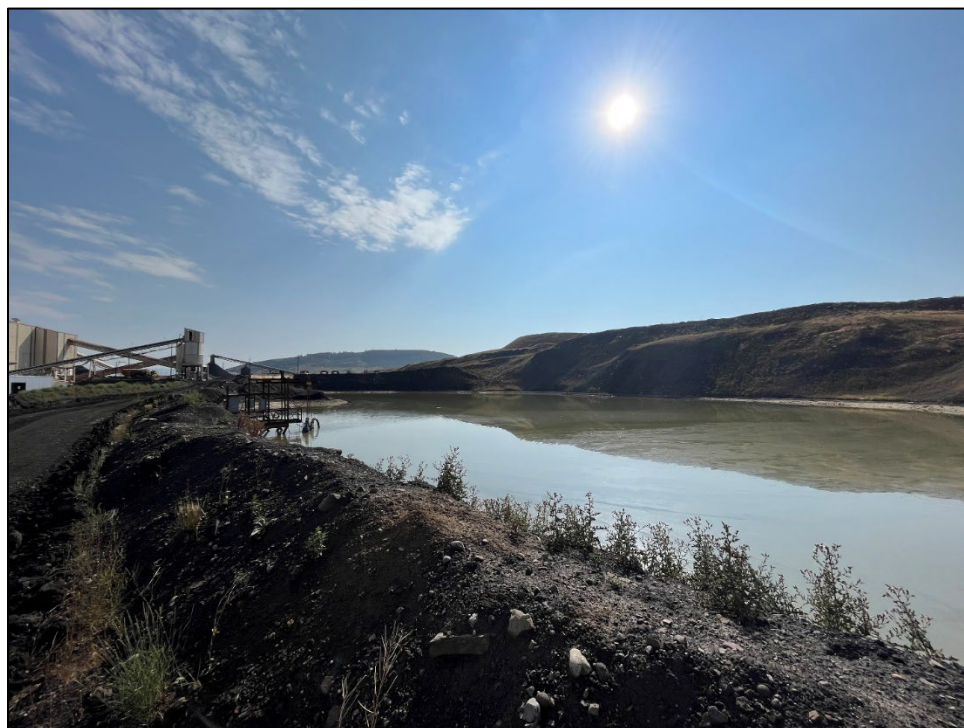
Photo 10: Southern side of Pond D, water levels are currently low.

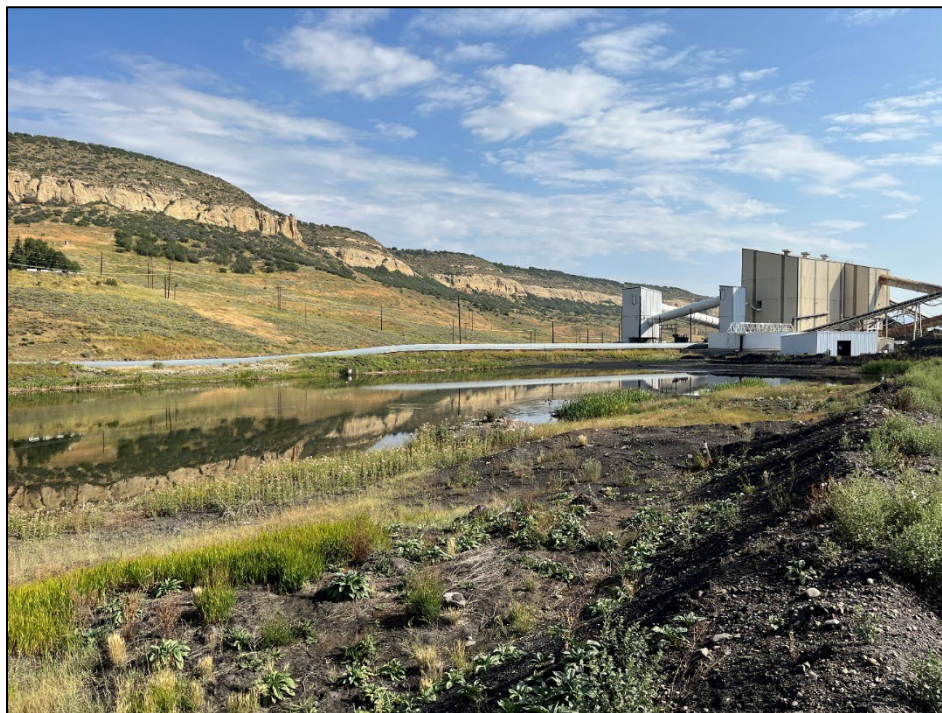
Photo 11: Northern side of Pond D, waterfowl were in use of the area.

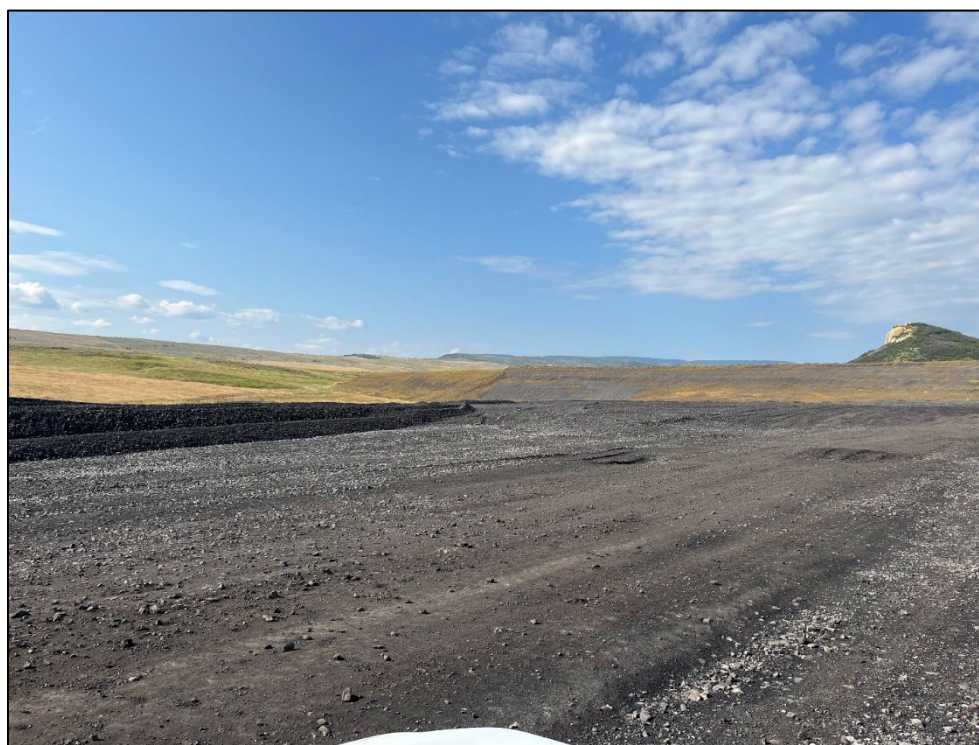
Compaction of refuse material piled throughout the winter continues throughout the summer. Drainage is functioning properly in this area with no standing water atop the pit. The third lift is still under construction. Clay overburden material will be taken from the southern portion of the refuse area to cover the pile before adding topsoil from the nearby stockpile to the northeast. Eventually, this refuse face will be built up to meet the ridge of the adjacent, older refuse pile (Photo 12).

Photo 12: Photo atop the refuse pile looking west.

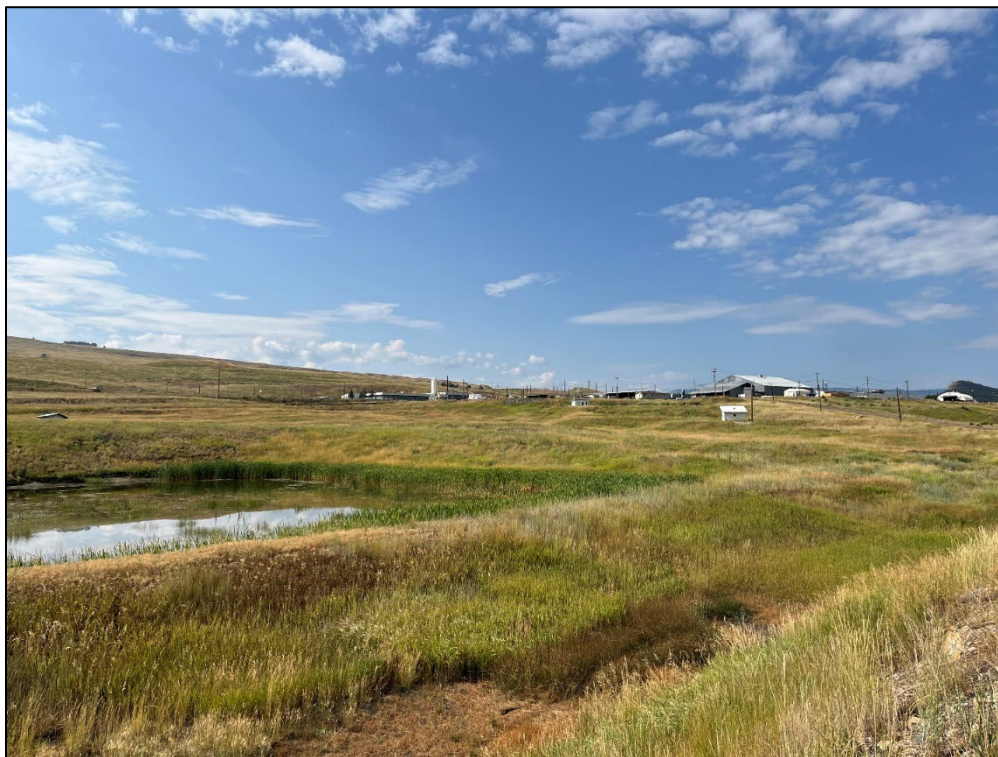
Photo 13: Pond F, not discharging.

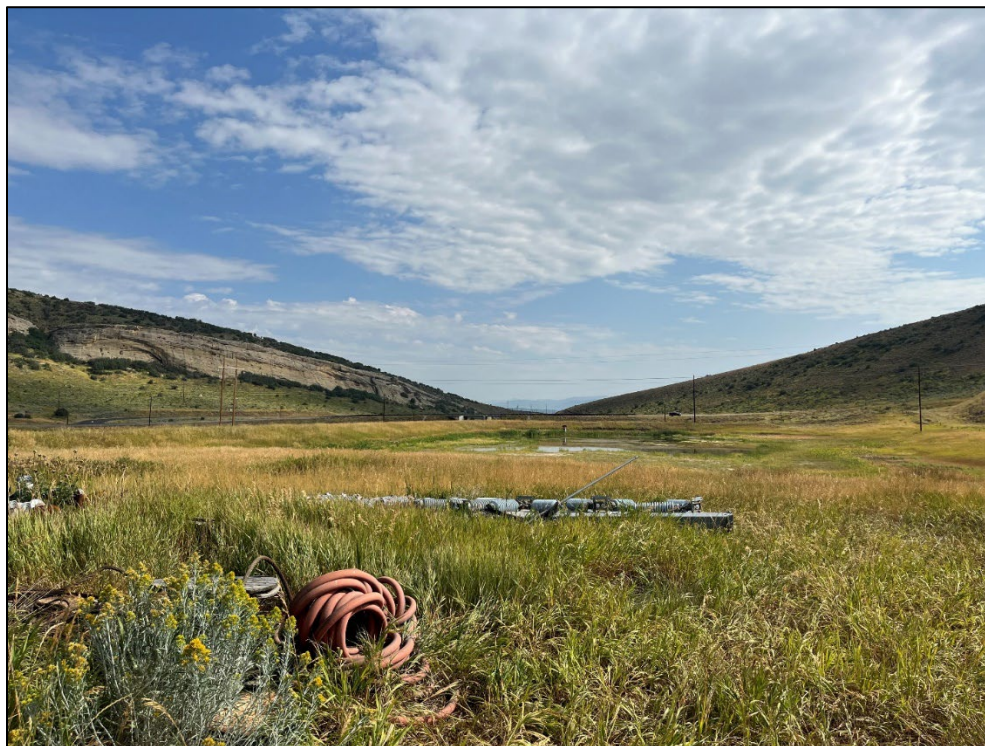
Photo 15: Pond G, not discharging.

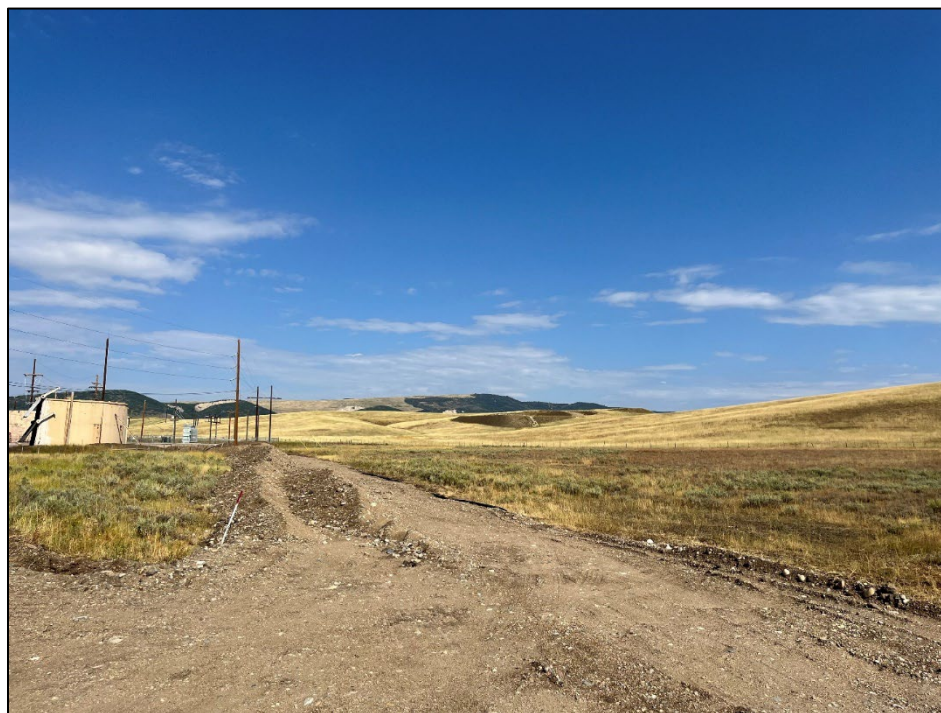
Haul roads across the site are well maintained and water trucks were noted in the main facilities area. MR322 was issued by the Division on 10/25/2022 and approved the relocation of an internal road. The construction of this new road continues in the 6MN area (Photo 16). Large hay bales originally placed in this same area to improve visibility issues in the winter months will remain in place to block noise from the vent for nearby neighbors.

Photo 16: Construction continues of the new internal haul road in the 6MN area.

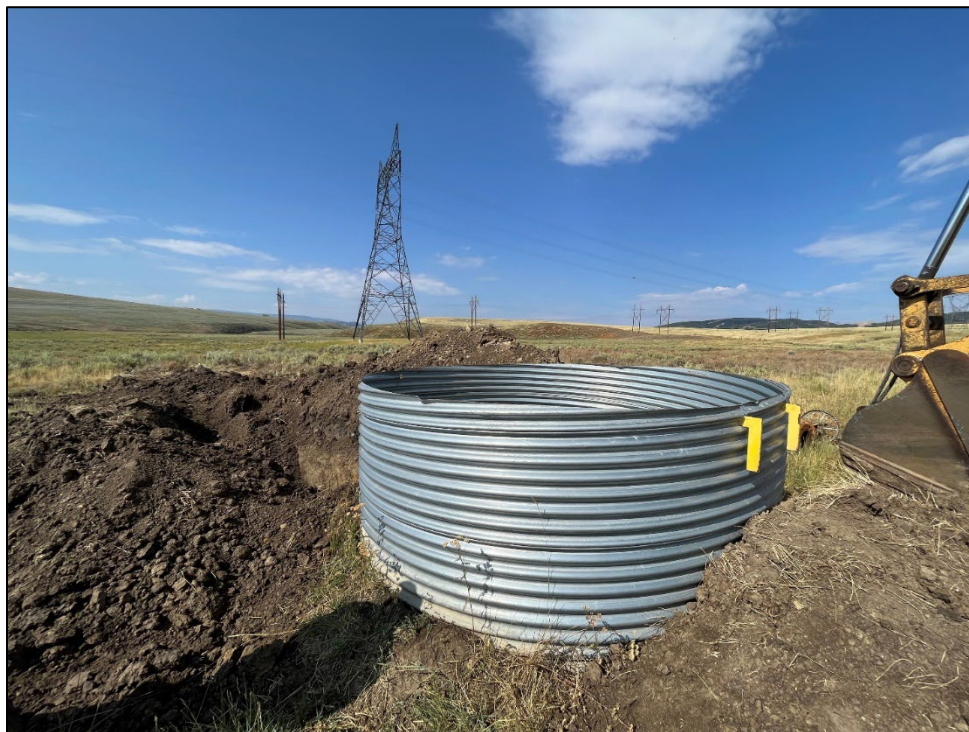
A water valve was in the process of being repaired in the 6MN area (Photo 17). Damage to this water valve created no major issues with water across the site.

Photo 17: A water valve was being replaced in the 6MN area.

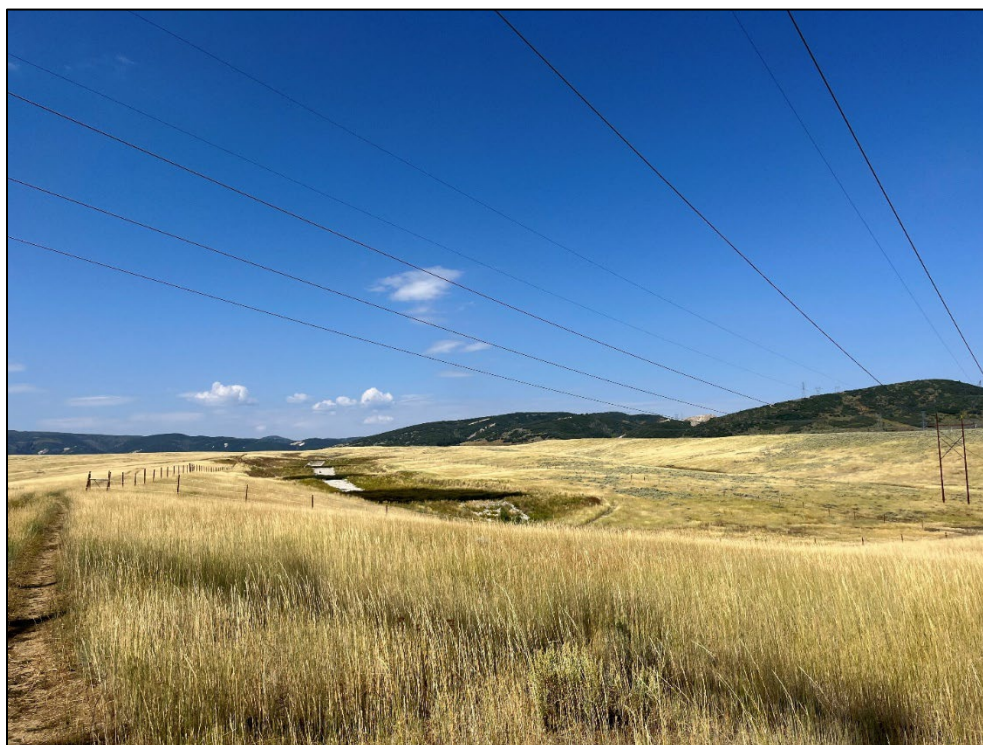
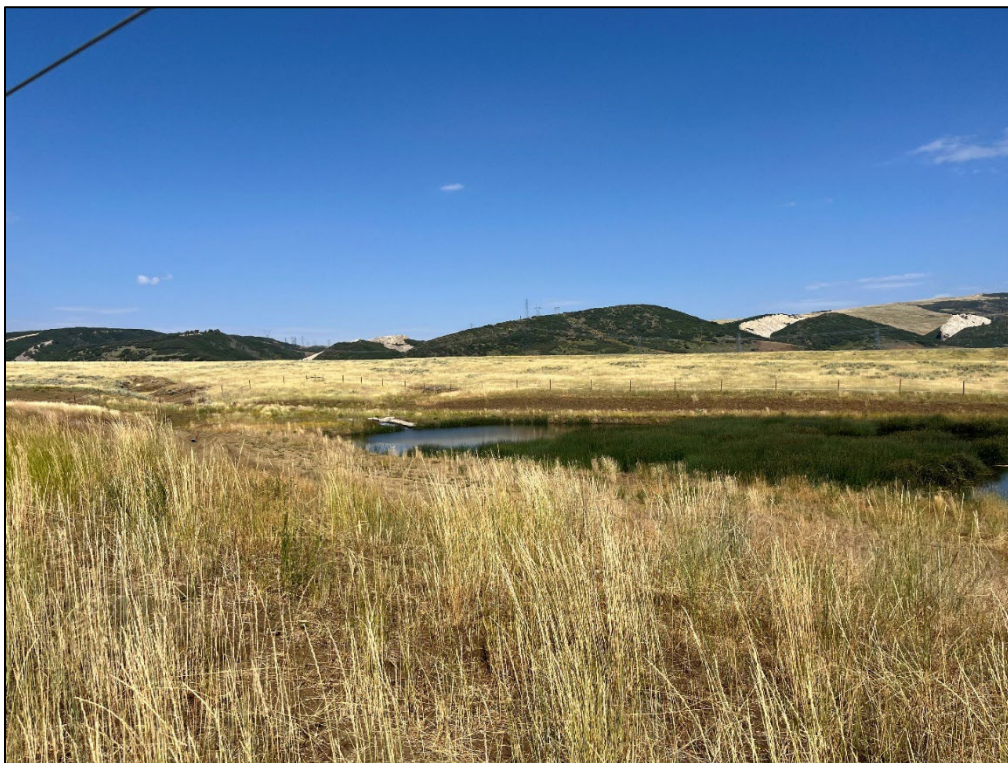
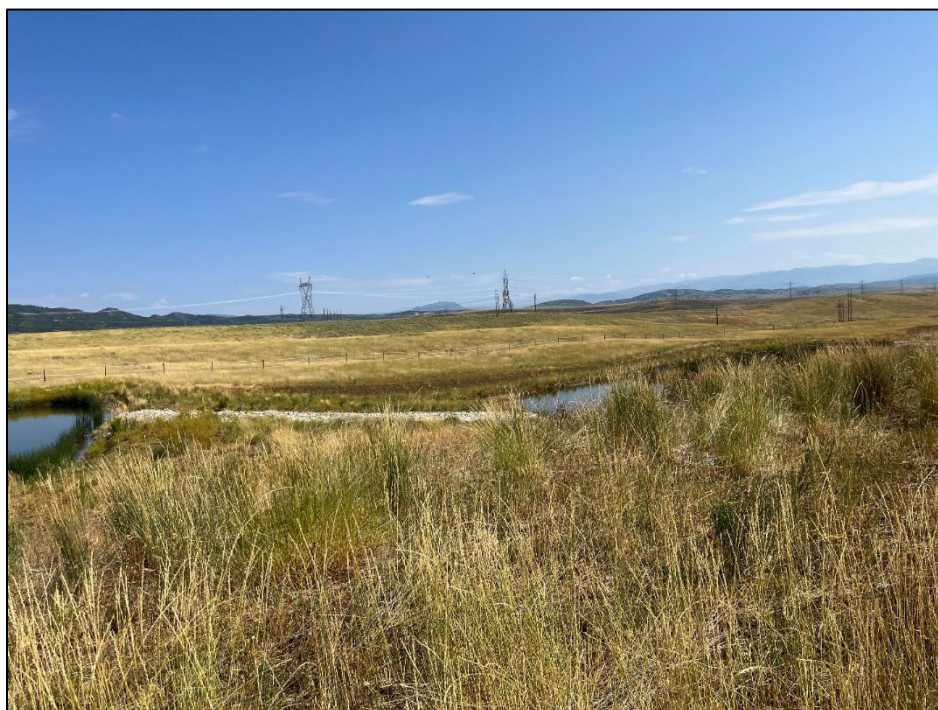
The Passive Water Treatment Facility area was noted to be functioning well by the Operator. Ponds were much more thickly grown with filtering vegetation since the last inspection and water was activity discharging into the system of ponds (Photos 18-20).

Photo 18: Passive Water Treatment Facility, view west.

Photo 19: Passive Water Treatment Facility, view north.

Photo 20: Passive Water Treatment Facility, view northeast.

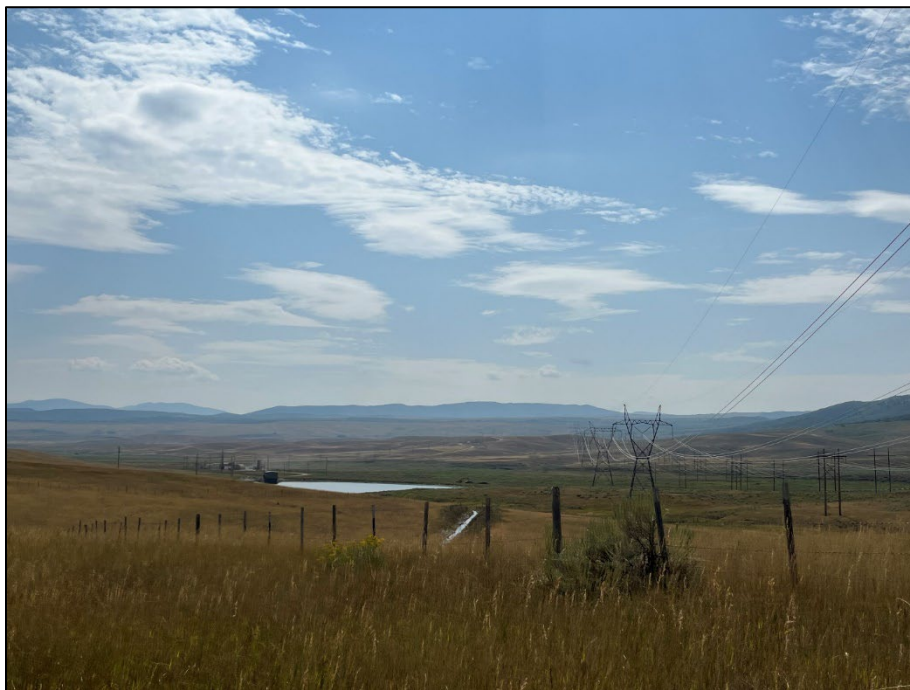
Facilities in the 6MN area were noted to be functioning properly and as usual (Photo 21). The weather station set up near the 6MN Reservoir was still present. A fence has been put up to protect this equipment from grazing cattle.

Photo 21: View east of the 6MN Reservoir.
