Inspection Report, Peabody Sage Creek Mine, C-2009-087

PERMIT INFORMATION

INSPECTION INFORMATION

This was a complete inspection of the Peabody Sage Creek Mine; DRMS Permit No. C-2009-087, operated by Peabody Sage Creek Mining, LLC. This inspection was conducted by Hunter Ridley with the Colorado Division of Reclamation, Mining and Safety (Division). The Sage Creek Mine is an inactive non-producing mine currently in Temporary Cessation since 2017. TC representative Miranda Kawcak was present at the time of the inspection and at the records check at the Foidel Creek Mine. **Please address the Bold items below.**

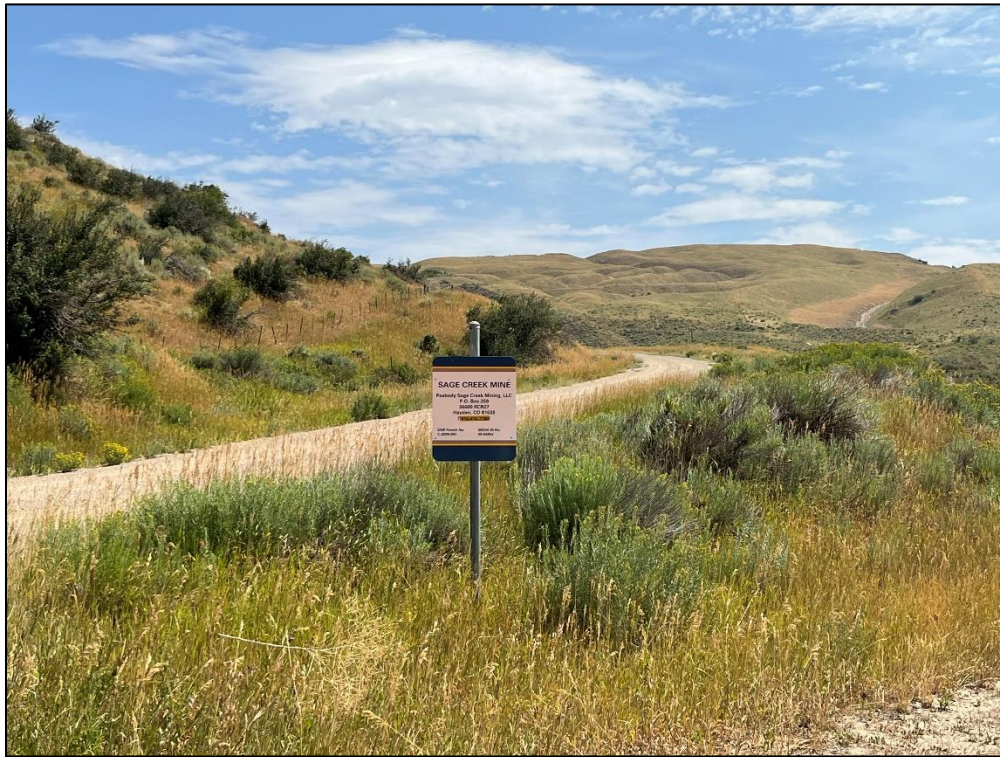
Mine identification markers were observed throughout the site. Previously illegible sign information which was noted in the May 2, 2023 inspection report has been added to mine signage (Photo 1). A scale, scale house, and office buildings are near the site entrance (Photo 3).

Photo 1: Mine identification at site entrance.

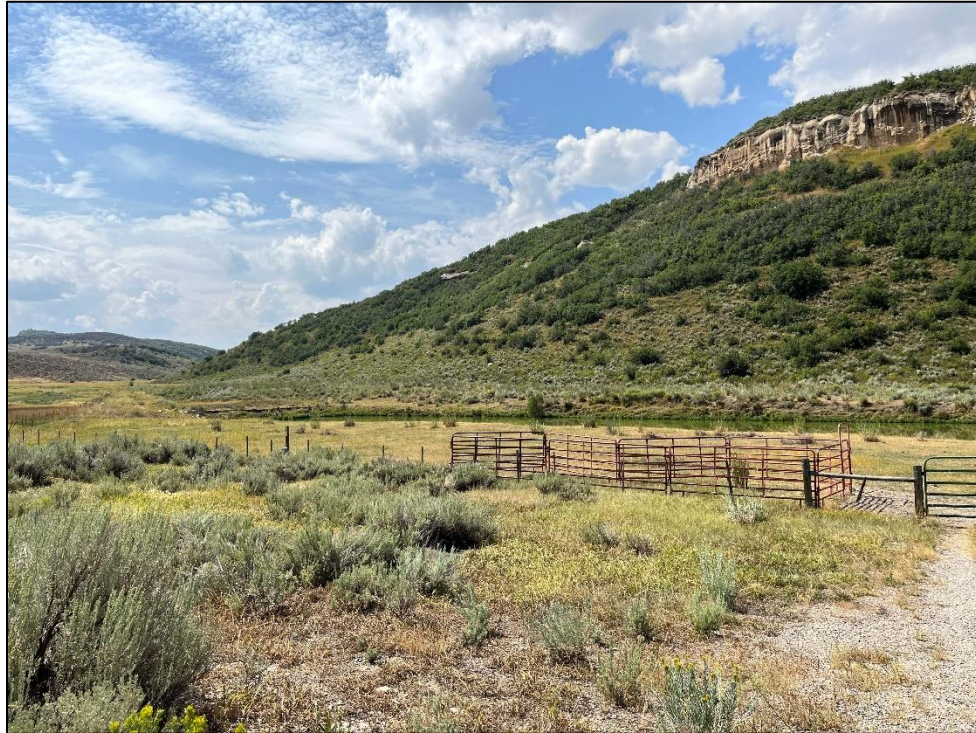
All ponds at the site were discharging at the time of inspection (Photos 2, 7, 10-12). NPDES #7, located by the site’s main office buildings (Photo 4), was also discharging.

Photo 2: Pond 003 near the site entrance. Cattle grazing occurs around this area.

- The ditch around the portal area needs to be cleared of cattail growth to maintain proper drainage in the area
- Additional disturbance markers are recommended.
- Trash screen at Pond 003 needs to be cleared.
- Monitor the pipe below Pond 002 for leakage or blowout.

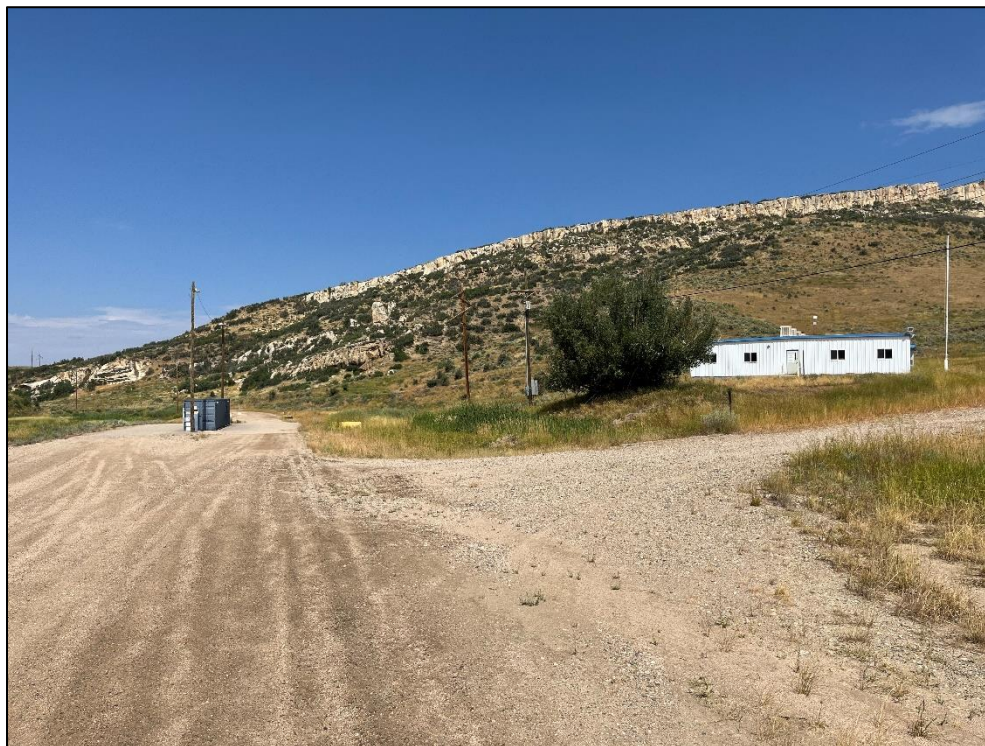
Photo 3: View north of the office building and scale/scale house.

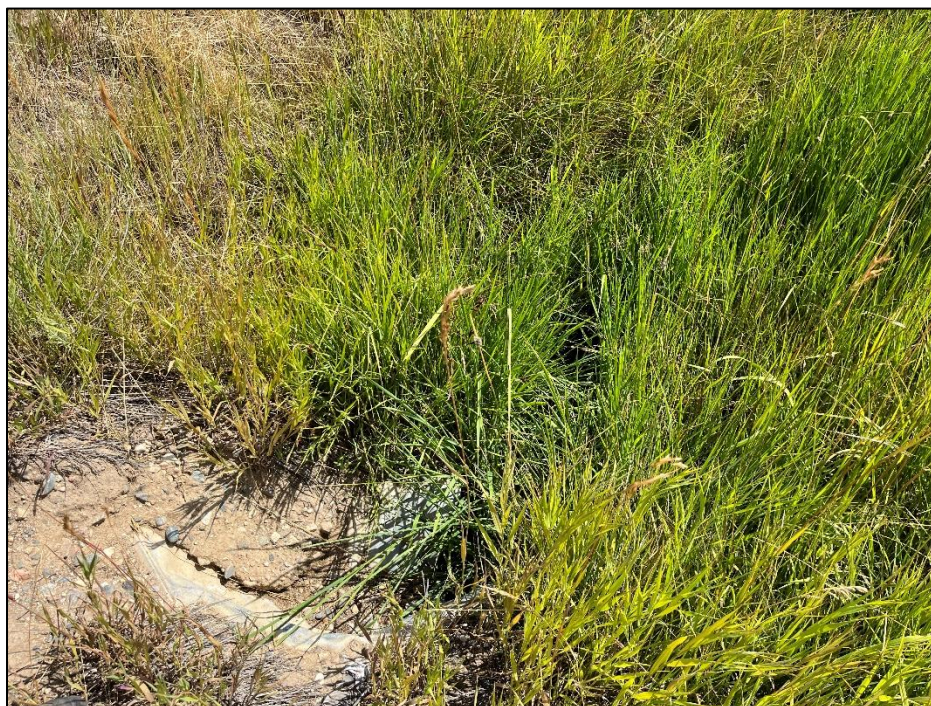
Photo 4: NPDES #7, discharging slightly.

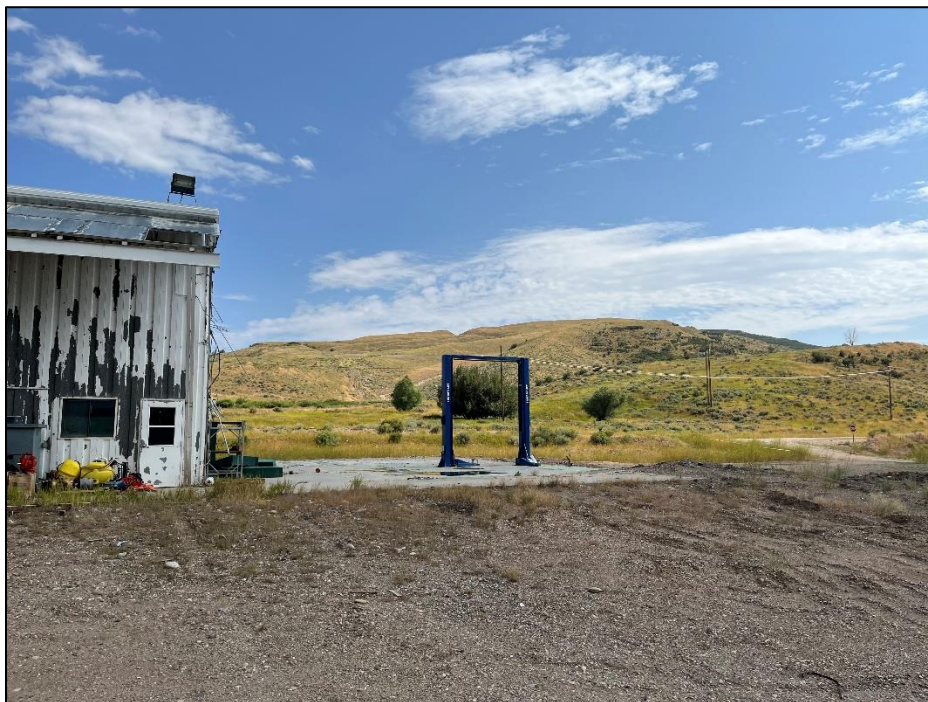
As this site is in temporary cessation, many of the on-site support facilities are unused. This includes storage buildings, a water tank located along Road B, and other unused storage areas (Photo 6). An office building in this area has recently collapsed. Debris in this area has been cleared (Photo 5).

Photo 5: Debris from a building which had previously collapsed has been cleared.

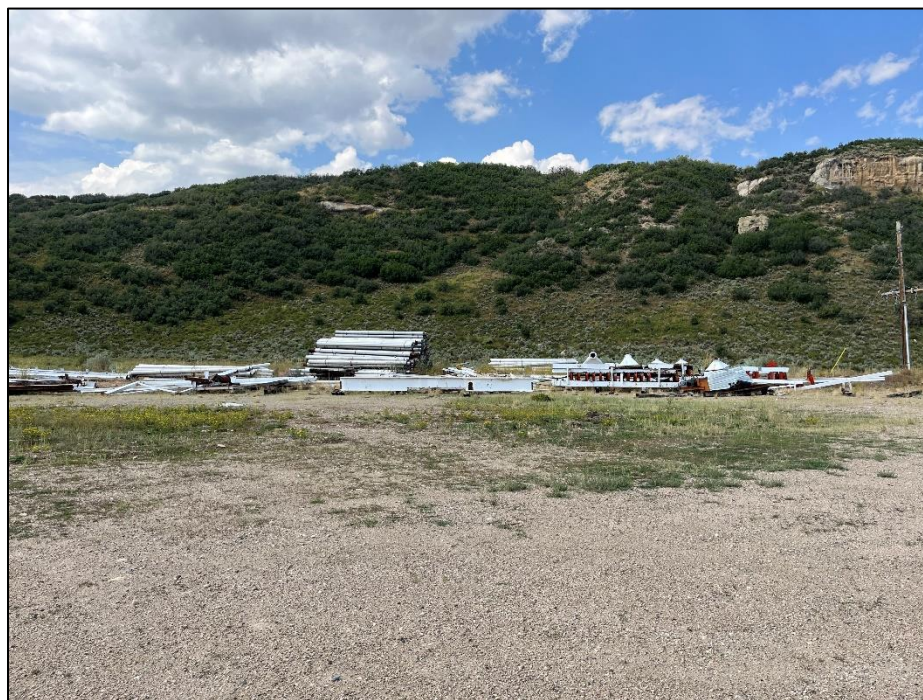
Photo 6: Storage located in the mostly unused main facilities area.

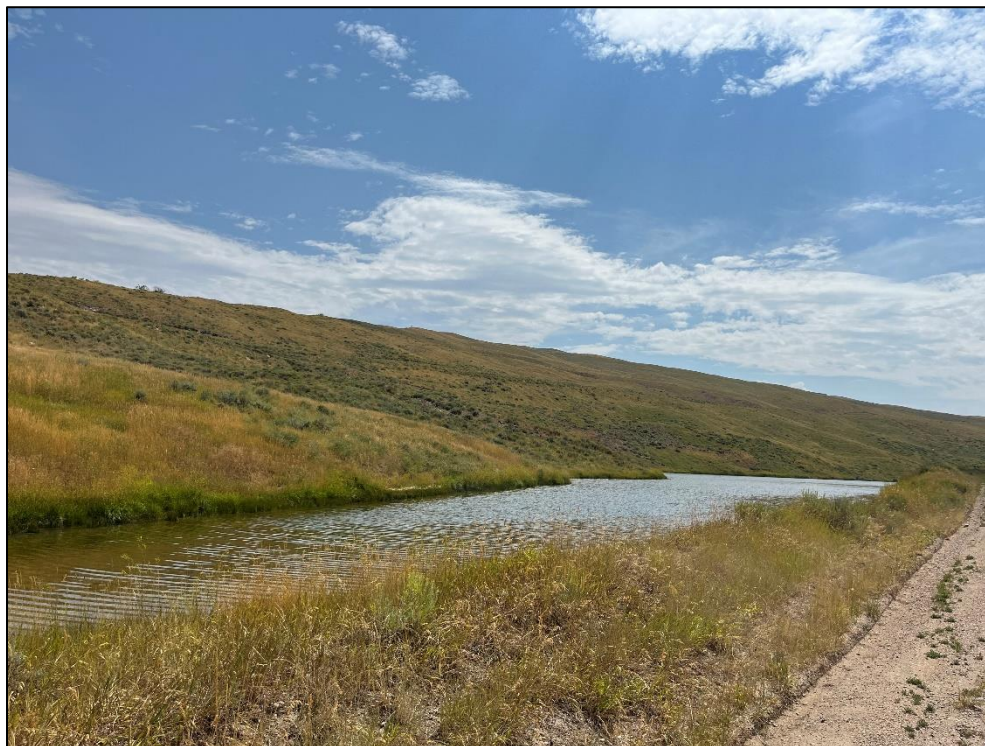
Photo 7: Pond 002, view south.

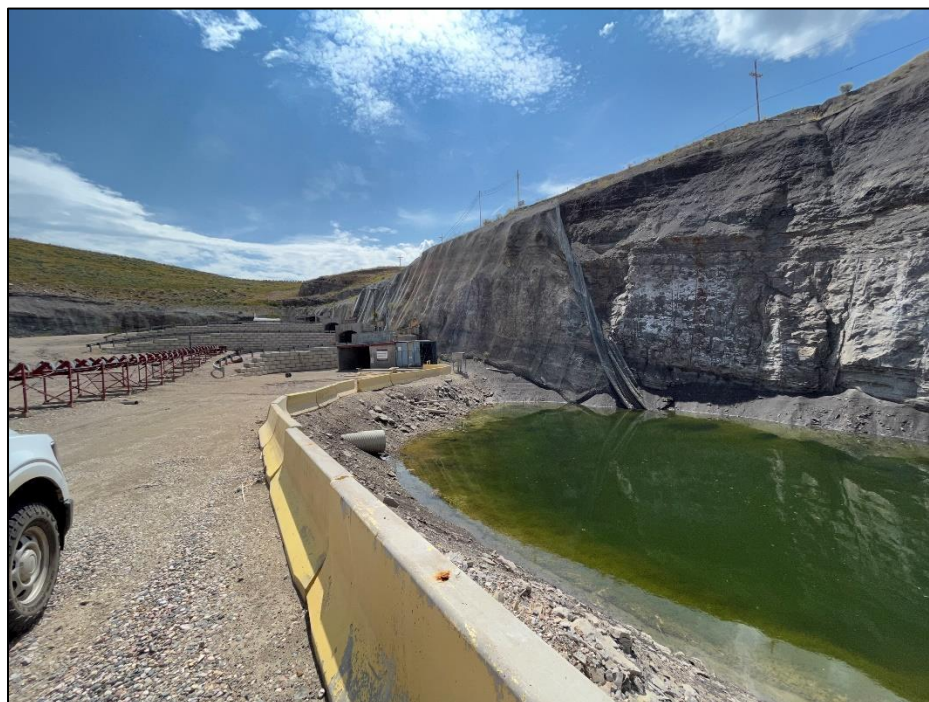
Mine water and snowmelt is no longer being continually pumped at the portal entrance (Photos 8). Instead, there is currently a float system in place which automatically turns on pumps when needed at the portal entry.

Photo 8: Portal entries, a float system located at this site of pumping.

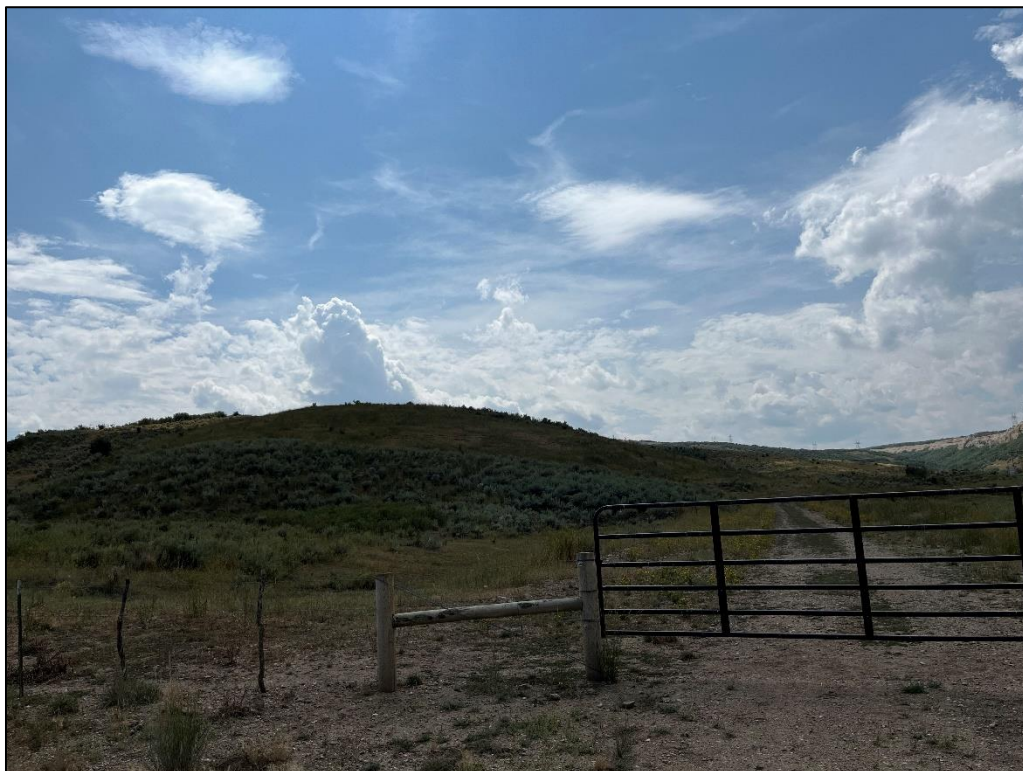
There is one large topsoil pile onsite located adjacent to the Pecoco pond (Photo 9). The pile appears stable, well vegetated and undisturbed. A small, orange flag marks this pile as topsoil.

Photo 9: Topsoil pile located to the south.

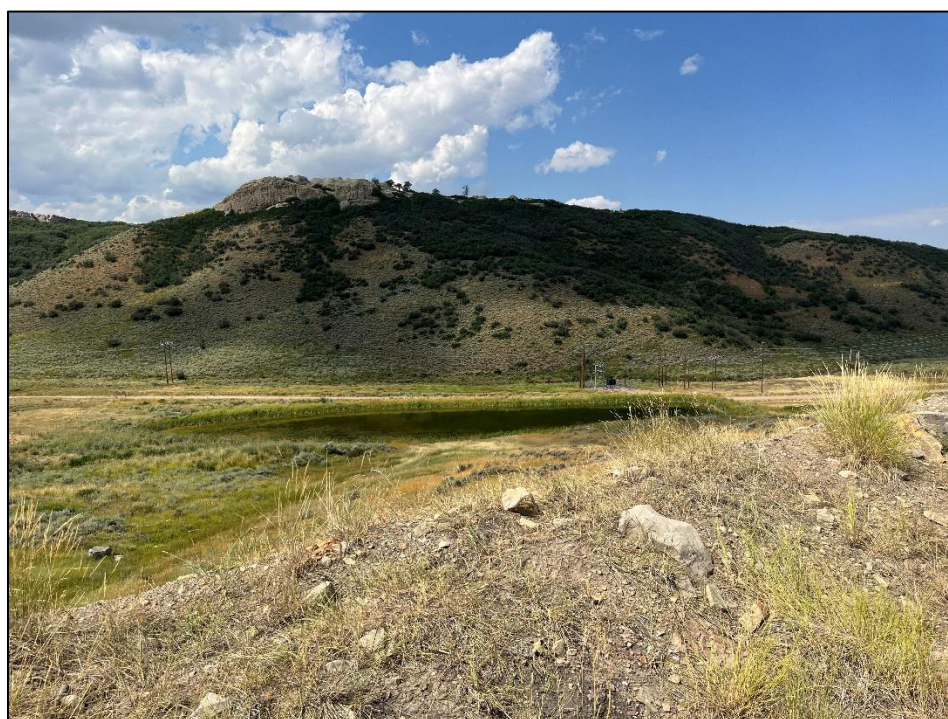
Photo 10: Upper sump located in the southern facilities area.

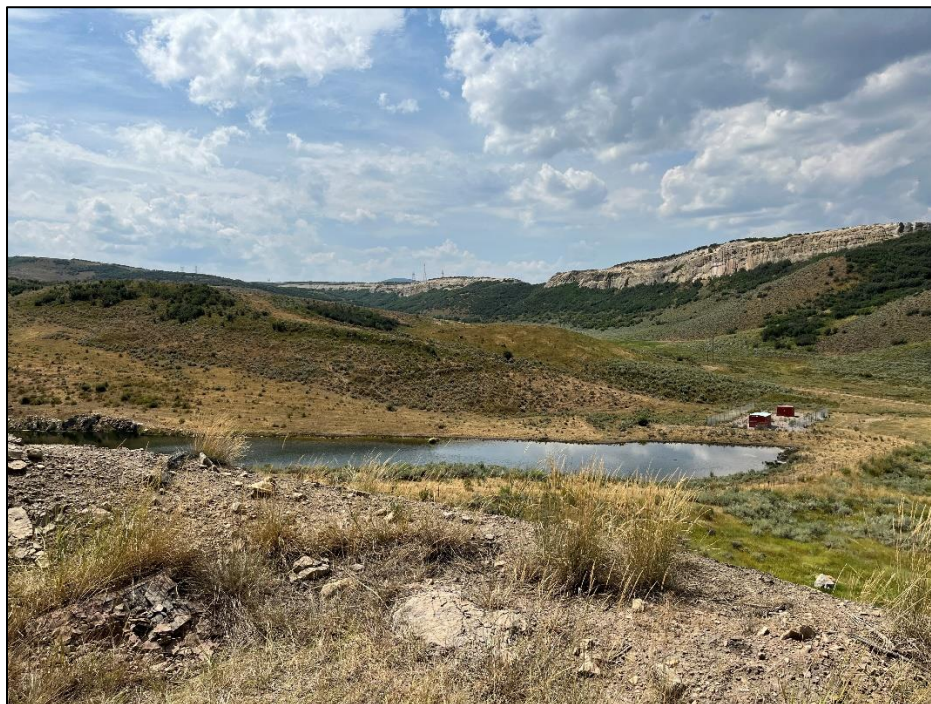
Photo 11: Pecoco Pond, view southwest.

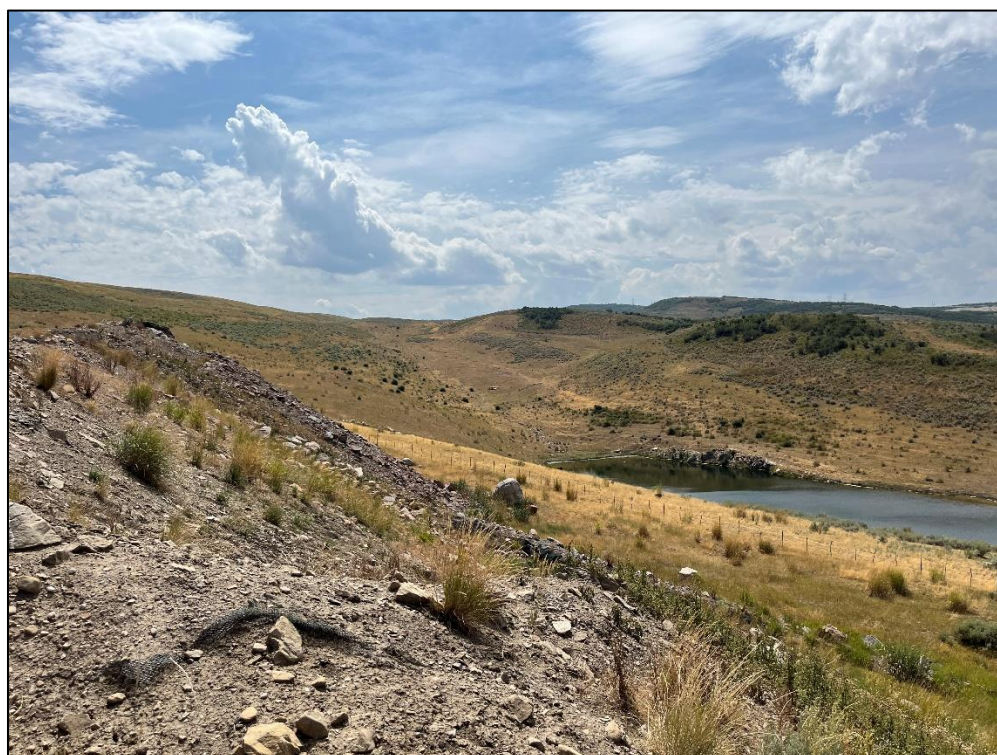
Photo 12: View from atop Haul Road D of Pecoco Pond.

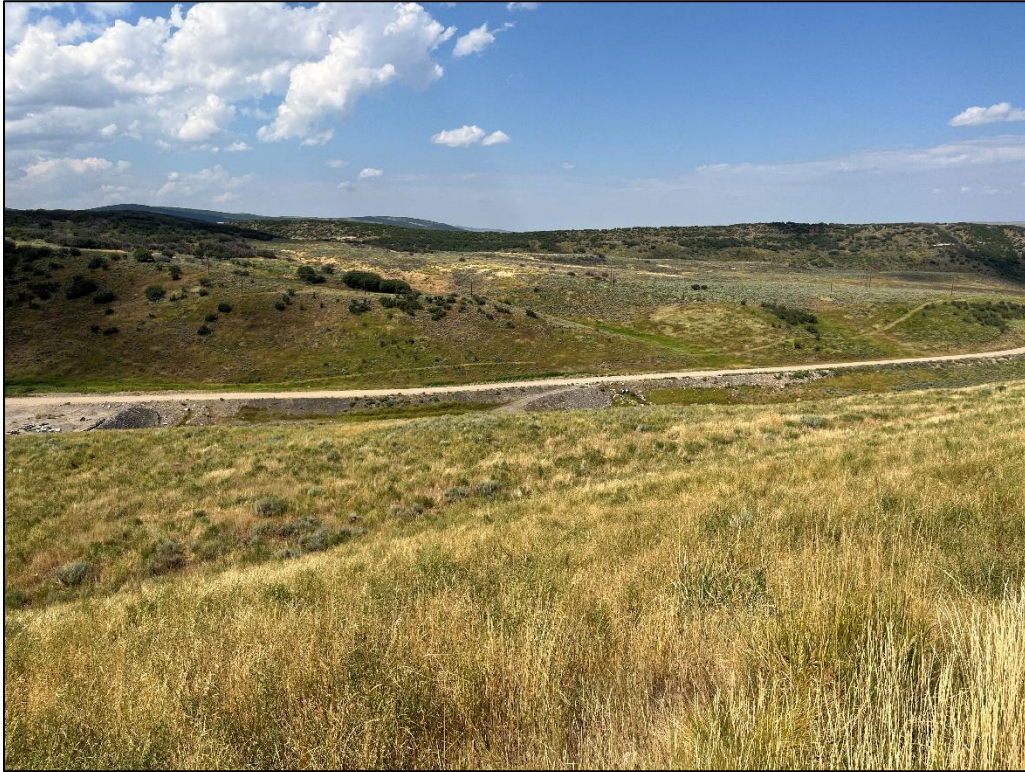
A dam is located between two ponds near the portal entries (Photo 13). The southernmost pond acts as a sump for mine water. The northernmost pond is Pond 002 and is the site of the previous surface mine's high wall which has been filled in. Two culverts also lead to Pond 002 which brings water from Little Grassy Creek, into Pond 002, and towards the natural drainage into Big Grassy Creek.

Photo 13: View west from Haul Road E-1 of Pond 002 and the mine water sump.
