MINERALS PROGRAM INSPECTION REPORT
PHONE: (303) 866-3567

MINE NAME: Crystal Hill Project	MINE/PROSPECTING ID#: M-2014-027	MINERAL: Silver and gold	COUNTY: Saguache
INSPECTION TYPE: Monitoring	WEATHER: Clear	INSP. DATE: August 10, 2023	INSP. TIME: 10:00
OPERATOR: Colorado Mining and Exploration, LLC	OPERATOR REPRESENTATIVE: None	TYPE OF OPERATION: 110(2) - Hard Rock Limited Impact	
REASON FOR INSPECTION: Normal I&E Program	BOND CALCULATION TYPE: Complete Bond	BOND AMOUNT: \$14,109.10	
DATE OF COMPLAINT: NA	POST INSP. CONTACTS: None	JOINT INSP. AGENCY: None	
INSPECTOR(S): Todd Jesse	INSPECTOR'S SIGNATURE:

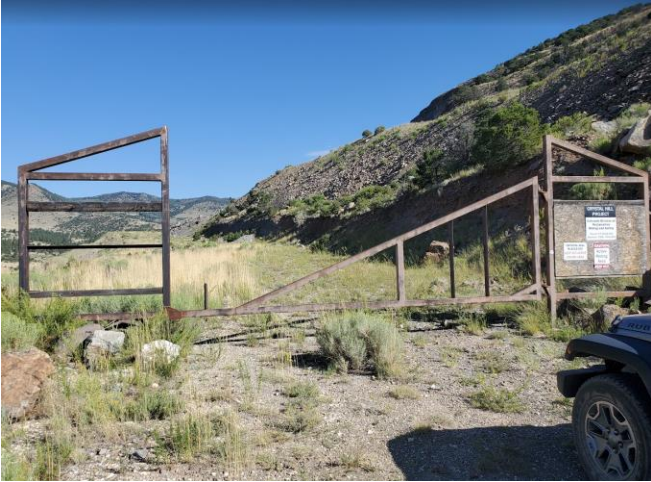
View to the north of gate that secures access and the proper Mine ID signage.

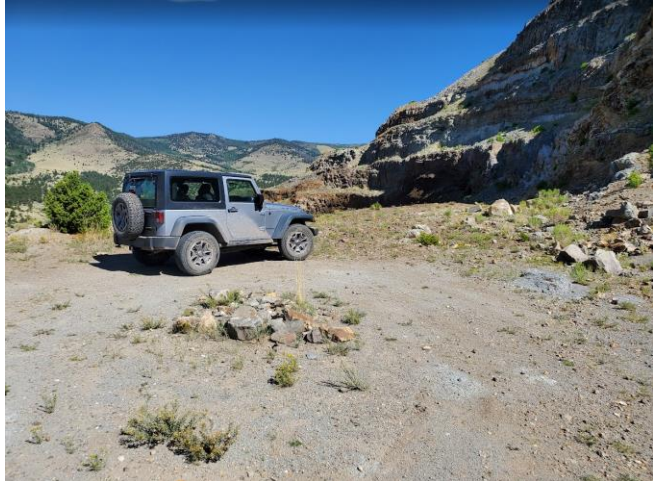
Public access to the site and pit floor is controlled by a locked gate along the access road that leads to the Crystall Hill Interpretive Site and t-posts adequately delineate the permit boundary. However, there is a upper road that leaves from the Interpretive Site and ends at top of the highwall above the pit. No gate or sign is present on the upper road and there is evidence that the general public is using the area to recreate. The Division recommends that a gate with signage be placed on the upper road to prevent unauthorized access. There also appears to be signs of unauthorized access by the general public on the pit floor in the form of fire rings and rifle targets. The Division also recommends that the operator attempt to better secure the permit area to protect themselves from liability.

View to the north of upper road that ends above highwall. No gate or signs in the area and a fire pit can be seen in the foreground.

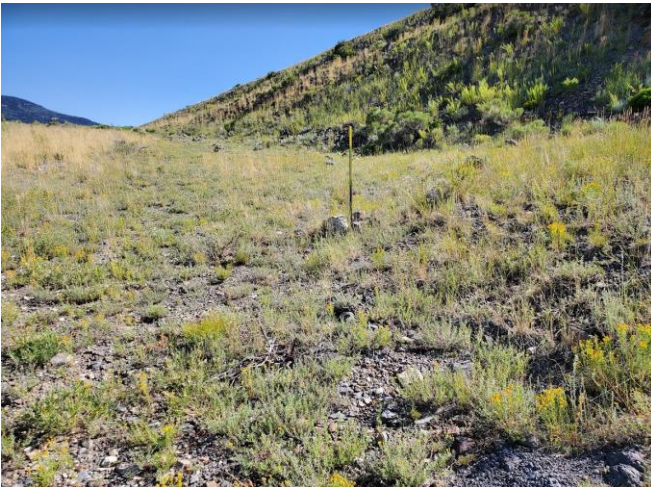
View to the north of t-post that marks permit boundary

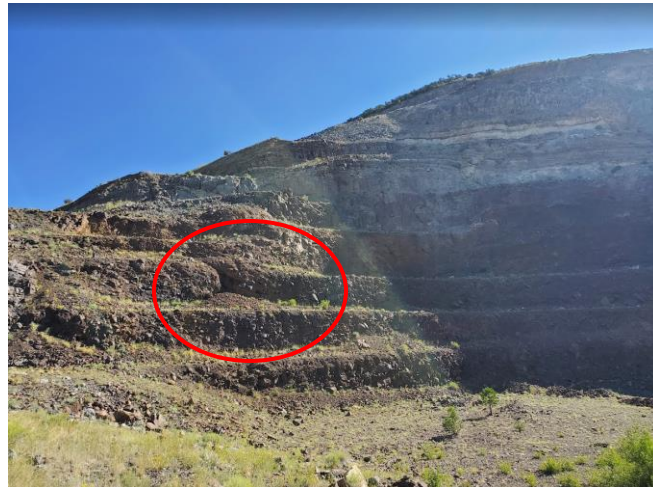
The site was not active at the time of the inspection and no mining equipment was present. There are no onsite support facilities and no hydrocarbons or hazardous chemicals are stored on site. No groundwater has been exposed and there is no evidence of metoric water being impounded on the pit floor. The highwall does have evidence of erosion. There are erosional channels in the benches on the north end of the pit and material the size of small boulders has come loose off the highwall and landed on the pit floor. The pit floor has multiple test trenches and the Annual Production Report indicated that 30 tons of material was mined during Q3 of 2022. It is presumed that the material was mined from one of the test pits. No overburden or waste material has been placed in the Waste Dump Area. Vegetation is present throughout the permit area, but no state listed invasive species were identified.

View to the northwest of highwall. Erosion channels can be seen on the north end of the pit highwall.

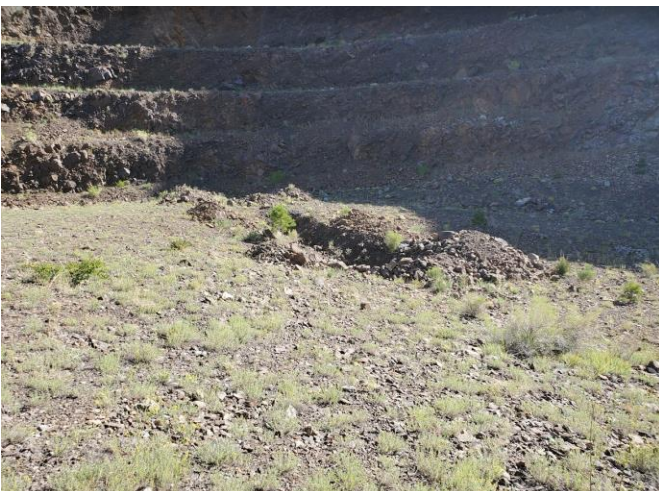
View to the northeast of trench on the pit floor.

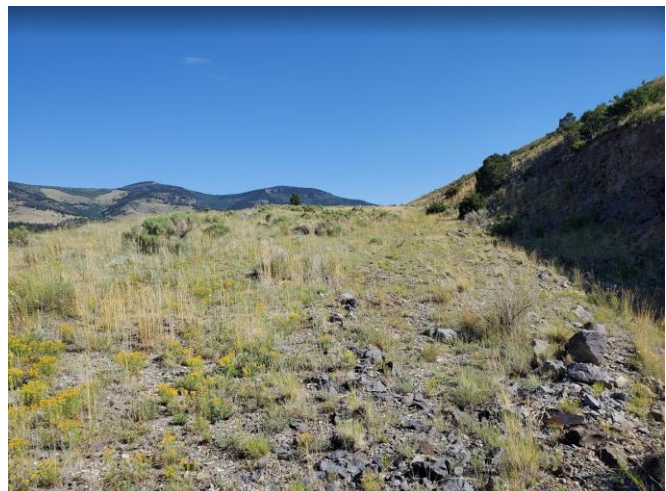
View to the north of the Waste Dump Area. No material has been placed here.
