MINERALS PROGRAM INSPECTION REPORT
PHONE: (303) 866-3567

MINE NAME: Pepper Pit	MINE/PROSPECTING ID#: M-2011-034	MINERAL: Sand and borrow material construction	COUNTY: Rio Grande
INSPECTION TYPE: Monitoring	WEATHER: Clear	INSP. DATE: August 8, 2023	INSP. TIME: 15:00
OPERATOR: Cooley & Sons Excavating, Inc.	OPERATOR REPRESENTATIVE: James Cooley	TYPE OF OPERATION: 110c - Construction Limited Impact	
REASON FOR INSPECTION: Normal I&E Program	BOND CALCULATION TYPE: Complete Bond	BOND AMOUNT: \$4,300.00	
DATE OF COMPLAINT: NA	POST INSP. CONTACTS: None	JOINT INSP. AGENCY: None	
INSPECTOR(S): Todd Jesse	INSPECTOR'S SIGNATURE:

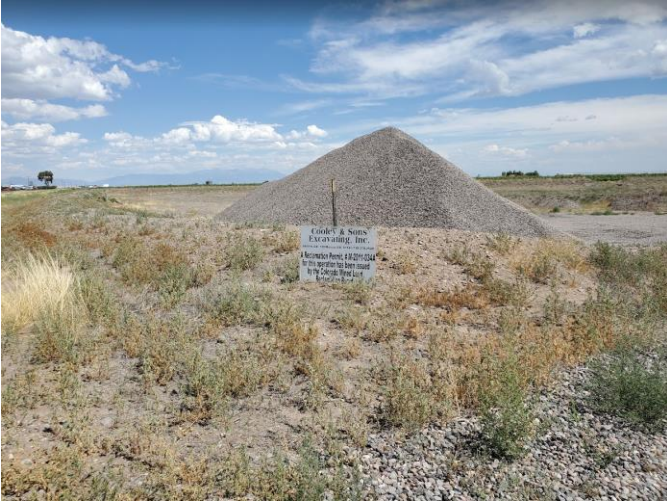
View to the southeast of Mine ID sign at entrance to site.

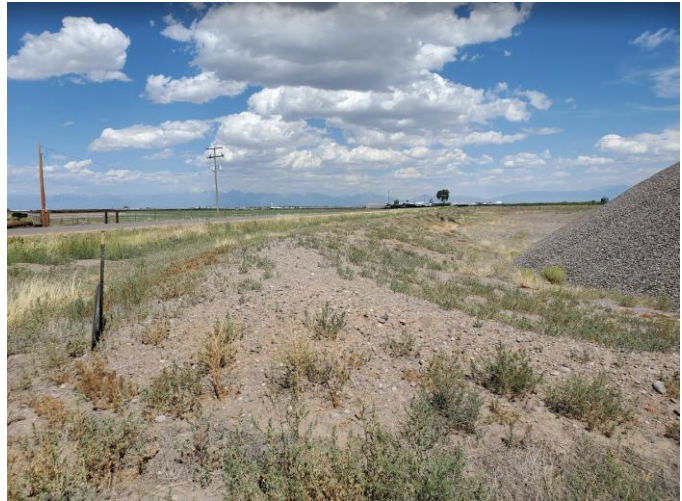
View to the east of berm that marks permit boundary.

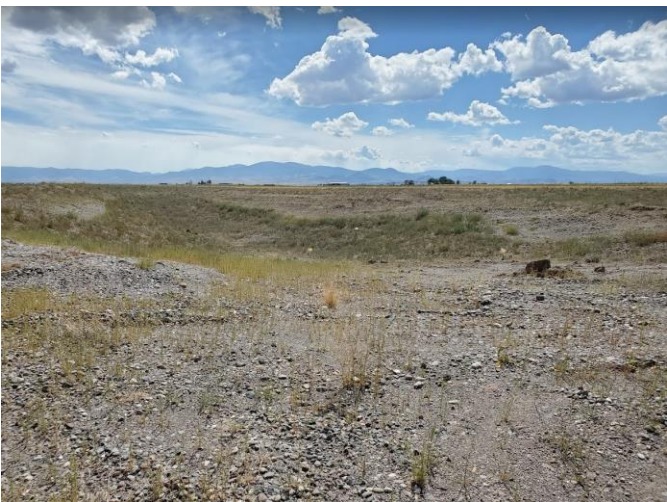
View to the south of Mine ID of southern edge of pit. Slopes are being mined at approximate reclamation grade.

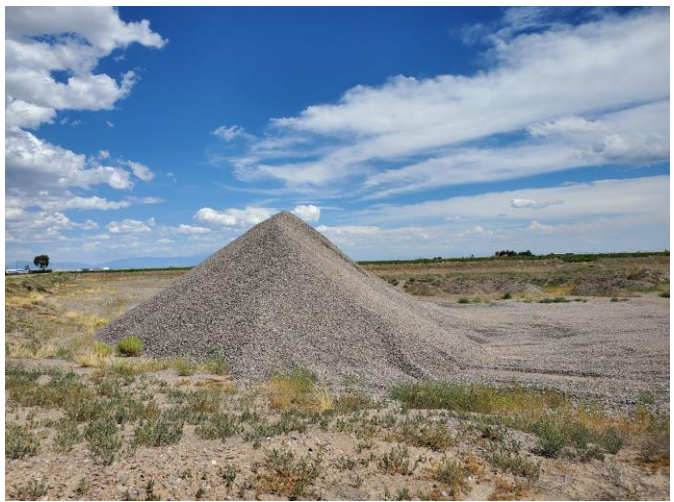
View to the east of 1 1/2 inch product stockpile .
