MINERALS PROGRAM INSPECTION REPORT

MINE NAME: Equity Exploration Project	MINE/PROSPECTING ID#: P-2011-010	MINERAL: Silver, gold, lead and zinc	COUNTY: Mineral
INSPECTION TYPE: Monitoring	WEATHER: Clear	INSP. DATE: August 9, 2023	INSP. TIME: 10:30
OPERATOR: Rio Grande Silver, Inc.	OPERATOR REPRESENTATIVE: Randy McClure	TYPE OF OPERATION: MP - Mineral Prospecting	
REASON FOR INSPECTION: Normal I&E Program	BOND CALCULATION TYPE: None	BOND AMOUNT: \$28,192.00	
DATE OF COMPLAINT: NA	POST INSP. CONTACTS: None	JOINT INSP. AGENCY: None	
INSPECTOR(S): Todd Jesse	INSPECTOR'S SIGNATURE:

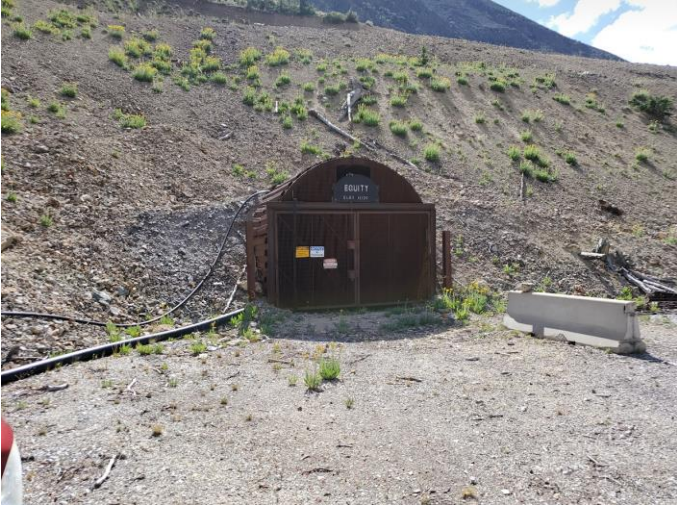
View to the east of the main portal. Gate securing portal is secure.

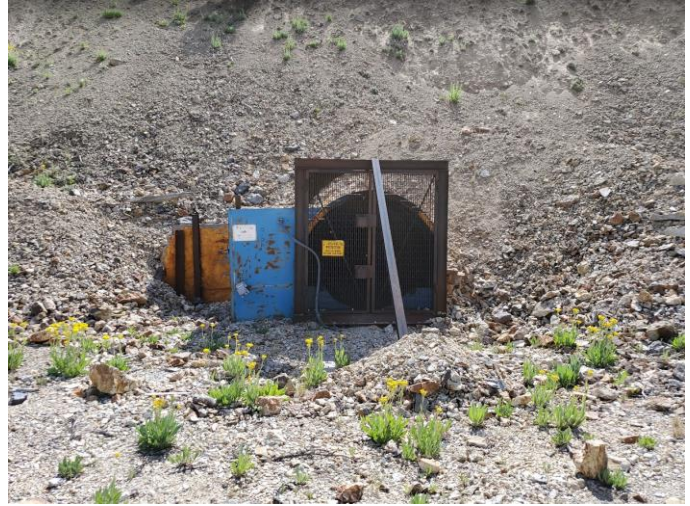
View to the east of vent adit. Gate securing adit is secure.

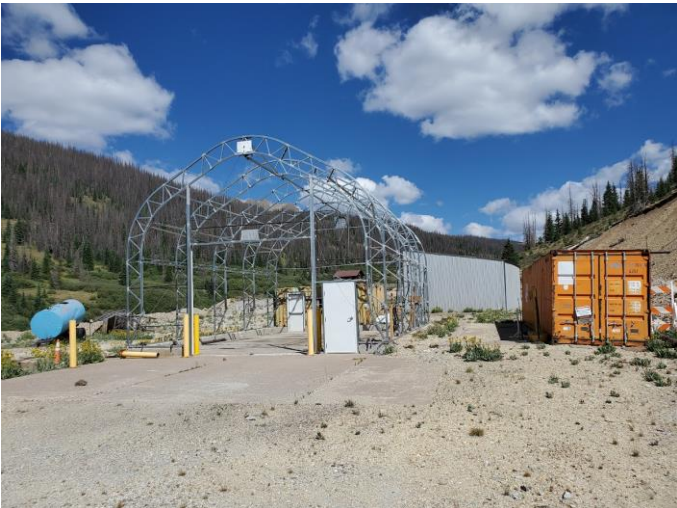
View to the north of the shop building frame.

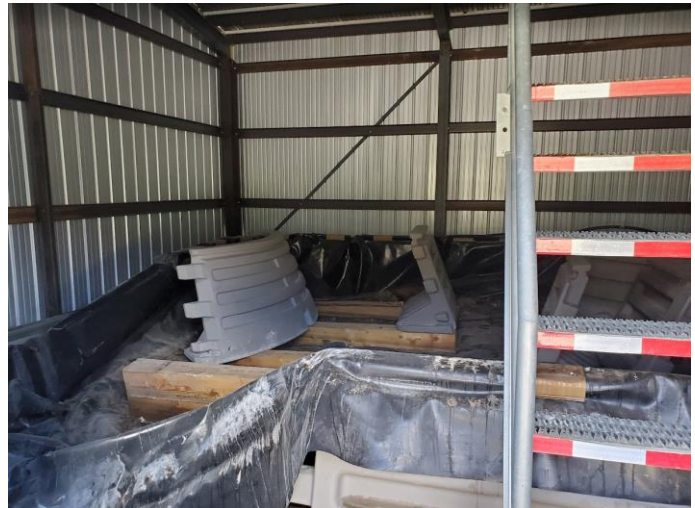
View to the east of the fuel storage building. Fuel tanks have been removed.

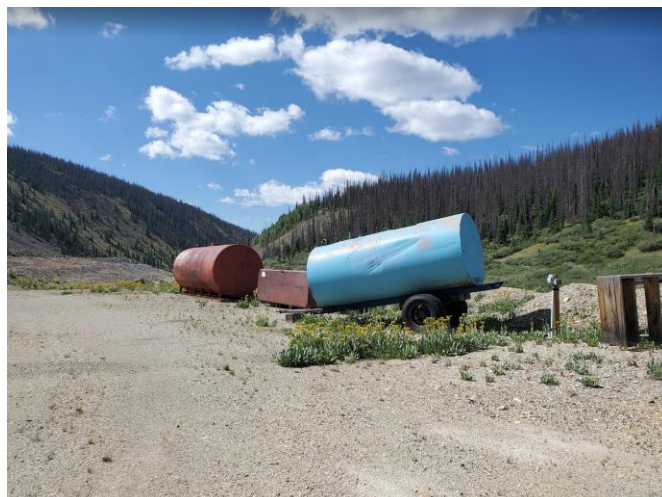
View to the south of empty water tanks in permit boundary.
