MINERALS PROGRAM INSPECTION REPORT
PHONE: (303) 866-3567

MINE NAME: Revenue Mine	MINE/PROSPECTING ID#: M-2012-032	MINERAL: Lead, silver and gold	COUNTY: Ouray
INSPECTION TYPE: Monitoring	WEATHER: Clear	INSP. DATE: August 15, 2023	INSP. TIME: 11:30
OPERATOR: Ouray Silver Mines Inc.	OPERATOR REPRESENTATIVE: CJ Dickerson	TYPE OF OPERATION: 112d-1 - Designated Mining Operation	
REASON FOR INSPECTION: Normal I&E Program	BOND CALCULATION TYPE:	BOND AMOUNT: \$517,219.00	
DATE OF COMPLAINT: NA	POST INSP. CONTACTS: None	JOINT INSP. AGENCY: None	
INSPECTOR(S): Lucas West	INSPECTOR'S SIGNATURE:

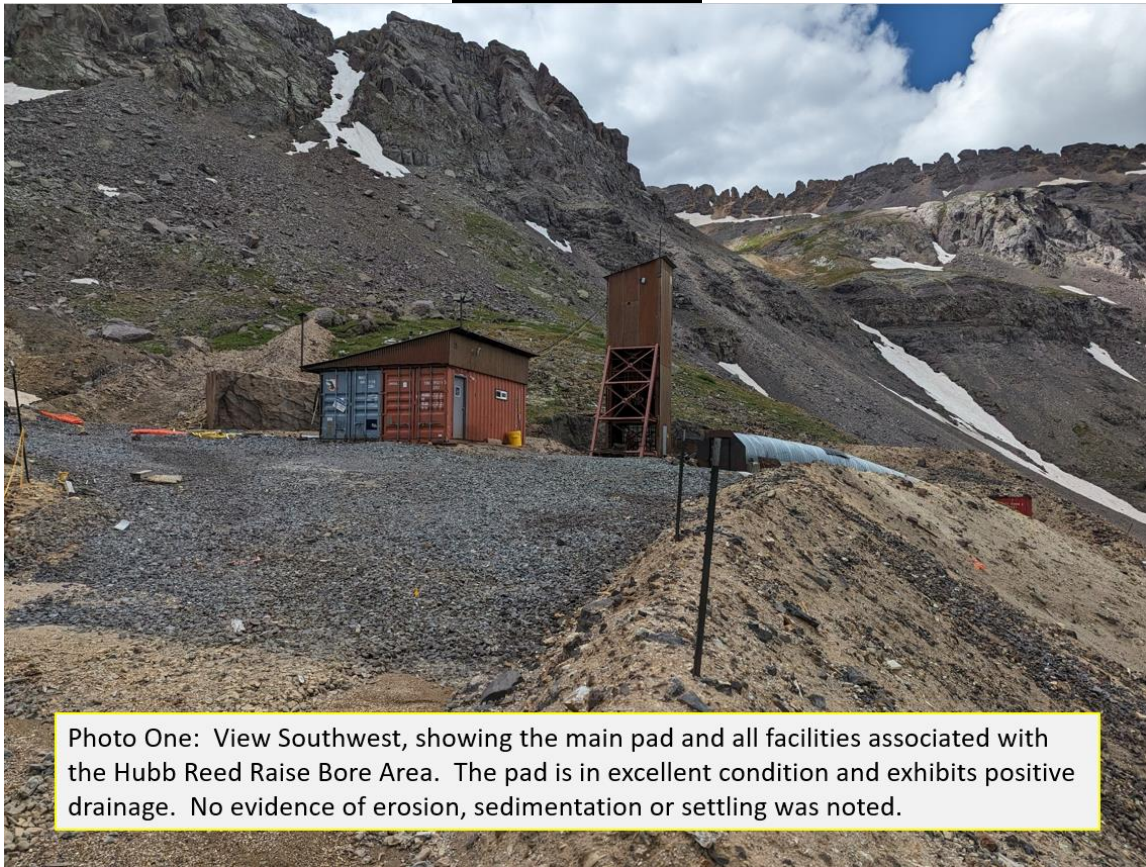
Photo One: View Southwest, showing the main pad and all facilities associated with the Hubb Reed Raise Bore Area. The pad is in excellent condition and exhibits positive drainage. No evidence of erosion, sedimentation or settling was noted.

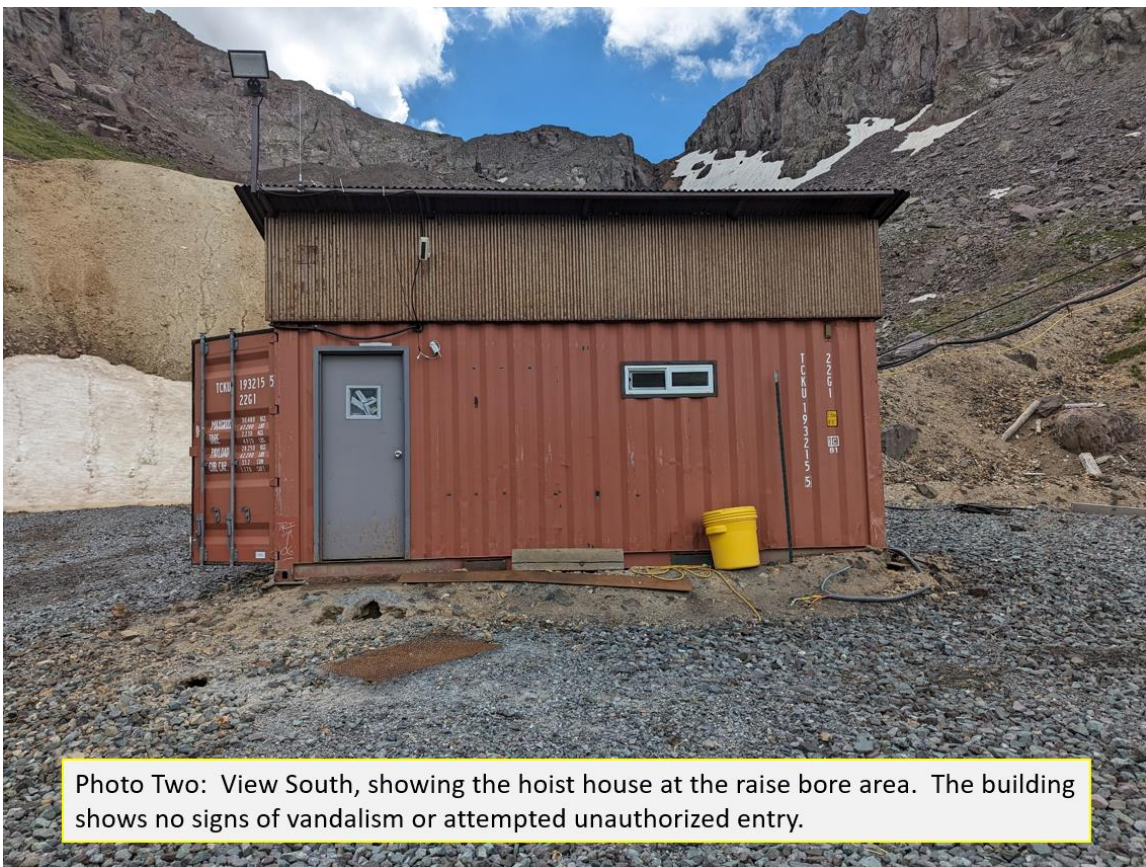
Photo Two: View South, showing the hoist house at the raise bore area. The building shows no signs of vandalism or attempted unauthorized entry.

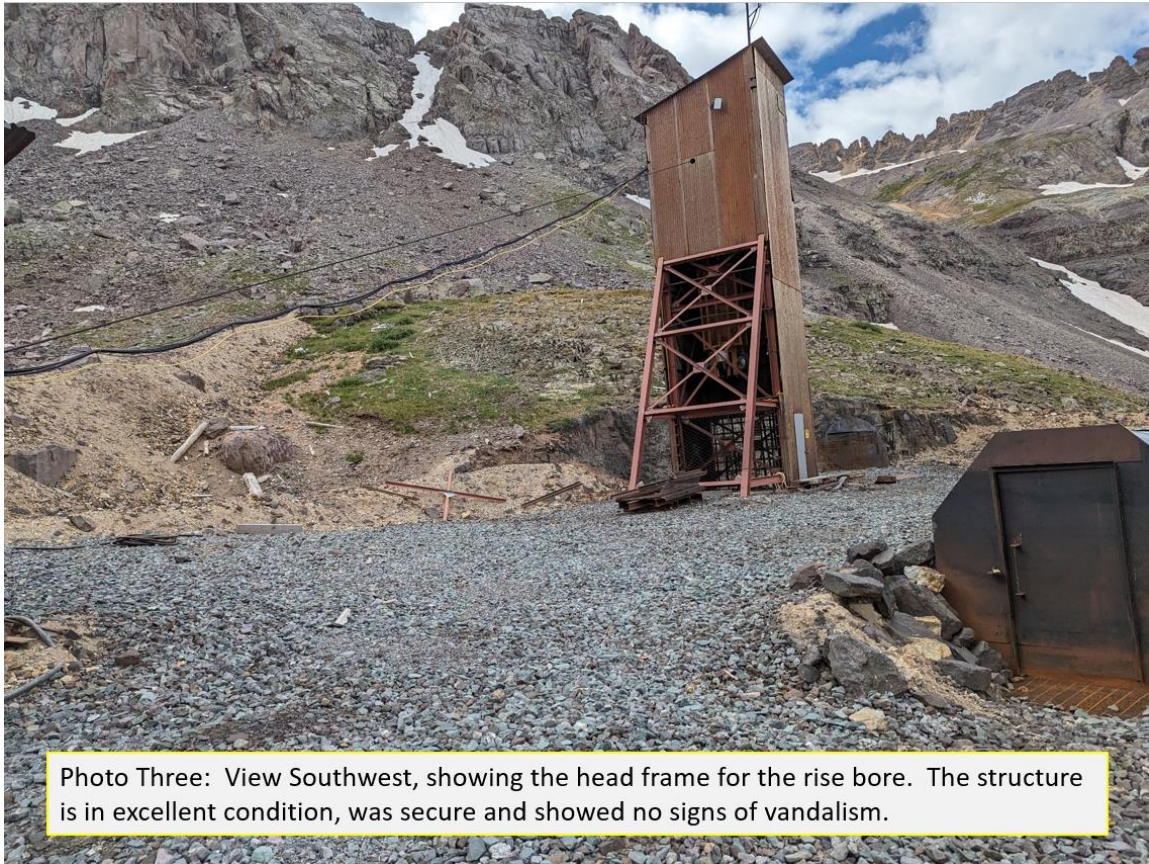
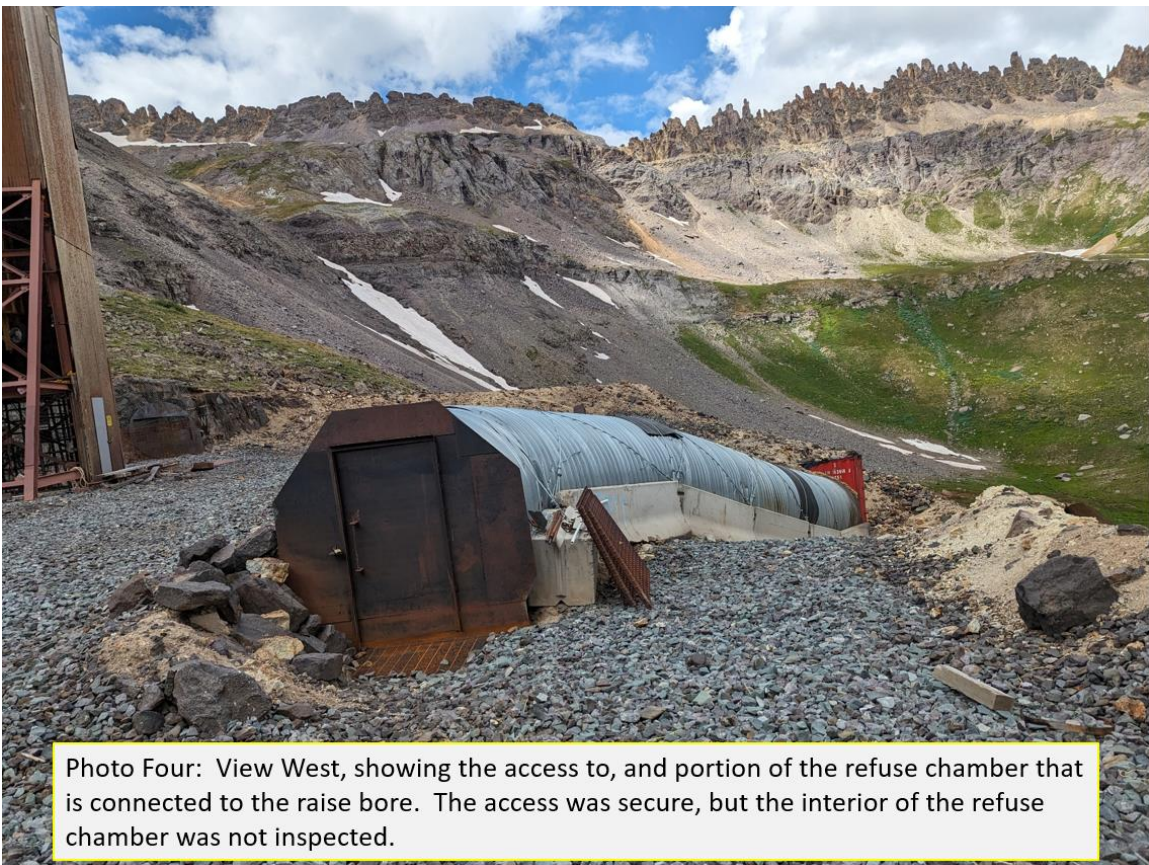
All structures located in the area, including the hoist house, head frame and refuse access were secure at the time of the inspection. The buildings shown in Photos Two through Four are in good condition and no evidence of attempted unauthorized entry was noted. The south side of the hoist house building had some minor damage from avalanche slides during the winter as seen in Photo Five, however the integrity of the building was not jeopardized and all components contained inside appear to be in good working order. The interior of the refuse chamber was not observed at this time.
