**MINERALS PROGRAM INSPECTION REPORT**  
**PHONE: (303) 866-3567**

| <b>MINE NAME:</b><br>Climax Mine | <b>MINE/PROSPECTING ID#:</b><br>M-1977-493 | <b>MINERAL:</b><br>Molybdenum | <b>COUNTY:</b><br>Lake, Summit |
| <b>INSPECTION TYPE:</b><br>Monitoring | <b>WEATHER:</b> Clear | <b>INSP. DATE:</b><br>August 23, 2023 | <b>INSP. TIME:</b><br>12:04 |

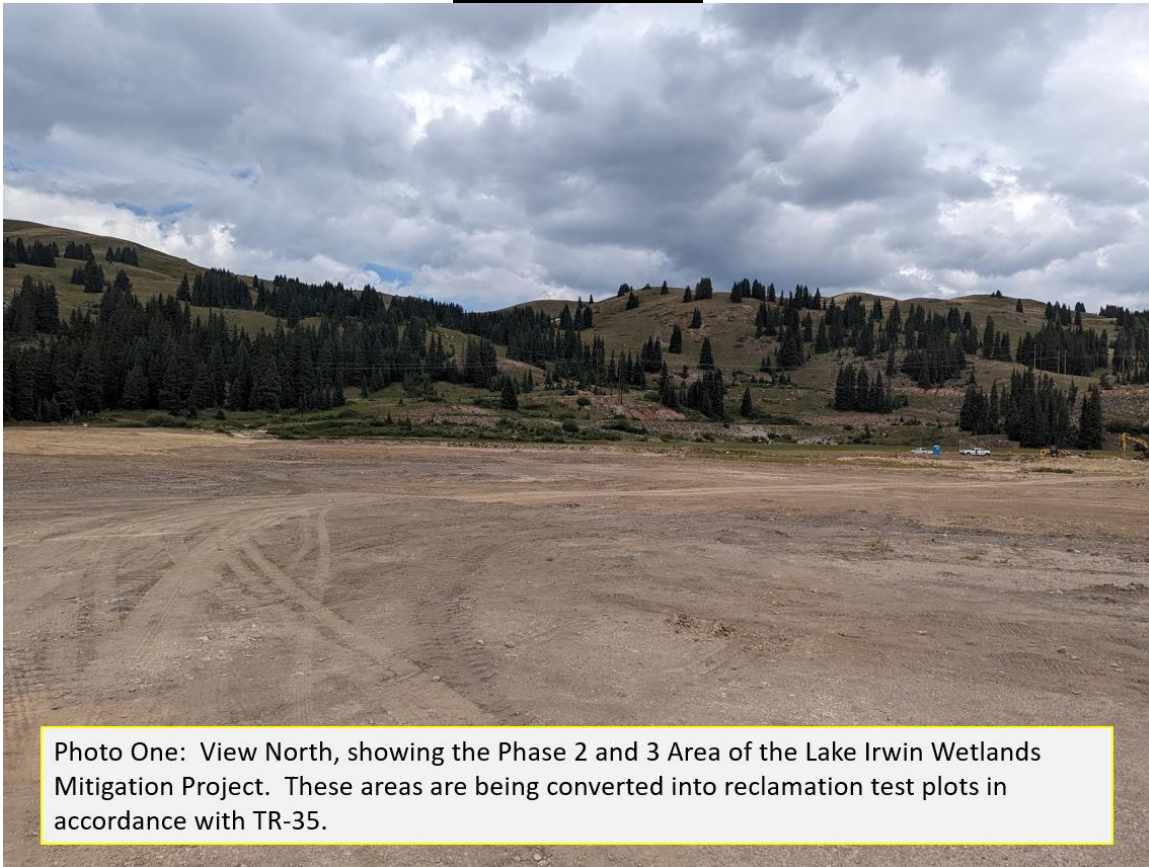
Lake Irwin Wetlands Project: At the time of the inspection, areas in Phases 2 and 3 of the Lake Irwin Area were being regraded in order to install reclamation test plots. The areas can be seen in Photo One, in April of 2023 the Operator submitted TR-35 that in part, modified the Lake Irwin Wetlands Mitigation Project to eliminate phases 2 and 3 from the project. Wetlands mitigation is being conducted by purchasing credits, therefore freeing up the area to install reclamation test plots. Several plots will be installed testing things such as topsoil depth and soil amendments to aid in reclamation success moving forward.

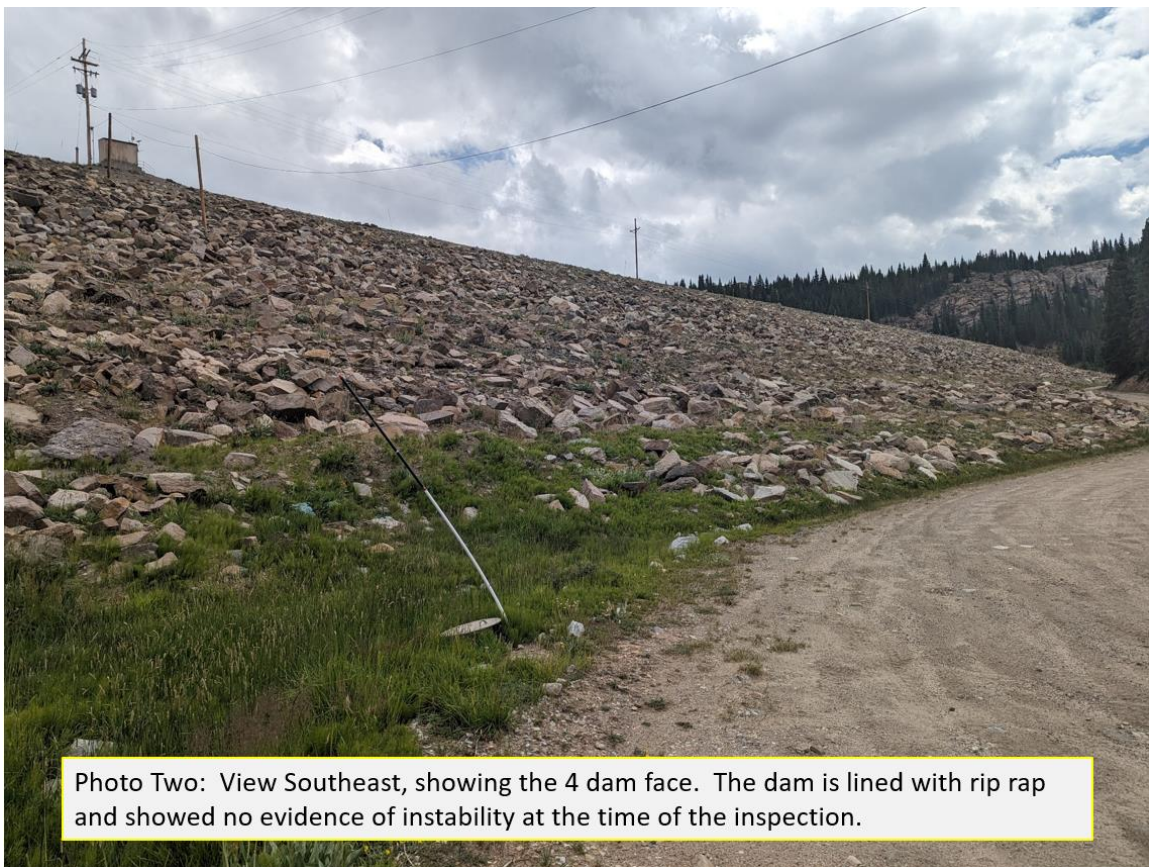
4 Dam Seepwater System: The 4 dam area along with the seepwater system was observed during this inspection. The dam appeared stable at the time, shown in Photo Two. No evidence of settling, slumping or erosion was noted on the rock lined face. The seepwater collection system was functioning as designed, the pond, shown in Photo Three has sufficient freeboard and is in good condition. The water line is well below the top of the cutoff wall, and a small amount of water was collected in the downgradient storm water collection pond. The interior of the pump house is neat, well-kept and in good condition. The pumps were not operating at the time of the inspection.

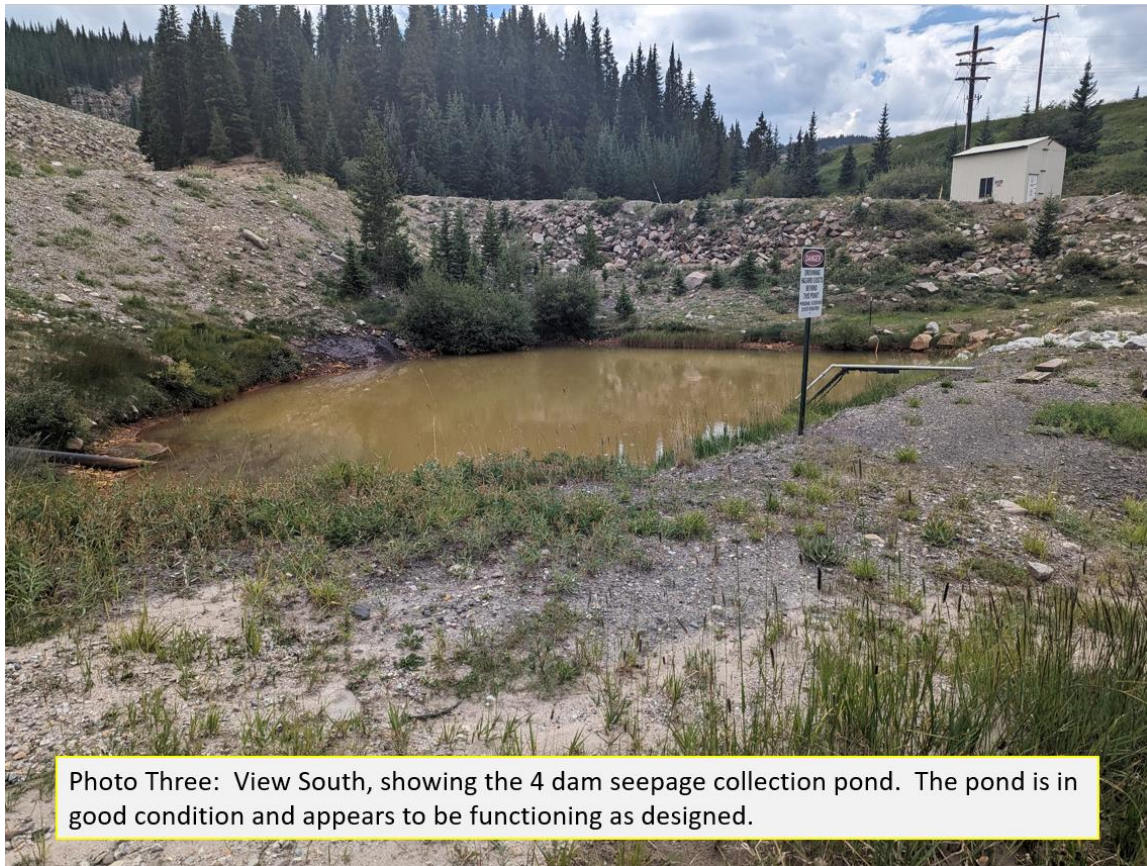
Photo Three: View South, showing the 4 dam seepage collection pond. The pond is in good condition and appears to be functioning as designed.

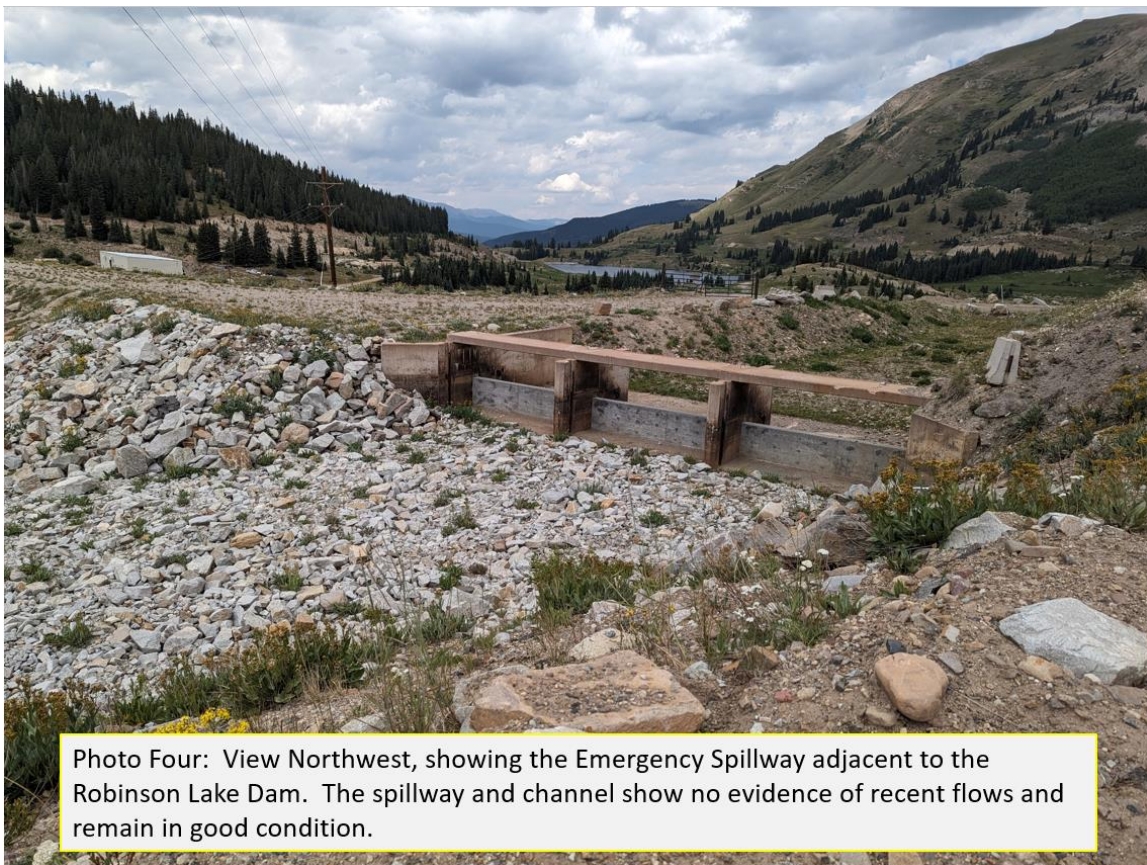
Robinson Lake, Dam and Seepwater Pump System: The Robinson Lake was noted to have somewhat reduced water levels as evidenced by the high water marks on the banks. The lake and banks appeared stable at the time of the inspection. The emergency spillway adjacent to the dam appears to be in good working order and shows no signs of recent flows as seen in Photo Four. The dam itself showed no signs of settling or slumping and no saturated areas indicating instability were noted. The dam can be seen in Photo Five. Below the dam, the seepage collection pond was noted to also have reduced water levels as seen in Photo Six. Overall the pond is in good condition, and no accumulated mineral precipitate or staining was noted. The Pump within the pump house was running, and appeared to be functioning as designed.

Photo Four: View Northwest, showing the Emergency Spillway adjacent to the Robinson Lake Dam. The spillway and channel show no evidence of recent flows and remain in good condition.

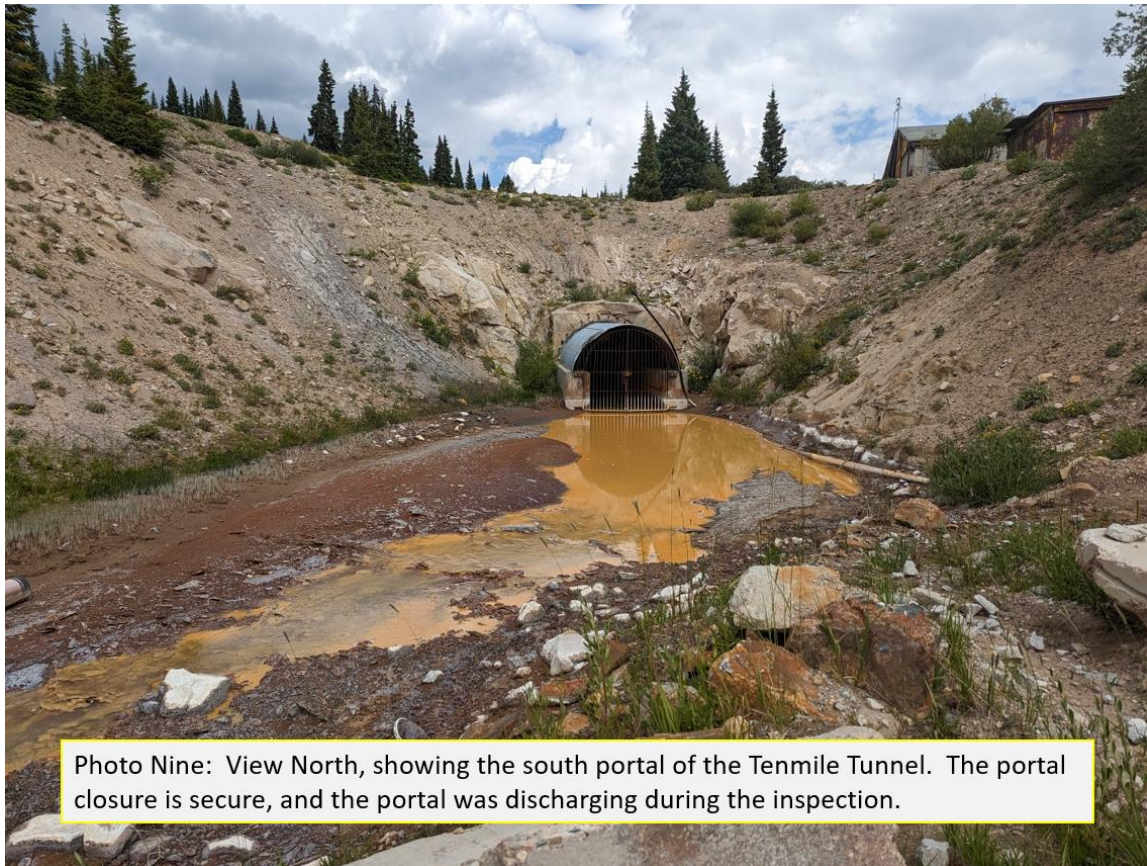
Tenmile Tunnel: The North and South Portals as well as the Tenmile Tunnel Decant were observed during this inspection. The South Portal, shown in in Photo Nine is located near Robinson Lake, adjacent to 1 dam. The portal structure is made of concrete and steel sets, and covered with a locking metal gate. The portal was discharging at a small rate during the inspection and the impacted water was migrating via established channels into Warren's Station. The portal and its discharge can be seen in Photo Nine. The channel leading to Warren's Station is unobstructed and able to function as designed.

Photo Nine: View North, showing the south portal of the Tenmile Tunnel. The portal closure is secure, and the portal was discharging during the inspection.

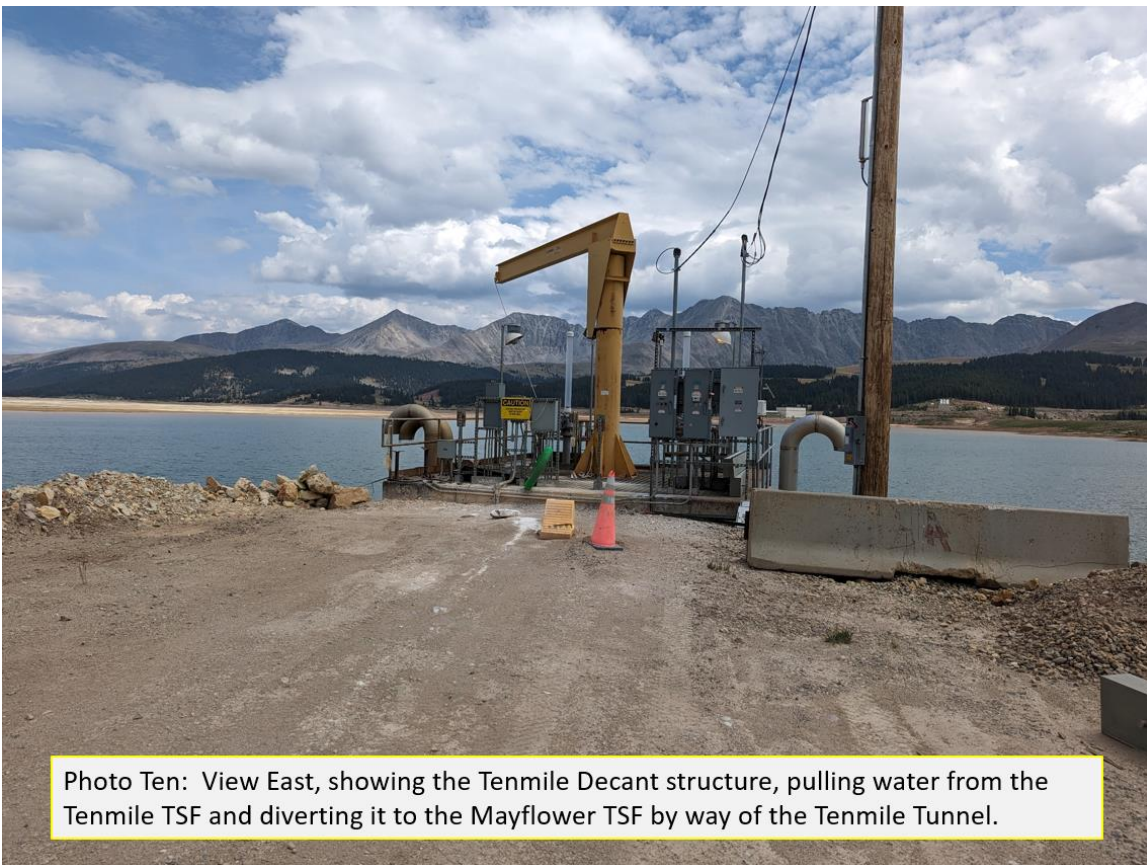
The Tenmile decant is located on a peninsula within the Tenmile Tailings Storage Facility. The greater decant structure appeared to be in good condition with all elements functioning as designed. The decant structure can be seen in Photo Ten. Within the decant structure, the actual decant pipe was observed as seen in Photo Eleven, flowing unobstructed delivering water from the Tenmile TSF to the Mayflower TSF.

Photo Ten: View East, showing the Tenmile Decant structure, pulling water from the Tenmile TSF and diverting it to the Mayflower TSF by way of the Tenmile Tunnel.

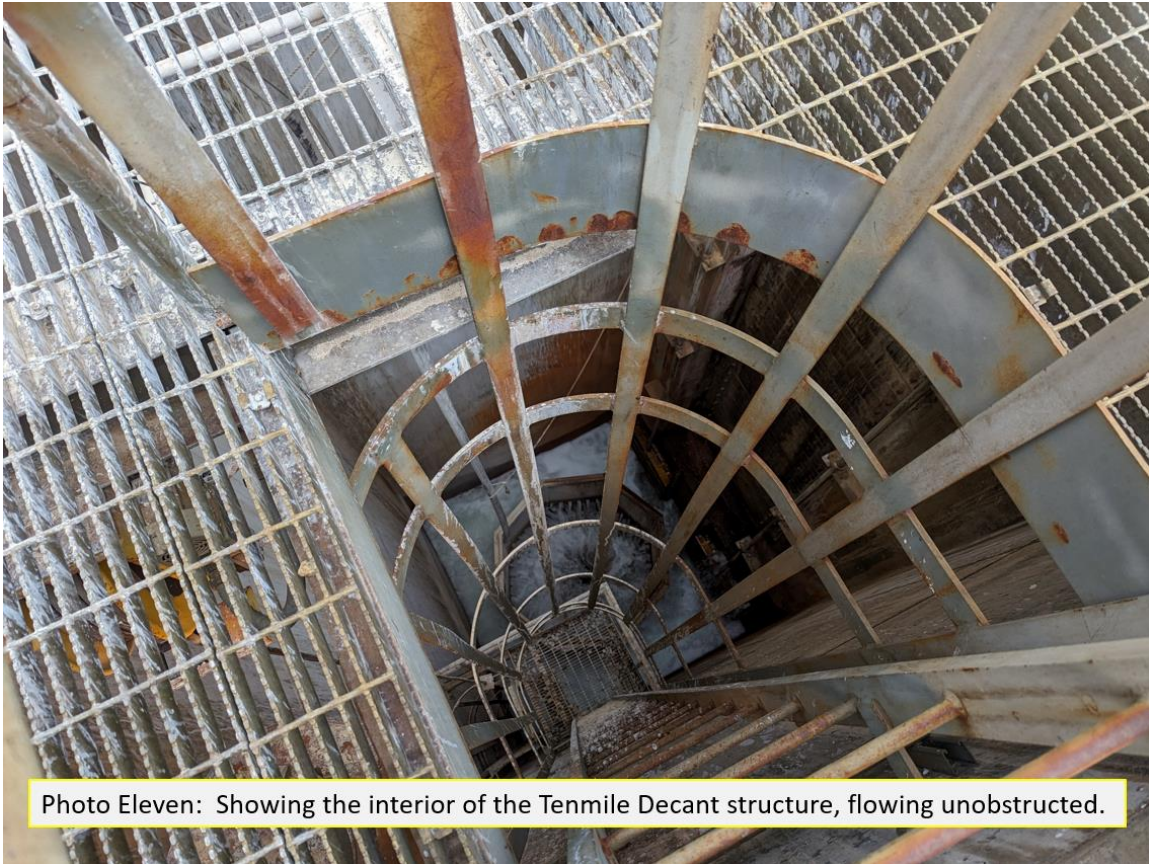
Photo Eleven: Showing the interior of the Tenmile Decant structure, flowing unobstructed.

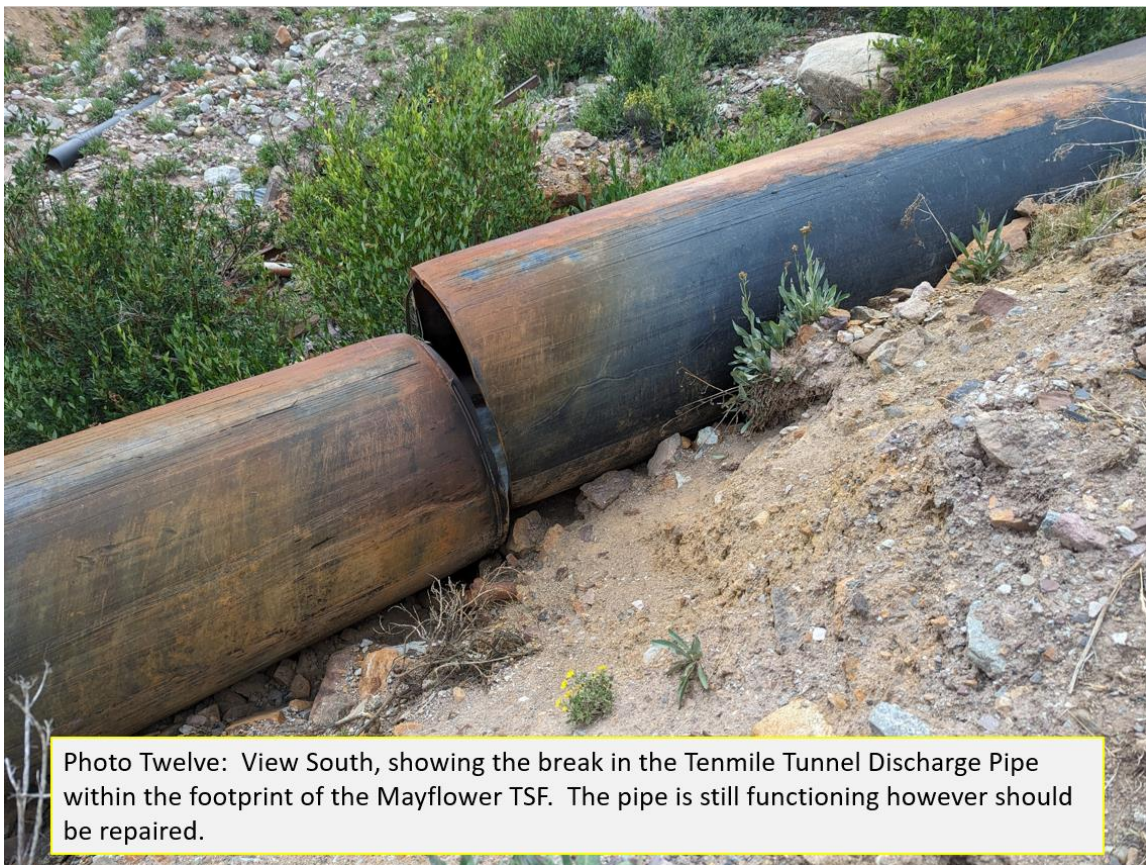
At the Mayflower TSF, the North Portal of the Tenmile Tunnel and associated discharge pipeline was observed. The discharge pipe is heavy gauge HDPE. A point in the discharge pipe has been severed, and dropped approximately 18 inches. The break in the pipe can be seen in Photo Twelve. Water is still flowing through the pipe, however evidence in the surrounding area suggests that during heavy flows, water is bypassing the pipe and eroding the surrounding area. The surrounding area is all within the greater footprint of the Mayflower TSF, and the water ultimately follows the discharge pipe to the point the pipe outfalls into an open channel and reports to the TSF. The point where the discharge pipe outfalls to open channel is shown in Photo Thirteen. There is no threat of loss of containment or migration at this time, however the Operator should develop a plan to repair the pipe to prevent further damage.

Photo Twelve: View South, showing the break in the Tenmile Tunnel Discharge Pipe within the footprint of the Mayflower TSF. The pipe is still functioning however should be repaired.
