Inspections August 2023 : Yoast, Seneca IIW and Williams Fort

29 August 2023

Permit Number: C-1994-082 Mine Name: Yeast Mine Operator Address: Seneca Property LLC Ms Miranda Kawcak 29515 Routt County Road No. 27 Oak Creek, CO 80467	County: Routt Operation Type: Surface Permit Status: Permanent Cessation Ownership: Private Operator Representative Present: Kevin Copeland and Michael Howard
Operator Representative Signature: (Field Issuance Only) This report was issued electronically from the Divisions' Denver Office.

This was a partial inspection of the Yoast Mine, C1994082, operated by Seneca Property LLC. The inspection was conducted, and the report prepared by me, Robin Reilley of the DRMS. The weather was clear and calm with temperatures hovering around 75 degrees Fahrenheit. The ground was dry. No hydrologic or air quality issues were detected at the time of inspection. The site was accessed from the County Road 37.

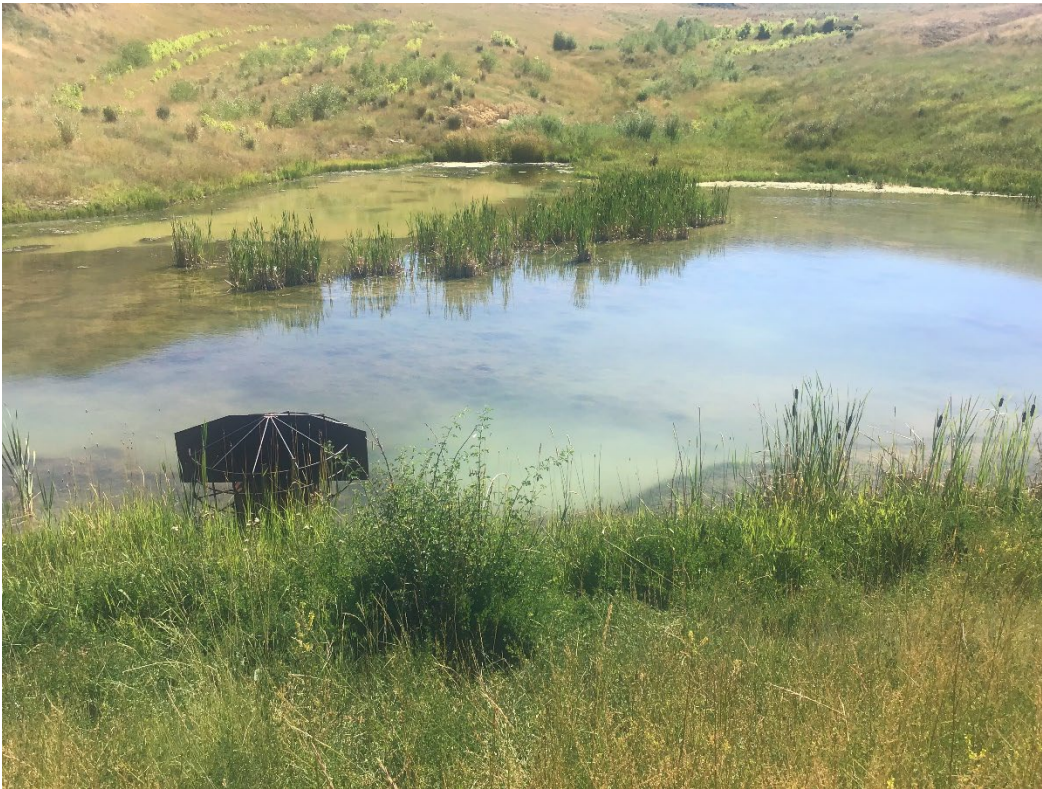
Reclamation has been completed at the site with the exception of the hillside above Pond 12.

- Vegetation on the slopes above Pond 12 appeared adequate and was beginning to dry out.

***Photo 1:** Pond 12, looking (east) up the slopes awaiting final bond release.*

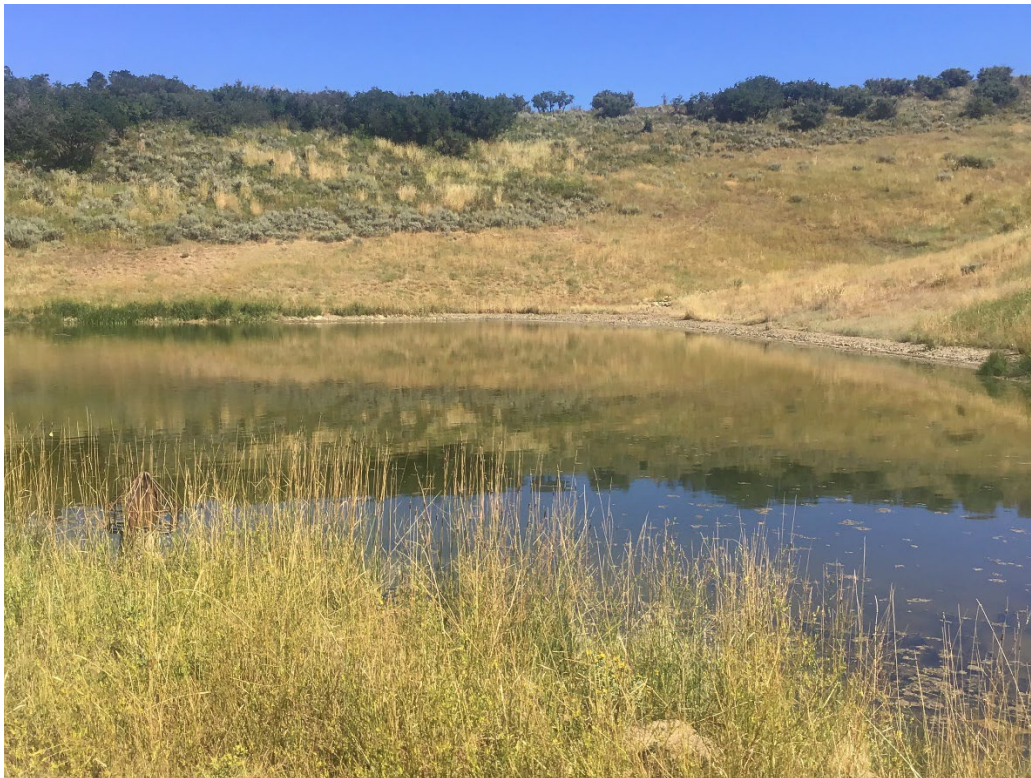
***Photo 2:** Pond 13 holding water.*

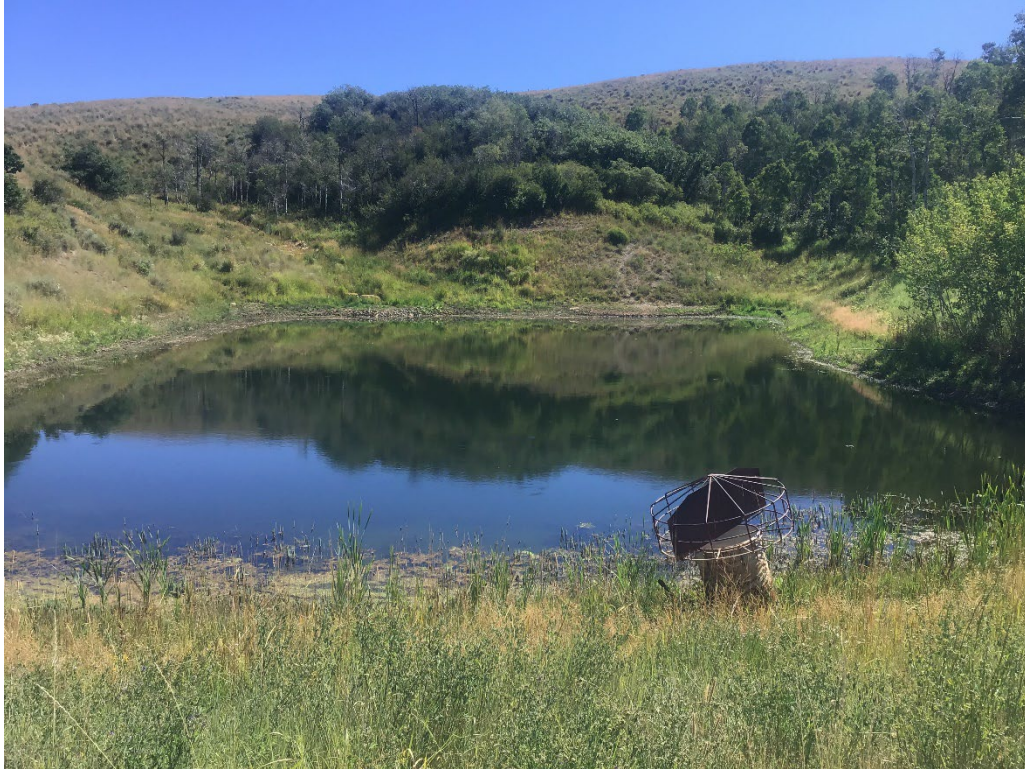
Pond 14 drop structure is cracked and water is flowing into structure. Structure requires sealing.

Photo 3: Pond 14 holding water.
