## Inspections August 2023 : Yoast, Seneca IIW and Williams Fort

**PERMIT INFORMATION**

<b>Permit Number:</b> C-1982-057 <b>Mine Name:</b> Seneca II-W Mine <b>Operator:</b> Seneca Property LLC <b>Operator Address:</b> Ms. Miranda Kawcak 29515 Routt County Road 27 Oak Creek, CO 80467	<b>County:</b> Routt <b>Operation Type:</b> Surface <b>Permit Status:</b> Permanent Cessation <b>Ownership:</b> Private
	<b>Operator Representative Present:</b>  Miranda Kawcak
<b>Operator Representative Signature: (Field Issuance Only)</b>

<b>Inspection Start Date:</b> 29 August, 2023 <b>Inspection Start Time:</b> 12:00 a.m. <b>Inspection End Date:</b> 29 August, 2023 <b>Inspection End Time:</b> 13:00 p.m.		<b>Inspection Type:</b> Coal Partial Inspection <b>Inspection Reason:</b> Normal I&E Program <b>Weather:</b> Clear	
<b>Joint Inspection Agency:</b>  None		<b>Joint Inspection Contacts:</b>	
<b>Post Inspection Agency:</b>  None		<b>Post Inspection Contacts:</b>	
<b>Inspector(s):</b>  Robin Reilley, GISP	<b>Inspector's Signature:</b>

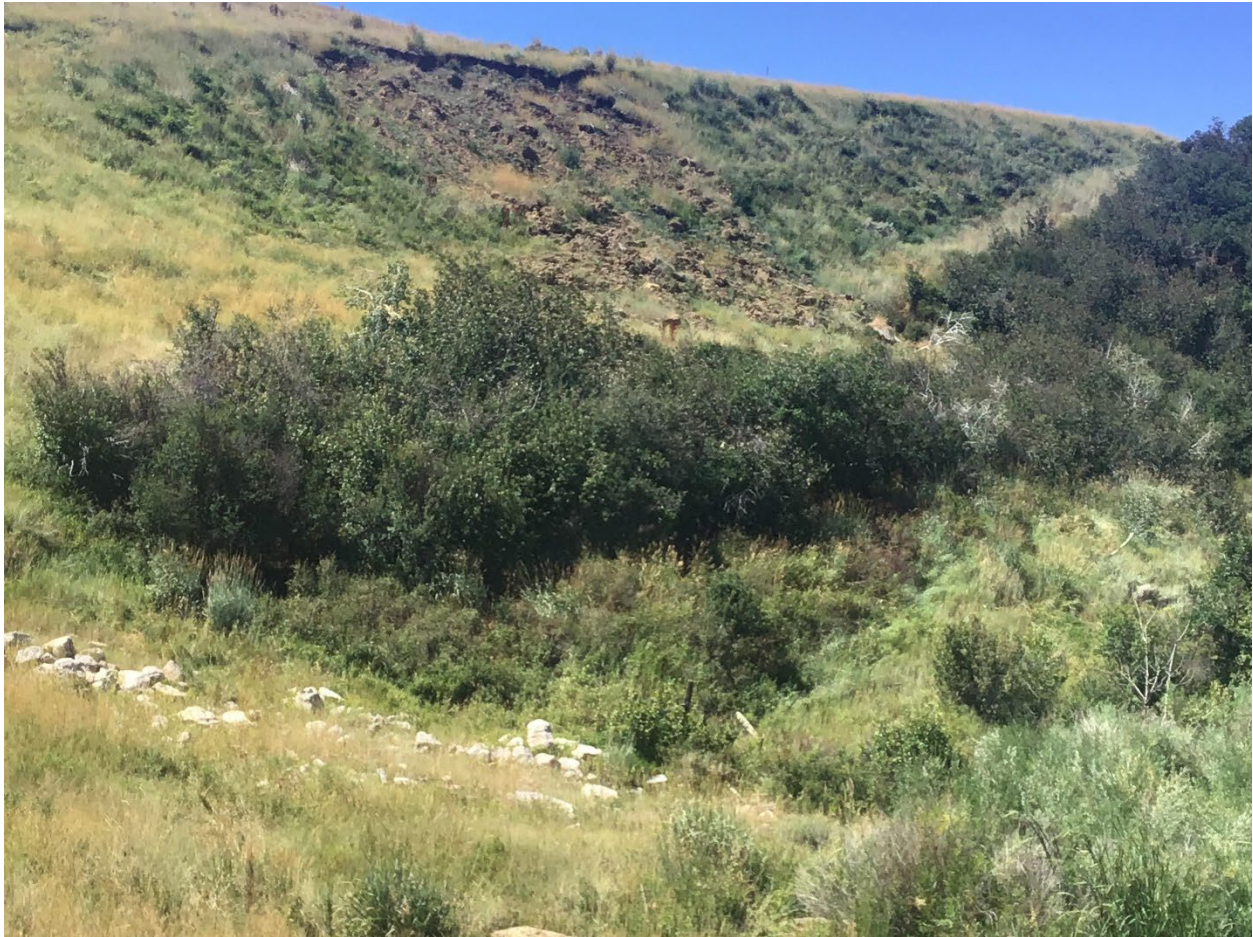
The purpose of the inspection was to discuss mitigation options for the 1/3 acre slide above the Pond 6 spillway. Due to a large amount of snow and an associated cornice that was wind deposited during winter of 2022/2023 saturating the unstable historic mud flows below. The drainage ditch on the haul road above the slide was walked. The ditch transports water from the slope above Pond 6, preventing water from flowing across the road, to a culvert that sends water to the inlet end of the pond.

Possible mitigation methods of the slide above the Pond 6 spillway were discussed. The slope has a history of instability and is a historic pre mining mud slide. There was a 1993 slide where movement was monitored until 1994 when movement had stabilized. The slope slid again in 2011. In 2012 the slide was mitigated through the reclamation activities occurring in that area at the time. The discussion centered on the following remediation:

*Photo 1: Slide area above Pond 6.*

1. Rework the road ditch by lining the ditch and hardening with a form of concrete rip rap. This would prevent spring runoff from pooling in check dams, and possible saturating the road bed above the slide area.
2. Installing approximately 100 feet of snow fence above the slide area to collect snow, preventing accumulation along road scarp above slide area and directing spring snow melt into a shallow depression located upslope and beyond the slide and down slope into dense oak brush.
3. Clean up and lower the raw edge at the upper portion of the slide where it cracked.
4. Seed with vegetation that has a vigorous root system.
