Inspections August 2023 : Yoast, Seneca IIW and Williams Fort

PERMIT INFORMATION

Permit Number: C-1981-044 Mine Name: Williams Fork Mines Operator: Moffat County Mining, LLC Operator Address: MS Miranda Kawcak 29515 Routt County Road #27 Oak Creek, CO 80467	County: Moffat Operation Type: Underground Permit Status: Active Ownership: Private Operator Representative Present: Kevin Copeland and Michael Howard
Operator Representative Signature: (Field Issuance Only) This report was issued electronically from the Divisions' Denver Office.

Inspection Start Date: 29. August, 2023 Inspection Start Time: 08:00 a.m. Inspection End Date: 29 August, 2023 Inspection End Time: 10:15 a.m.		Inspection Type: Coal Partial Inspection Inspection Reason: Normal I&E Program Weather: Clear	
Joint Inspection Agency: None		Joint Inspection Contacts:	
Post Inspection Agency: None		Post Inspection Contacts:	
Inspector(s): Robin Reilley, GISP	Inspector's Signature:

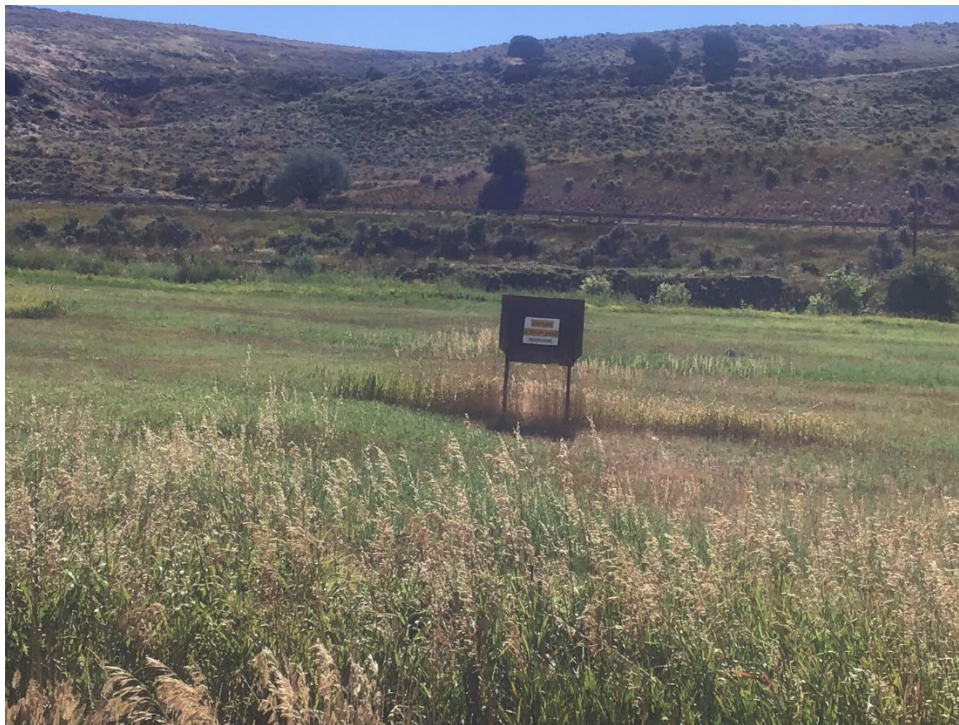
None of the ponds held water at the time of inspection. A couple of pond bottoms were covered with cottonwood and Russian olive saplings. All pond slopes, outslopes and dams appeared stable and vegetated. Ditches were vegetated, stable and appeared to be in good repair. Stream buffer zone was marked along the Williams Fork River.

***Photo 1:** Stream buffer zone sign in place along the Williams Fork River.*

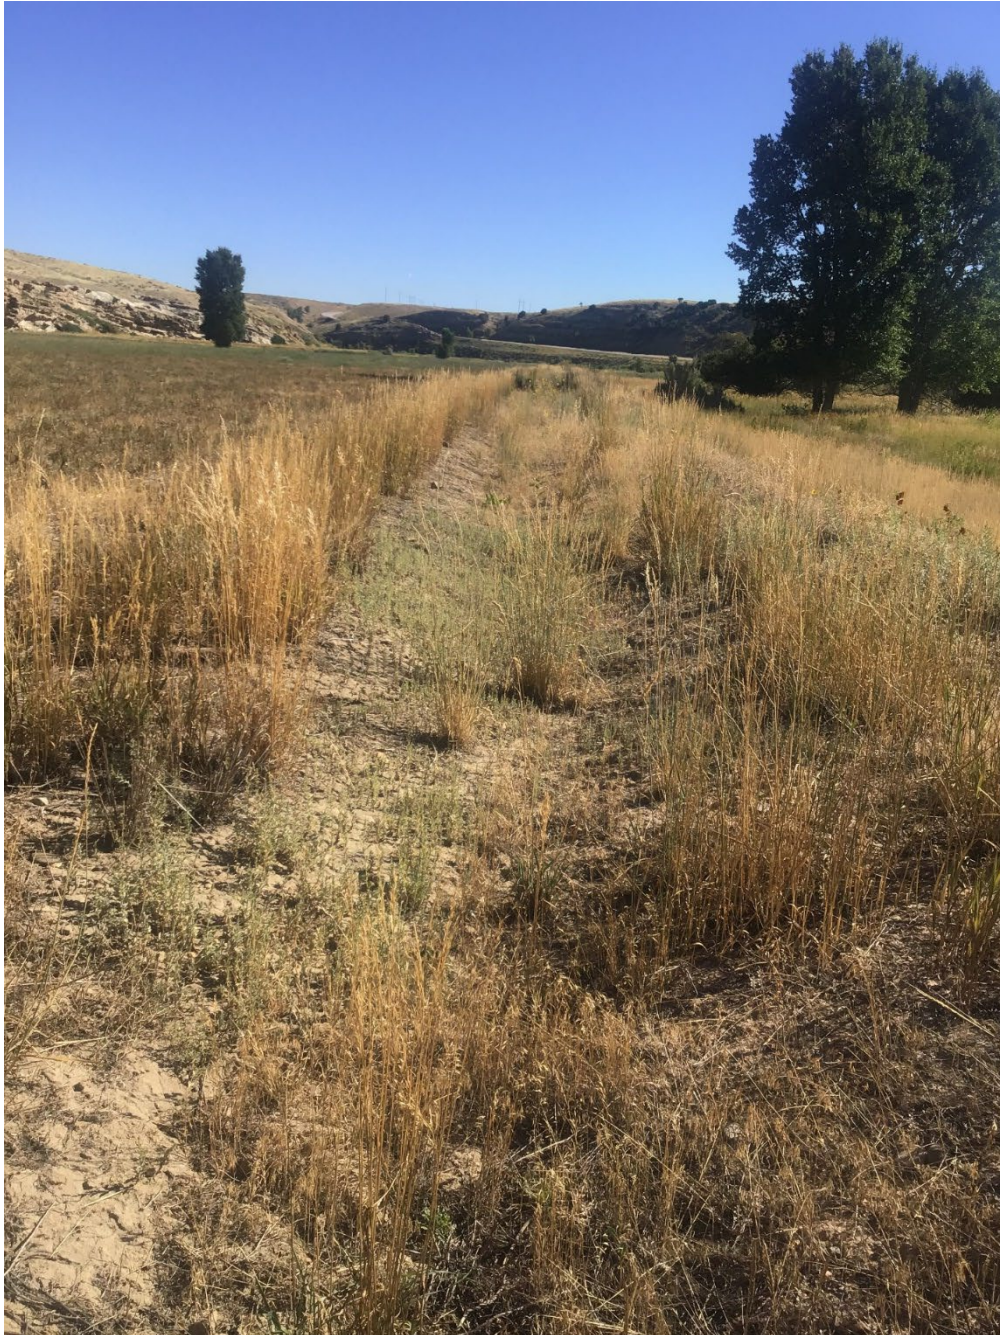
Photo 2: *The 5D-1P ditch located in Williams Fork bottom land looking north.*

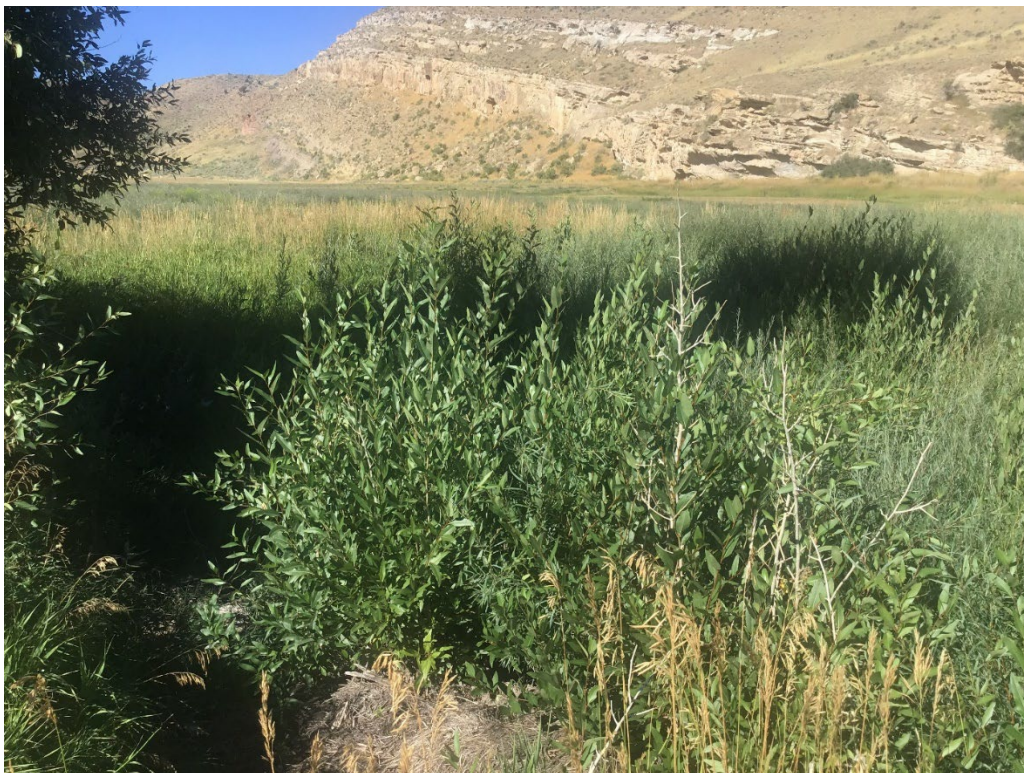
Photo 3: Cottonwood saplings growing in the bottom of Pond 5P-1.

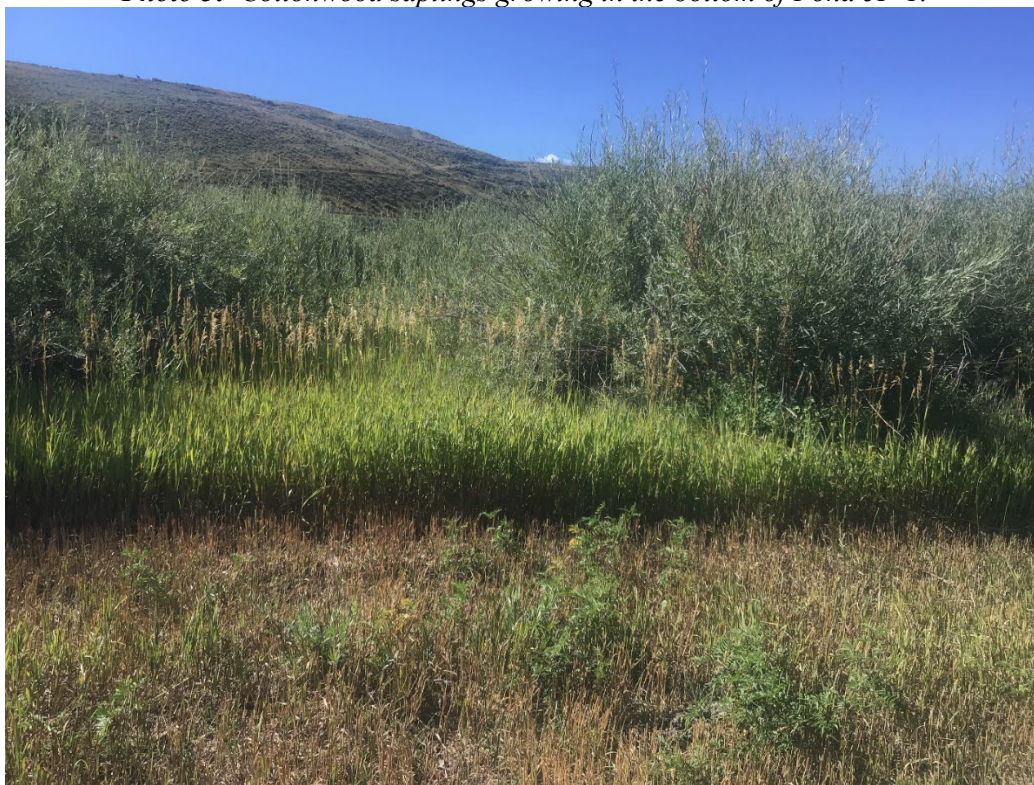
Photo 4: Russian Olive saplings growing in the 5P-2 Pond bottom.

1. Rills and gullies at the slope below the No 5 Portal to the 5A-P1 Pond require grading.
2. Russian olive saplings in Pond 5-P2 require removal.

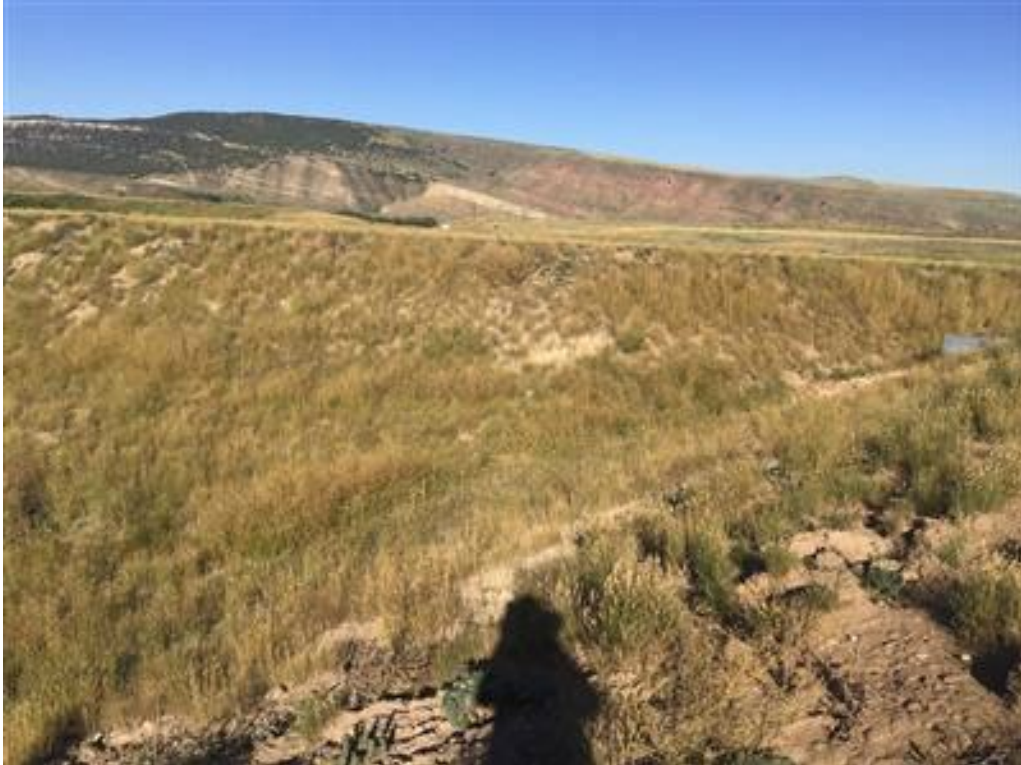
Photo 5: Pond 9P-6 and culvert from road and ditch entering pond.

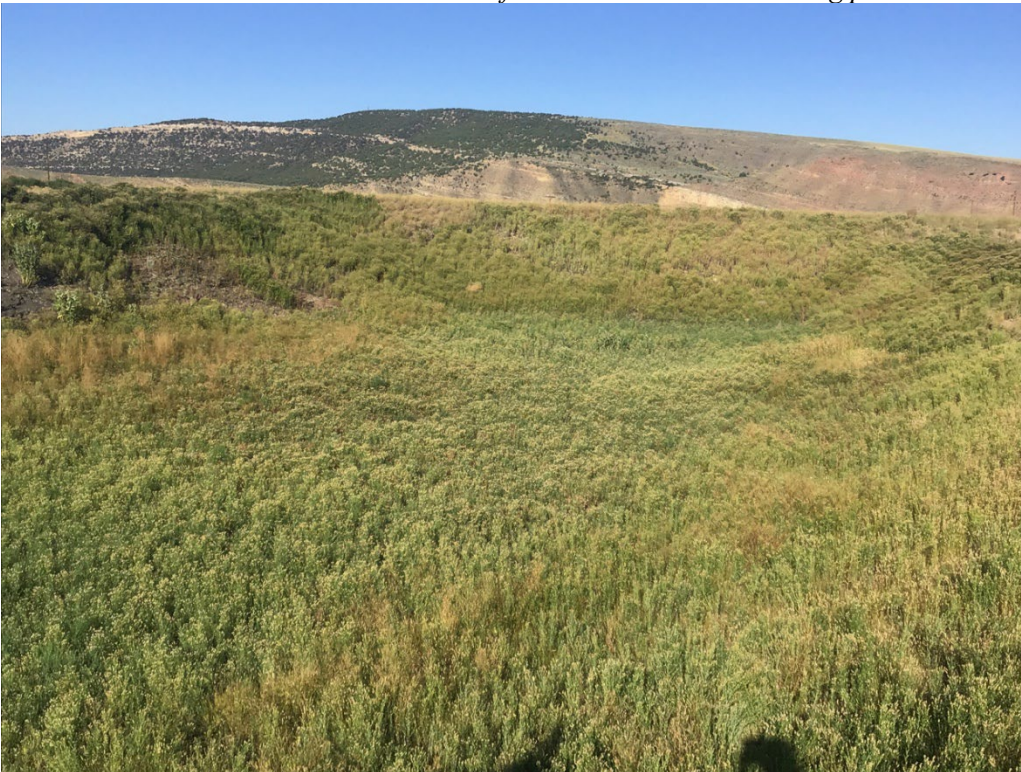
- Pond 9-P1 was dry with dense vegetation covering the bottom of the pond.
- Ponds HR-P1 a, and b were dry with vegetated stable slopes.
- Pond 5A-P1 at 5A at portal was dry at the time of inspection. Pond slopes and bottom are vegetated. Sloped area to the pond had been topsoiled but not seeded. The slope has rills and gullies the length of the slope to the pond and is scheduled for repair and seeding.
- The 9D-2 Ditch appeared stable and functioning adequately.
- The 5D-1P Ditch south end located in Williams Fork bottom land was vegetated, in good repair and appeared to be functioning adequately at the time of inspection.
- 9-D15 Ditch appeared in good repair.

Photo 6: Pond 9P-1, exhibiting a densely vegetated bottom.

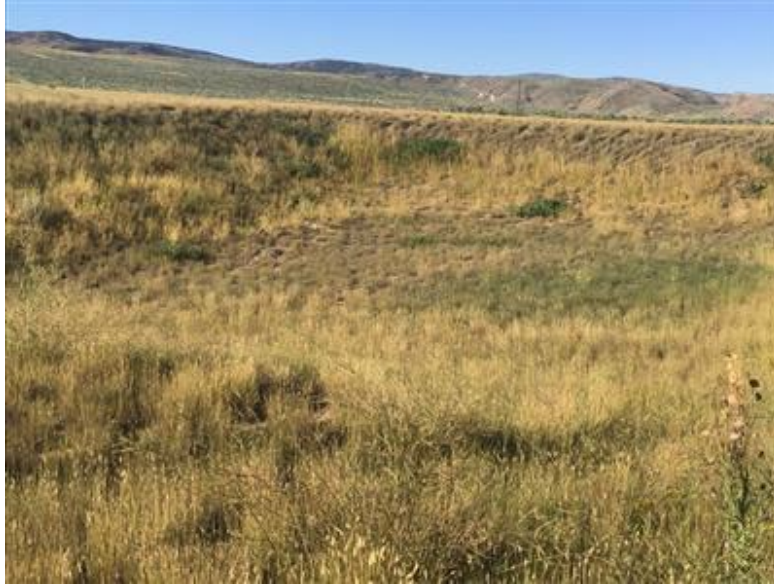
Photo 7: Pond 9P-5, dry with vegetated bottom and banks.

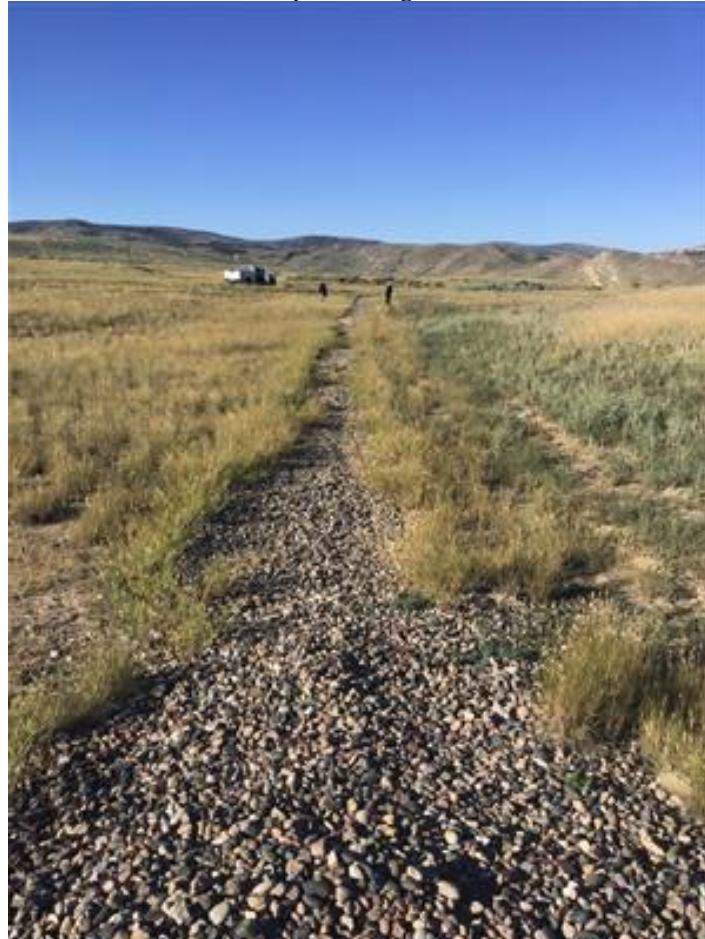
Photo 8: Pebble lined 9-D15 Ditch.

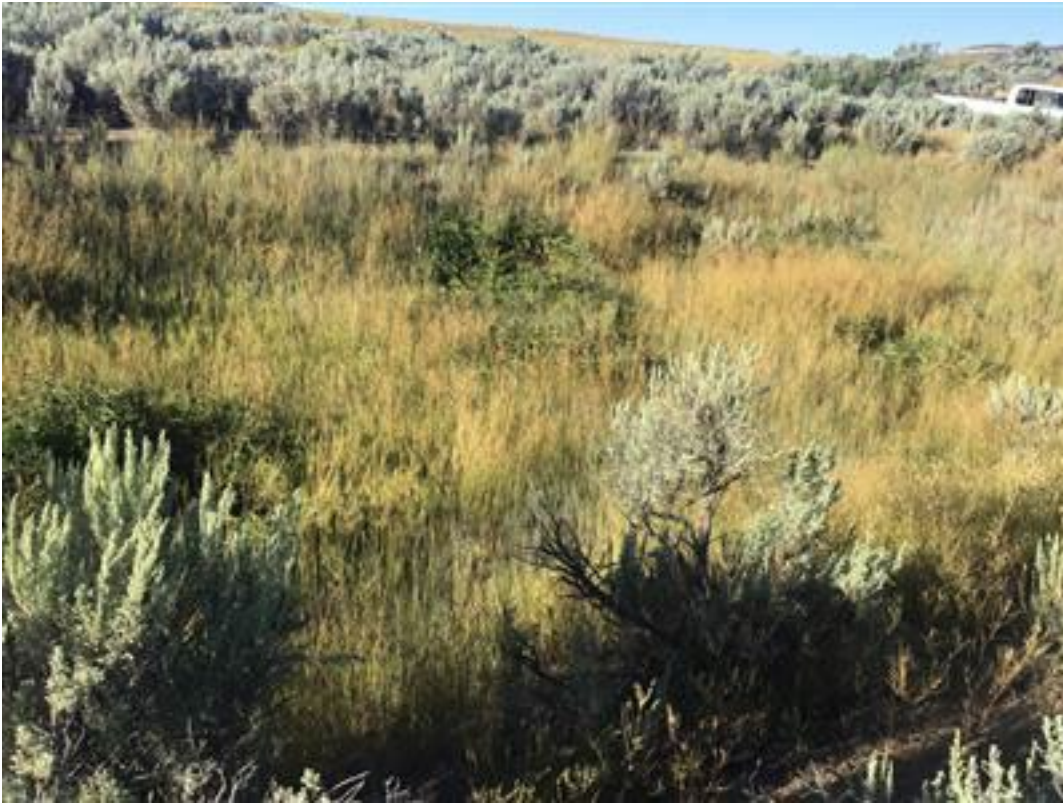
Photo 9: Pond 9P-7, exhibiting well established vegetation and big sagebrush shrubs.

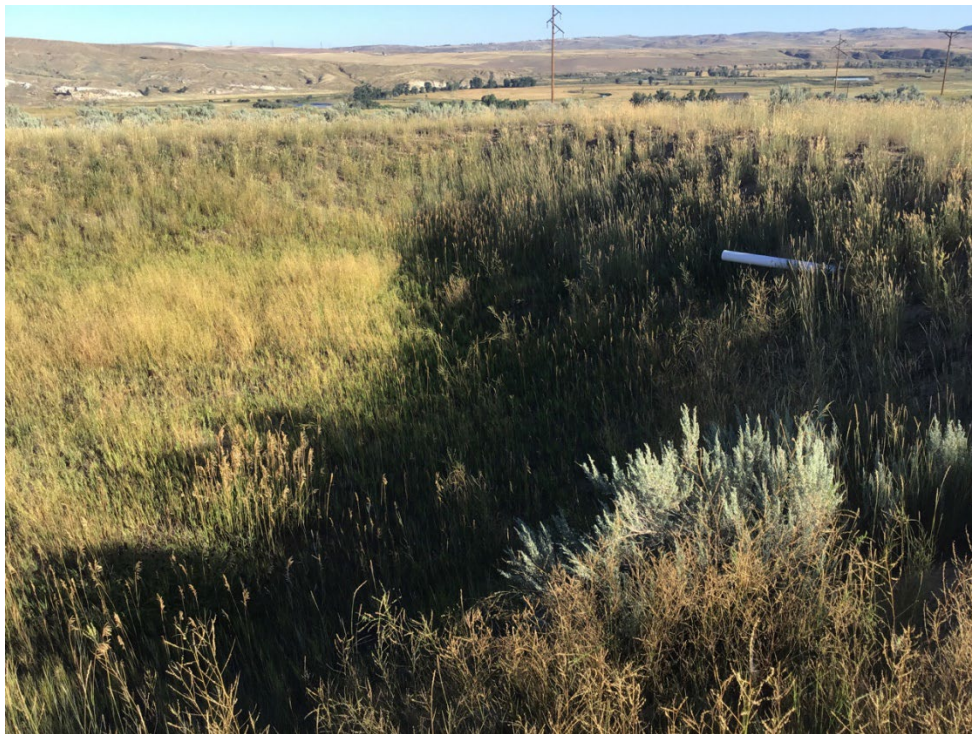
Photo 10: Pond 9P-8 and its inlet culvert.

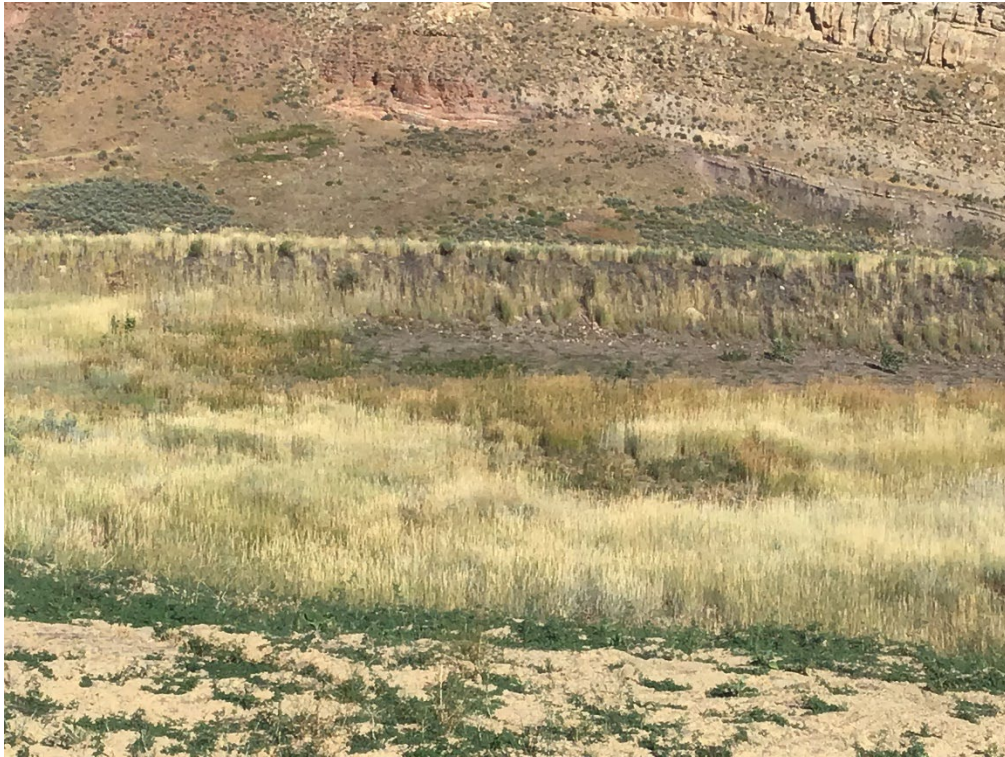
Photo 11: Pond 5A-Plat the portal

- Backfilling and grading has been completed.
- Rills and gullies on the slope below the 5A Portal to 5A-P1 Pond will be graded and repaired.

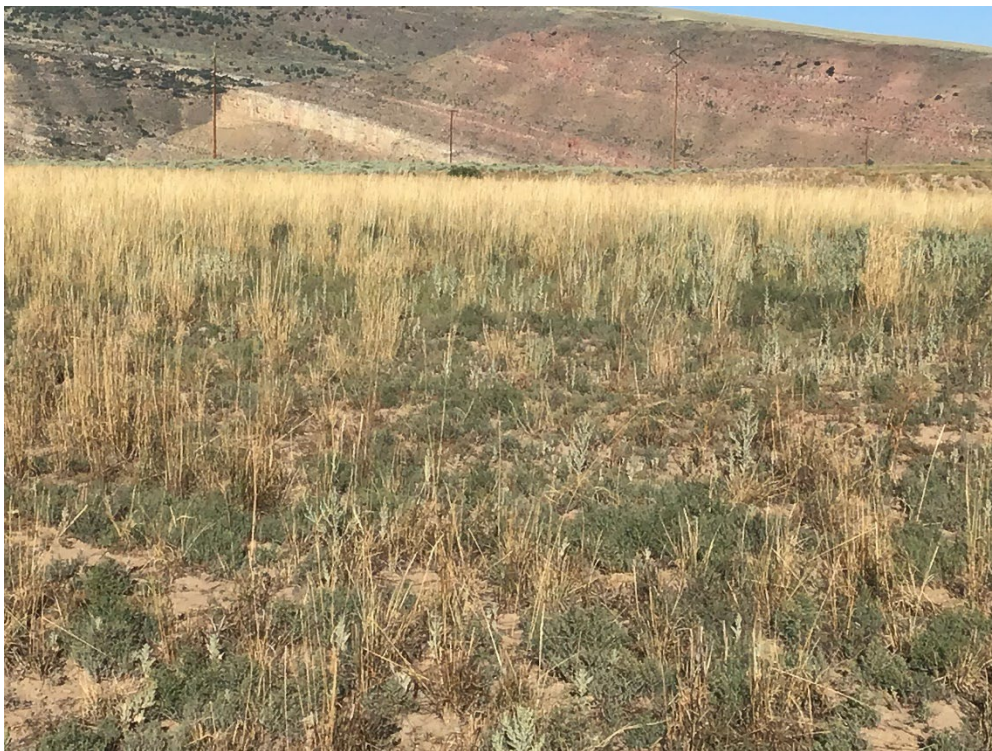
- With the exception of the slope to the 5A-P1 Pond, reclamation, (topsoil and seeding) has been completed as has hydroseeding at the 5A Portal.
- Cropland areas along the Williams Fork River were dry stubble having been harvested earlier in the season. Alfalfa stands was present in areas of the field.
- Refuse pile vegetation cover comprises areas with adequate native grasses and areas of weeds. Cover is patchy.

Photo 12: Overview of vegetation at the refuse pile.

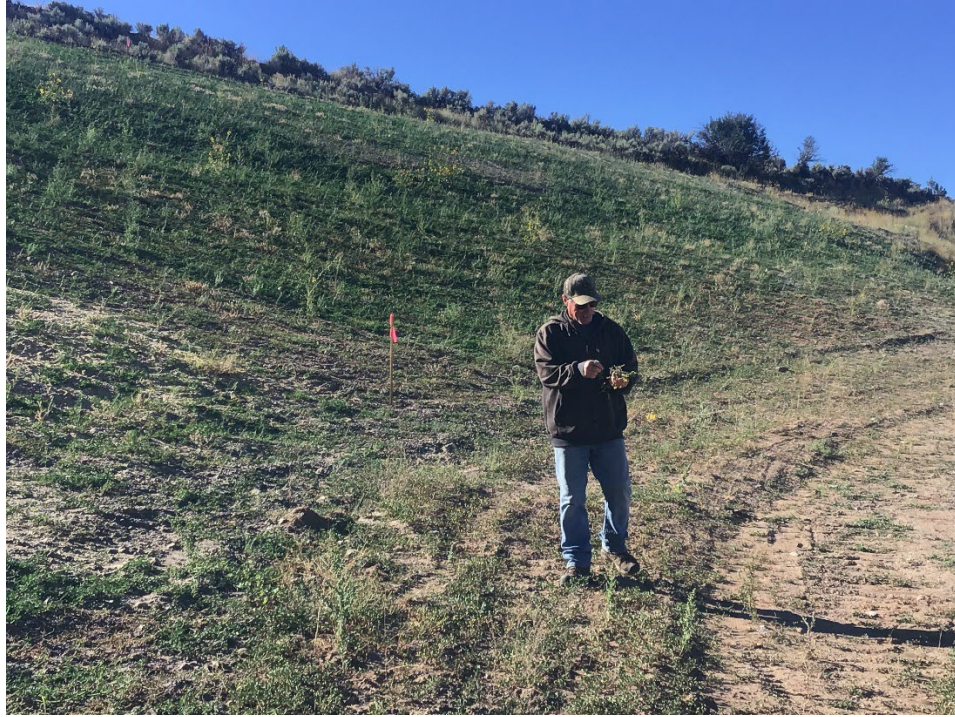
Reclamation is progressing as permitted. Facilities have been removed throughout the site and reclamation has been completed. Hydroseeding the portal slope was completed, and grasses, native shrubs and sweet clover had emerged.

Photo 13: Hydroseeded slopes at the 5A Portal, showing signs of emerging vegetation.
