Permit Number: C-1981-012 Mine Name: New Elk Mine Operator: New Elk Coal Company, LLC Operator Address: Mr. Nick Mason 12250 Highway 12 Weston, CO 81091	County: Las Animas Operation Type: Underground Permit Status: Active Ownership: Private
	Operator Representative Present: Nick Mason
Operator Representative Signature: (Field Issuance Only)

Inspection Start Date: August 23, 2023 Inspection Start Time: 14:00 Inspection End Date: August 24, 2023 Inspection End Time: 14:00	Inspection Type: Coal Complete Inspection Inspection Reason: Normal I&E Program Weather: Clear
Joint Inspection Agency: None	Joint Inspection Contacts:
Post Inspection Agency: None	Post Inspection Contacts:
Inspector(s): Brock Bowles Amber Michels	Inspector's Signature:

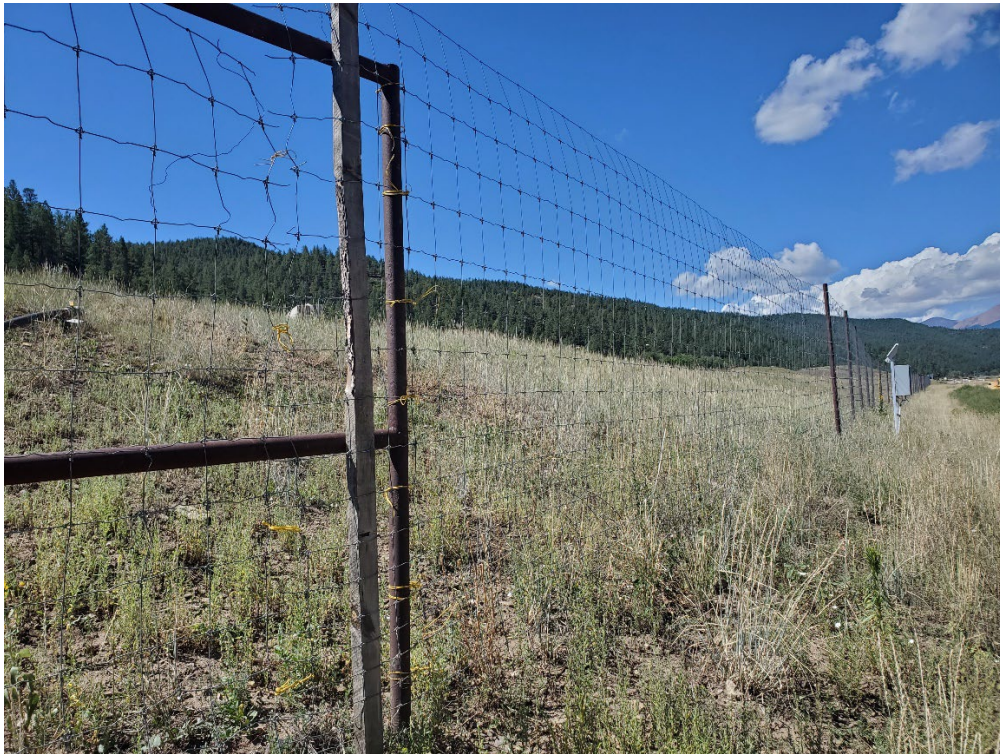
Pond 1 contained water and was not discharging. The primary spillway was free of obstructions. The pond liner appeared to be in good condition. The fence around the pond (photo 1) was in good condition and the gate was closed upon arrival. The vegetation on the embankment was good and the embankment appeared to be stable

Photo 1 – Fencing around Pond 1

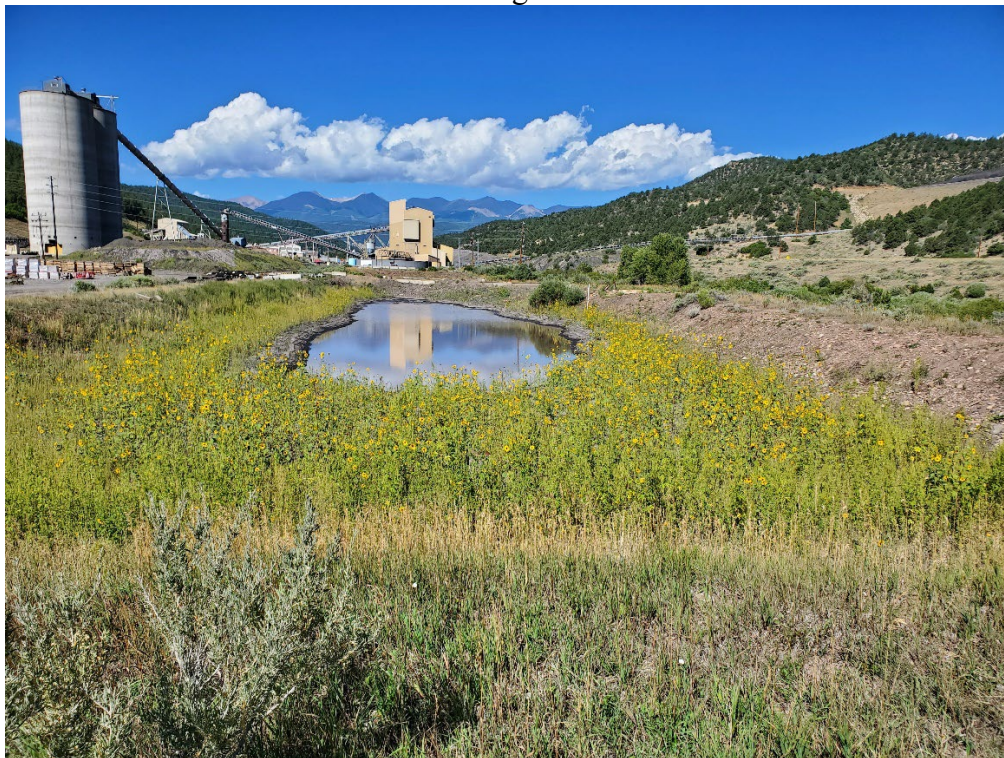
Pond 7 contained a small amount of water but was not discharging (photo 2). The bottom of the pond had a large

crop of sunflowers. At the present time this is not a problem as it has only has minimal effect on capacity and water flow. However, as these annual plants die, they will generate debris that will interfere with the primary drainage spillway. The emergency spillway was free of obstructions and the embankment appeared to be stable.

Photo 2 – Pond 7 facing west

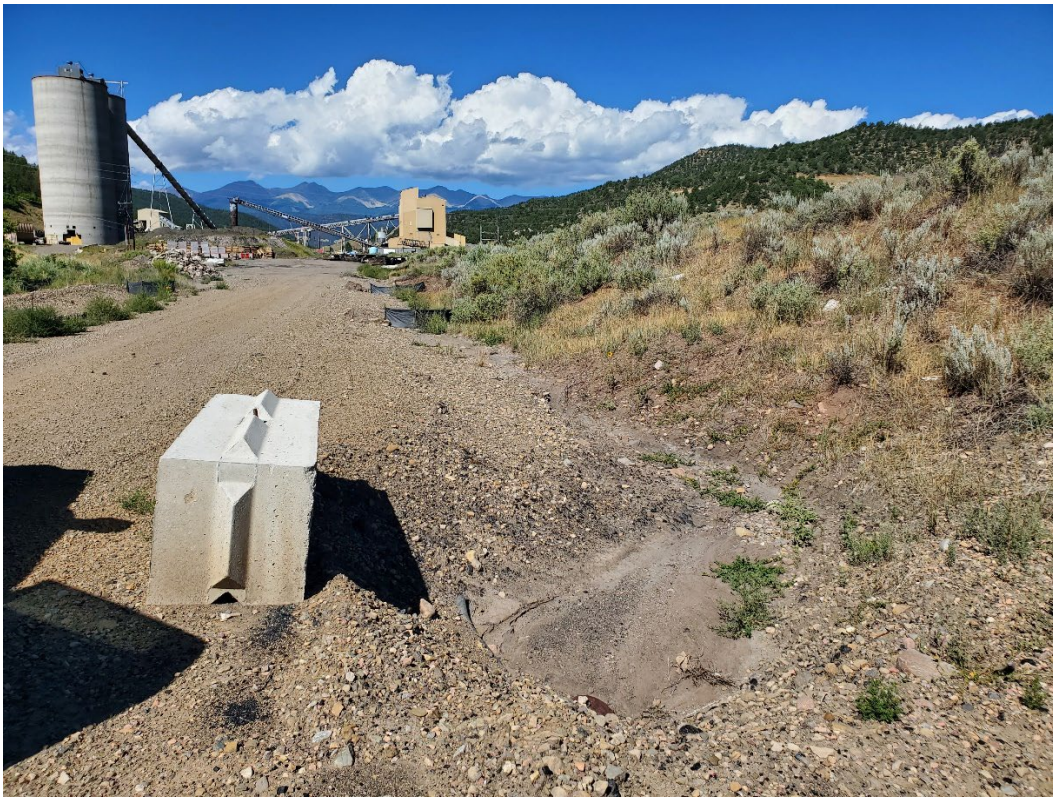
SAE 10 consists of a series of silt fence dams on either side of the haul road next to Pond 7 (photo 3). The sumps in front of the silt fences were clean. The outfall was also free of obstructions.

Photo 3 – SAE 10 along haul road

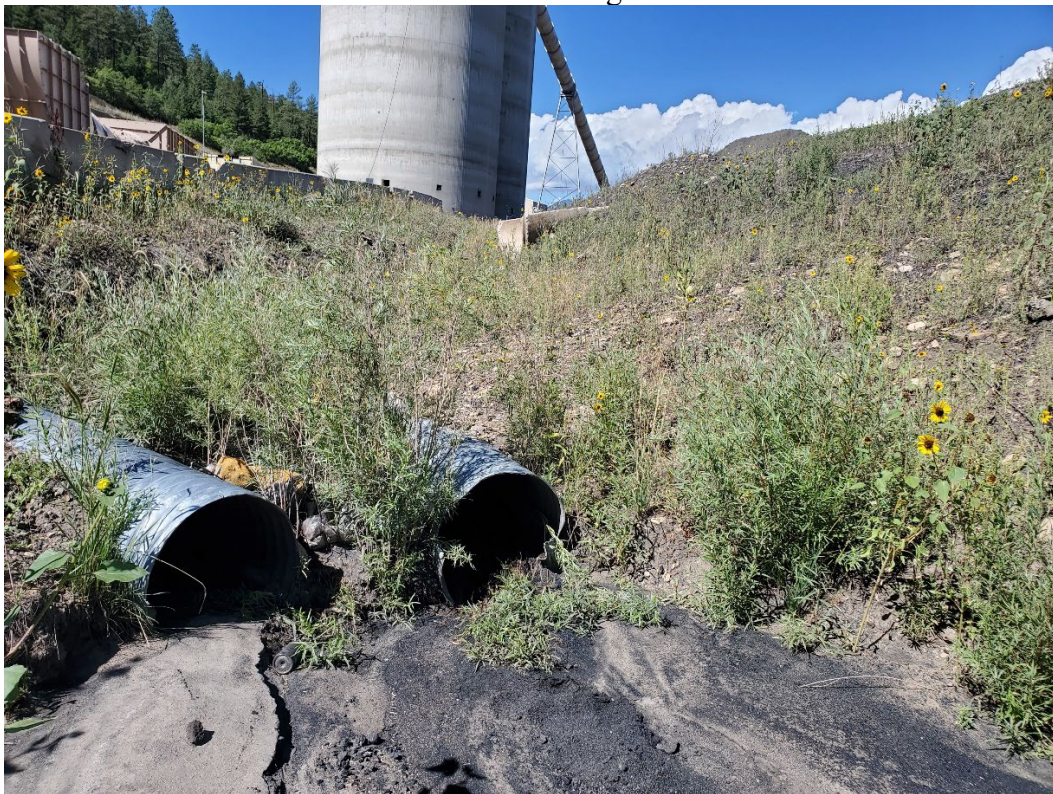
The outlet side of culverts C46 and C34 have sediment build up restricting the flow of water (photo 4). These culverts need to be cleaned.

Photo 4 – Outlets of Culverts C46 and C34

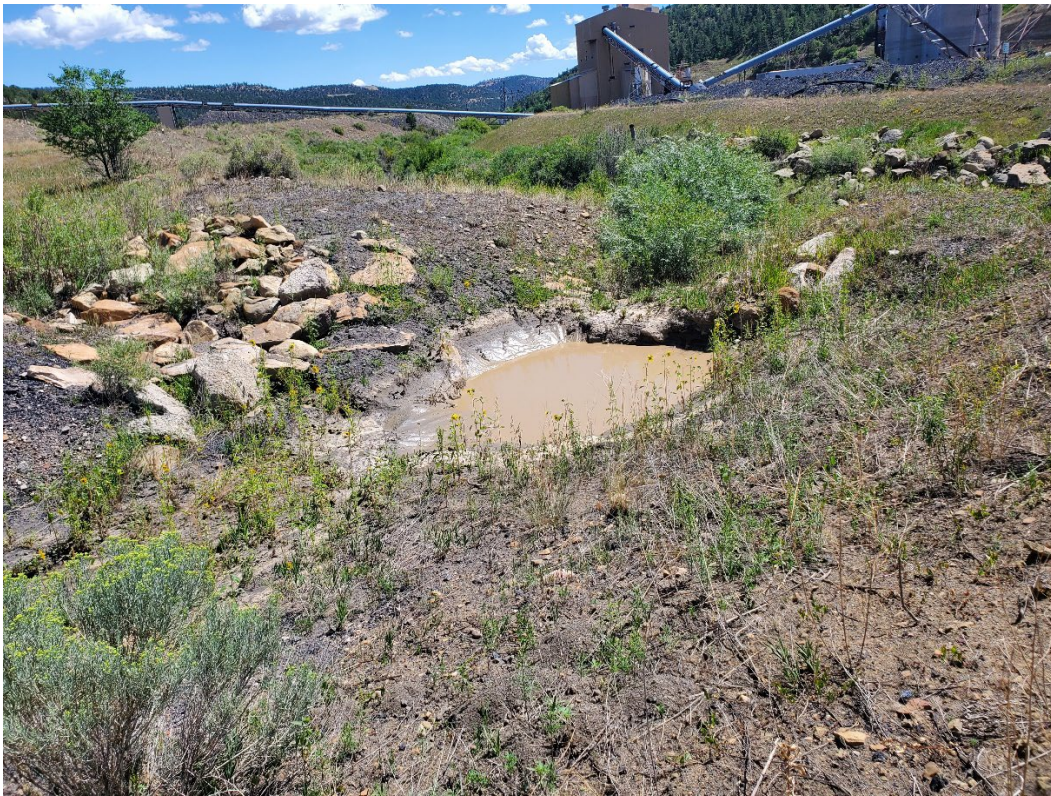
The sediment catch basin at Outfall 11 contained water but was not discharging. The basin had extra capacity and was in working order (photo 5).

Photo 5 – Outfall 11

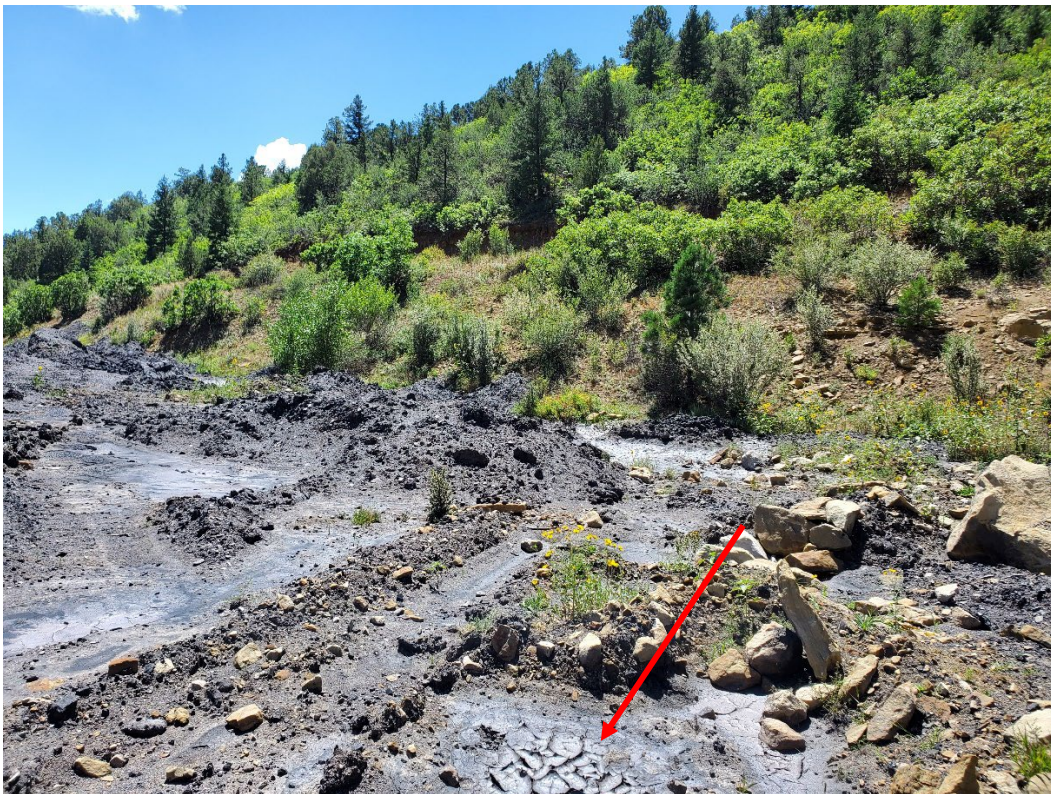
The ditch along the west perimeter of RDA needs to convey water past the underdrain. Some work has been done since the last inspection, but additional work is needed. Water has been ponding in this area as noted by dried up puddles (photo 6).

Photo 6 – Dried puddle on top of RDA shows water cannot drain properly.

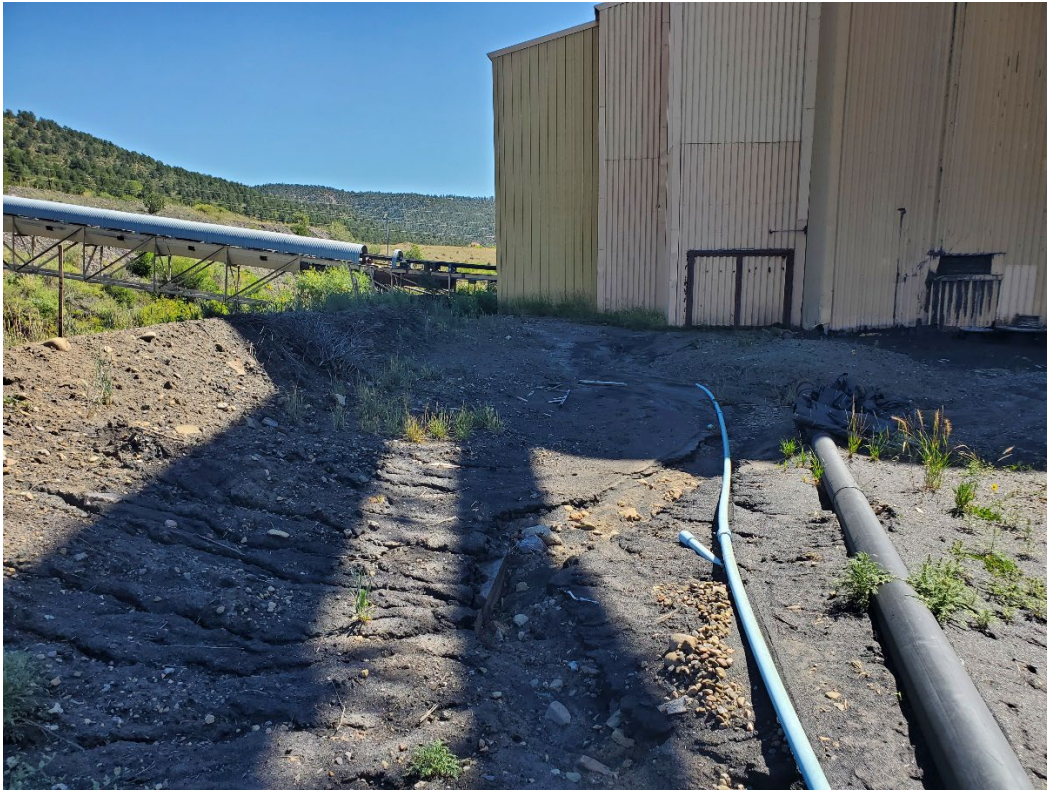
The vegetation on the hillside above the river behind the wash plant was looking good. The berm separating the creek from the disturbed area was in good condition (photo 7).

Photo 7 – Berm behind wash plant protecting the river
