MINERALS PROGRAM INSPECTION REPORT
PHONE: (303) 866-3567

MINE NAME: BLM East Gravel Pit	MINE/PROSPECTING ID#: M-1977-472	MINERAL: Sand and gravel	COUNTY: Jackson
INSPECTION TYPE: Monitoring	WEATHER: Clear	INSP. DATE: August 22, 2023	INSP. TIME: 13:00
OPERATOR: Jackson County	OPERATOR REPRESENTATIVE: Tootie Crowner	TYPE OF OPERATION: 112c - Construction Regular Operation	
REASON FOR INSPECTION: Normal I&E Program	BOND CALCULATION TYPE: None	BOND AMOUNT: \$0.00	
DATE OF COMPLAINT: NA	POST INSP. CONTACTS: Stephen Leonard	JOINT INSP. AGENCY: U.S. BLM	
INSPECTOR(S): Hunter Ridley	INSPECTOR'S SIGNATURE:

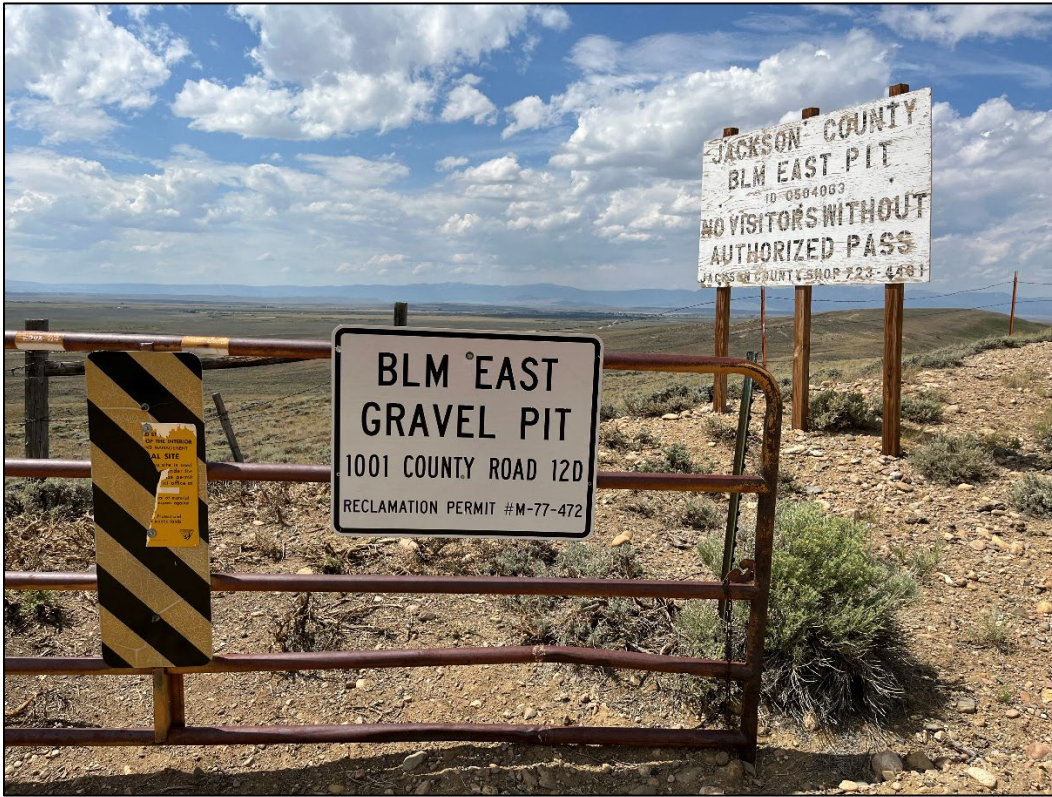
An entrance sign was posted and permit boundary markers were observed as required by Rule 3.1.12 (Photos 1 and 2).

Photo : A mine identification sign is located at the pit entrance.

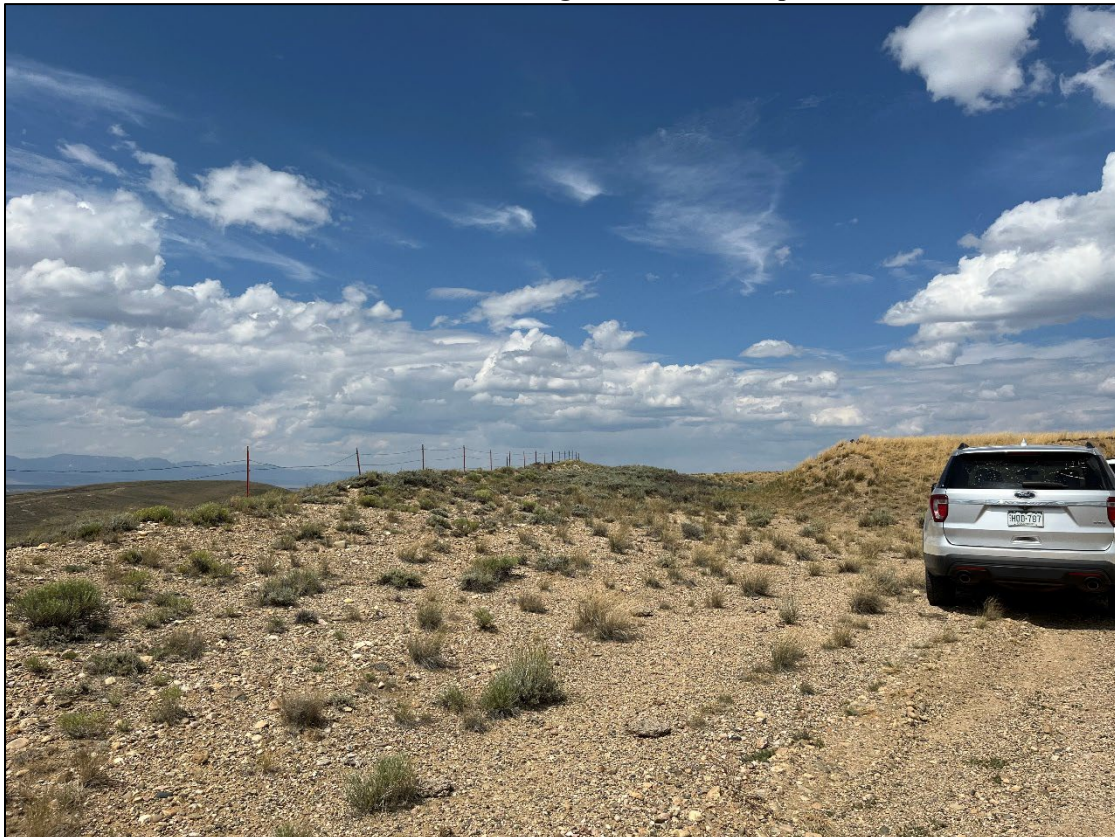
Photo 1: Permit boundaries are marked with a fence.

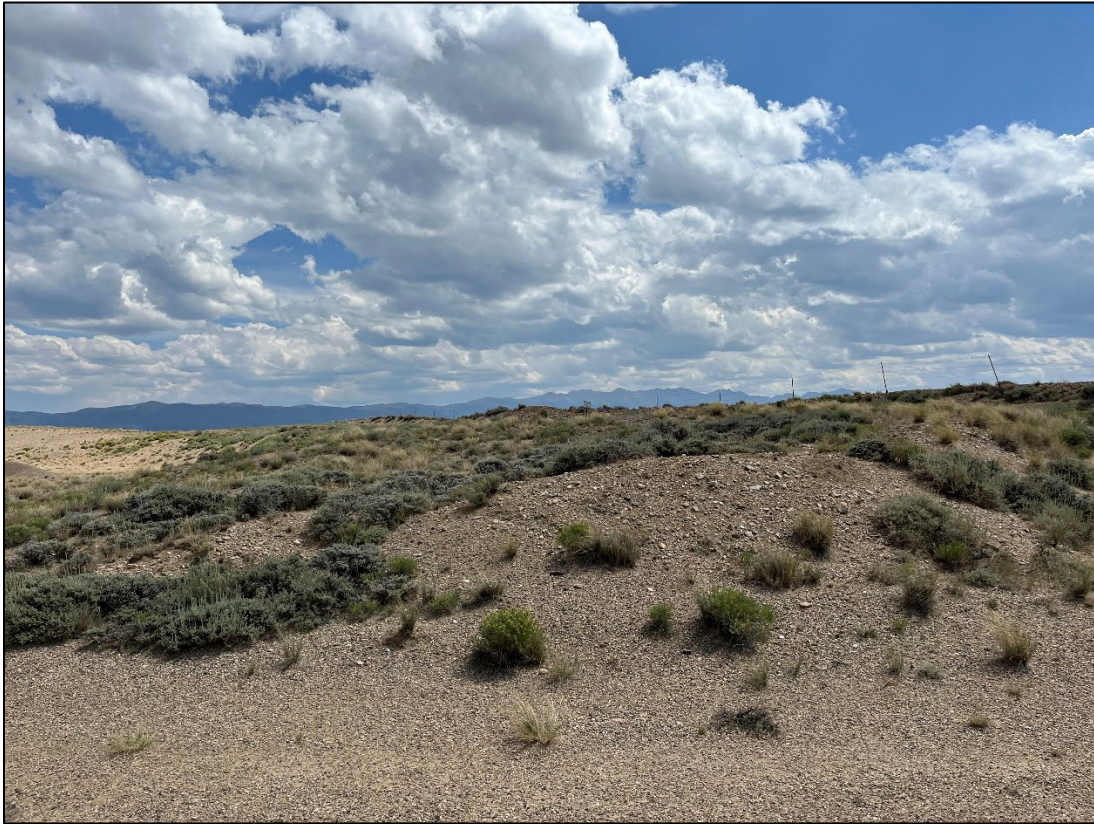
Topsoil has been stripped and stored onsite on the southeast and southwest boundaries of the pit (Photos 3 and 4). A large overburden pile is located on the northwest side of the pit (Photo 5). Topsoil and overburden piles have been stabilized with volunteer vegetation and include identifying signage. Approximately, 4,700 cubic yards of topsoil has been imported for use in final reclamation. Weeds had already been sprayed this season and no noxious weeds were identified during the inspection.

Photo 2: View east of a topsoil stockpile.

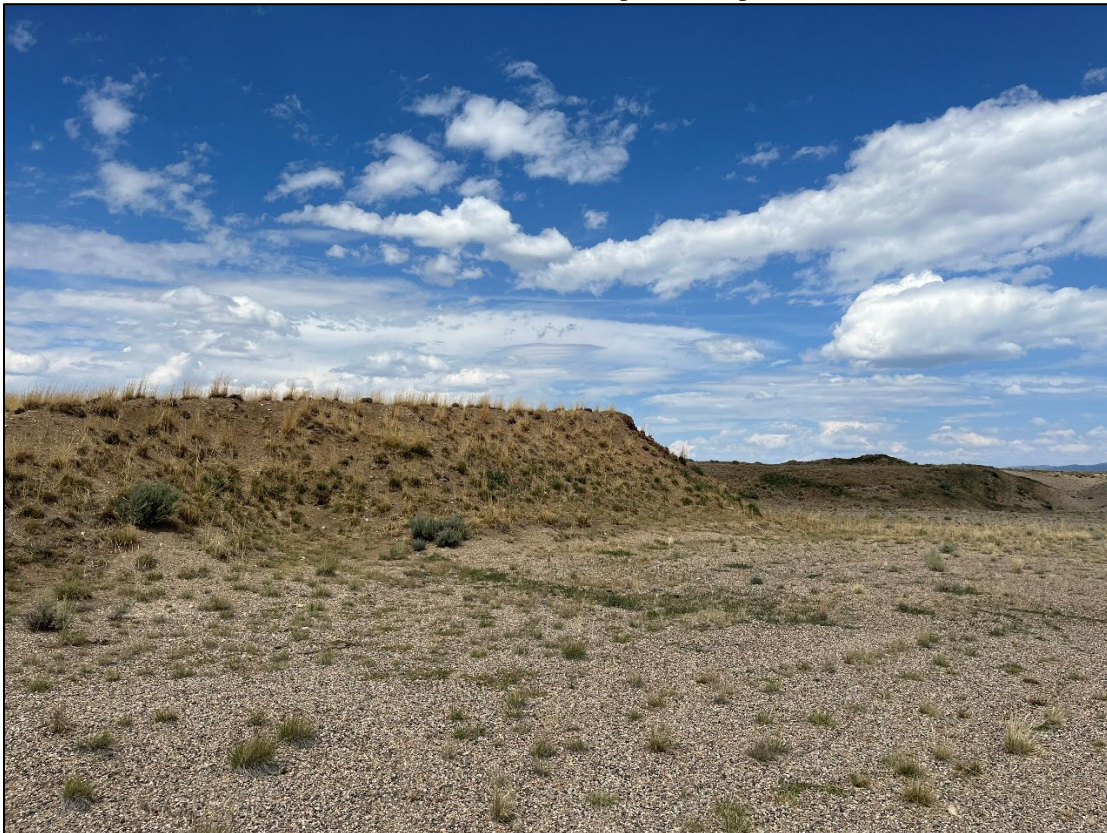
Photo 3: View west of a topsoil stockpile.

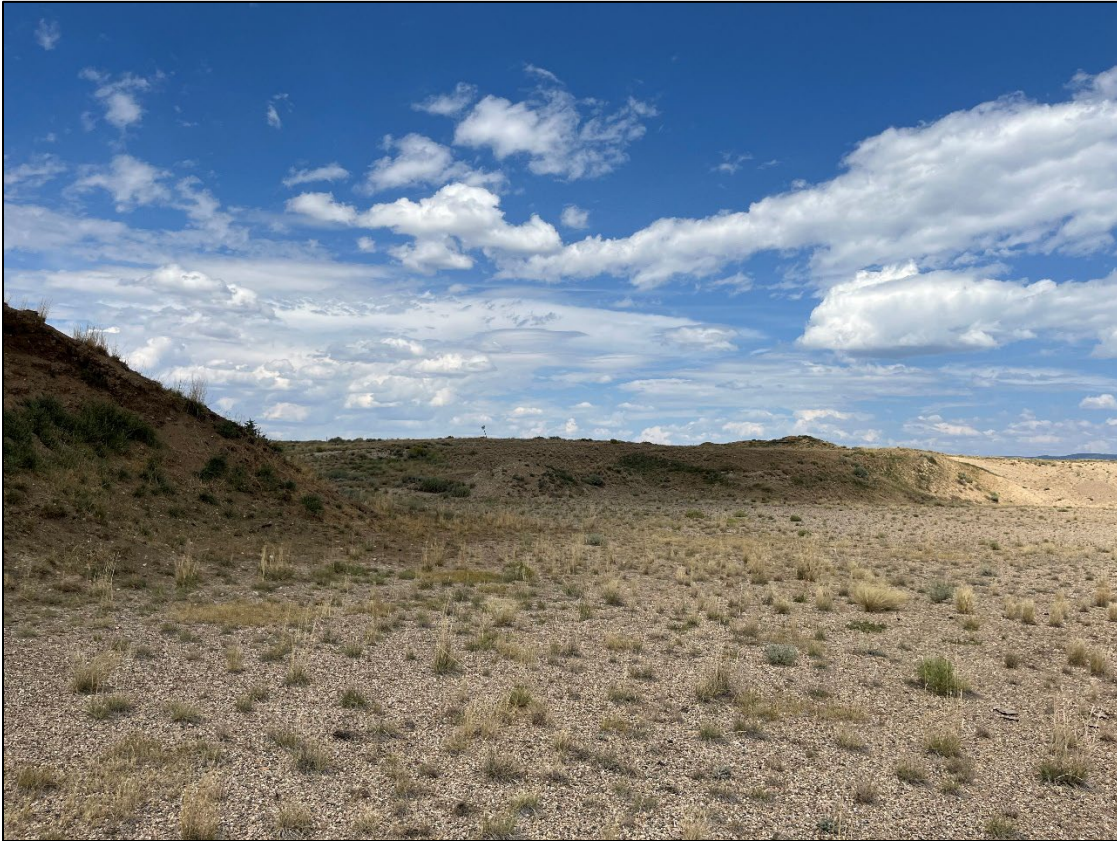
Photo 4: View to the north of an existing overburden pile.

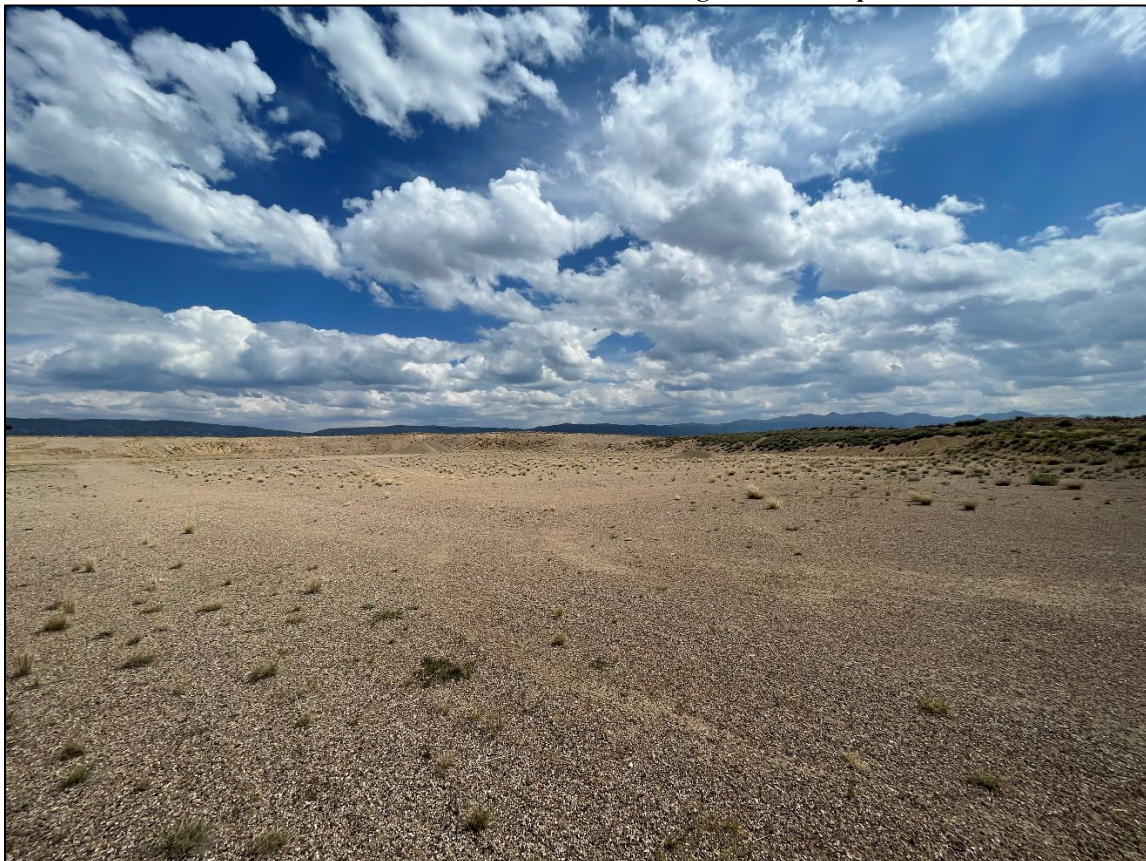
Mined highwalls are located along the northern and eastern disturbance boundaries and exist at varying slopes (Photos 6, 7, 10, and 11). Overall, mined slopes are at an average of a 3H:1V slope. Mr. Jones stated that although active mining of material had not occurred in many years, the pit still holds a large amount of material reserves.

Photo 5: View northeast of open pit floor, eastern highwall, and small stockpiles of material.

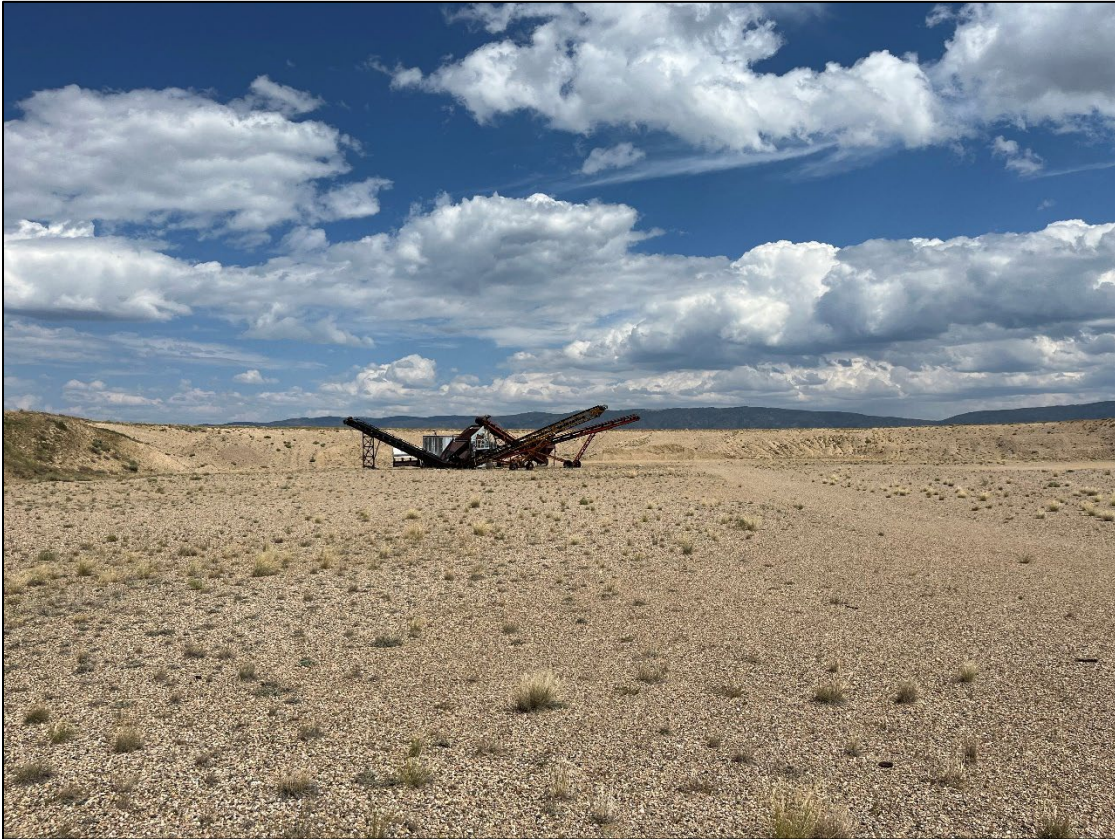
The BLM East Gravel pit is approved for a maximum disturbance area of 30 acres at a time and a maximum excavation depth of 20 feet. Current disturbance is approximately 13 acres. Unmined areas are located to the northwest and east (Photo 12). The site was not active at the time of inspection and has not been actively mining new material for many years. However, hauling of material stockpiled on the pit floor occurs several times per year. Processing equipment and fuel is stored on site, but the processing plant has not been active in approximately 6 years (Photos 7 and 9).

Photo 6: View north of pit floor, unused processing equipment, and highwall.

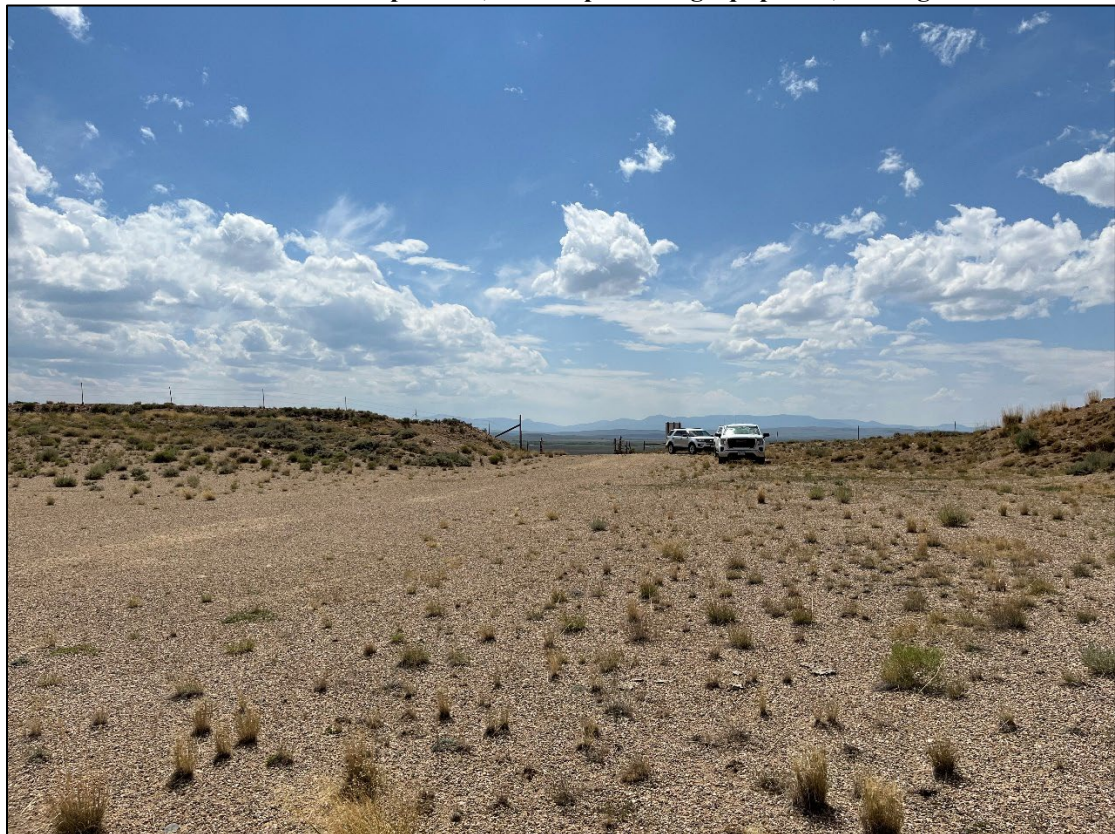
Photo 7: View south of pit entrance.

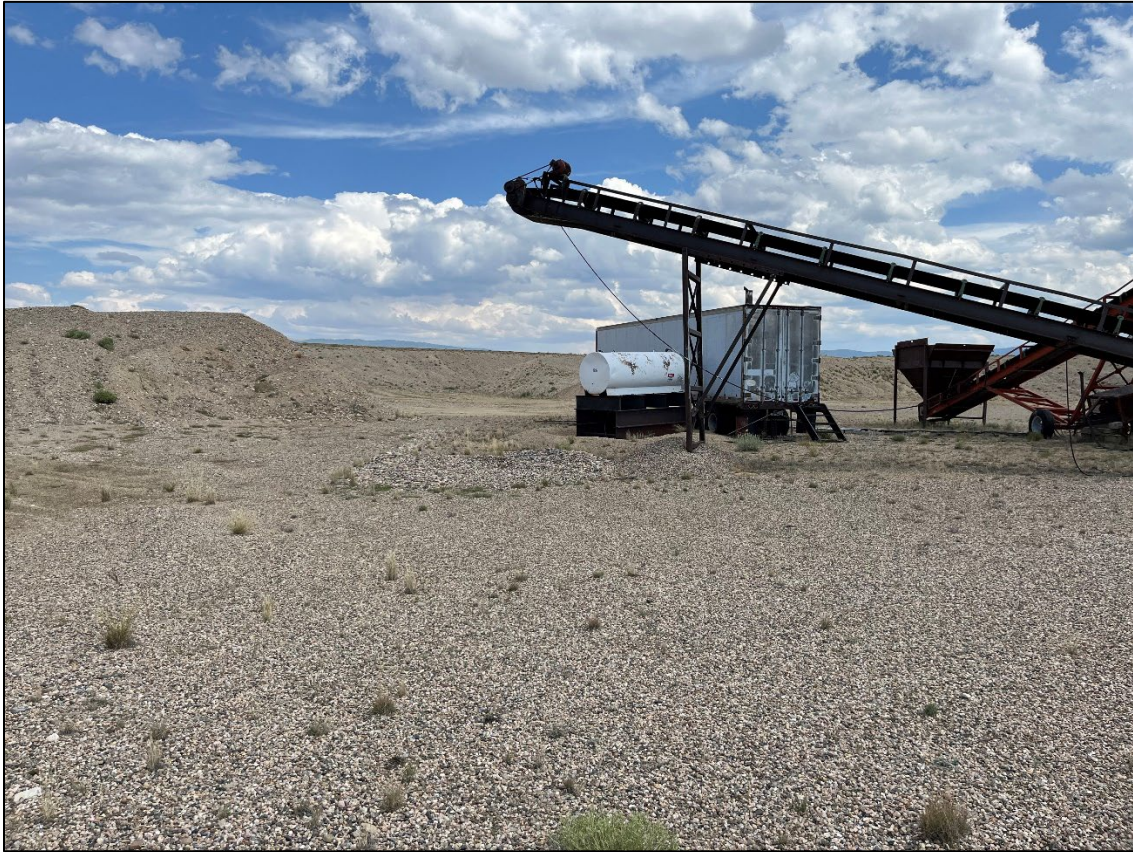
Photo 8: Fuel is stored in secondary containment on site.

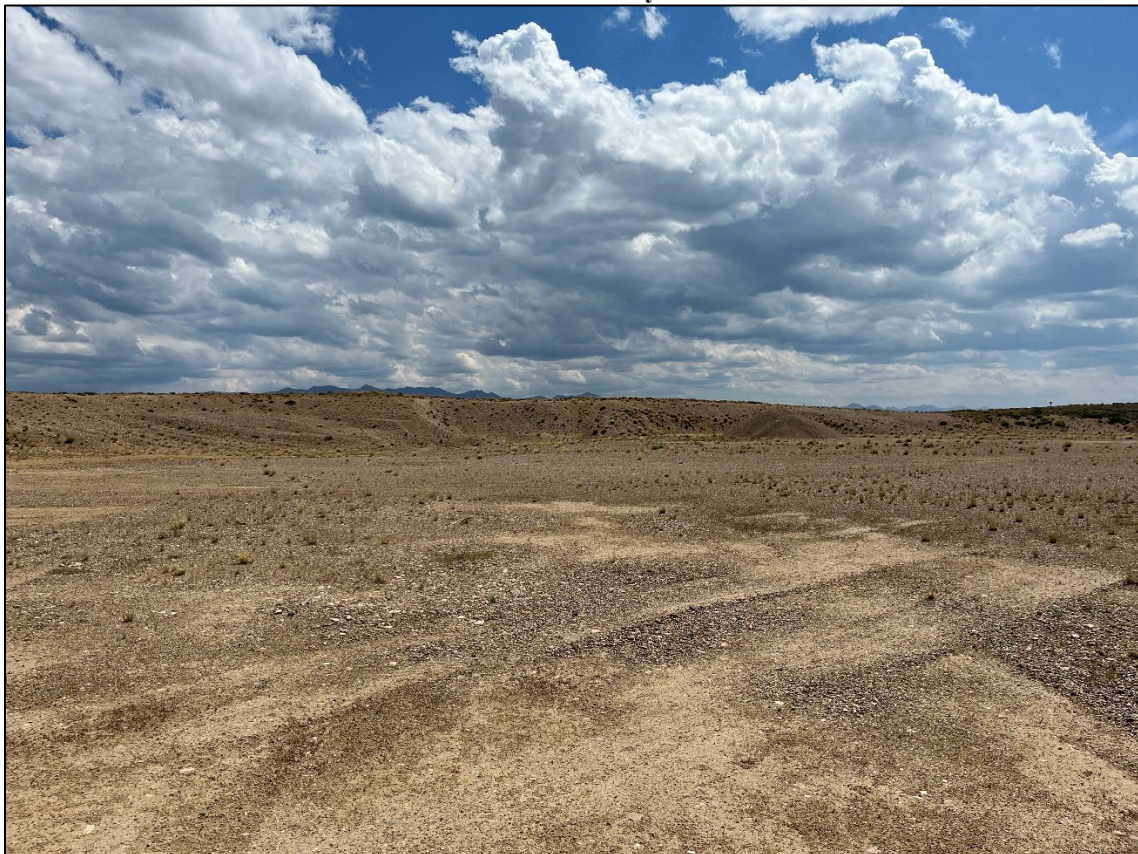
Photo 9: View east of mined slopes and stockpiled material.

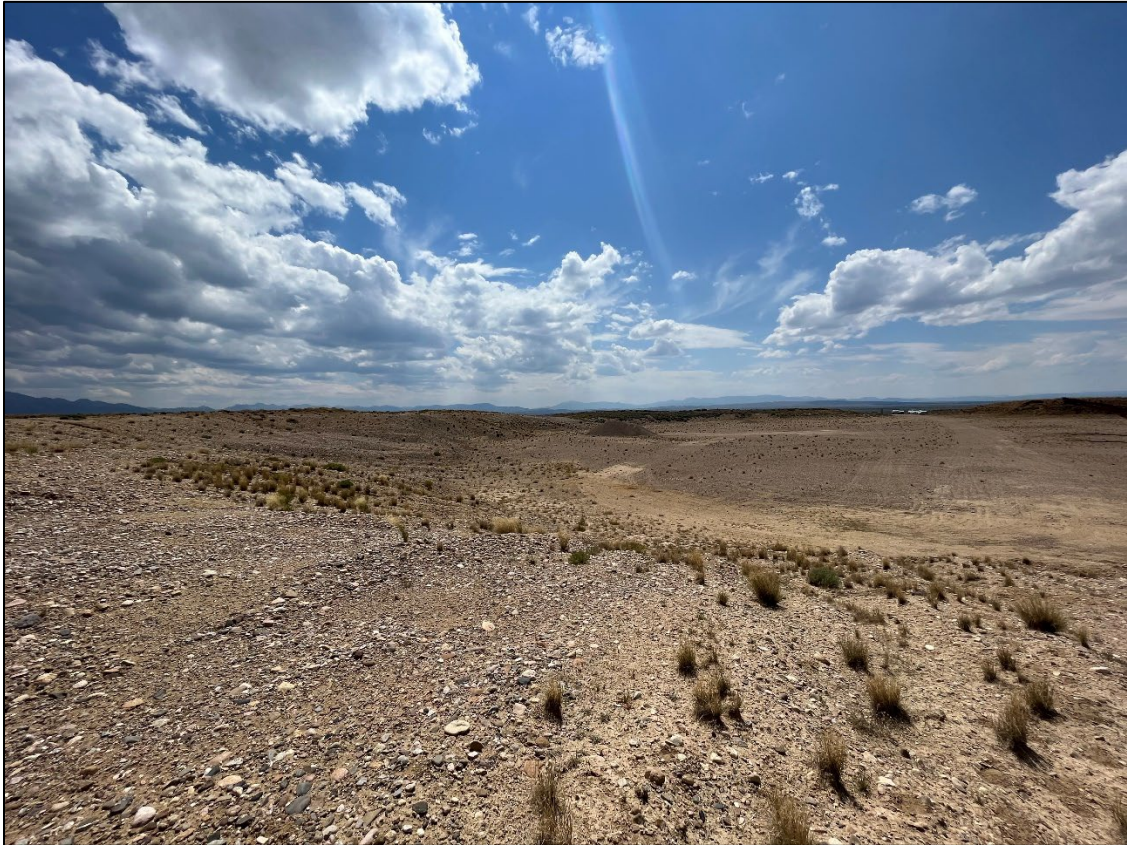
Photo 10: View from atop the northern most mined slope looking south towards the pit floor.

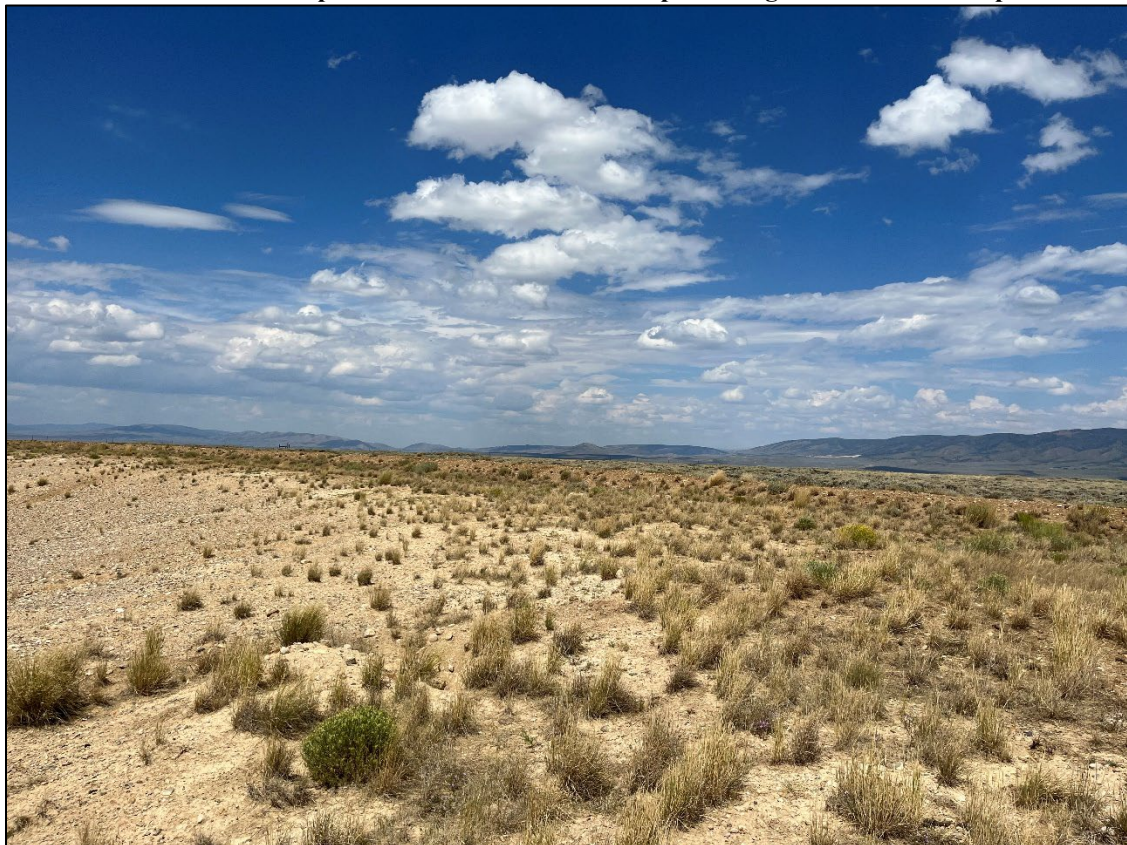
Photo 11: View north of additional land included in the permit boundary which is not yet stripped or mined.

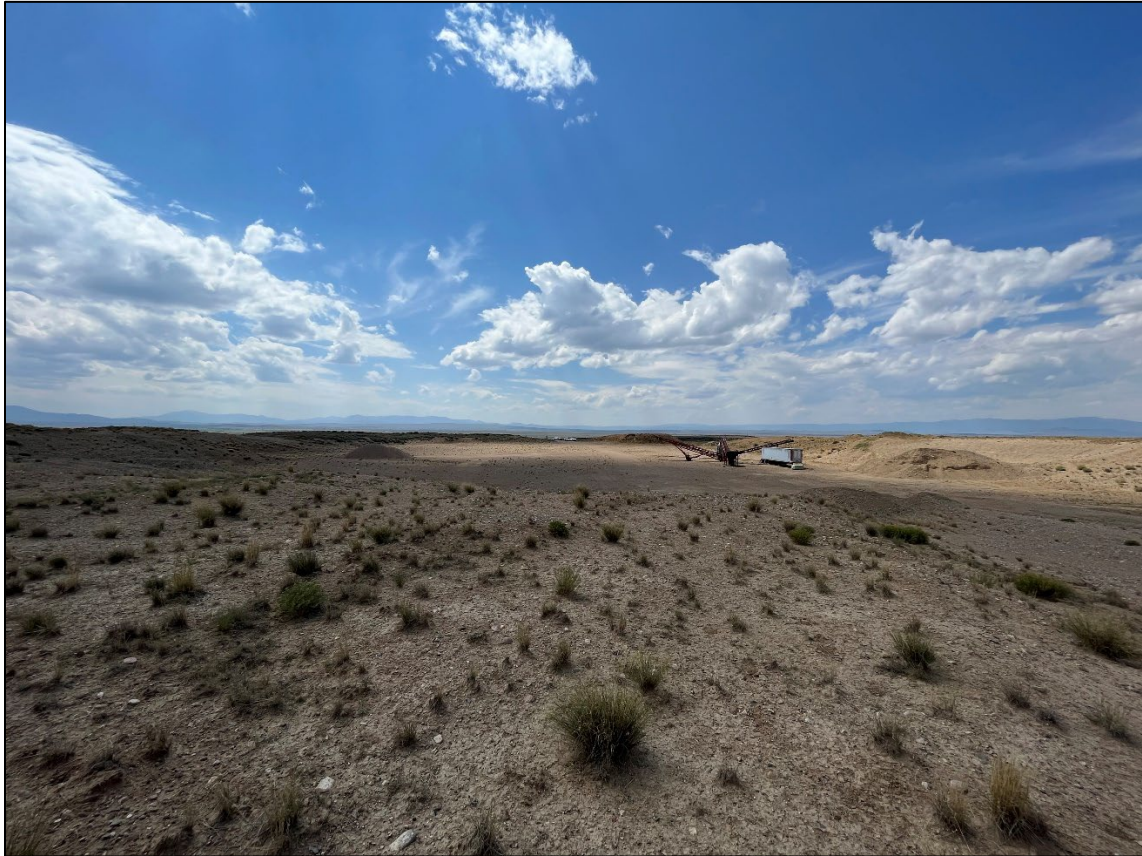
Photo 12: View southwest of the pit floor from atop the northern most mined slope.
