MINERALS PROGRAM INSPECTION REPORT

MINE NAME: San Luis Project	MINE/PROSPECTING ID#: M-1988-112	MINERAL: Gold and silver	COUNTY: Costilla
INSPECTION TYPE: Multi Person Inspection	WEATHER: Clear	INSP. DATE: August 24, 2023	INSP. TIME: 08:55
OPERATOR: Battle Mountain Resources, Inc.	OPERATOR REPRESENTATIVE: Julio Madrid, Steve Carino	TYPE OF OPERATION: 112d-3 - Designated Mining Operation	
REASON FOR INSPECTION: Normal I&E Program	BOND CALCULATION TYPE: None	BOND AMOUNT: \$7,400,000.00	
DATE OF COMPLAINT: NA	POST INSP. CONTACTS: None	JOINT INSP. AGENCY: None	
INSPECTOR(S): Lucas West G. Russell Means	INSPECTOR'S SIGNATURE:

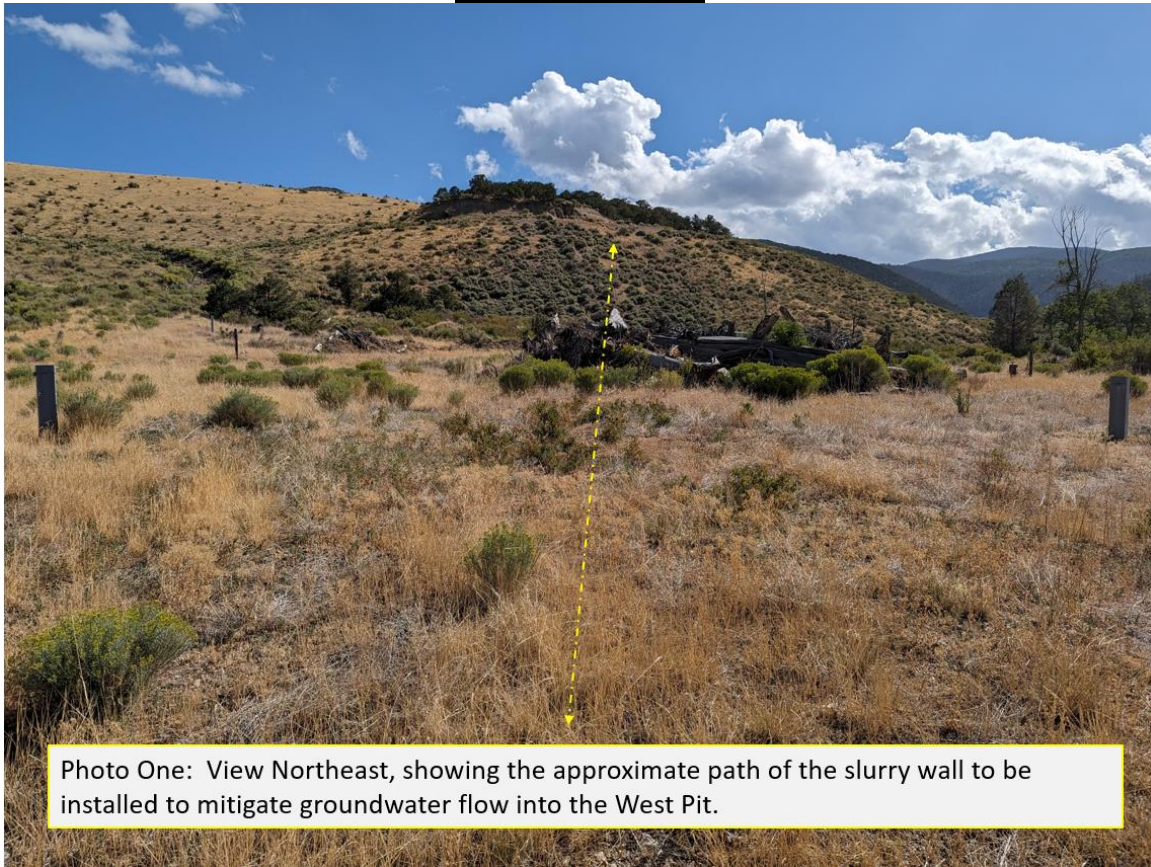
The main purpose of this inspection was to conduct a complete inspection of the site as well as observe the proposed location of a groundwater curtain that is being investigated by the Operator. No revision has yet been submitted, however initial discussions have been conducted regarding the installation of a "Slurry Wall" groundwater curtain. The purpose of this Slurry Wall, will be to cut off the groundwater entering the backfilled West Pit, whereby reducing the volume of water to be treated and subsequently discharged. Discussions are in the infantile stages, with a revision proposed to be submitted sometime in 2024. The proposed path of the Slurry Wall can be seen in Photos One and Two. The path is currently undisturbed with the exception of drill holes that have been drilled to explore the depth to bedrock, and two minor test pits. The test pits have been backfilled and no evidence of settling was noted. The drill holes are cased and left in place. Initial discussions suggest the Slurry Wall will span approximately 1500 linear feet, and reach a maximum depth of approximately 65 feet.

Photo One: View Northeast, showing the approximate path of the slurry wall to be installed to mitigate groundwater flow into the West Pit.

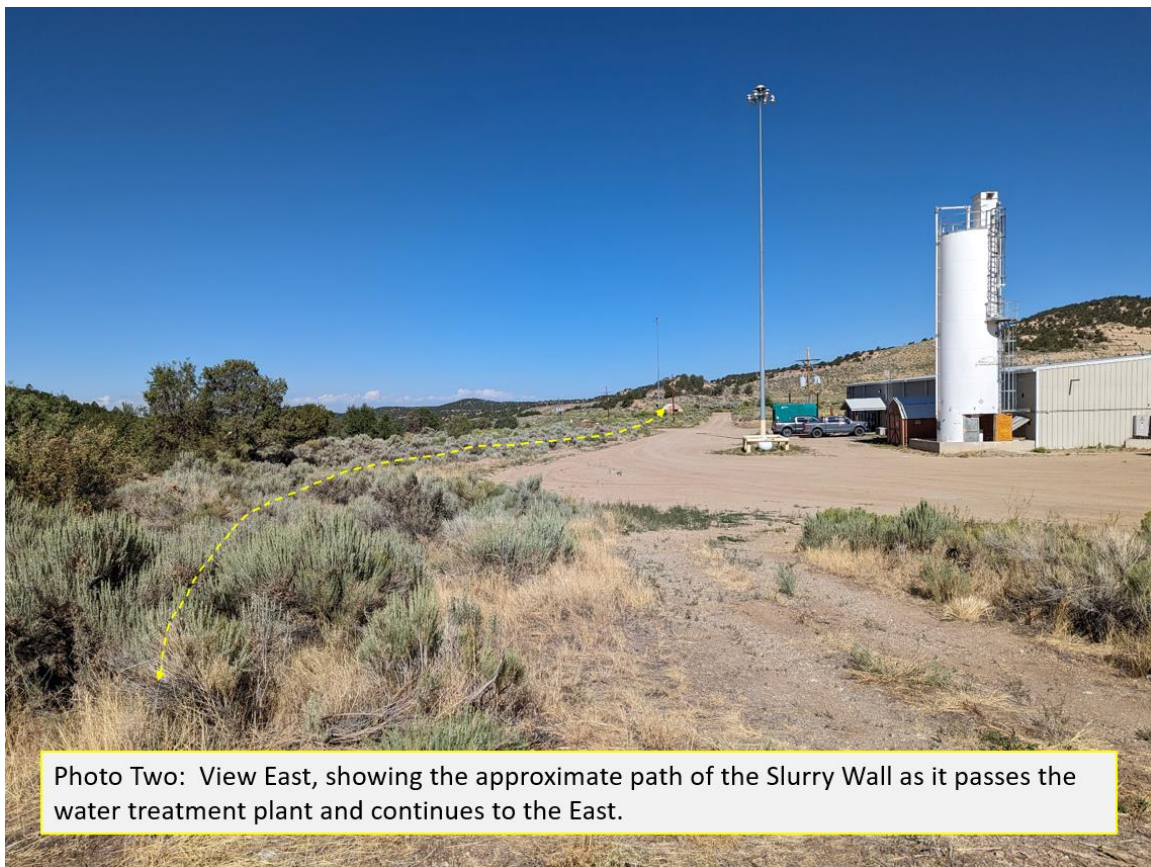
Photo Two: View East, showing the approximate path of the Slurry Wall as it passes the water treatment plant and continues to the East.

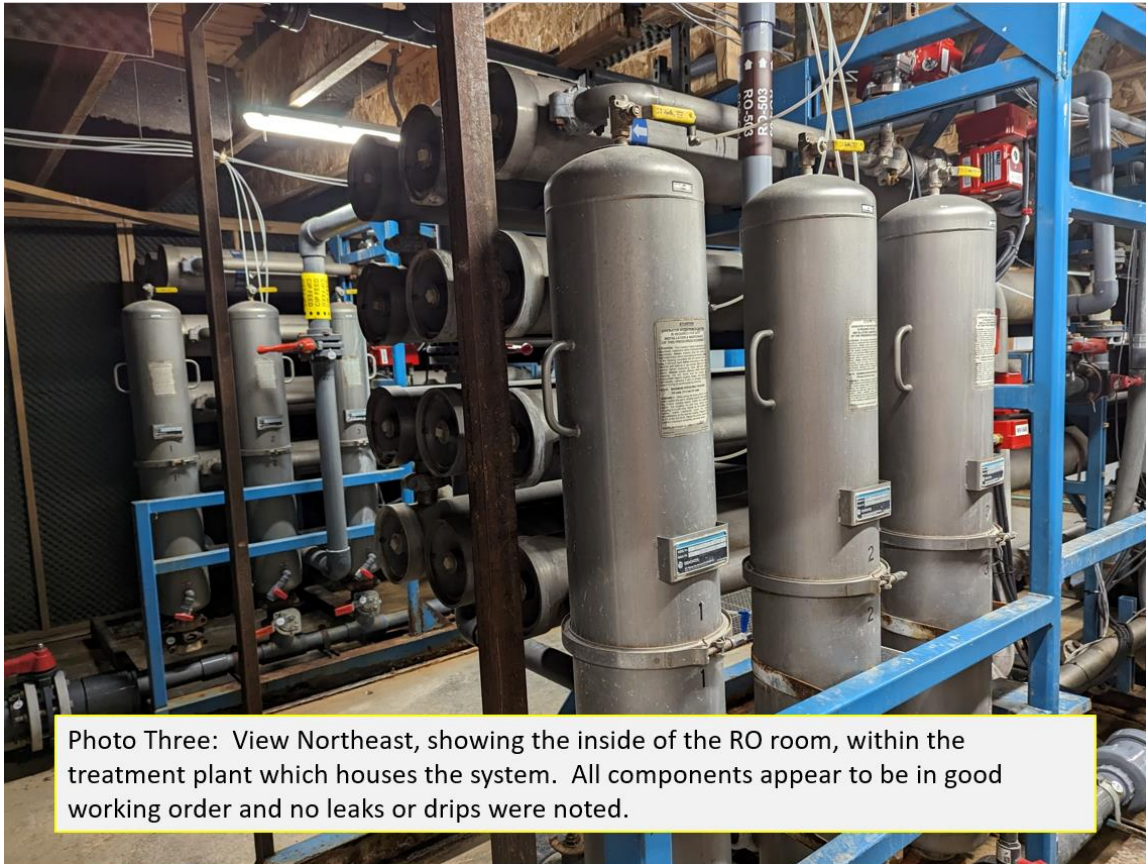
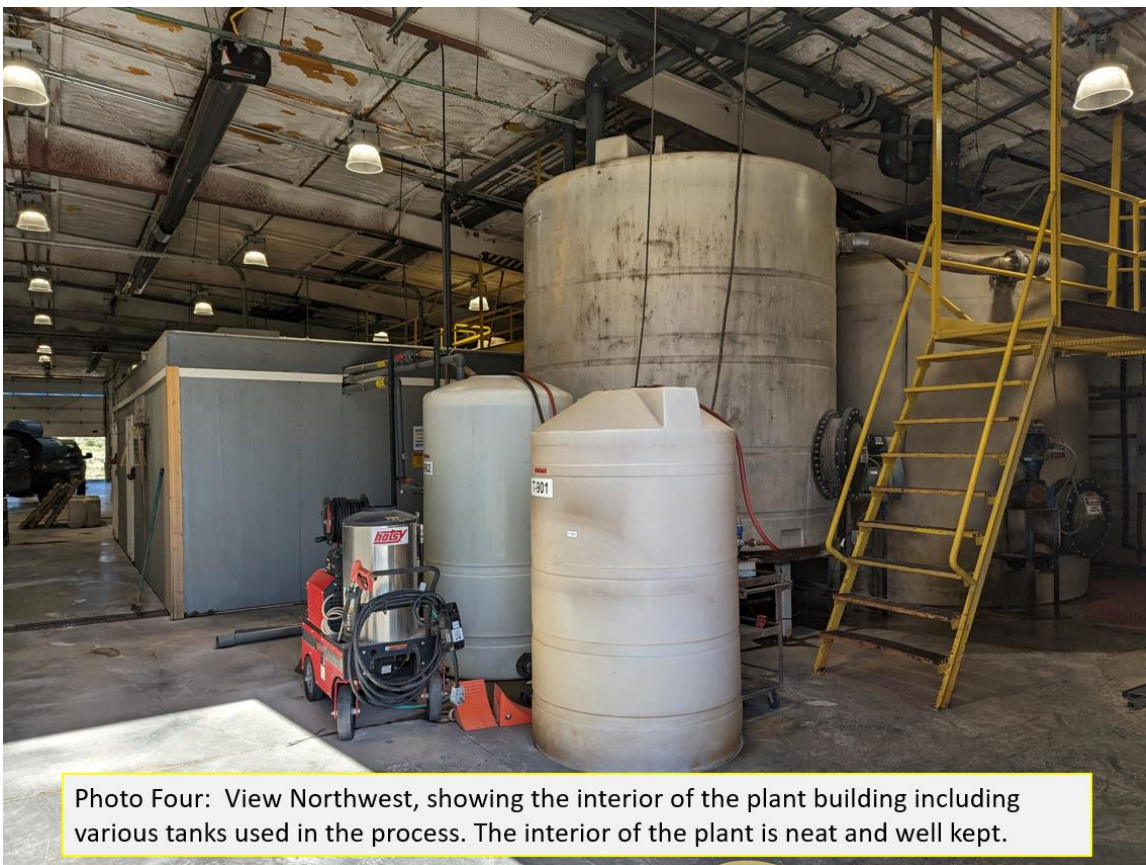
The site was not active but the water treatment facility was operating during this inspection. The water treatment facilities utilizes a series of holding ponds, tanks, media filters and a reverse osmosis (RO) system to treat ground water prior to discharge. The interior of the plant can be seen in Photos Three and Four. At the time of the inspection the RO system was treating and discharging water at approximately 500gpm at their discharge point. Within the treatment plant, several plumbing and infrastructure upgrades have been conducted, all appearing to be in good working order. A shipment of HCL was recently received and still on the truck parked within the secondary containment of the plant. One of the upgrades performed was a new HCL tank that feeds the plant, located on the east side of the building. Due to the tank replacement, temporary HCL dosing was done from inside the plant, however construction has been completed and the tank will be utilized again. The tank, seen in Photo Five, is set within a secondary containment structure that is in good condition.

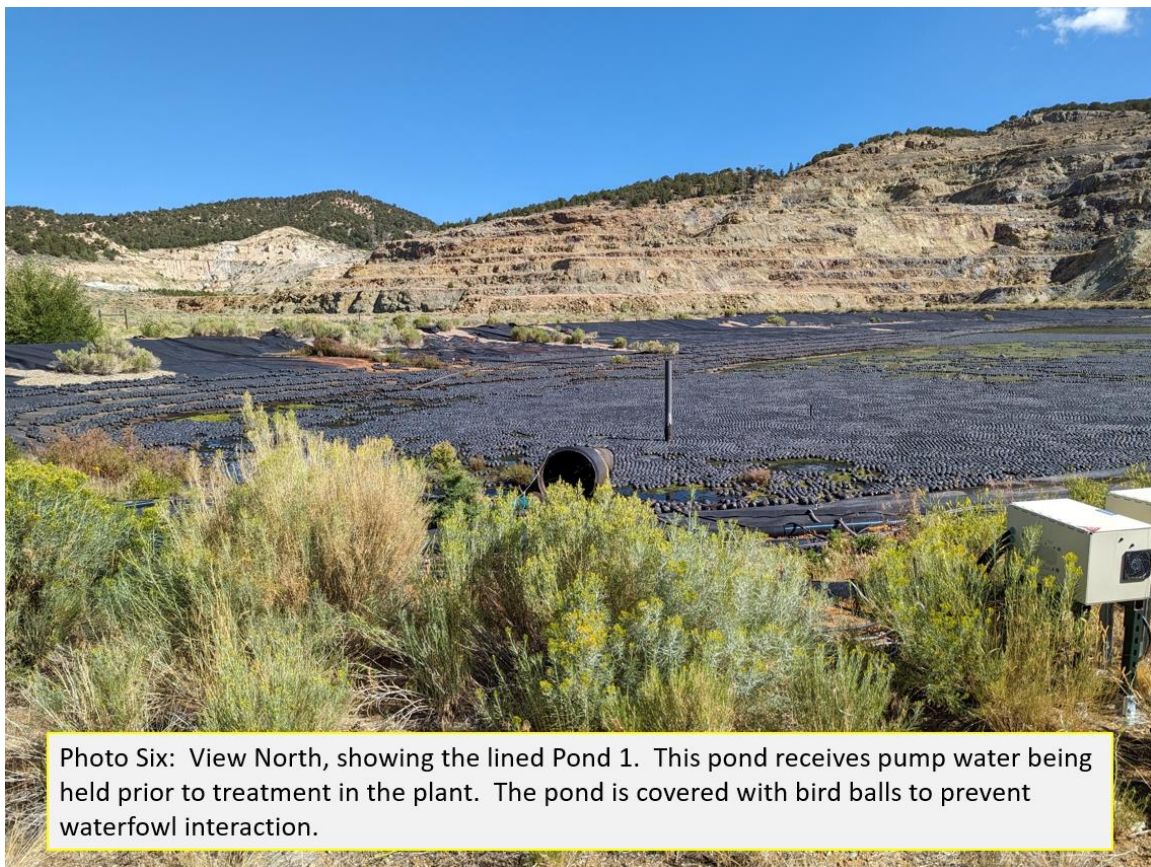
The holding ponds are all fenced in facilities. Pond 1 consists of raw water pumped from a series of wells and feeds the treatment system. The pond is lined with an HDPE liner, which is in good condition. Pond 1 can be seen in Photo Six. Ponds 2, 3 and 4 are used to store water at various stages of the treatment procedure. Ponds 2 and 3 have been recently upgraded from the old HDPE liner to Concrete. At the time of the inspection both ponds contained water, Pond 3 having significantly more than pond 2. Both ponds are in excellent condition and functioning as designed. The construction has been completed and the as-built package has been received by the Division. Photos Seven and Eight show the two ponds respectively. Pond 4 is another HDPE lined pond holding water. The liner showed no signs of impairment and significant algae growth was present. Photo Nine shows Pond 4. The areas around the water treatment facility include access

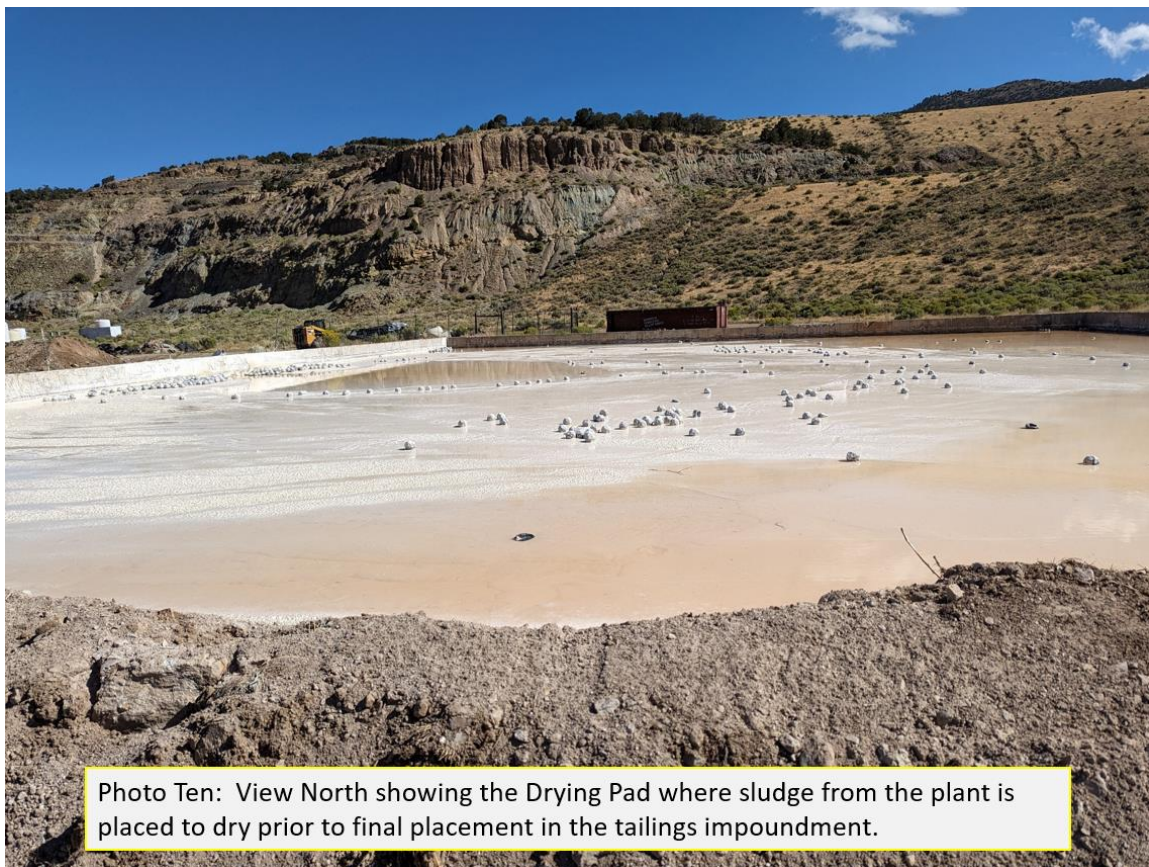
roads, equipment storage areas and parking areas are all in good condition. Adjacent to the plant area, the Drying Pad is located which houses the sludge produced from the RO treatment system. The pad allows the excess water to evaporate before the sludge is loaded and trucked to the disposal cell within the Tailings Storage Facility. The Drying Pad is in good condition and can be seen in Photo Ten.

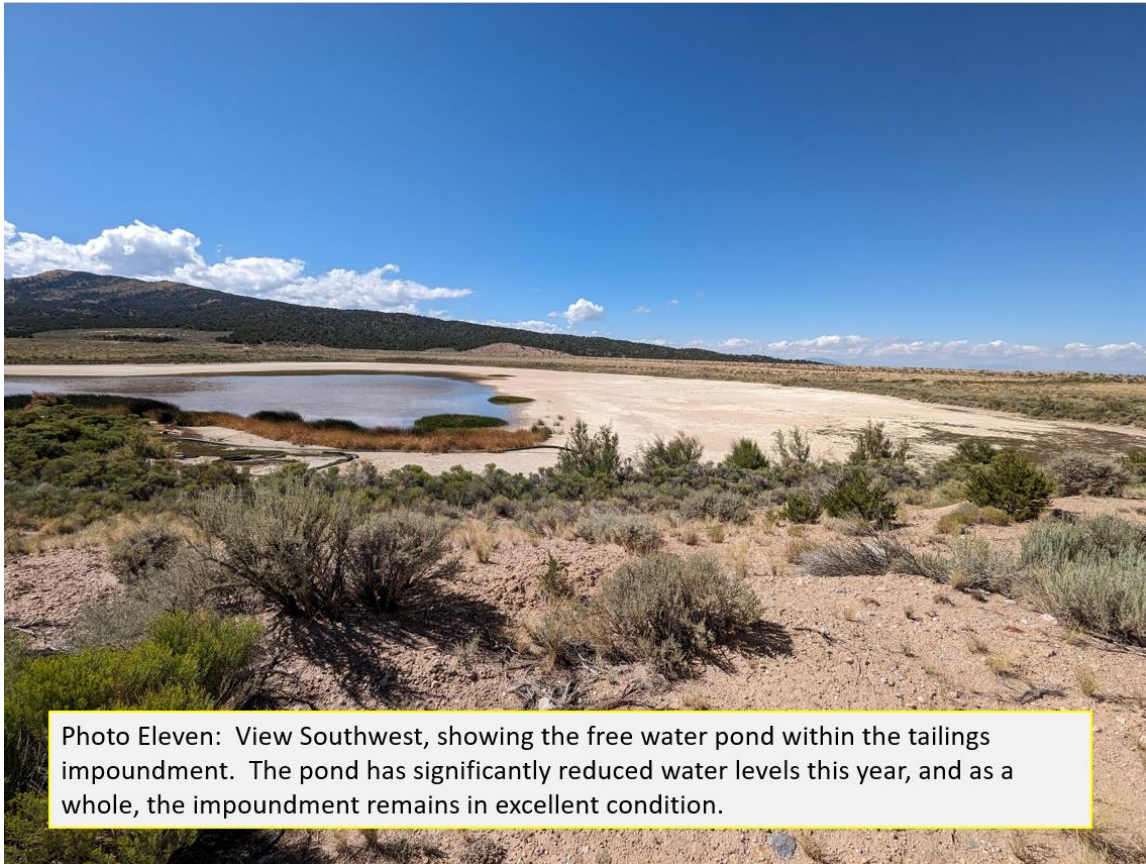
The tailings impoundment area appeared to be stable and in good condition. The free water pond located on top of the impoundment was observed, and the water levels are far below the maximum waterline that is outlined in the permit conditions. Photo Eleven shows the free water pond and surrounding vegetation. The other areas of the tailings impoundment are very well vegetated and appear to meet or exceed the conditions of the adjacent undisturbed areas. The maximum water line is designed to protect the main embankment from saturation which could lead to stability issues. The main embankment is well vegetated, appears to be stable and in good condition as seen in Photo Twelve. The tailings impoundment is a lined facility, complete with under drains and an HDPE Liner that extends from under the impoundment and the main embankment to the collection pond immediately down gradient. The underdrains, shown in Photo Six, convey water that has percolated through the tailings impoundment down to the collection pond, where it is then recirculated back to the free water pool. The under drain was observed discharging water into the collection pond, which indicates the liner, and all of its components are functioning as designed. The underdrain as well as collection pond can be seen in Photos Thirteen and Fourteen. Another upcoming change was discussed during the inspection that focused on the water management within the impoundment. Currently, some water is pumped from the plant up to the free water pond, however the Operator would like to install gated irrigation pipe along the West and Southwest ends of the impoundment, within the lined area, to allow water to be consumed by evapotranspiration. This change would be a benefit to the current water management plan, and should be addressed through the Division's Technical Revision Process.

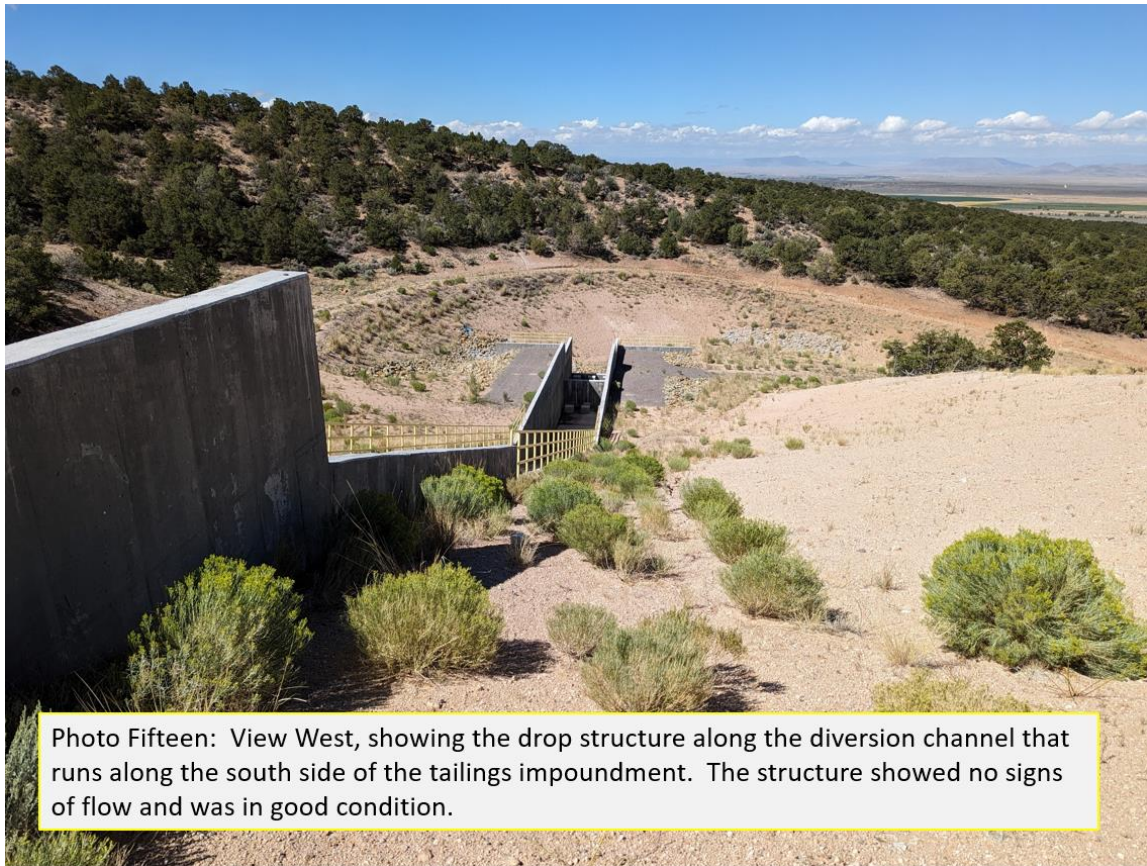
Adjacent to the tailings dam is the constructed spillway designed to convey storm water from the diversion ditch around the tailings storage facility and away from the main embankment. The spillway can be seen in Photo Fifteen. The spillway is in good condition and shows no evidence of recent flows. In the Arroyo, downstream of the spillway, all culverts have been upgraded, lined with rip rap and seeded. All culverts observed are in excellent condition. The south diversion ditch along the southern perimeter of the tailings facility was observed and is in good condition. Similar to the diversion ditch, no evidence of recent flows were observed.
