MINERALS PROGRAM INSPECTION REPORT
PHONE: (303) 866-3567

MINE NAME: Ophir Lode	MINE/PROSPECTING ID#: M-2001-063	MINERAL: Silver, gold, lead, zinc	COUNTY: Hinsdale
INSPECTION TYPE: Monitoring	WEATHER: Clear	INSP. DATE: August 30, 2023	INSP. TIME: 13:43
OPERATOR: Midas Mining Company, Inc.	OPERATOR REPRESENTATIVE: Wayne Giesy	TYPE OF OPERATION: 110(2) - Hard Rock Limited Impact	
REASON FOR INSPECTION: Normal I&E Program	BOND CALCULATION TYPE:	BOND AMOUNT: \$7,077.00	
DATE OF COMPLAINT: NA	POST INSP. CONTACTS: None	JOINT INSP. AGENCY: None	
INSPECTOR(S): Lucas West	INSPECTOR'S SIGNATURE:

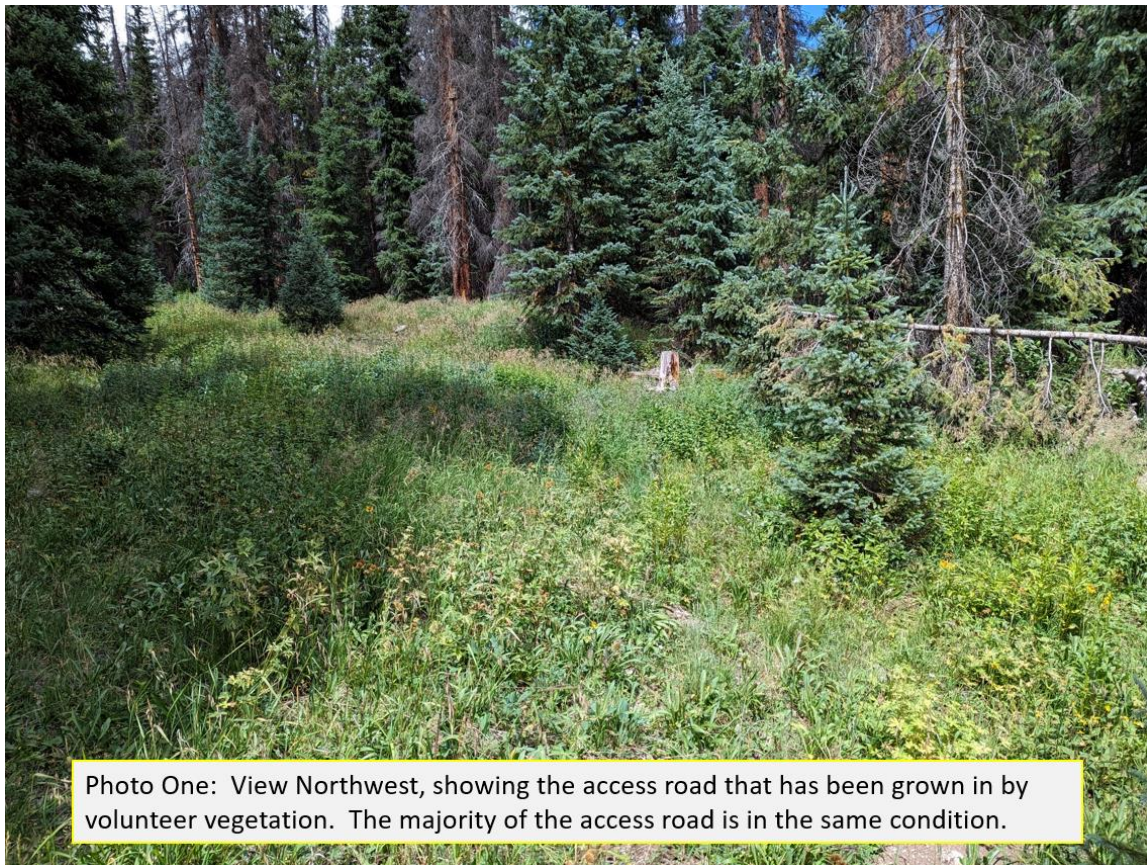
As stated previously, modern activity has not begun on site, and no equipment was present during the inspection. Access to the site was gained by crossing Henson Creek on foot. The access road has almost fully grown in with volunteer vegetation as seen in Photo One. Along the access roads are a series of four small depressions, that when mining activity begins, will serve as storm water settling ponds. The depressions are densely vegetated with grasses and in good condition. An example of the settling basins can be seen in Photo Two. The access road and basins appeared stable at the time of the inspection and no evidence of erosion was noted. At the top of the access road lies the portal pad, and portal to the underground workings. On the portal pad, are two stockpiles of waste rock that appear to have been generating from driving the approximately 300 foot tunnel. The stockpiles were stable at the time and show no signs of settling or erosion. The rock does not show evidence of mineralization or acid generation and evidence of leaching was noted. The stockpile can be seen in Photos Three and Four. Various pieces of historic mining debris are located around the portal pad area including pieces of rail and portion of a compressor. This is not considered a problem at this time, however will need to be disposed of either on or offsite upon final reclamation.

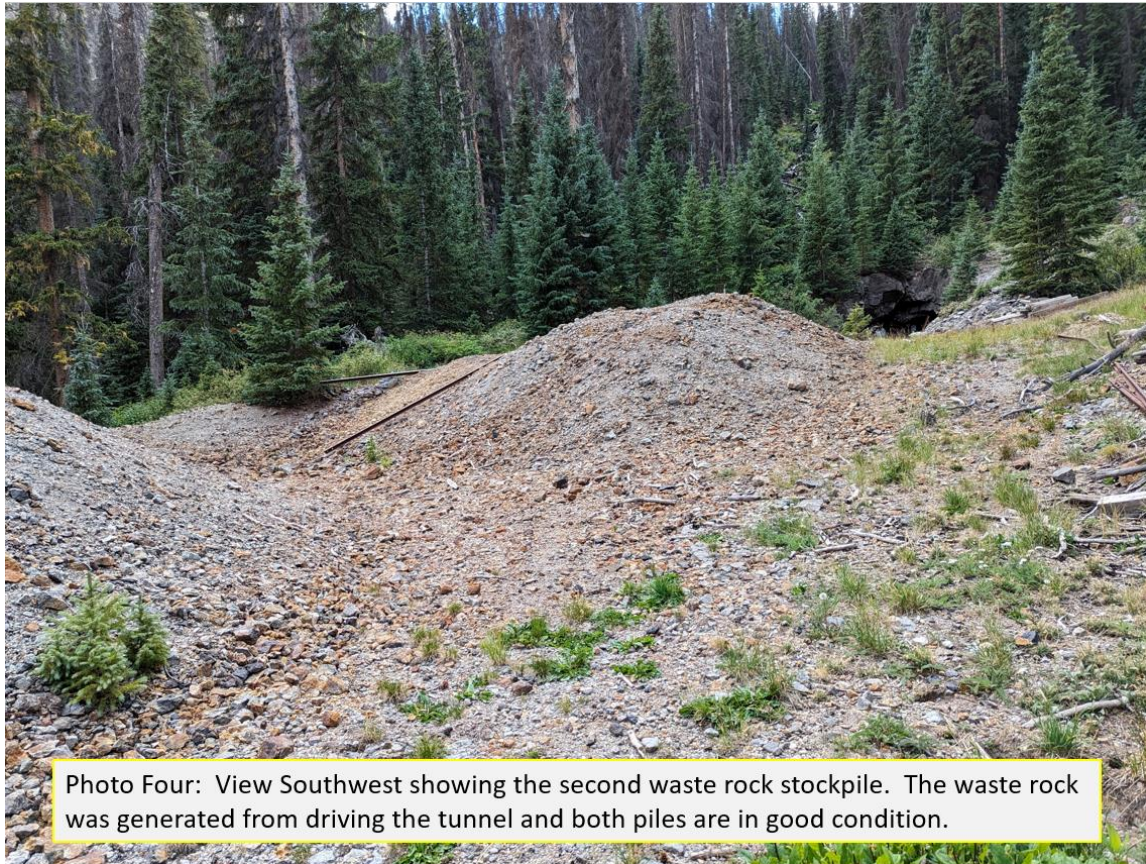
Photo Four: View Southwest showing the second waste rock stockpile. The waste rock was generated from driving the tunnel and both piles are in good condition.

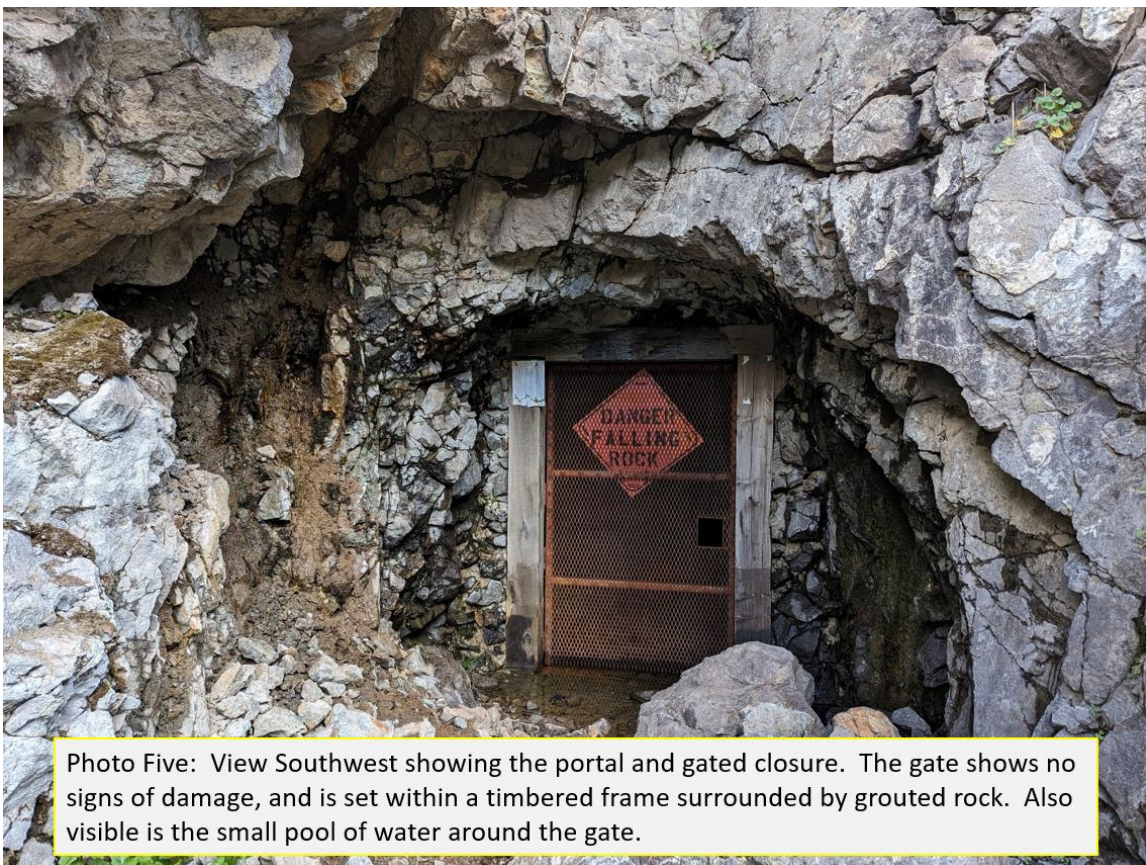
The portal was observed to be in good condition and secured by way of a locking metal gate. The frame and gate are in good condition and show no signs of vandalism or attempted unauthorized entry. The portal gate can be seen in Photo Five. A small amount of water has accumulated near the entrance and into a small and dug ditch leading away from the portal. The water appears to be coming from just near the door, and dripping down to the floor. The flow was barely flowing, estimated to be less than ½ gallon per minute, and infiltrates into the ground approximately 100 feet from the portal. Photo Six shows the water as it leaves the portal. The water shows no visual signs of impairment or mineral staining, and water testing at the time of permitting indicates it to be of high quality. The source of the water is likely to be Red Cloud Creek which flows just up gradient from the portal. It appears historic operations had rerouted the creek, but its proximity to the portal could explain the seepage of water. The presence of water is not considered a problem at this time.

Photo Five: View Southwest showing the portal and gated closure. The gate shows no signs of damage, and is set within a timbered frame surrounded by grouted rock. Also visible is the small pool of water around the gate.
