**MINERALS PROGRAM INSPECTION REPORT**  
**PHONE: (303) 866-3567**

<b>MINE NAME:</b> Pitch Project	<b>MINE/PROSPECTING ID#:</b> M-1977-004	<b>MINERAL:</b> Uranium	<b>COUNTY:</b> Saguache
<b>INSPECTION TYPE:</b> Monitoring	<b>WEATHER:</b> Clear	<b>INSP. DATE:</b> August 23, 2023	<b>INSP. TIME:</b> 09:00
<b>OPERATOR:</b> Homestake Mining Company	<b>OPERATOR REPRESENTATIVE:</b> Dave Wykoff	<b>TYPE OF OPERATION:</b> 112d-3 - Designated Mining Operation	
<b>REASON FOR INSPECTION:</b> Normal I&E Program	<b>BOND CALCULATION TYPE:</b>	<b>BOND AMOUNT:</b> \$24,451,940.00	
<b>DATE OF COMPLAINT:</b> NA	<b>POST INSP. CONTACTS:</b> None	<b>JOINT INSP. AGENCY:</b> None	
<b>INSPECTOR(S):</b> Dustin Czapla Russ Means	<b>INSPECTOR'S SIGNATURE:</b>

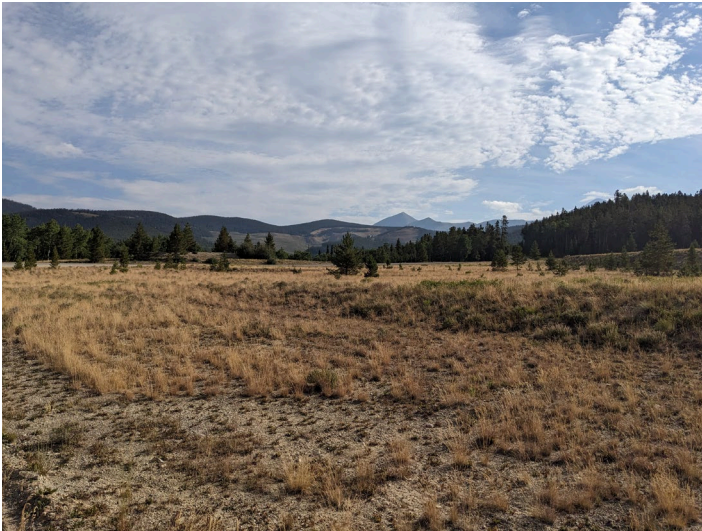
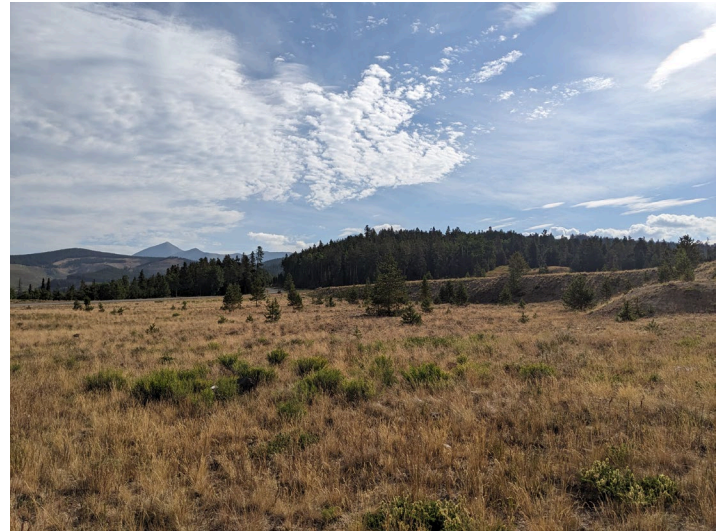
Mill Site: Reclamation of the mill area is complete. The area has been regraded and vegetation is well established. No problems were noted.

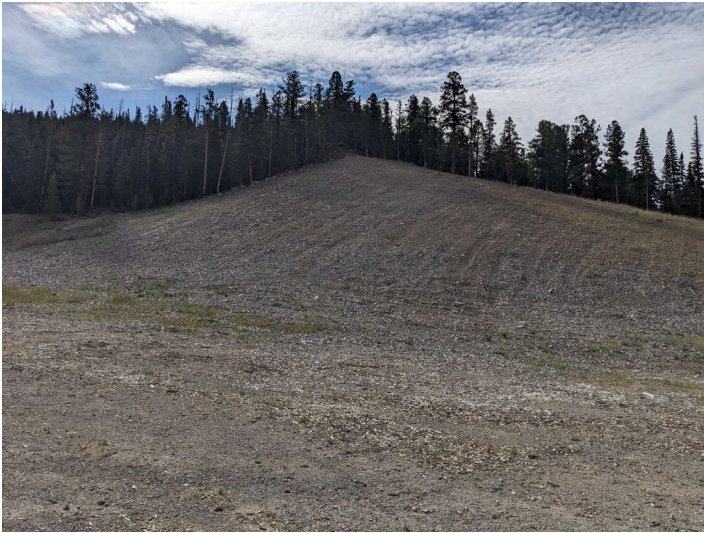
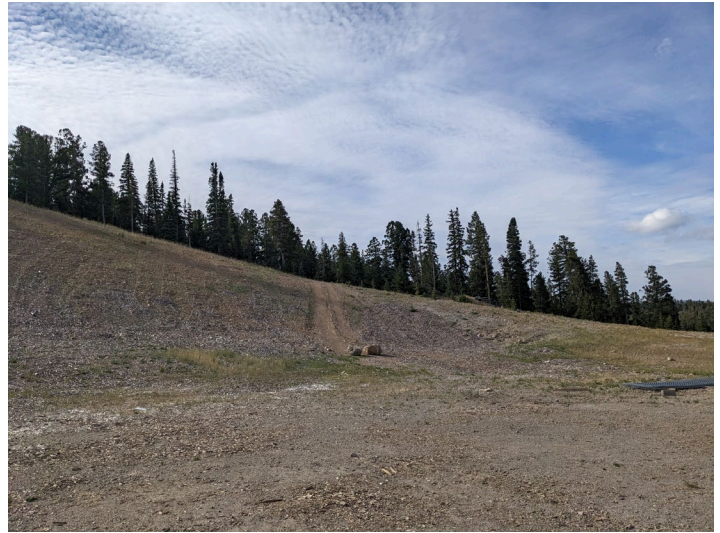
Limestone Quarry: Reclamation grading at the quarry area is complete. The area has been seeded and vegetation is becoming established. The work observed appears to be in accordance with the approved reclamation plan. No problems were noted.

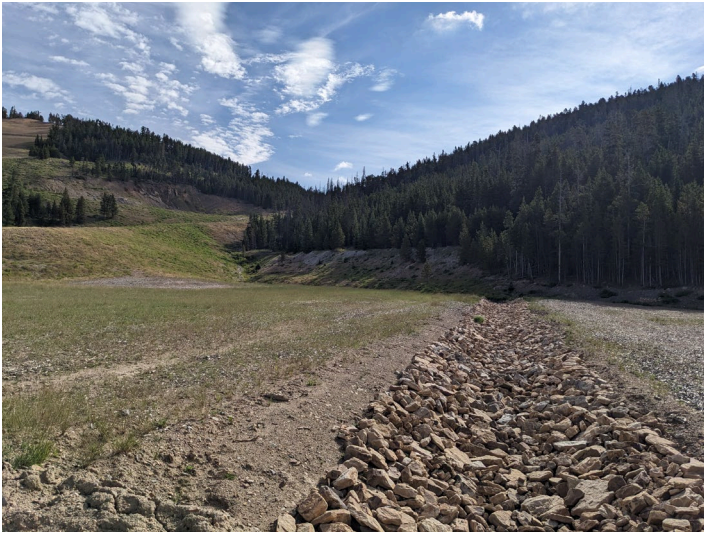
Tie Camp area: The laydown area has been regraded and seeded. Vegetation is becoming established. Drainage structures have been constructed and appear to be functioning as designed. No problems were noted in this area.

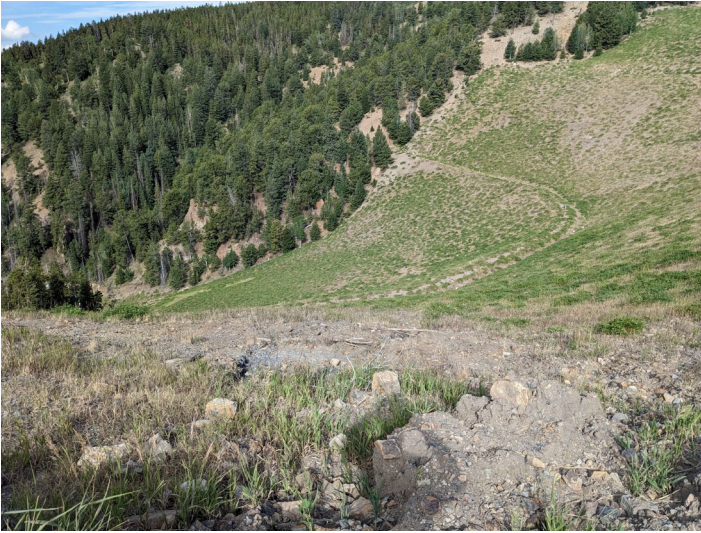
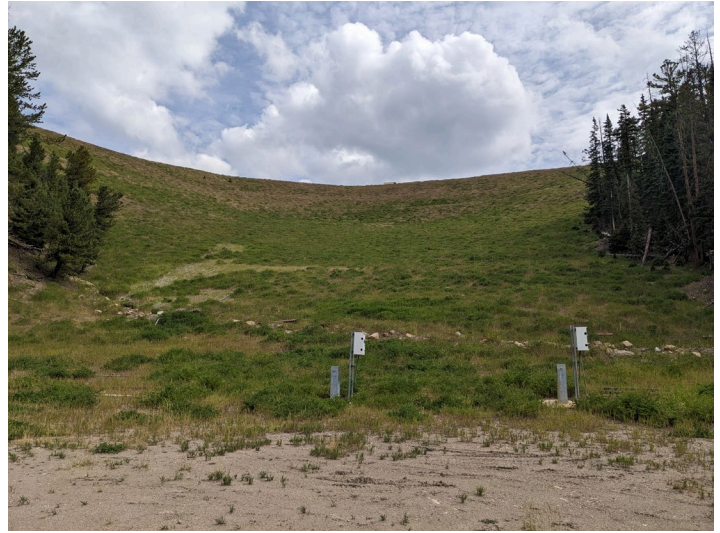
Indian Rock Dump: Slopes appear stable here. Vegetation is well established. No problems were noted.

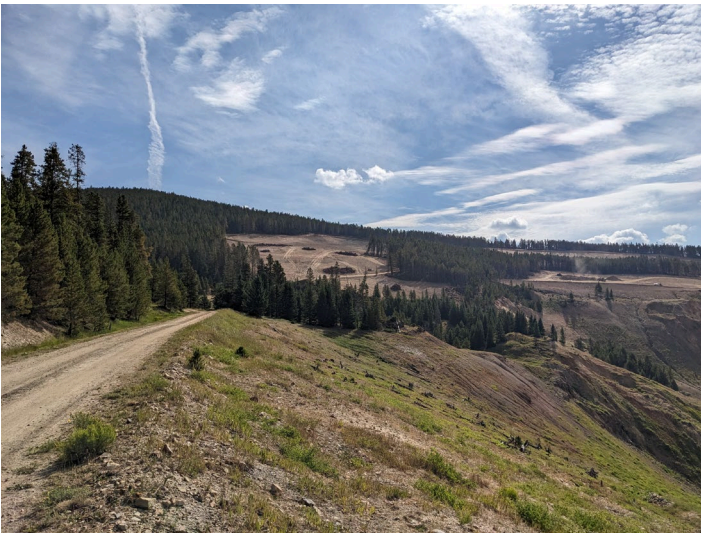
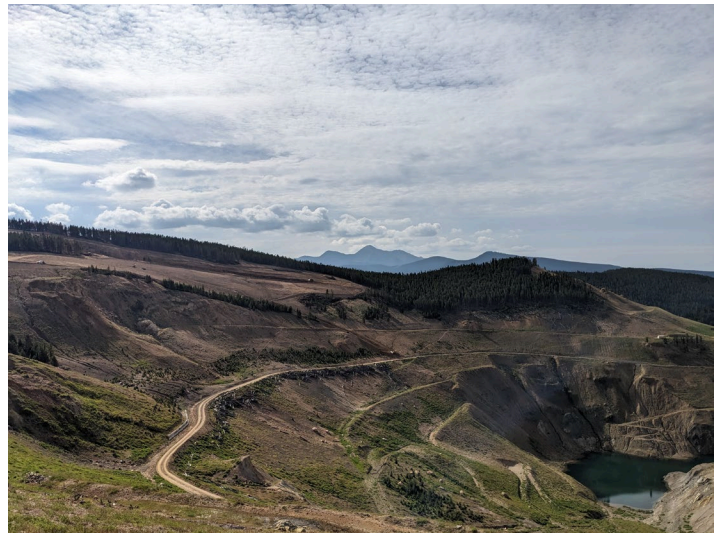
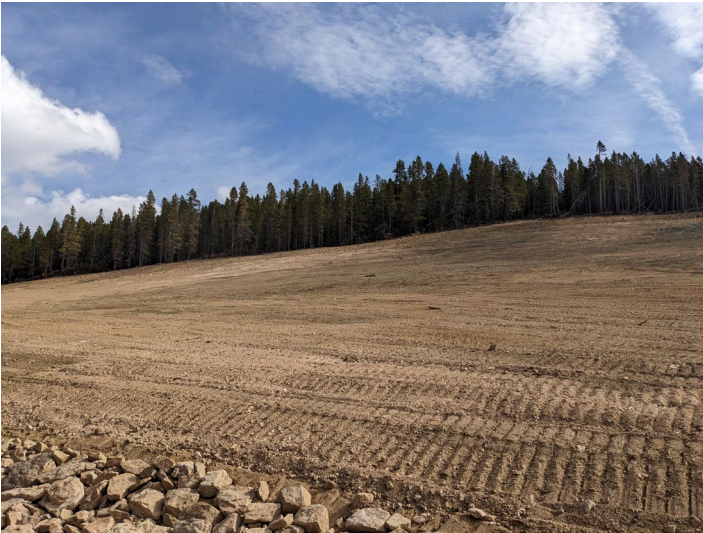
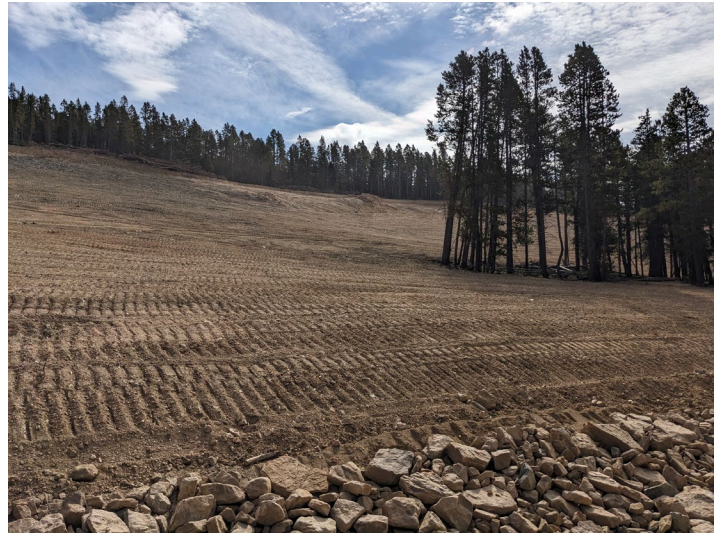
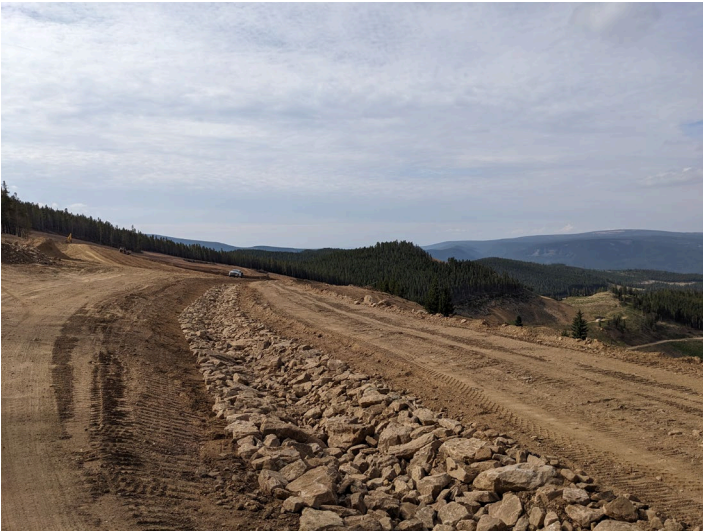
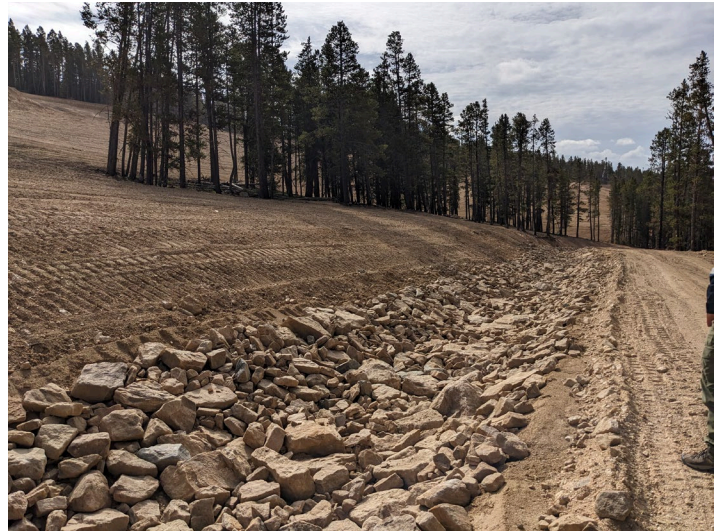
North Pit: The landslide area has been logged and grading is underway. The operator has made significant progress in the area during this operating season. The North Pit diversion ditch was extended behind the Mine Shop and additional drainage channels are being constructed in the landslide area. No problems were noted in this area.

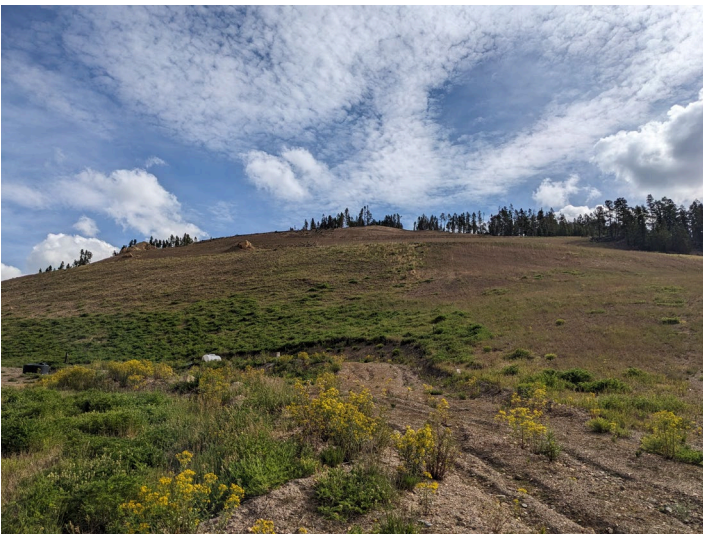
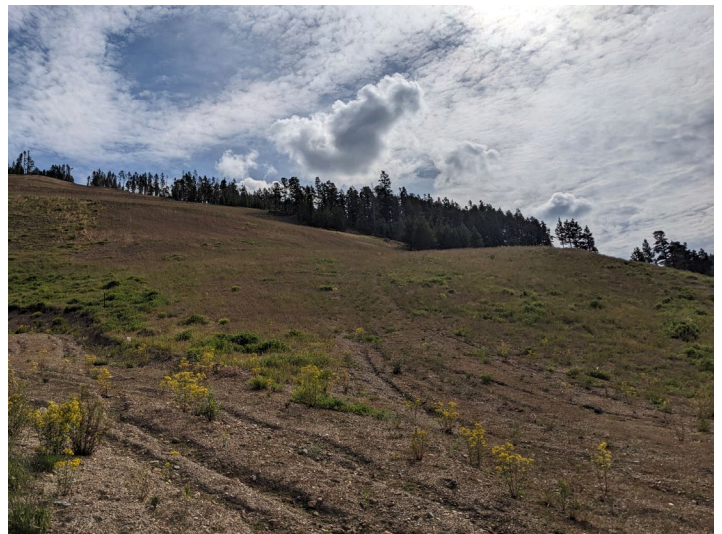
South Pit: Grading and stabilization work took place in the South Pit area in 2020. The slope appears stable and vegetation is becoming well established. No problems were noted in this area.

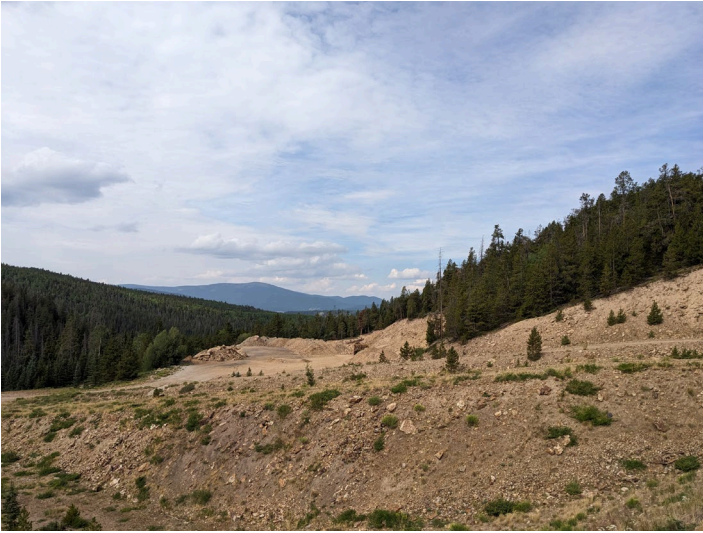
Sandstone Quarry: The quarry is still utilized for rip rap material on site. No problems were noted in this area.

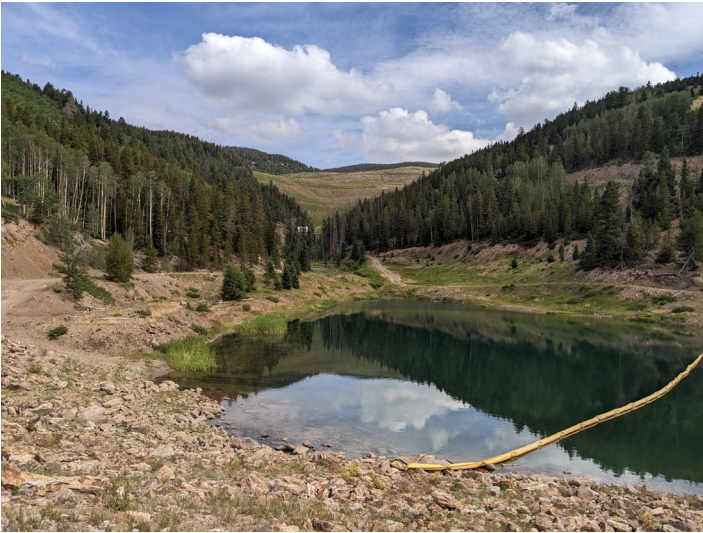
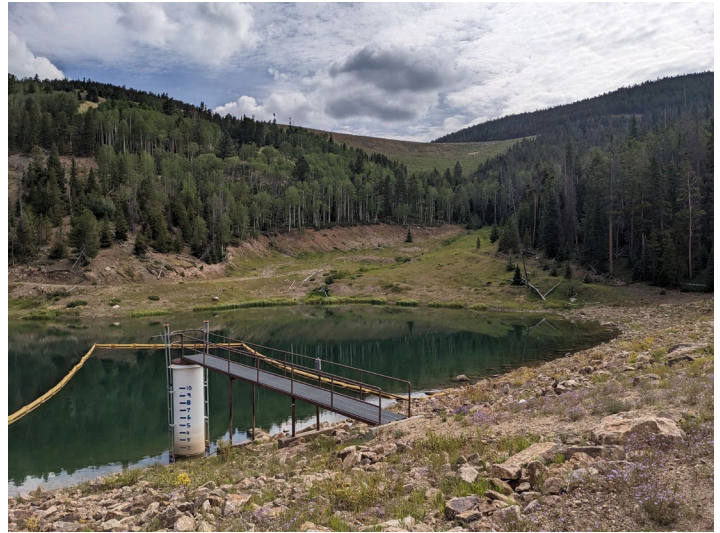
Sediment Pond: The sediment pond is well maintained and appeared to be functioning as designed. No problems were noted.
