MINERALS PROGRAM INSPECTION REPORT
PHONE: (303) 866-3567

MINE NAME: May Day Idaho Mine Complex	MINE/PROSPECTING ID#: M-1981-185	MINERAL: Gold and silver	COUNTY: La Plata
INSPECTION TYPE: Monitoring	INSPECTOR(S): Dustin Czapla	INSP. DATE: August 29, 2023	INSP. TIME: 13:00
OPERATOR: Sunrise Mining LLC	OPERATOR REPRESENTATIVE: Jack and Barbara Nielsen	TYPE OF OPERATION: 112d-2 - Designated Mining Operation	
REASON FOR INSPECTION: Normal I&E Program	BOND CALCULATION TYPE: None	BOND AMOUNT: \$137,448.00	
DATE OF COMPLAINT: NA	POST INSP. CONTACTS: None	JOINT INSP. AGENCY: None	
WEATHER: Clear	INSPECTOR'S SIGNATURE:

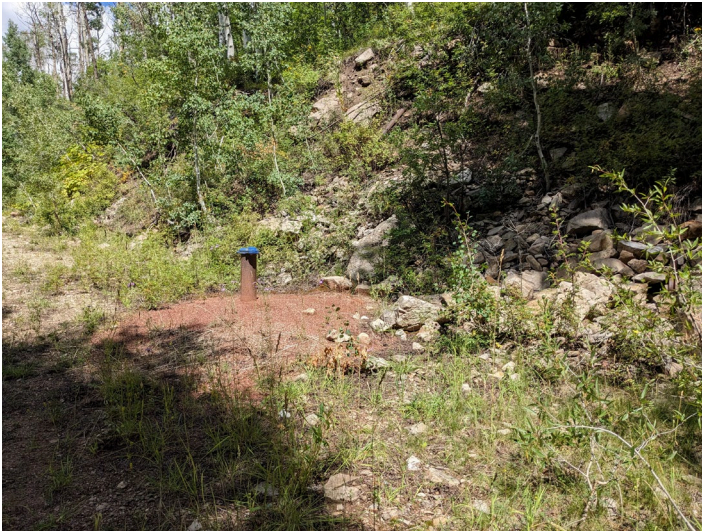
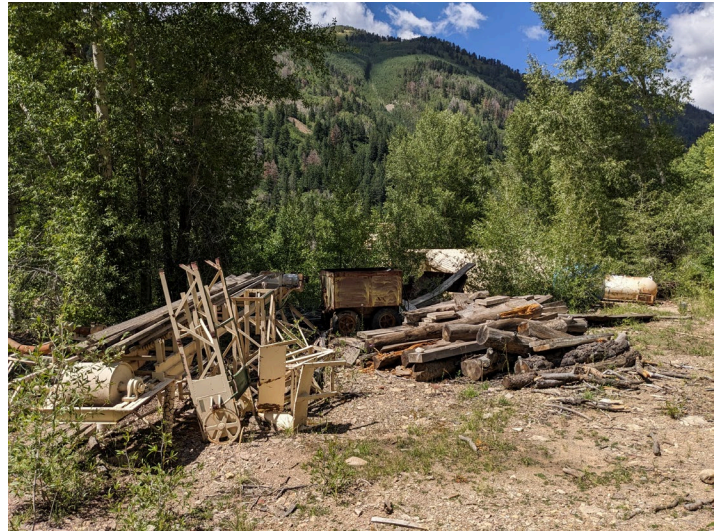
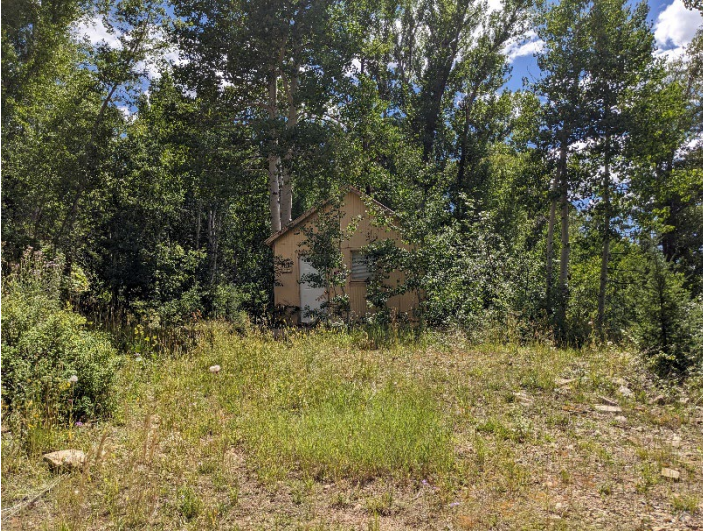
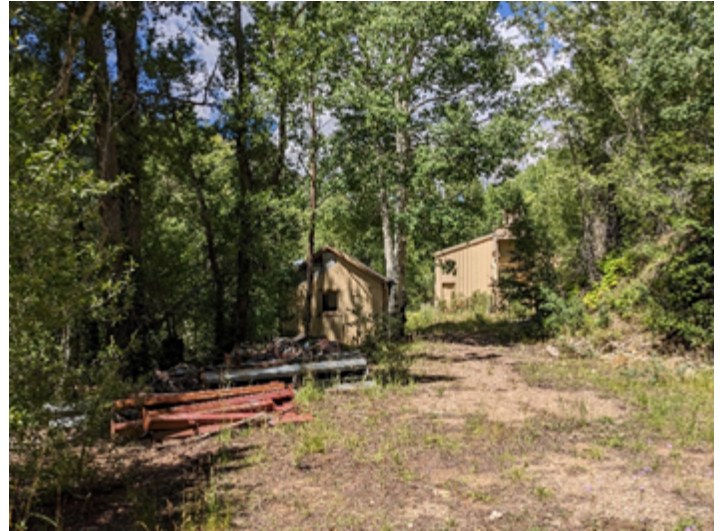
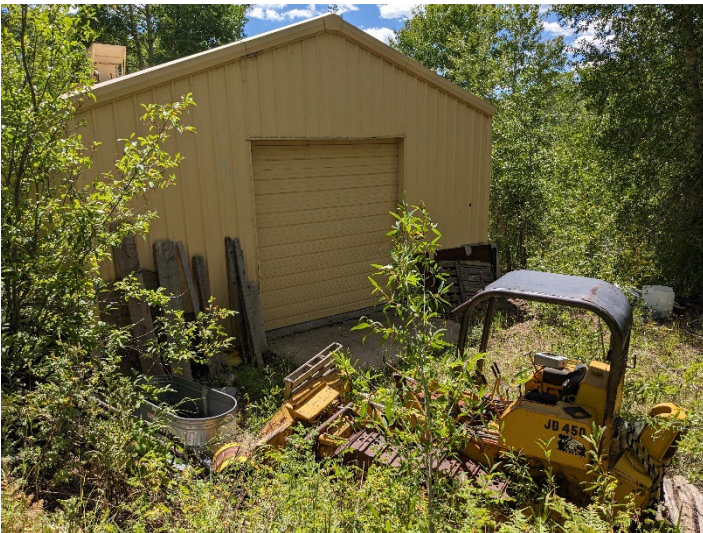
Conditions at the Idaho Area are unchanged from previous inspections. Equipment and debris are stored in an orderly fashion around the building. Vegetation is well established throughout the area. No problems or violations were noted. On March 31, 2023 the Division received correspondence from Wildcat Mining Company (Idaho property landowner) requesting that the road and structures currently existing on the property remain after reclamation. This was approved by the Division through TR10 on May 10, 2023.

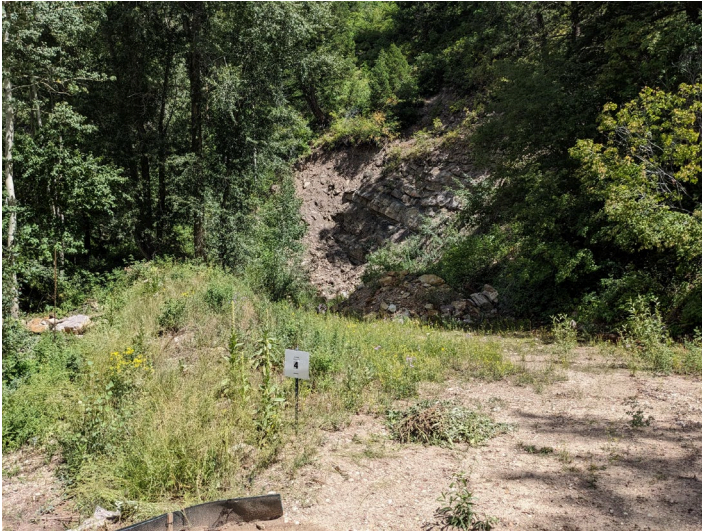
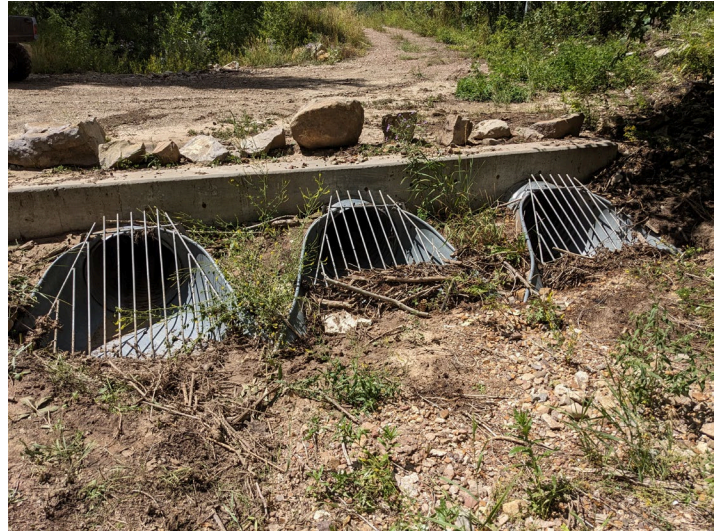
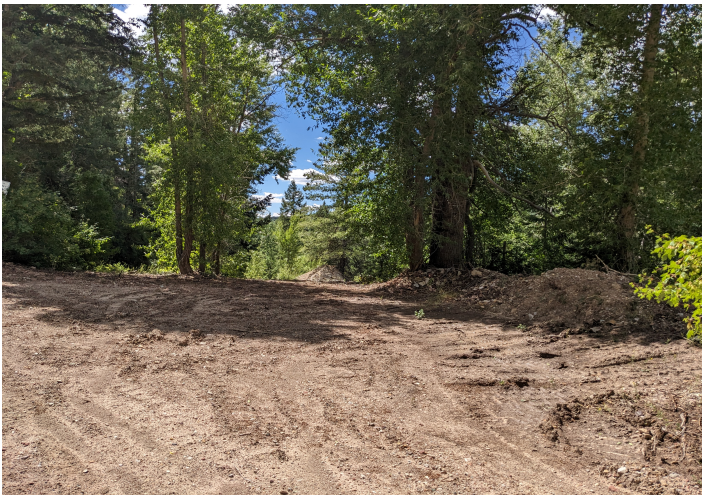
Conditions at the May Day 2 Area are unchanged from previous inspections. The culvert system located in Little Deadwood Gulch appears to be functioning as designed. The portal remains collapsed. No problems or violations were noted in this area.

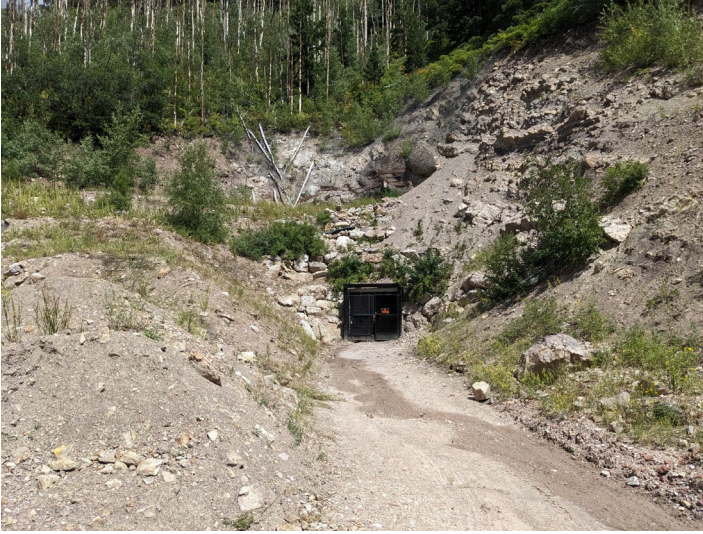
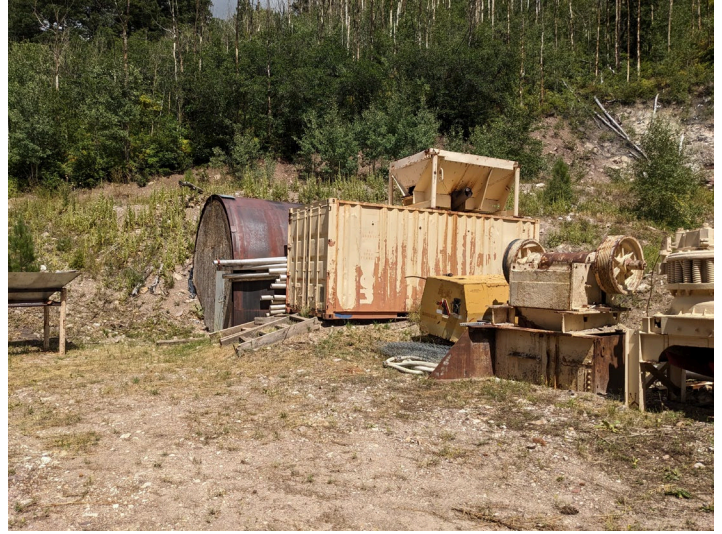
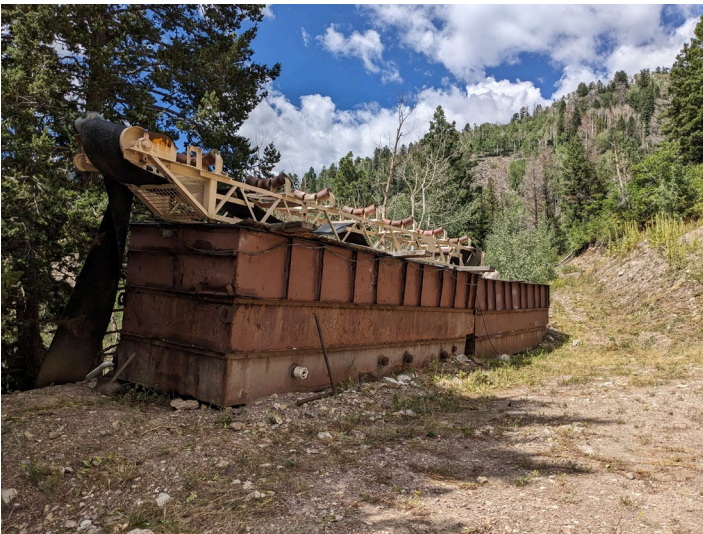
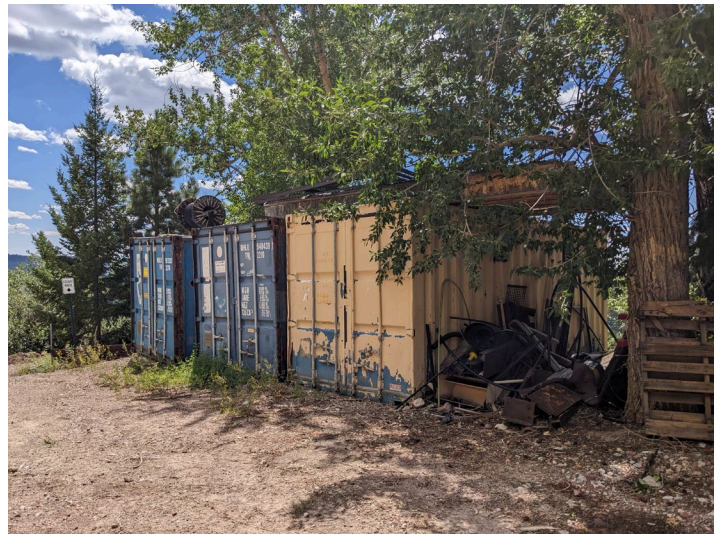
Conditions at the May Day 1 Area are unchanged from previous inspections. Evidence of any recent mining activity was not observed in this area. The portal is secured with a locked gate. The gate was recently painted. Wire mesh and rock bolts used to stabilize the highwall above the portal appear to be functioning effectively. The milling equipment that was removed from the collapsed mill portal is still located on the May Day 1 pad, along with several shipping containers. No problems or violations were noted in this area.

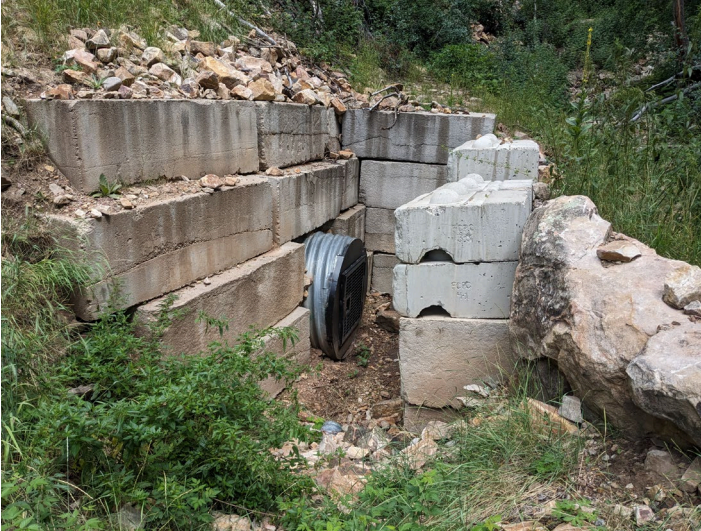
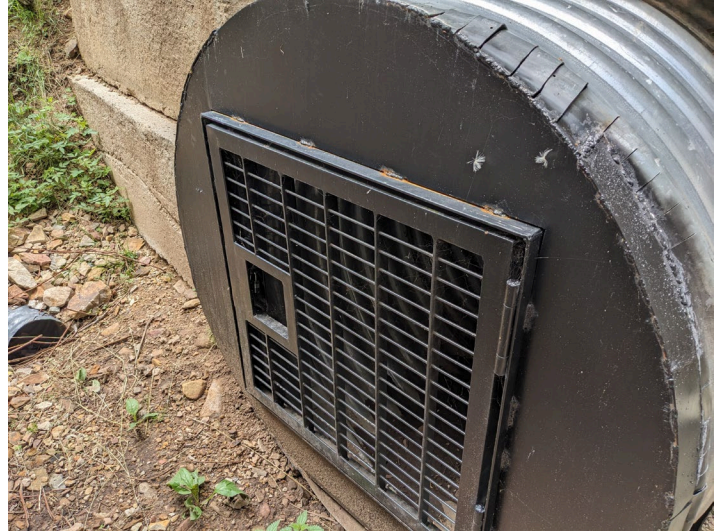
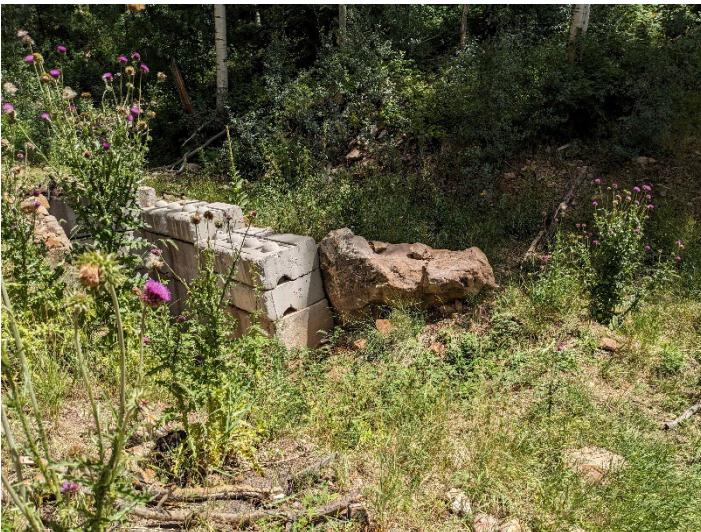
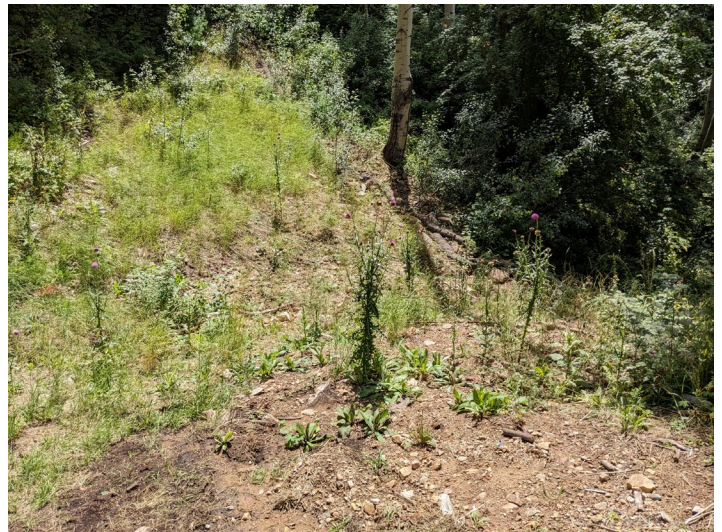
Chief Tunnel

A locked grate has been installed on the Chief Portal. The portal is secure and the grate complies with the reclamation requirements. All backfilled areas appear to be stable and in good condition. No evidence of settling, slumping or subsidence was observed. The area is well vegetated and stable. No problems or violations were noted.
