MINERALS PROGRAM INSPECTION REPORT
PHONE: (303) 866-3567

MINE NAME: Juniper Quarry	MINE/PROSPECTING ID#: M-1982-141	MINERAL: Limestone (general)	COUNTY: Moffat
INSPECTION TYPE: Monitoring	WEATHER: Clear	INSP. DATE: August 30, 2023	INSP. TIME: 09:00
OPERATOR: Moffat Limestone Company	OPERATOR REPRESENTATIVE: Mike Anson	TYPE OF OPERATION: 112c - Construction Regular Operation	
REASON FOR INSPECTION: Normal I&E Program	BOND CALCULATION TYPE: Complete Bond	BOND AMOUNT: \$200,768.00	
DATE OF COMPLAINT: NA	POST INSP. CONTACTS: None	JOINT INSP. AGENCY: None	
INSPECTOR(S): Zach Trujillo	INSPECTOR'S SIGNATURE:

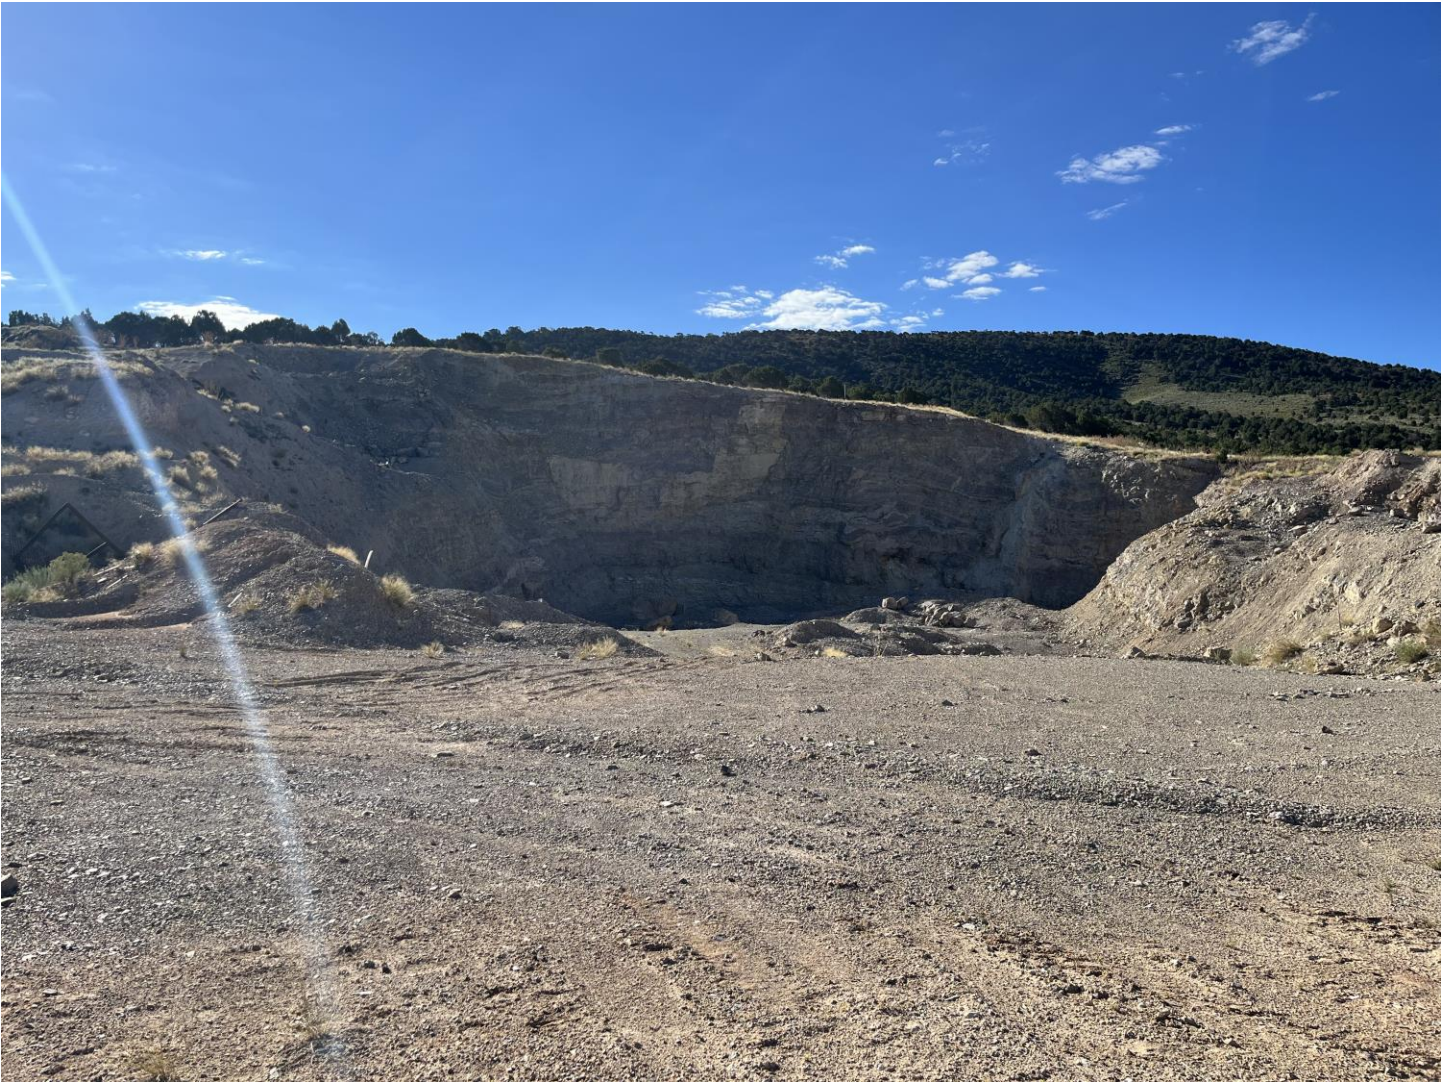
There appears to be no changes to the highwall and over all disturbance footprint since the last inspection. The highwall is approximately 50' tall and sloped 1:1 to near vertical. There is also approximately 200 linear feet of highwall 30' tall sloped 1:1 that will required backfill. The main pit floor has been dropped approximately 10' below original contour and generally follows the permit boundary. There are several material stockpiles within the South Pit area. All stockpiles are stored along northern portion of the approved boundary with no issues observed. No fuel or processing equipment is stored at this location. The entire affected boundary was inspected and all disturbances was within the approved limits. No issues were observed at the South Pit.

South Pit highwall.

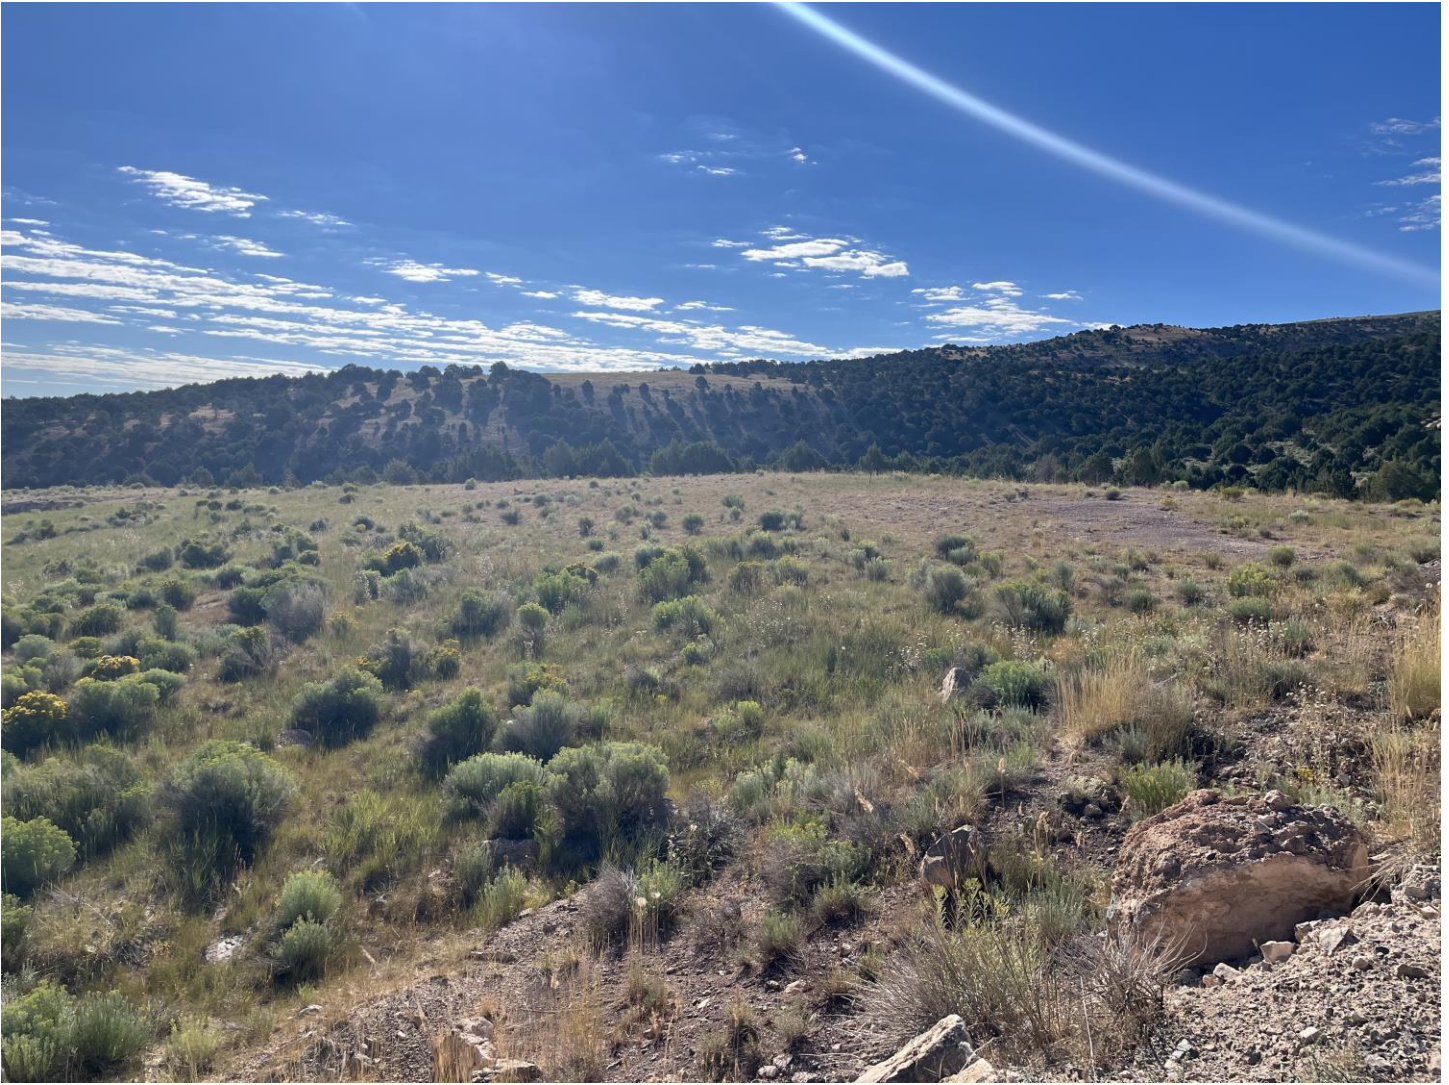
Reclamation was inspected along the southern portion of the North Pit area. Vegetation was decently established and mature shrubs were observed. A small portion of the area was slightly bare however no signs of erosion was observed. The pre-existing south highwall just below the reclamation is approximately 100 linear feet wide, by 50 feet tall and near vertical. Backfill has been placed at the pit floor of the associated bench below the highwall. The reclamation plan calls for the area to be graded to 3H: 1V and conform to the previous reclamation areas to the south.

Reclamation along southern end of North Pit.

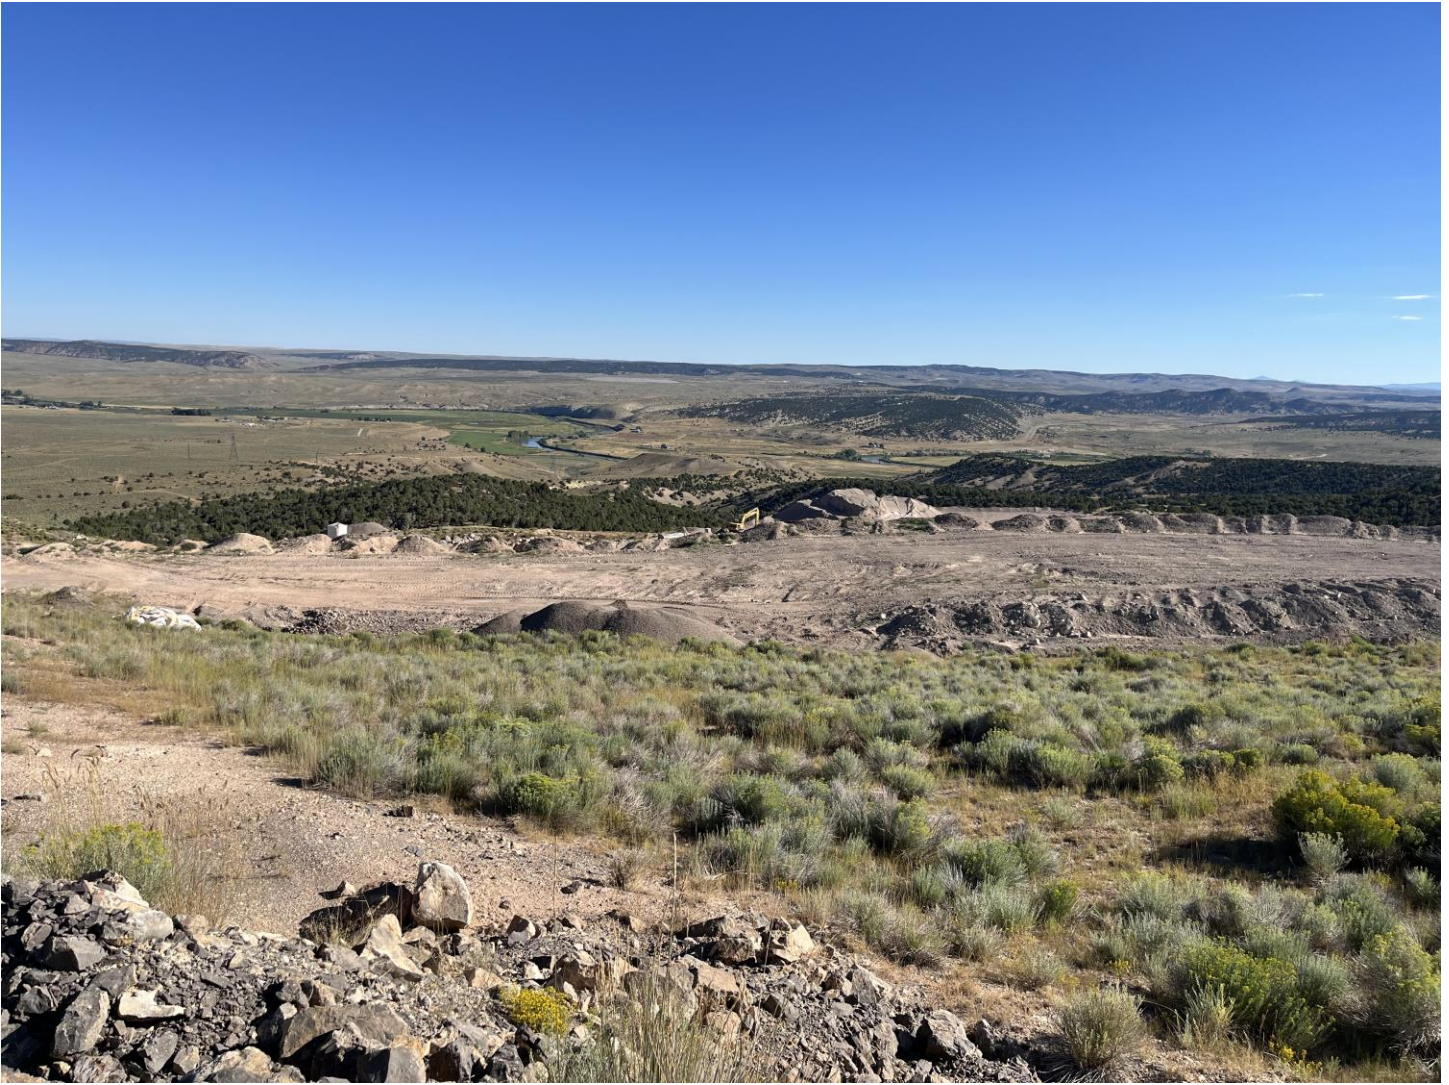
Current backfill operations.

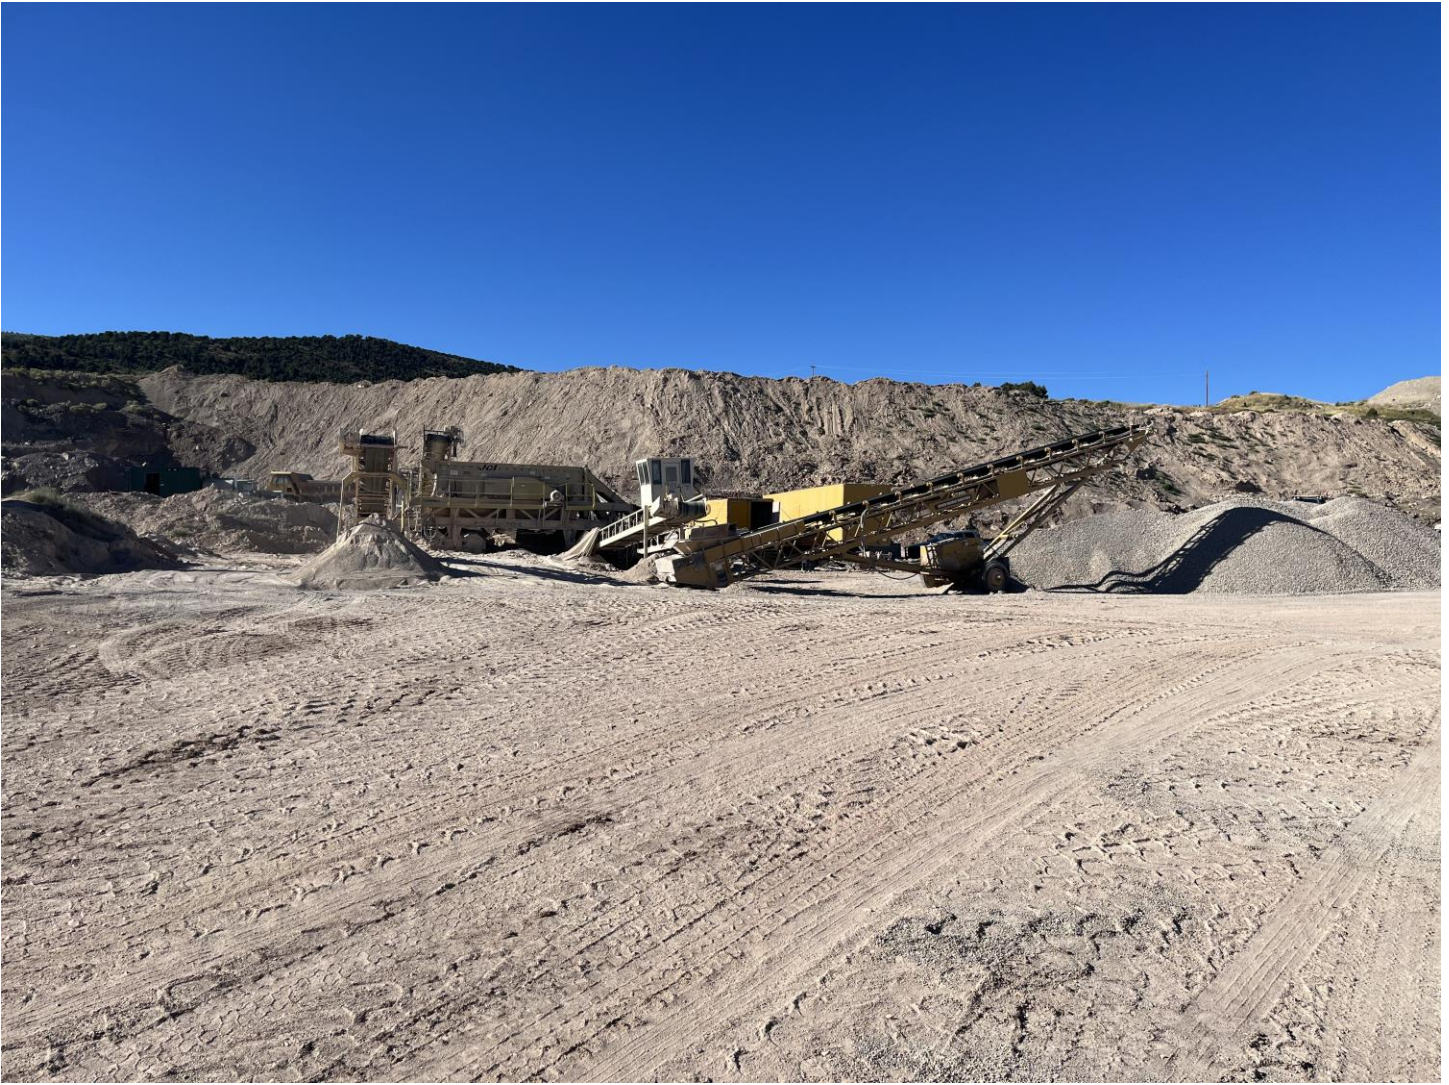
The middle bench is where the associated facilities is staged along with material stockpiles. No active mining could be observed in this area. Based on discussions with the operator, current mining activities is primarily occurring in the northwest corner of the North Pit. The highwall is bowl shaped and is approximately 300 linear feet wide and 50 feet high near vertical with one bench in the middle. It appeared that mining is currently moving along the southern portion of highwall as well as the upper bench. There is an overhead electrical line that goes through this area and a 50 foot setback from the poles resulting in pillars/islands.

Facilities and stockpiles.

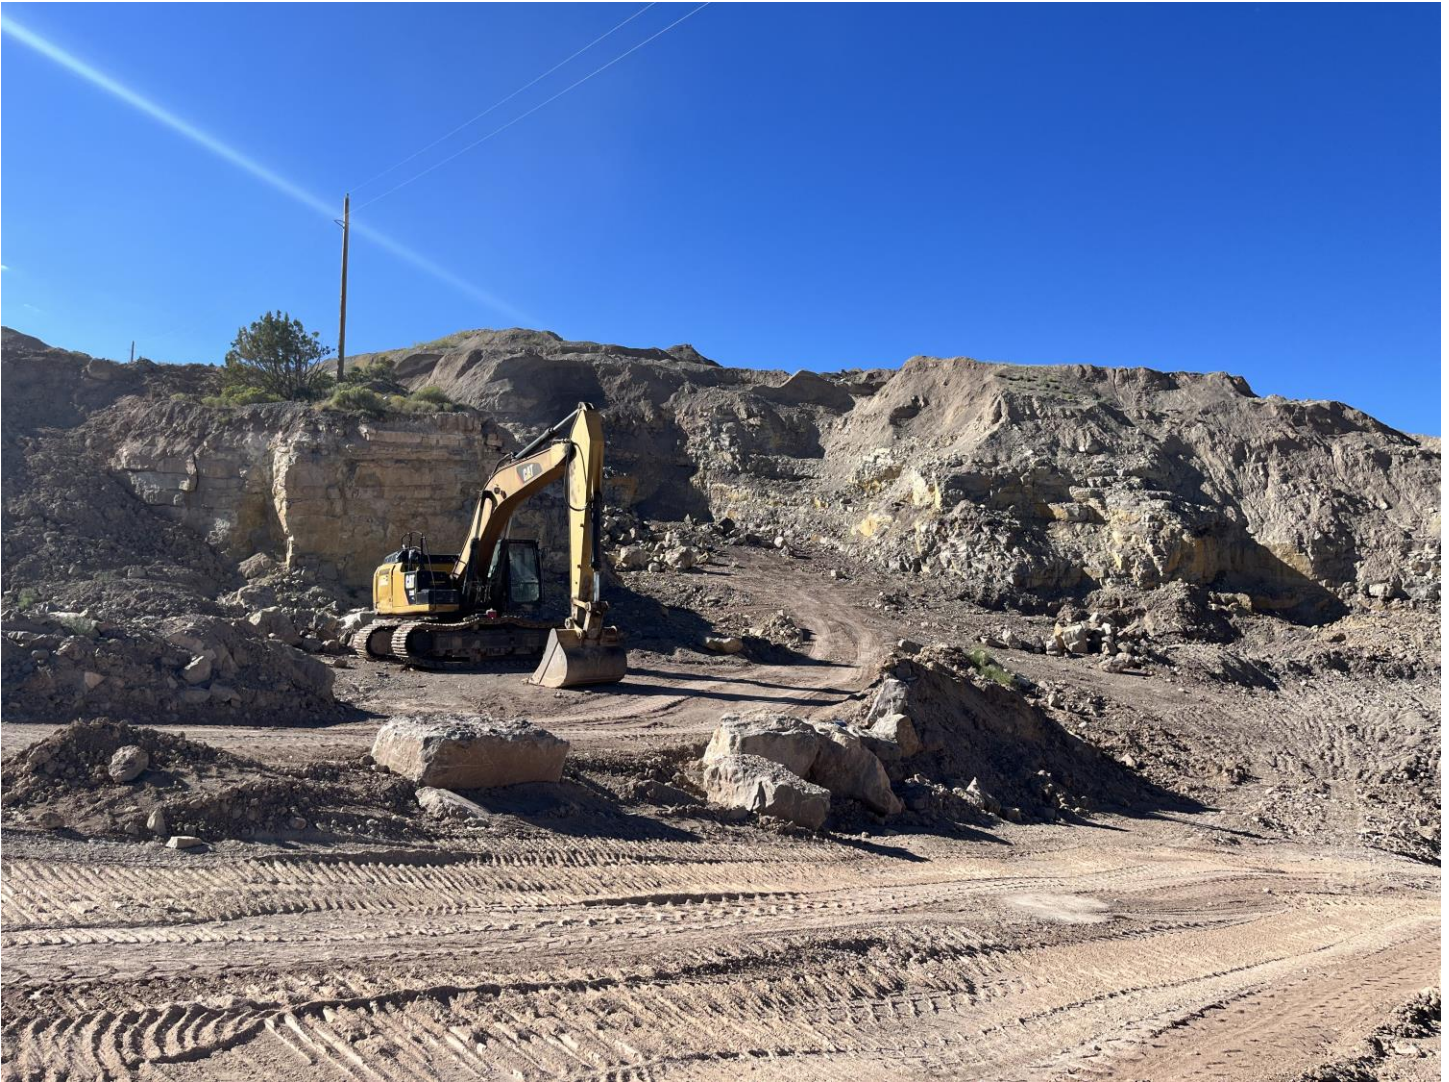
Current active mining along southern portion of highwall.
