**MINERALS PROGRAM INSPECTION REPORT**  
**PHONE: (303) 866-3567**

<b>MINE NAME:</b> West of Maybell Pit	<b>MINE/PROSPECTING ID#:</b> M-1979-142	<b>MINERAL:</b> Sand and gravel	<b>COUNTY:</b> Moffat
<b>INSPECTION TYPE:</b> Monitoring	<b>WEATHER:</b> Clear	<b>INSP. DATE:</b> August 30, 2023	<b>INSP. TIME:</b> 10:00
<b>OPERATOR:</b> Colorado Department of Transportation	<b>OPERATOR REPRESENTATIVE:</b> None	<b>TYPE OF OPERATION:</b> 112c - Construction Regular Operation	
<b>REASON FOR INSPECTION:</b> Normal I&E Program	<b>BOND CALCULATION TYPE:</b> None	<b>BOND AMOUNT:</b> \$0.00	
<b>DATE OF COMPLAINT:</b> NA	<b>POST INSP. CONTACTS:</b> None	<b>JOINT INSP. AGENCY:</b> None	
<b>INSPECTOR(S):</b> Zach Trujillo	<b>INSPECTOR'S SIGNATURE:</b>

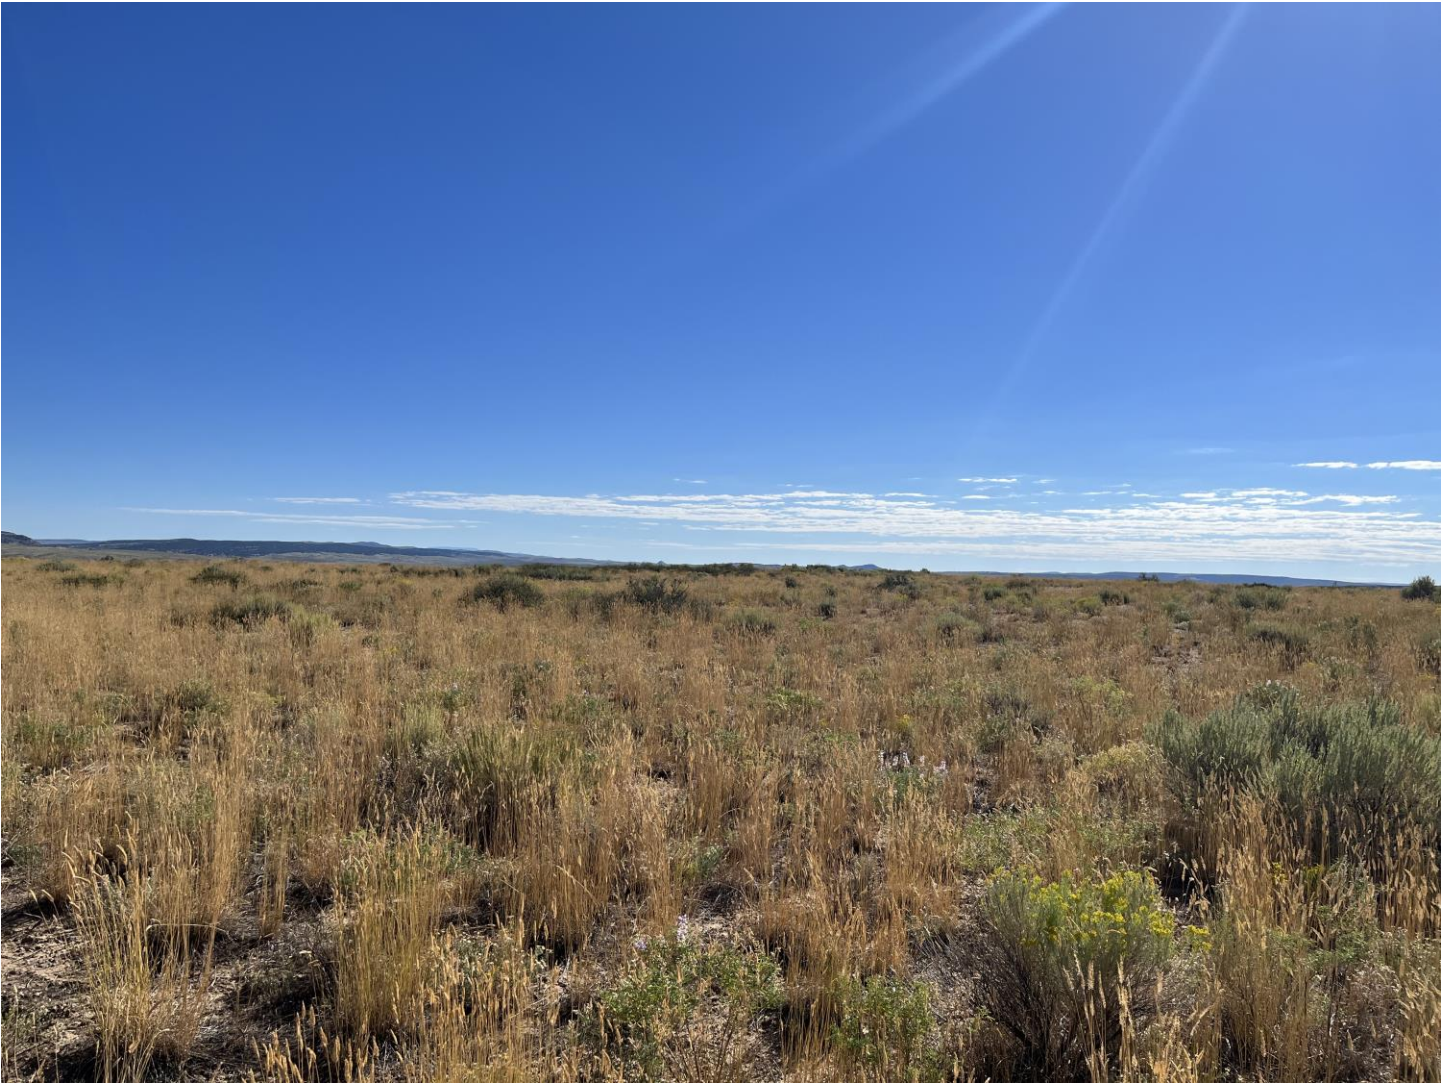
West Pit reclamation.

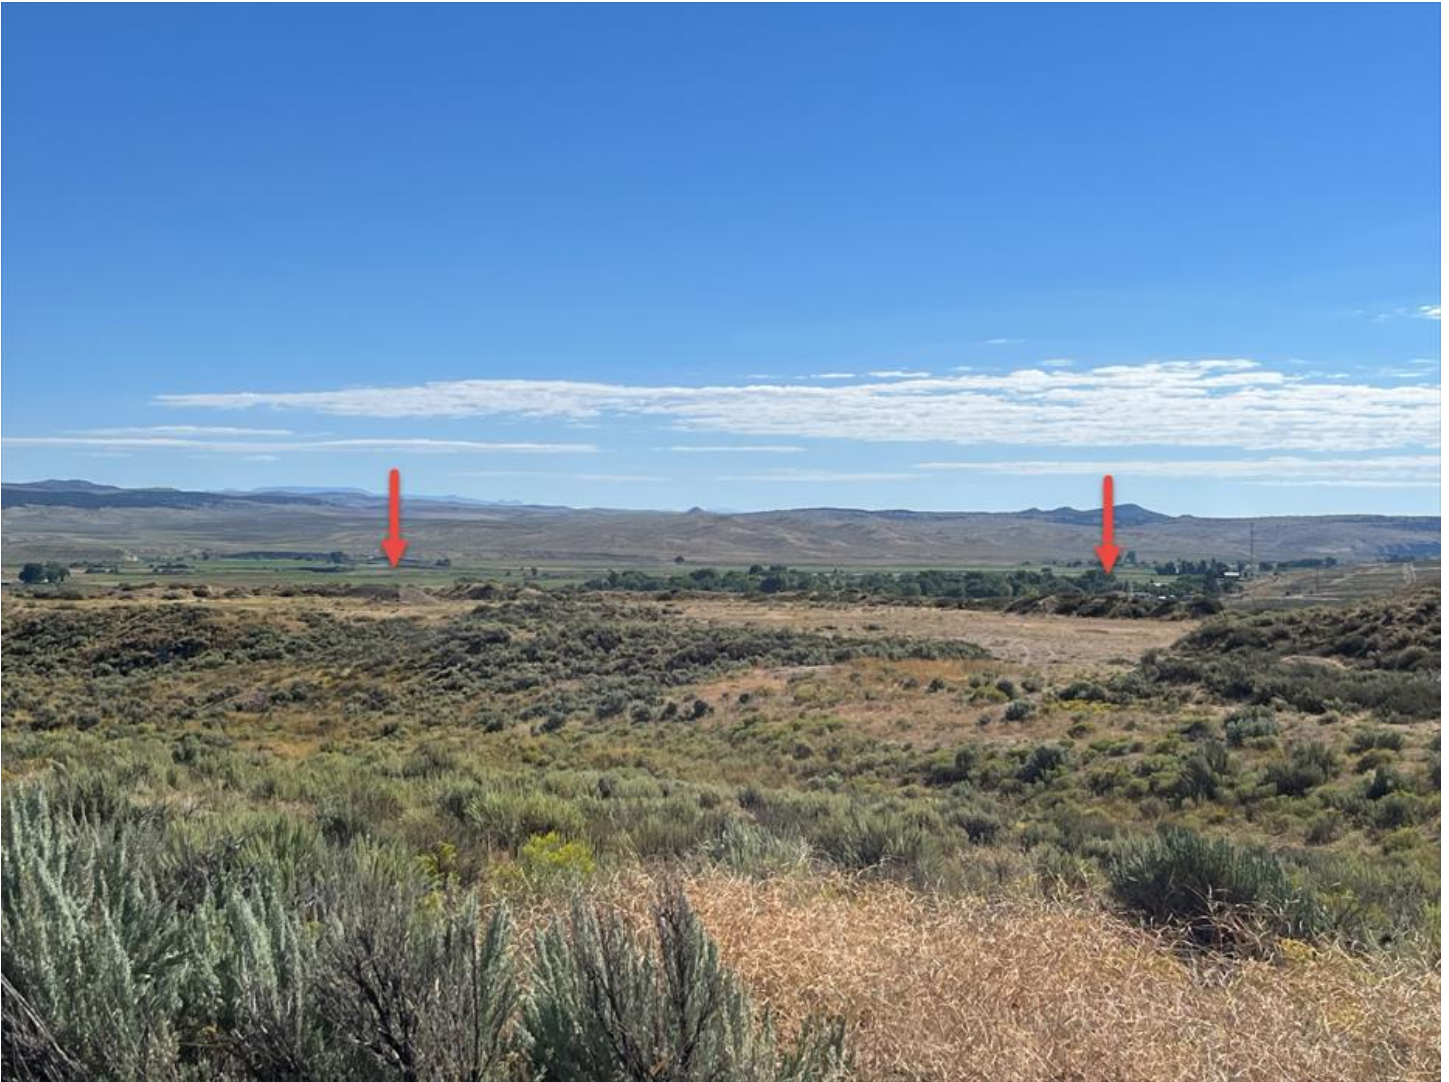
This site has been inactive for several years and limited native vegetation has volunteered throughout most of site and in some areas appears to have self-reclaimed. Topsoil and reseeding does appear to have occurred specifically at the East and Middle Pits. Multiple stockpiles were observed throughout the site and will need to be removed. The fence line has been damaged in a couple of regions due to wildlife. Livestock was observed on both ends of the fence along all pits of the site. If reclamation commences, it would be recommended to reestablish the fence to limit grazing on areas that have been reseeded.

Material stockpiles at Middle Pit.

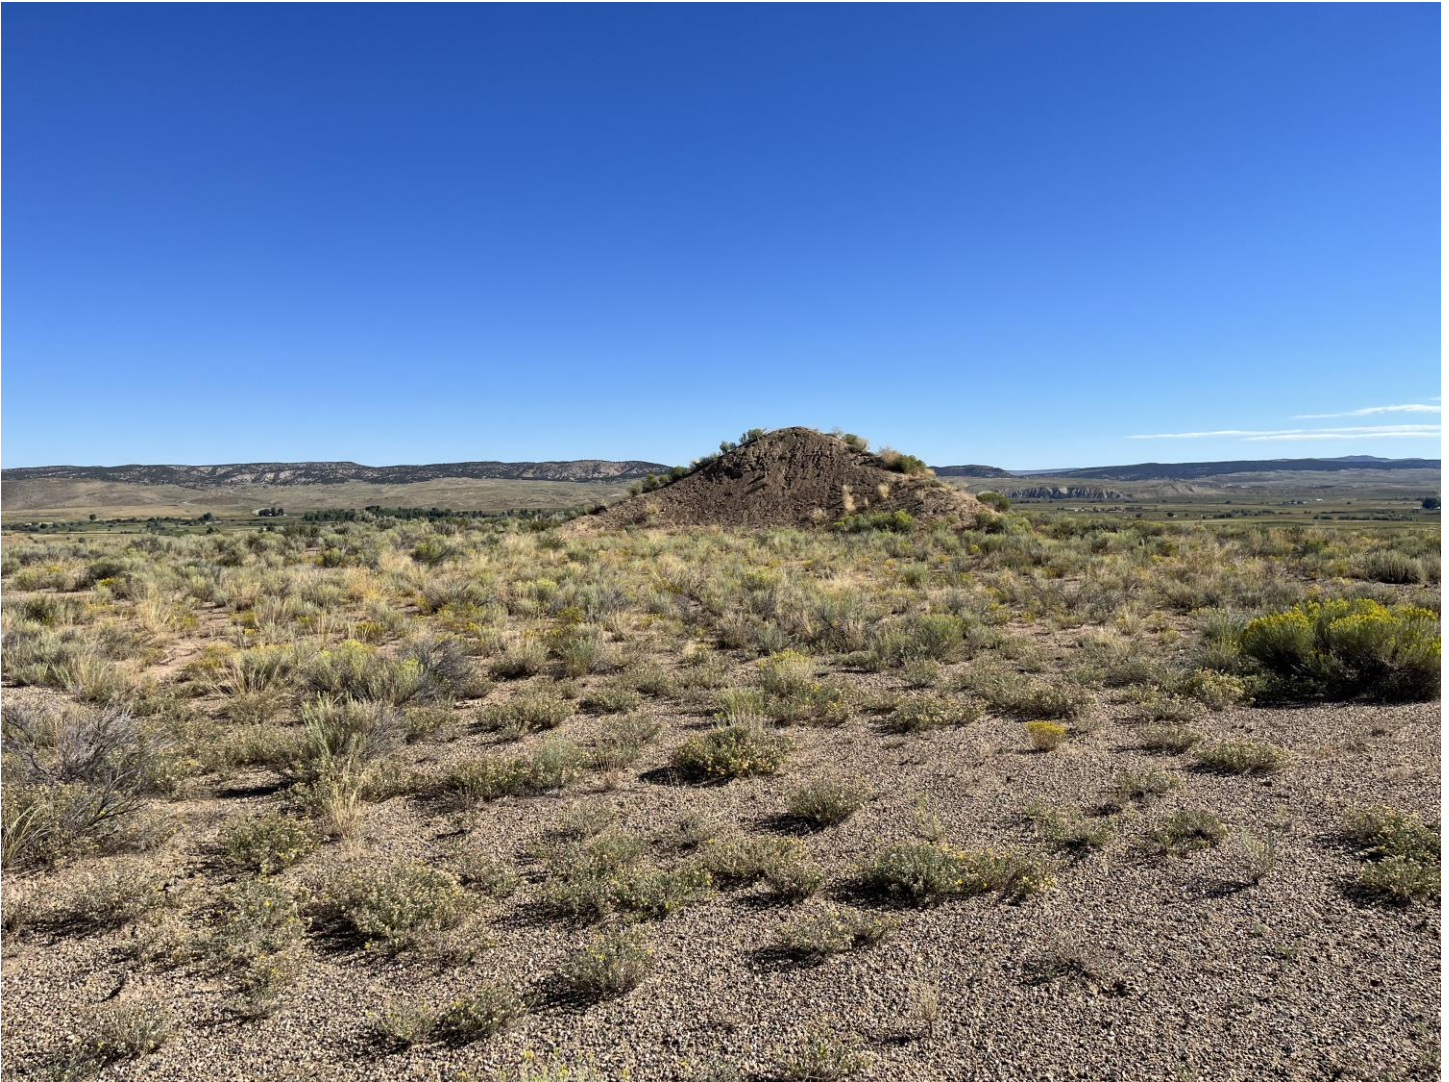
Material stockpile at Middle Pit.
