MINERALS PROGRAM INSPECTION REPORT
PHONE: (303) 866-3567

MINE NAME: Nahcolite Project	MINE/PROSPECTING ID#: M-1983-194	MINERAL: Carbonates	COUNTY: Rio Blanco
INSPECTION TYPE: Monitoring	WEATHER: Clear	INSP. DATE: August 28, 2023	INSP. TIME: 11:00
OPERATOR: Natural Soda LLC	OPERATOR REPRESENTATIVE: Kirk Daehling	TYPE OF OPERATION: 112d-3 - Designated Mining Operation	
REASON FOR INSPECTION: Normal I&E Program	BOND CALCULATION TYPE: None	BOND AMOUNT: \$4,466,425.00	
DATE OF COMPLAINT: NA	POST INSP. CONTACTS: DRMS	JOINT INSP. AGENCY: None	
INSPECTOR(S): Amy Yeldell	INSPECTOR'S SIGNATURE:

This is the third quarter inspection for 2023. The primary focus of this inspection was stormwater management. Additionally the two new/extended pads and additional roads for the 18H-1V and 18H-IR-W wells were observed. There are no open revisions for this permit. No changes to production level or staffing have occurred or are anticipated in the near future. Division staff first checked in at the main office.

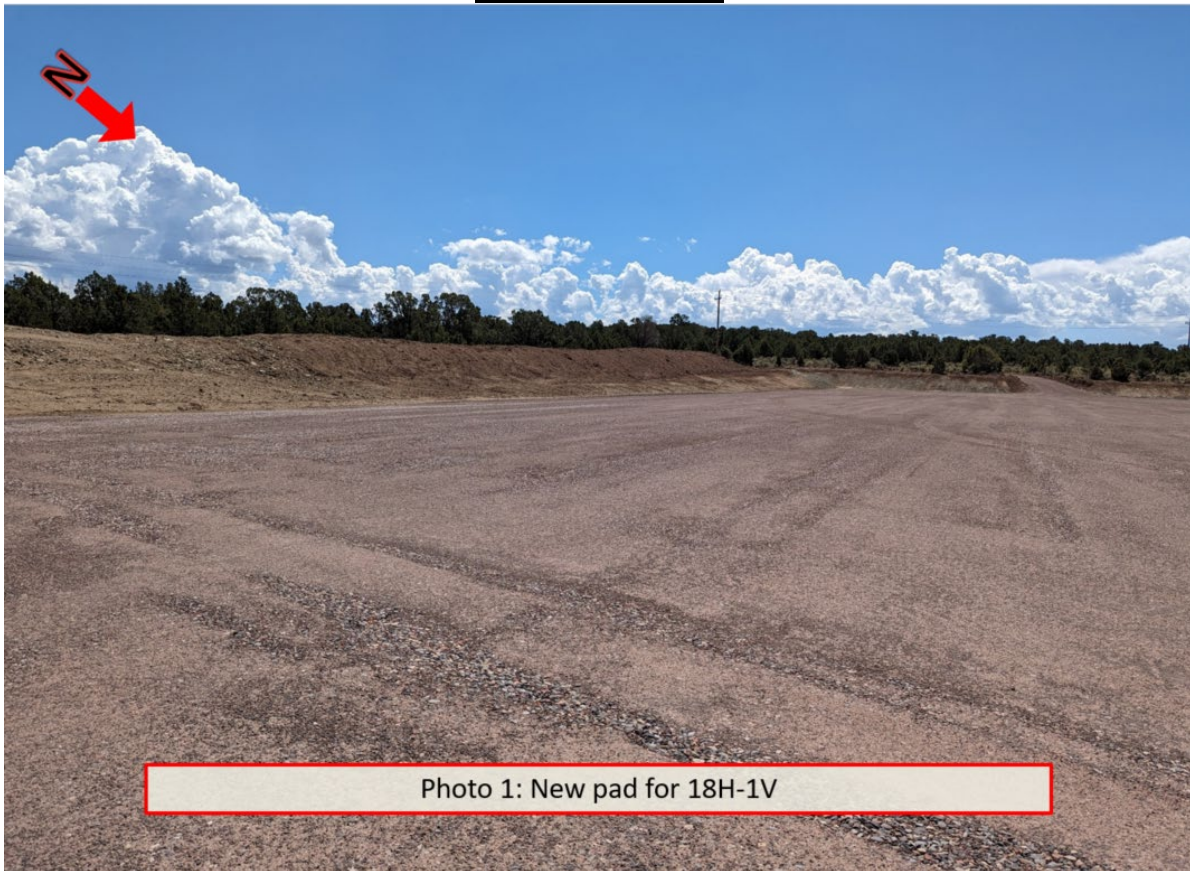
Construction of the access road and new pad for 18H-1V and subsequent wells is also completed (Photo One). The 15 pad has been extended to the south on a higher tier (level) to accommodate the 18H-IR-W and subsequent wells. Well pad construction is completed (Photo Two). The access road is either through the 15 Pad on the southwest side or from the existing county road to the south. Both pads appear to be constructed as approved under TR-50. Cut slopes are stable and perimeter berms/ditching is in place.

Photo 1: New pad for 18H-1V

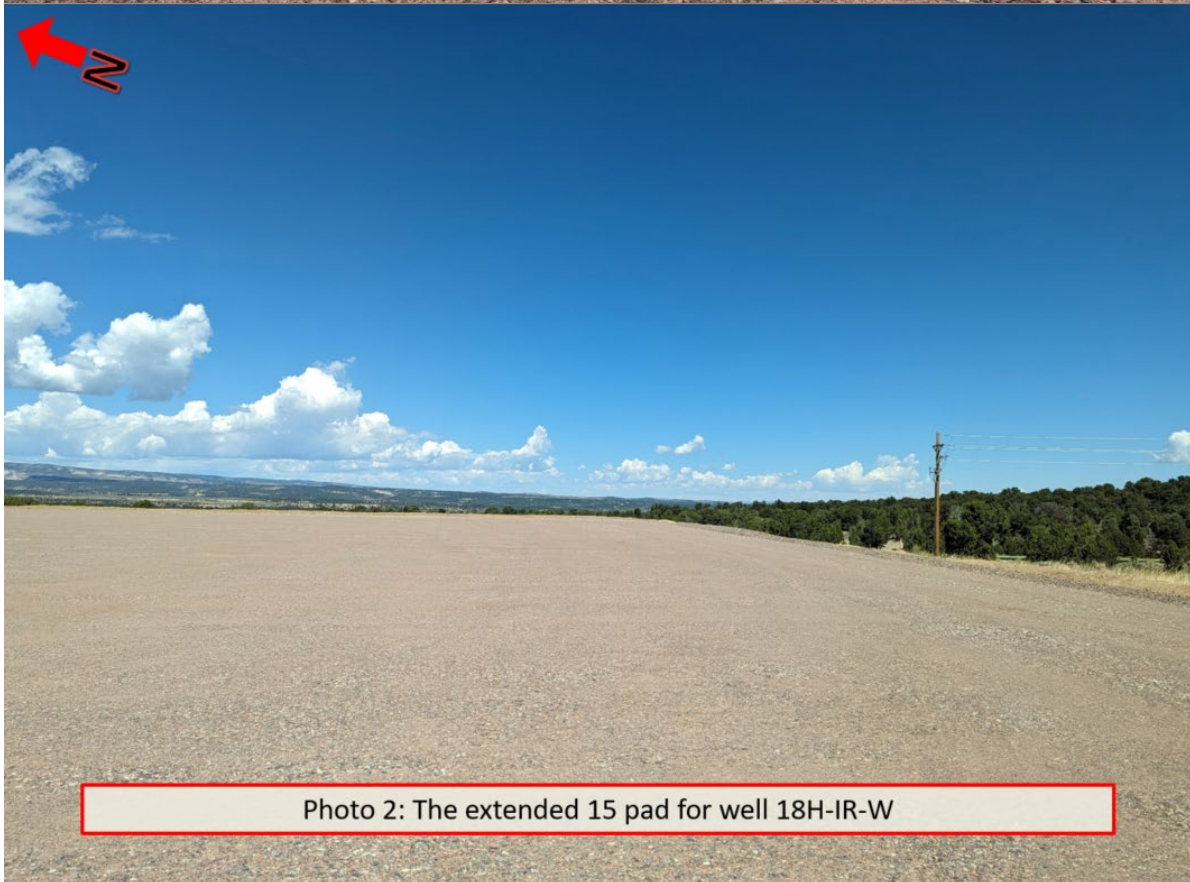
Photo 2: The extended 15 pad for well 18H-IR-W

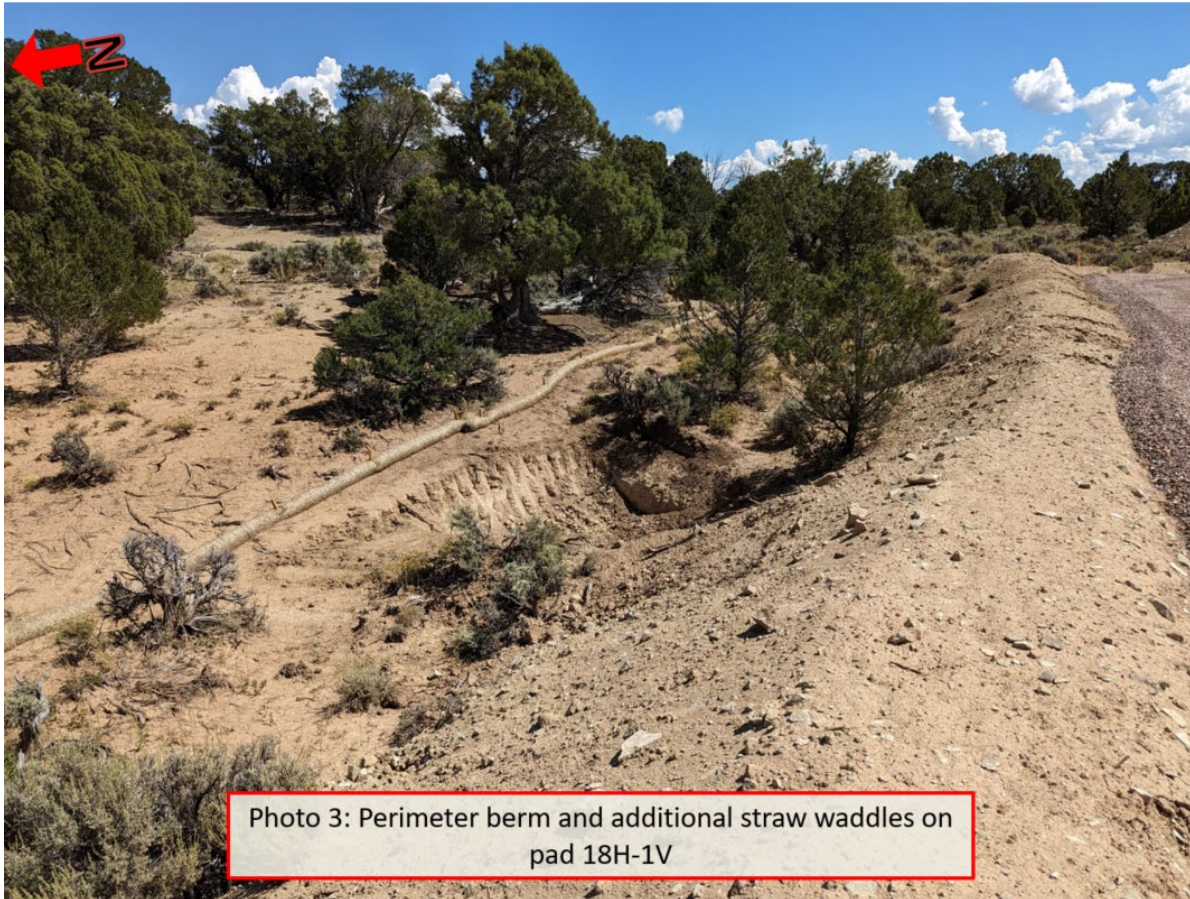
in existence to prevent erosion. Upon inspection all pads had perimeter berms surrounding the leveled gravel area. Additionally most pads appear to be using berms on the up gradient side to divert clean water around the pad. Then any affected water is collected into ditches and then a sediment pond. The two newly constructed pads also had straw wattles just outside of the pad footprint to help control run-on water flowing into the stormwater ditches (Photo Three).

Photo 3: Perimeter berm and additional straw waddles on pad 18H-1V

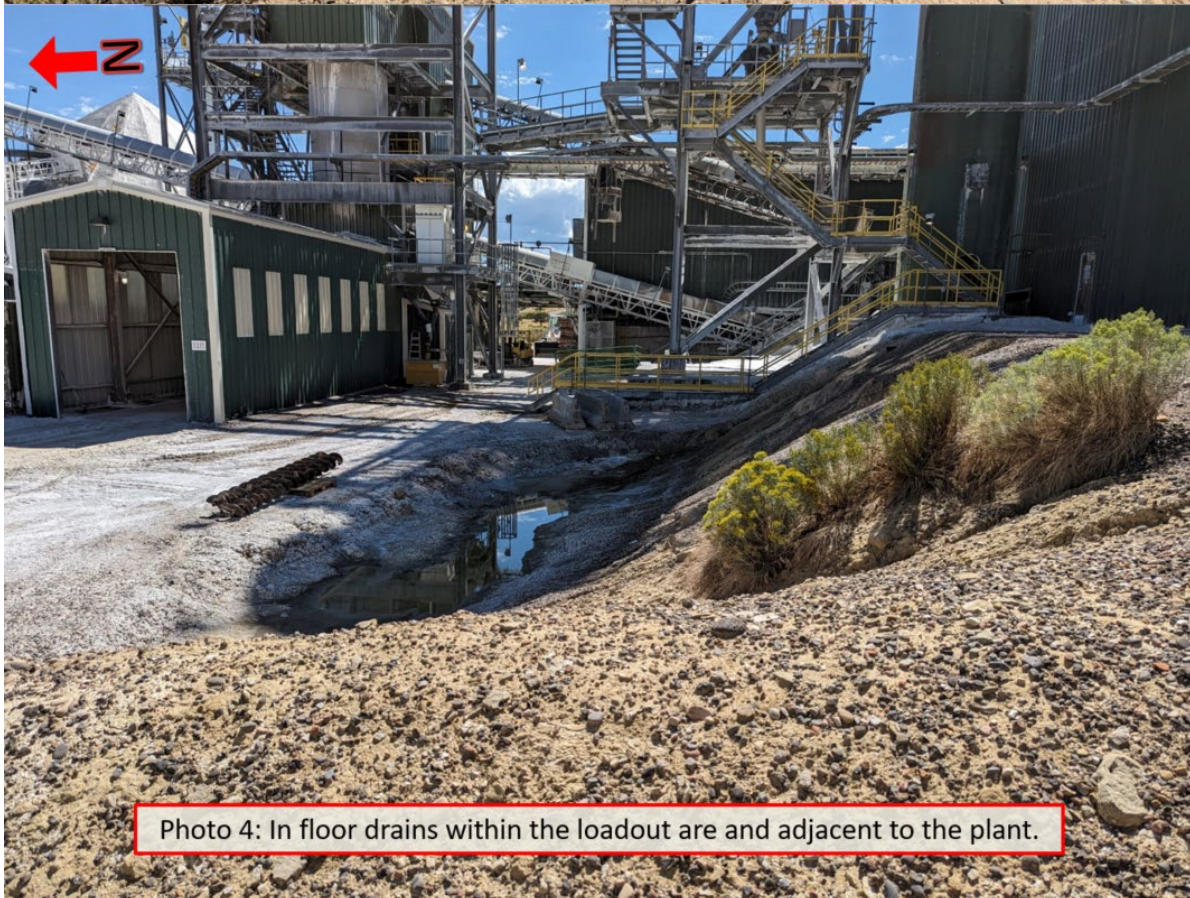
Stormwater surrounding the plant area is managed by 8 drainage zones, 6 catchments and 4 outfalls. All vehicle maintenance is done within the shop area so that materials are not exposed to stormwater discharge. Similarly the storage silos and bulk loadout building is enclosed to keep the sodium bicarbonate dust contained. The dust that accumulates in this area is then periodically washed down to the process ponds. Additionally there are a handful of floor drains located within Zones 1, 2 and 3 that also allow for periodic wash downs and clean ups if material was spilt adjacent to the plant and load out areas (Photo Four).

Photo 4: In floor drains within the loadout are and adjacent to the plant.

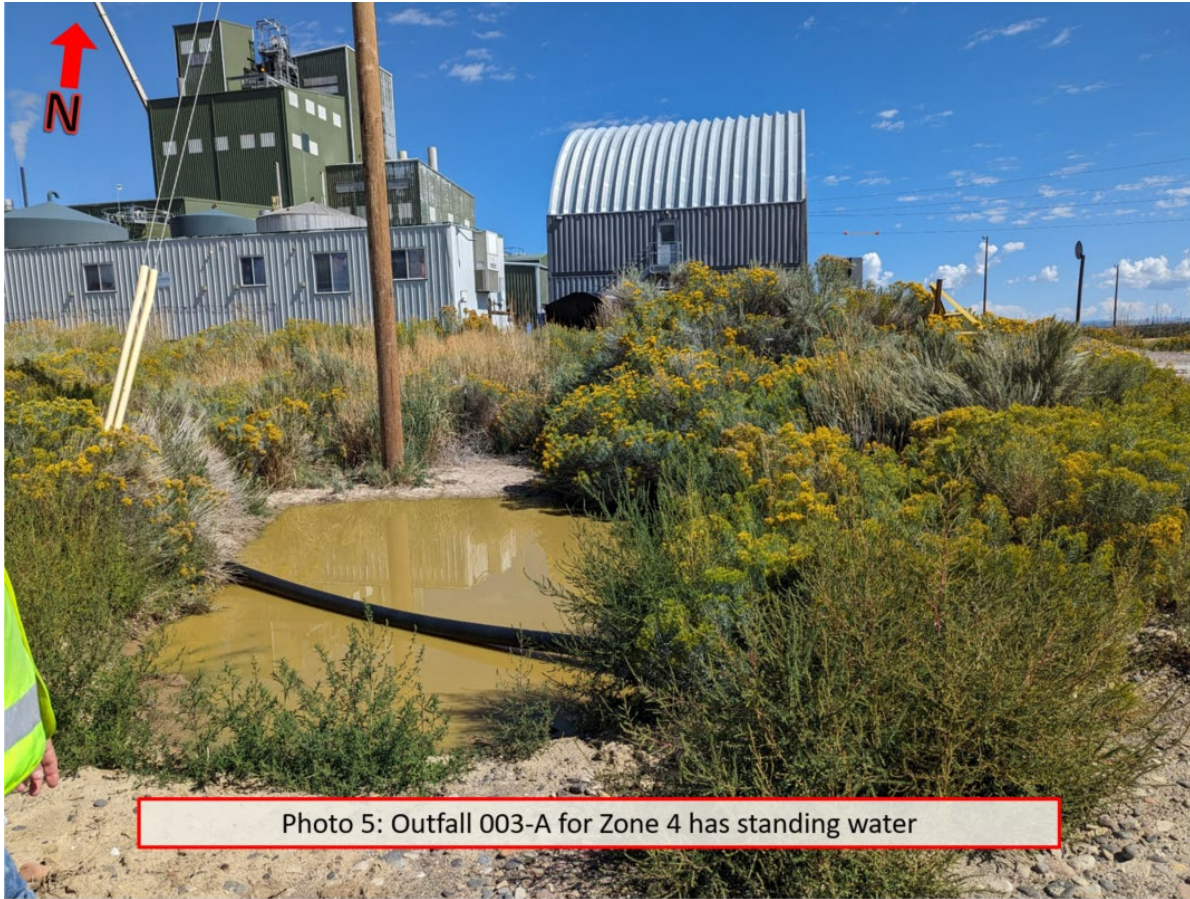
The employee parking lot on the south side of the plant has been constructed since the last Figure 2 (SWMP Map) was created. Outfall 003-A conveys runoff from Zone 4. According to Ms. Reck Outfall 003-A was recently cleaned out. Standing water was observed (Photo Five). A culvert directs water from the outfall point under the road to the east and into the catchment of Zone 4 which ultimately reports to an unnamed tributary of the Yellow Creek. During the inspection it appears that only the southern half of Zone 4 drains to the south. The northern half drains to the north and east into Zone 2 and the catchment of Zone 4. The Zone 4 catchment also had standing water at the time of the inspection.

Photo 5: Outfall 003-A for Zone 4 has standing water

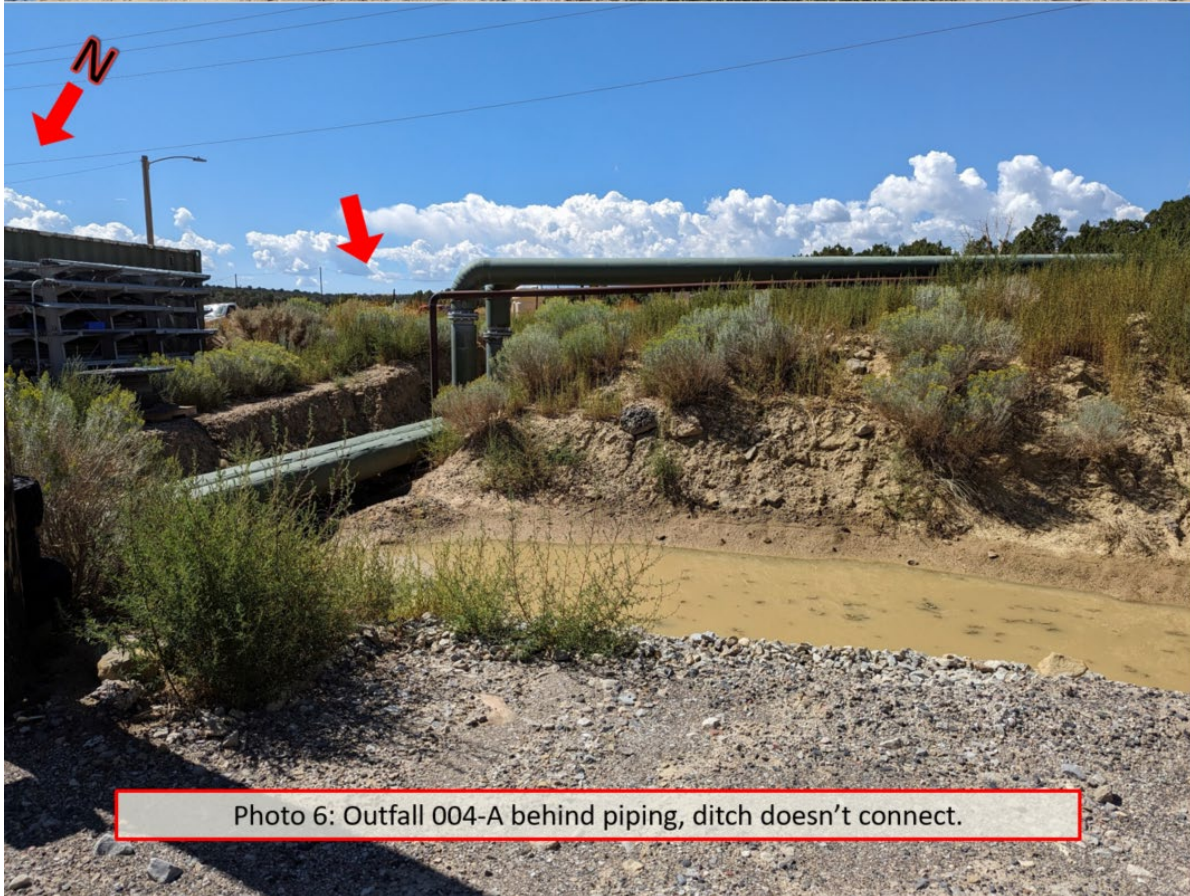
Outfall 004-A discharges water from Zone 5. There is a berm separating the majority of Zone 5 from the parking area. Water generally sheds to the west and is collected into the Zone 5 catchments but is not directed to a discharge point (Photo Six). Only the water collected into the southeast finger of Zone 5 will report to Outfall 004-A. All other water will be diverted around the perimeter of the plant and into Zone 6 and on (Photo Seven). Based on grade, flows from Outfall 004-A will join Outfall 003-A. Small puddles of water were observed in the perimeter ditches (catchments) of Zone 5.

Photo 6: Outfall 004-A behind piping, ditch doesn't connect.

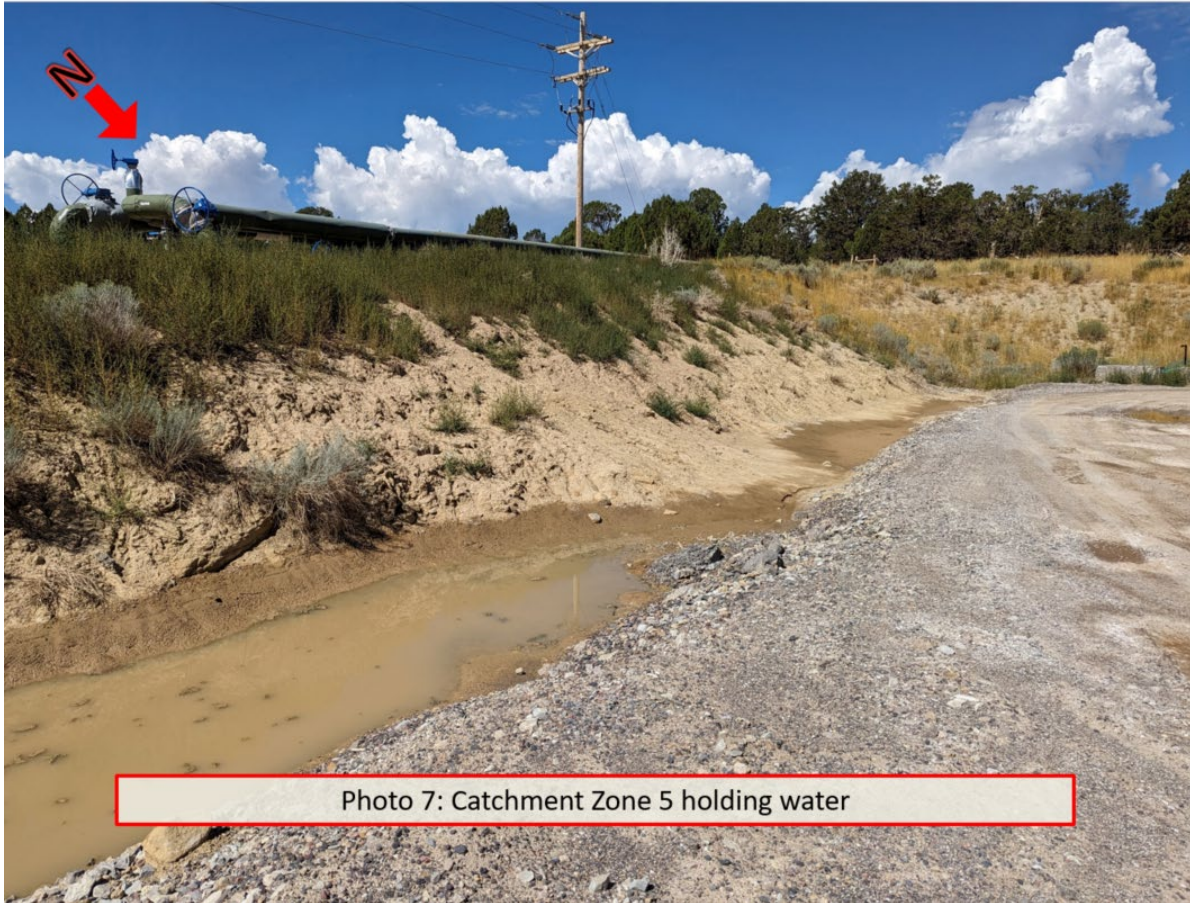
Photo 7: Catchment Zone 5 holding water

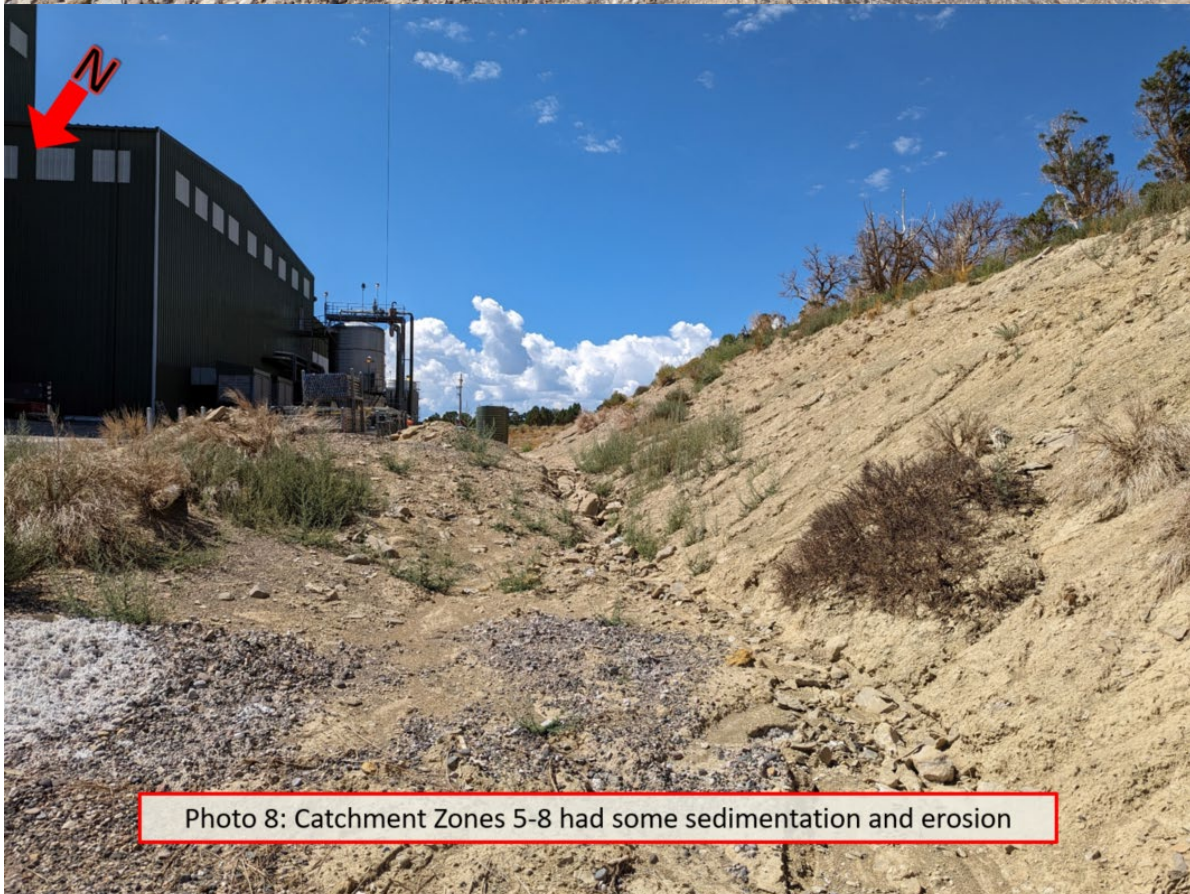
Zones 6, 7 and 8 all have a cut slope on the west/ northwest side with a catchment Zones 5-8 (ditch) to direct water to the north end of the plant into Catchment Zone #8. Catchment Zones 5-8 had some sedimentation and erosion, but overall the ditch appeared to be effectively directing water (Photo Eight). The Catchment Zone #8 is bisected by a dirt berm resulting in two pond features, both of which had standing water (Photo Nine). Ultimately water flows to the east into Outfall 002-A on the southwest side of the road to the evaporation pond. Sedimentation from the parking area was evident and erosion was observed within the catchment Zones 5-8 and Outfall 002-A (Photo Ten). There was also trash present in the catchment #8. This is cited as a problem for failure to operate and maintain drainage control and containment facilities per Rule 6.4.21(10)(b). Trash and excess sediment shall be removed from the Zone 8 catchment and Outfall 002-A so that water can be properly captured and appropriately directed to approved outfall location.

Photo 8: Catchment Zones 5-8 had some sedimentation and erosion

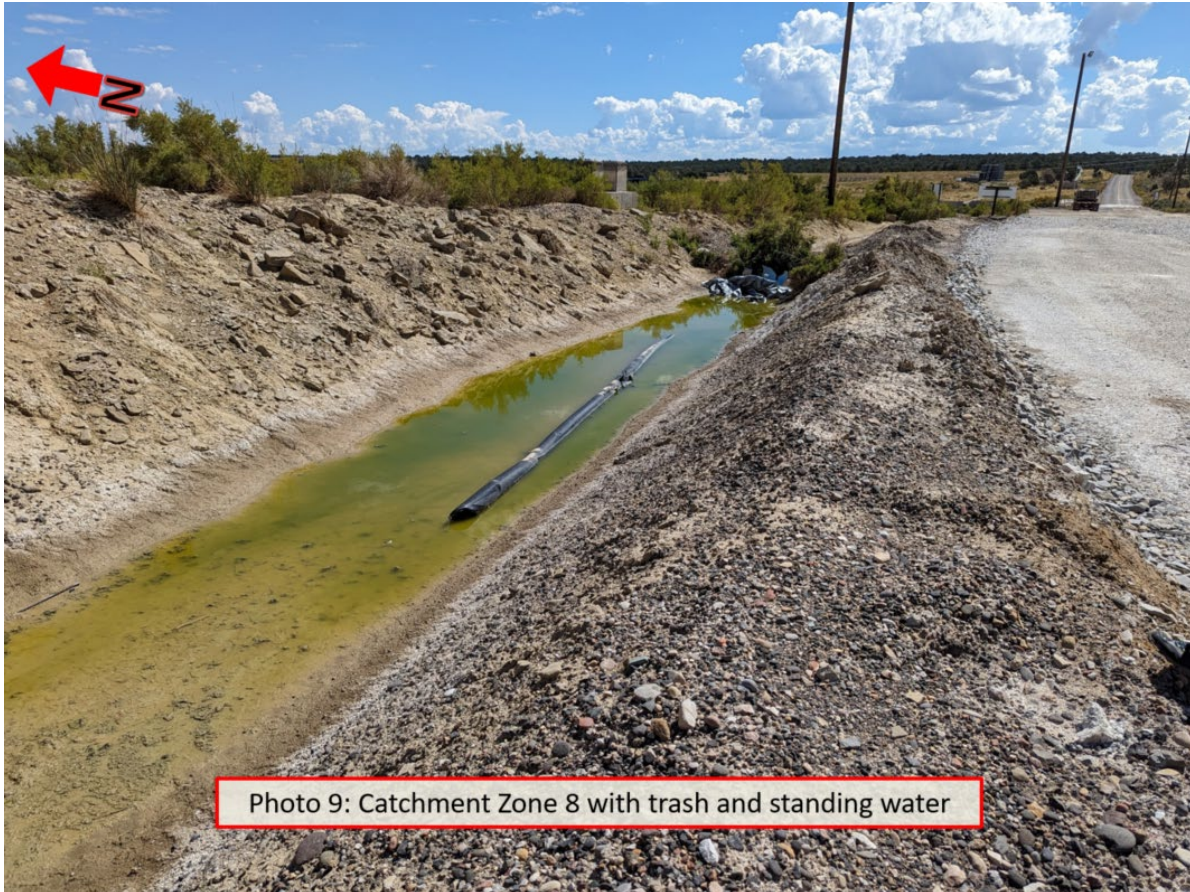
Photo 9: Catchment Zone 8 with trash and standing water

CORRECTIVE ACTIONS: Trash, ditches and berms surrounding the plant area need to be cleaned out/constructed so that water flows to the appropriate BMP features as designed prior to discharge. All site facilities shall function (operated and maintained) as designed in the approved Stormwater Management Plan. The operator shall provide photo documentation to the Division verifying that all facilities have been reconstructed/ maintained, and that the site has been stabilized so that facilities function as designed in the approved Stormwater Management Plan by the corrective action date.

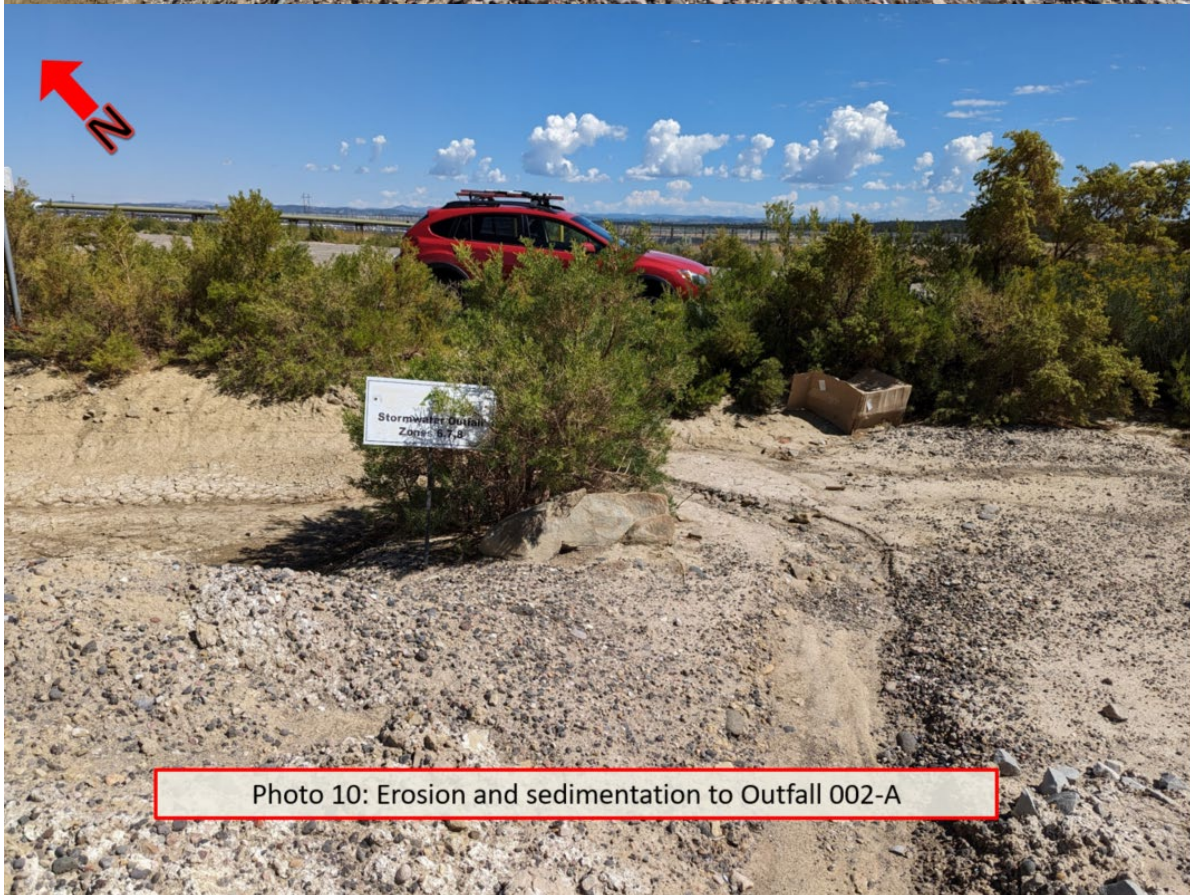
Photo 10: Erosion and sedimentation to Outfall 002-A

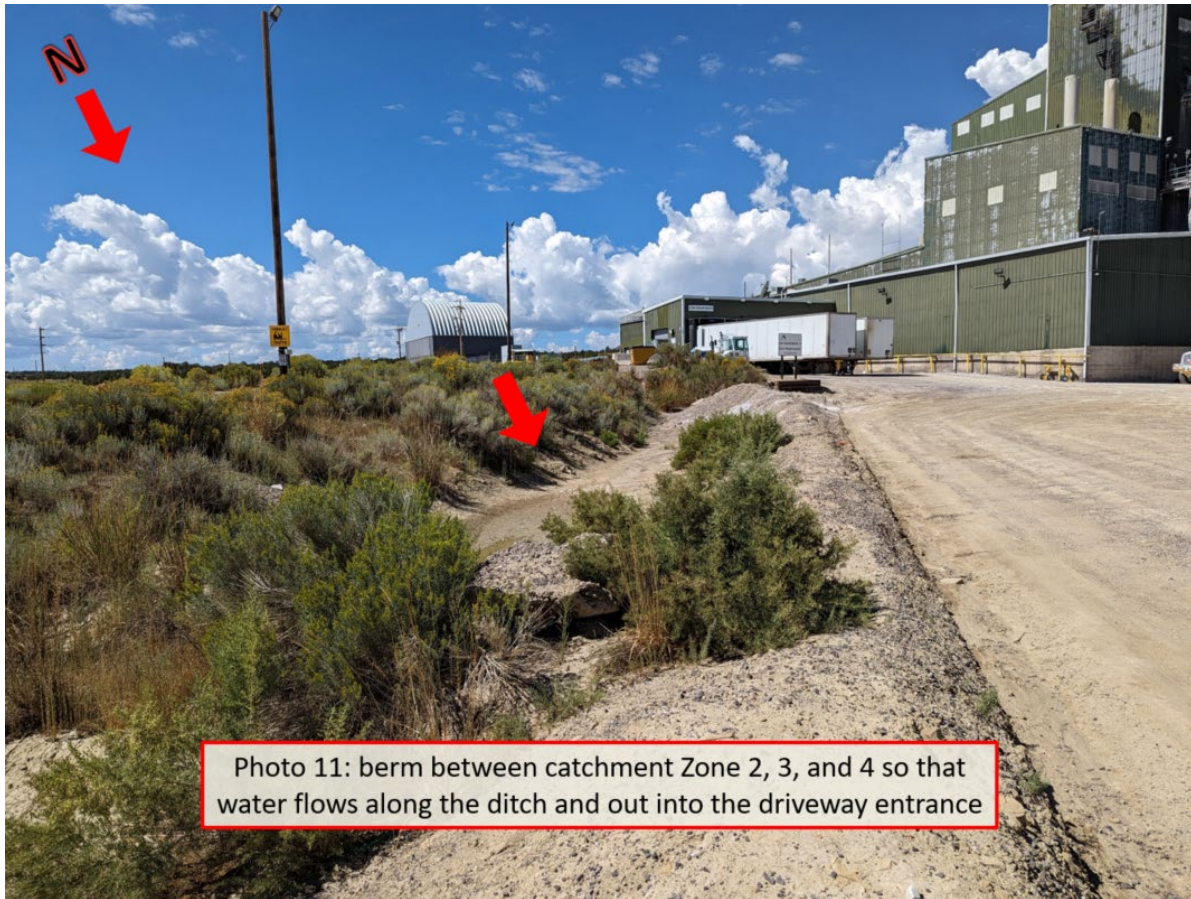
PROBLEM/POSSIBLE VIOLATION: Problem: Trash and sedimentation was observed surrounding the plant area affecting functionality of Stormwater BMPs. All drainage control and containment facilities shall be properly operated and maintained as specified in the approved Stormwater Management Plan pursuant to Rule 3.1.6 and 6.4.21(10)(b).

water cannot flow into the catchment, rather it flows along the ditch and out into the driveway entrance (Photo Eleven). Water designed to flow into the Zone 2, 3 and 4 catchment is not being properly channeled and flowing from the road into the unnamed tributary of the Yellow Creek. This is cited as a problem for failure to operate and maintain drainage control and containment facilities per Rule 6.4.21(10)(b). Ditched and berms within Zones 1, 2 and 3 need to be cleaned out/constructed so that water flows to the appropriate BMP features as designed prior to discharge.

Photo 11: berm between catchment Zone 2, 3, and 4 so that water flows along the ditch and out into the driveway entrance
