Division of Reclamation,
Mining and Safety

MINERALS PROGRAM INSPECTION REPORT

MINE NAME: Sheehan Pit	MINE/PROSPECTING ID#: M-2007-058	MINERAL: Sand and gravel	COUNTY: Moffat
INSPECTION TYPE: Monitoring	WEATHER: Clear	INSP. DATE: August 28, 2023	INSP. TIME: 14:00
OPERATOR: C&B Sand and Gravel Inc.	OPERATOR REPRESENTATIVE: Donald Corson	TYPE OF OPERATION: 110c - Construction Limited Impact

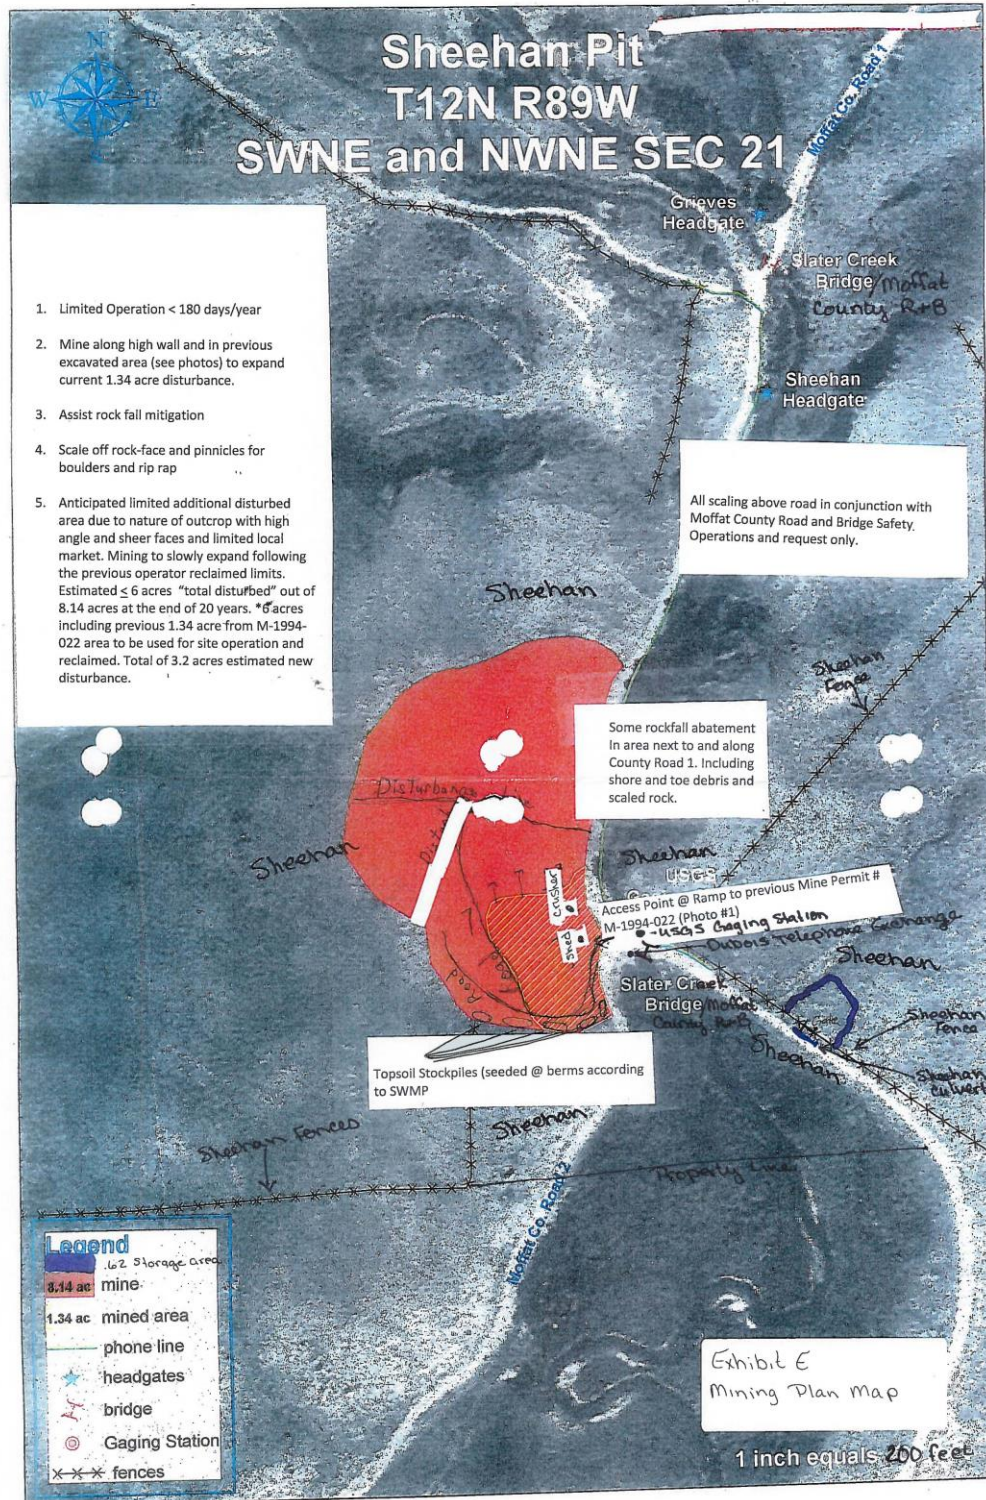
Figure 1. Approved Exhibit E – Mining Plan Map

Prior to the inspection, the approved permit and associated maps were reviewed along with previous inspection reports (2018 and 2022). The Division georeferenced the approved Mining Plan Map (Figure 1.) within ArcGIS and uploaded to ArcGIS Field Maps (Field Maps) for use during the inspection. Field Maps is an all-in-one app that uses data-driven maps and mobile forms to help workers perform data capture and editing, find assets and information, and report their real-time locations with the use of GPS. This allowed the inspector to ensure he was able to document his location and any potential issues during the inspection with

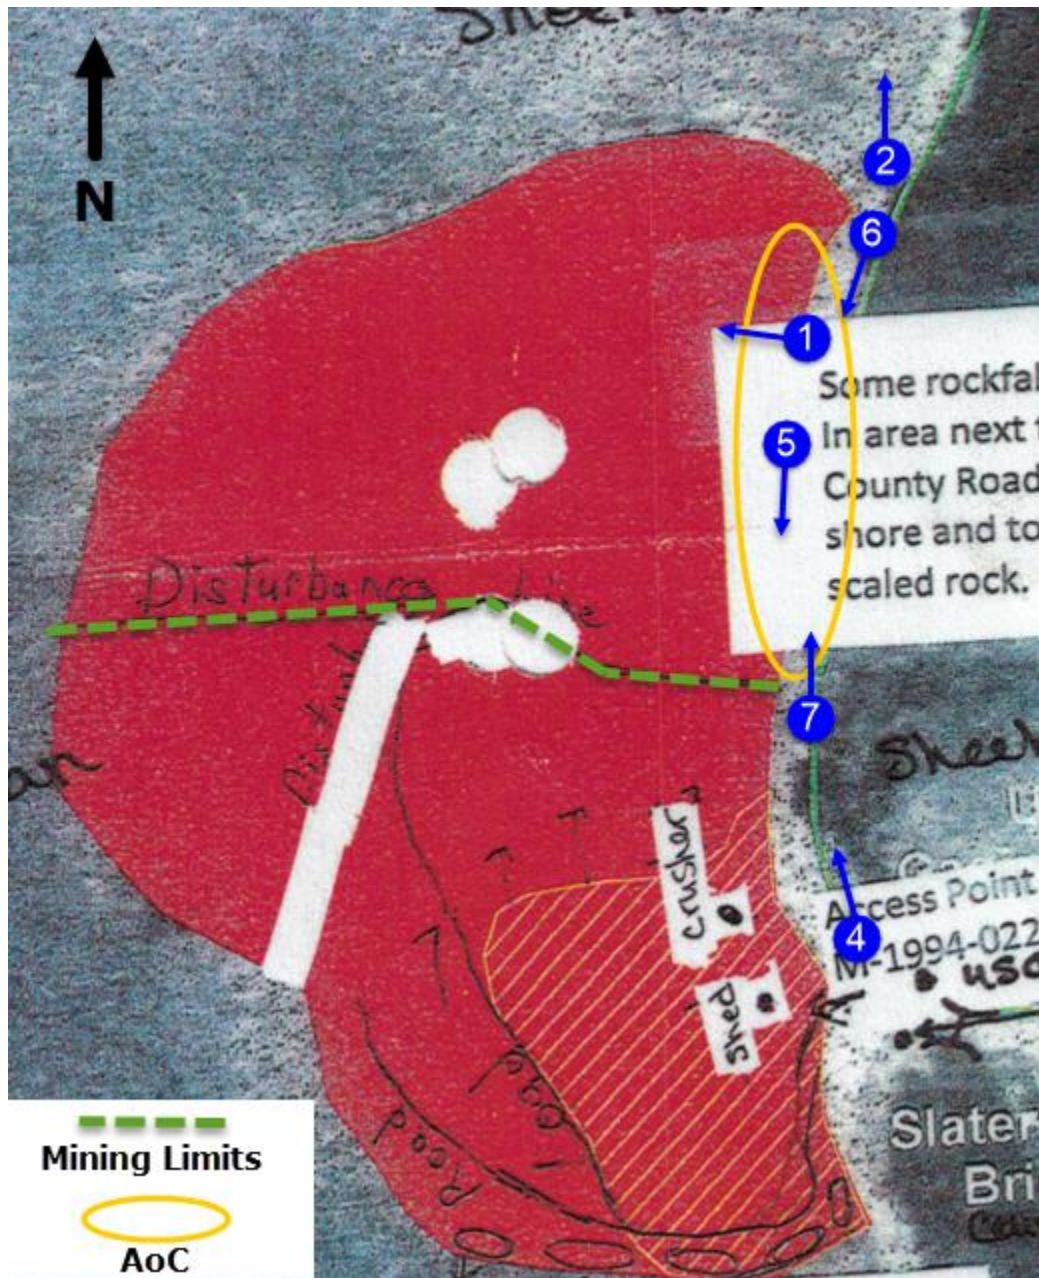
Figure 2. Photo location and direction.

Based on surface observations during the inspection, the Sheehan Pit is located in a steep narrow canyon along Slater Creek comprised mostly of underlying weathered and erosive soils especially noted along the slope intersection with the County Road 1. Overlying these soils is loose rock at approximately angle of repose (Photo 1). Comparing the area of concern to native undisturbed adjacent areas within the canyon (Photo 2), it appears to the Division that the loose rock is from previously created disturbances with some degree of contribution from natural weathering and erosion. Overall, the site location is very steep and erosive. For use within this inspection report, the area observed during this inspection that had the potential for immediate sloughing and/or rock fall in relation to County Road 1 as noted by the Division will be called the "Area of Concern" (AoC). Please refer to Figure 2 of this report for the location of the AoC.

Using Field Maps, the Division compared the AoC with the approved mining permit (Figures 1 and 2). The Division also inspected the active mining locations along with the review of previous Division inspection reports. Based on this inspection and previous inspection reports, no mining activity outside of the mining limits was or could be observed. Additionally, based on discussions with the Operator, the site has been inactive since 2022. Comparing this information along with the location of the AoC, it does not appear to the Division that the rock fall or sloughing is caused directly from current mining activities but from the current loose conditions of the slope along with seasonal precipitation and snow melt. With that said, the AoC is within the limits of the approved mining permit (Photos 6 and 7) and needs to be stabilized. Per Rule 3.1.6(3), all surface areas of the affected land, including spoil piles, shall be stabilized and protected so as to effectively control erosion. Additionally, per Rule 6.3.3(I), [the mining plan must] describe what measures will be taken to minimize disturbance to the hydrologic balance, prevent off-site damage, and provided for a stable configuration of the reclaimed area consistent with the proposed future land use. Based on the observations of this inspection, additional measures are necessary within the permit to ensure all Rules and Requirements are met by the Sheehan Pit. Therefore, a problem is cited in this report (see page 1), requiring the operator to submit a Technical Revision with an updated mining plan that describes what measures will be taken to stabilize the slope within the permit area and prevent off-site damage from occurring due to rock falls.

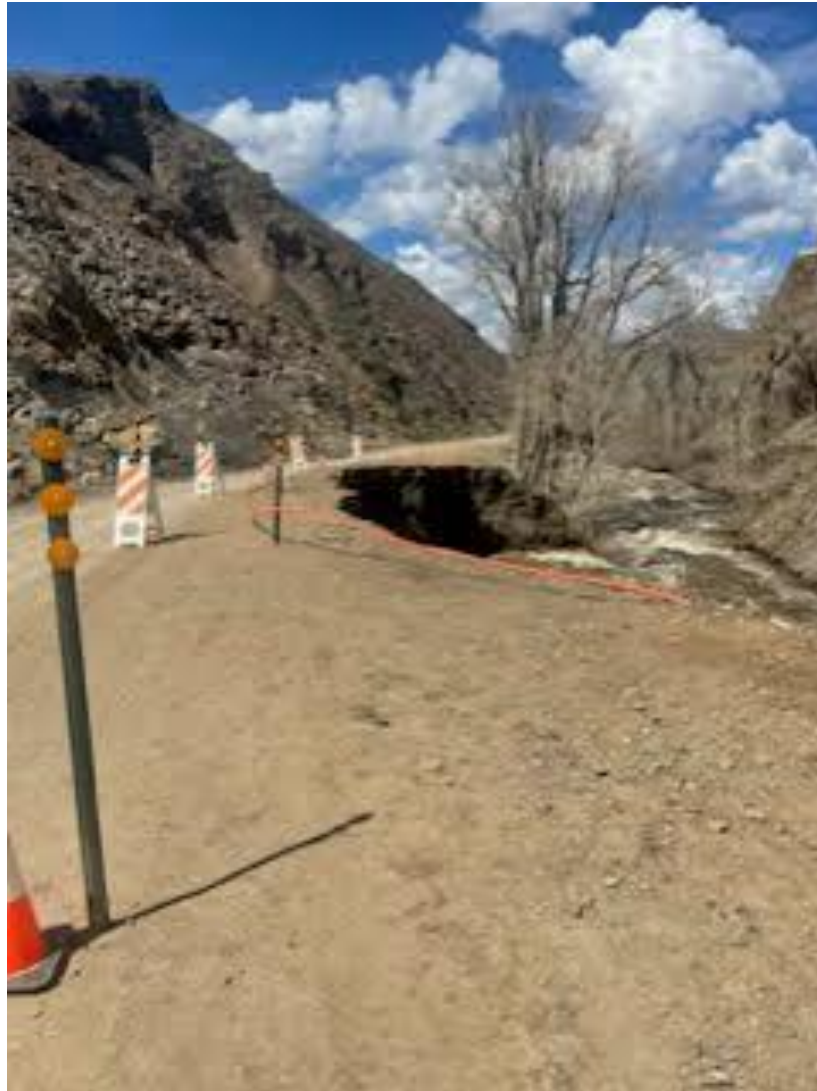
Photo 3.

During the inspection, the Operator discussed maintenance and repair work that occurred to County Road 1 as a result of cutting from Slater Creek. On August 30, 2023, the Operator provided photo documentation of the cutting that occurred along the outer creek embankment along County Road 1 (Photo 3). Based on the provided photos, it appears that the erosion impacted a portion of County Road 1. The Operator stated that during the road maintenance, road grading cut into the slope at the AOC which potentially compounded the issue and may have caused additional sloughing to occur. At the time of this inspection, road maintenance had concluded at County Road 1 (Photo 4).
