MINERALS PROGRAM INSPECTION REPORT
PHONE: (303) 866-3567

MINE NAME: London Mine	MINE/PROSPECTING ID#: M-2023-015	MINERAL: Gold and silver	COUNTY: Park
INSPECTION TYPE: Preoperation Inspection	WEATHER: Clear	INSP. DATE: August 14, 2023	INSP. TIME: 12:45
OPERATOR: MineWater LLC	OPERATOR REPRESENTATIVE: Joseph Harrington	TYPE OF OPERATION: 110d - Designated Limited Impact

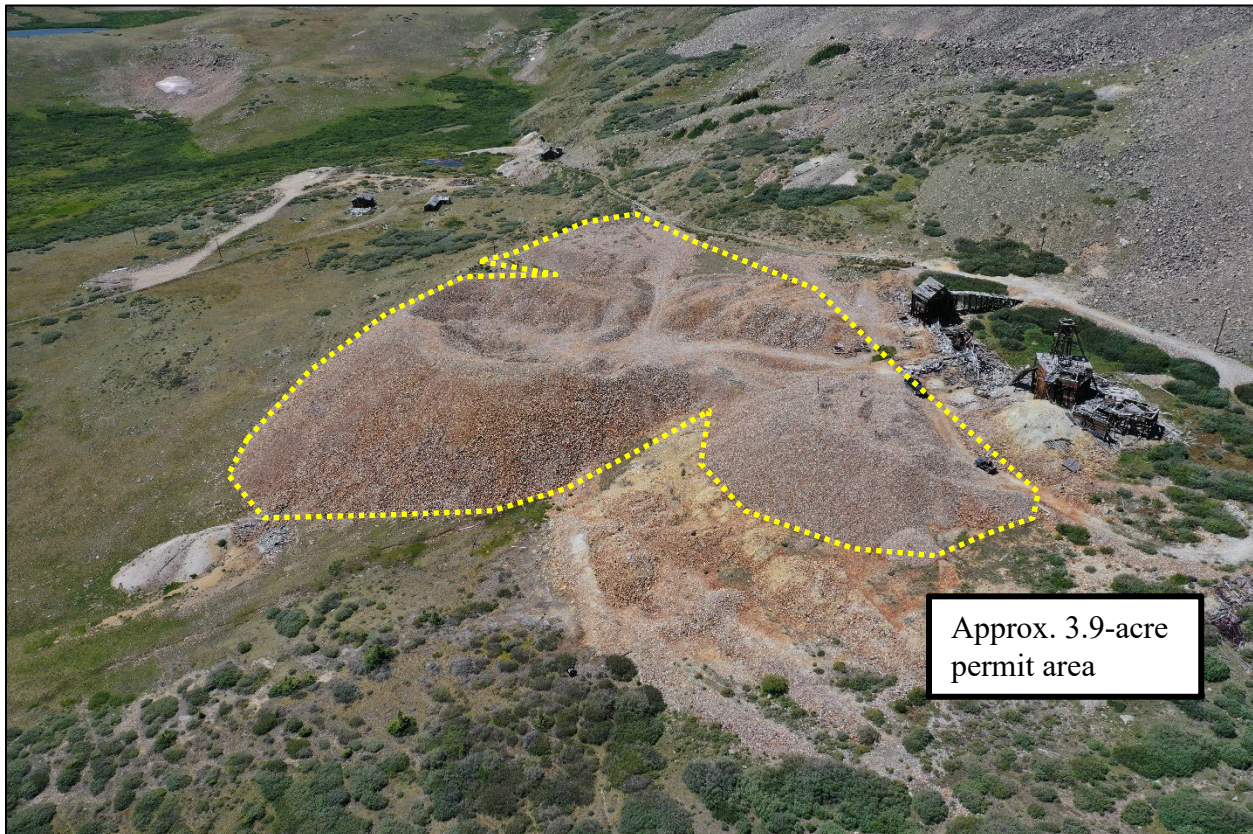
Photo 1. Overview of the South London Stockpile Area; looking northwest.

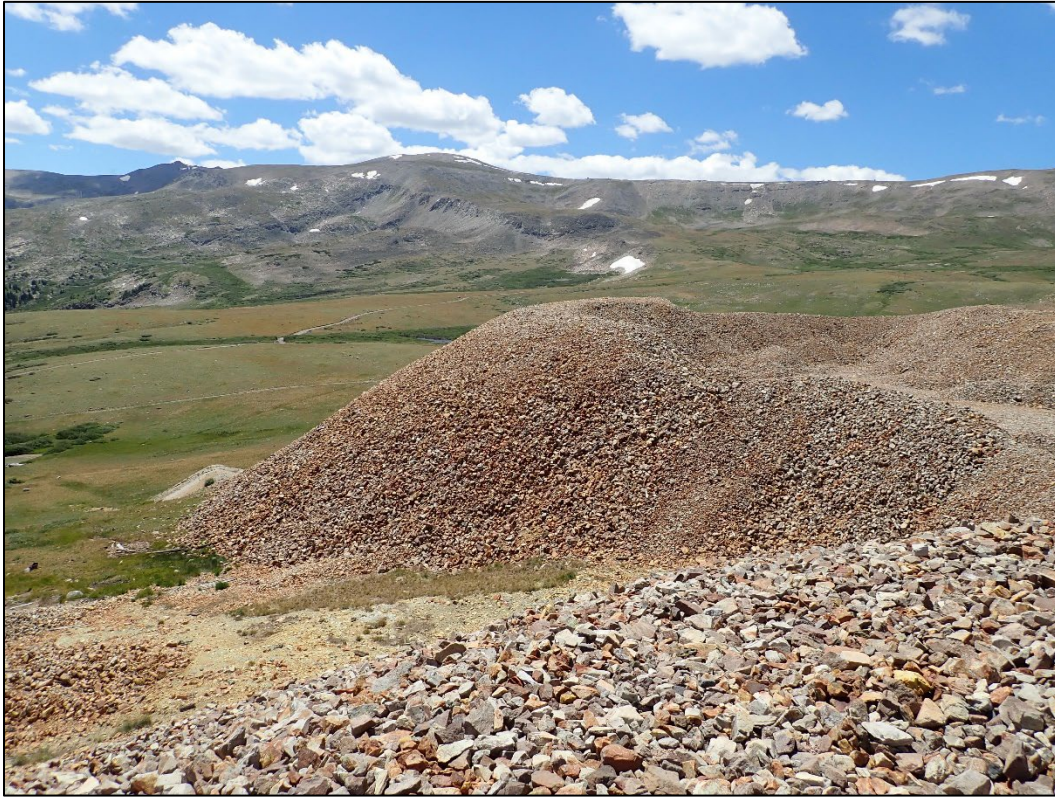
Photo 2. South London Stockpile Area; looking west.

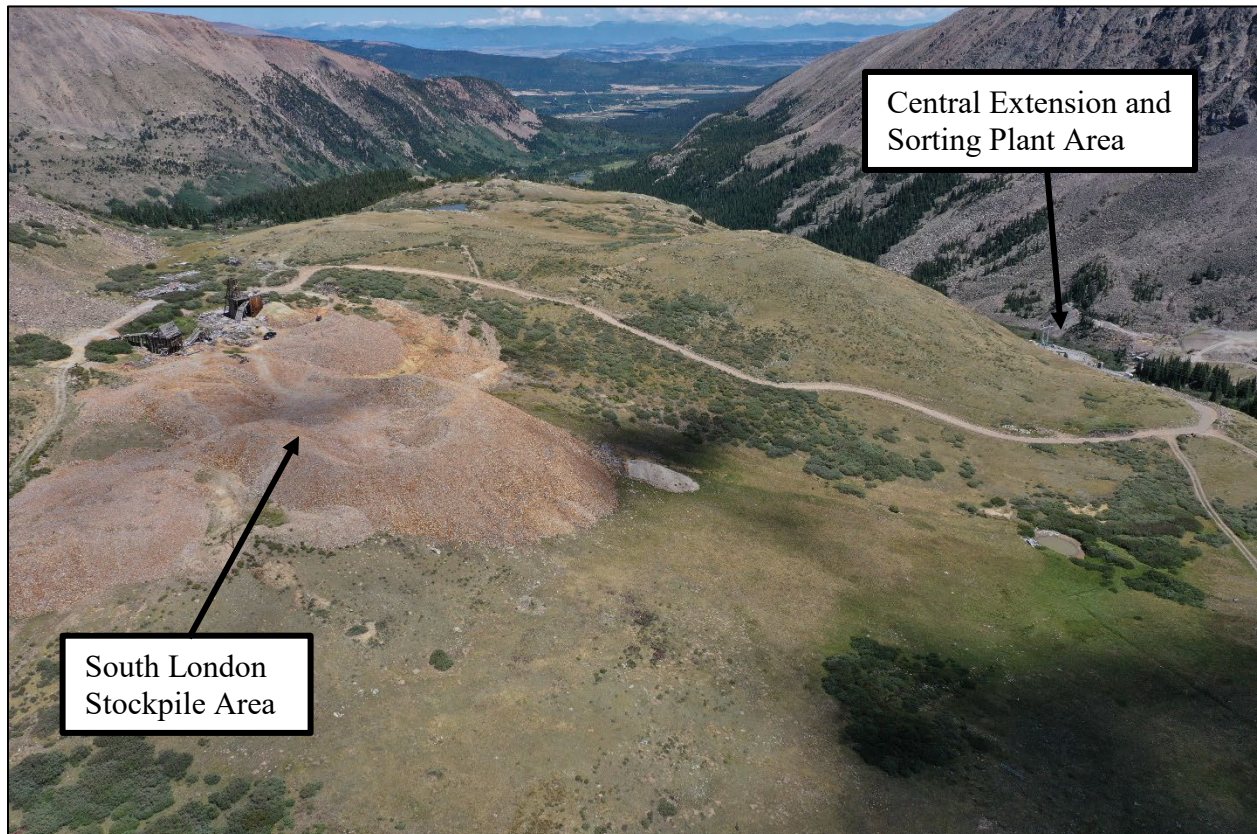
Photo 3. Location overview of the proposed operation's two permitted areas; looking east.

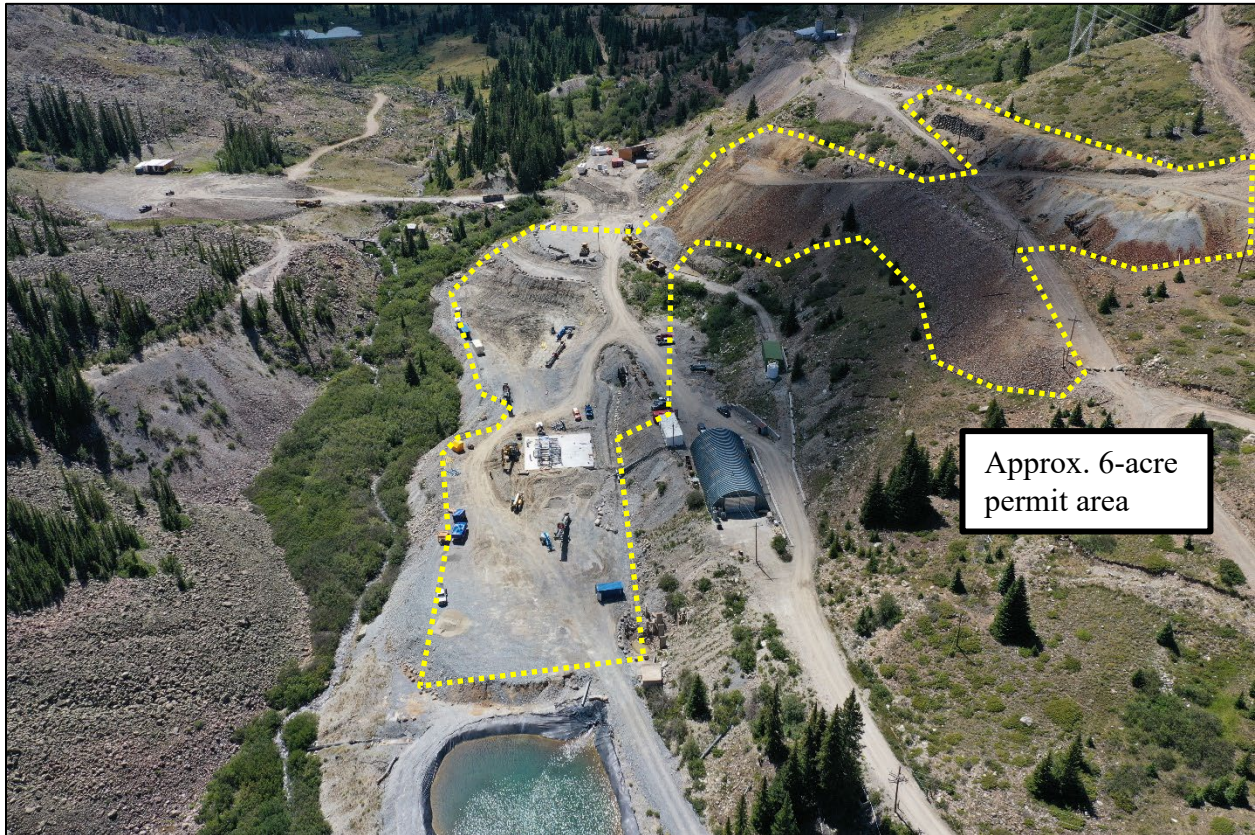
Photo 4. Overview of the Central Extension and Sorting Plant Area; looking west.

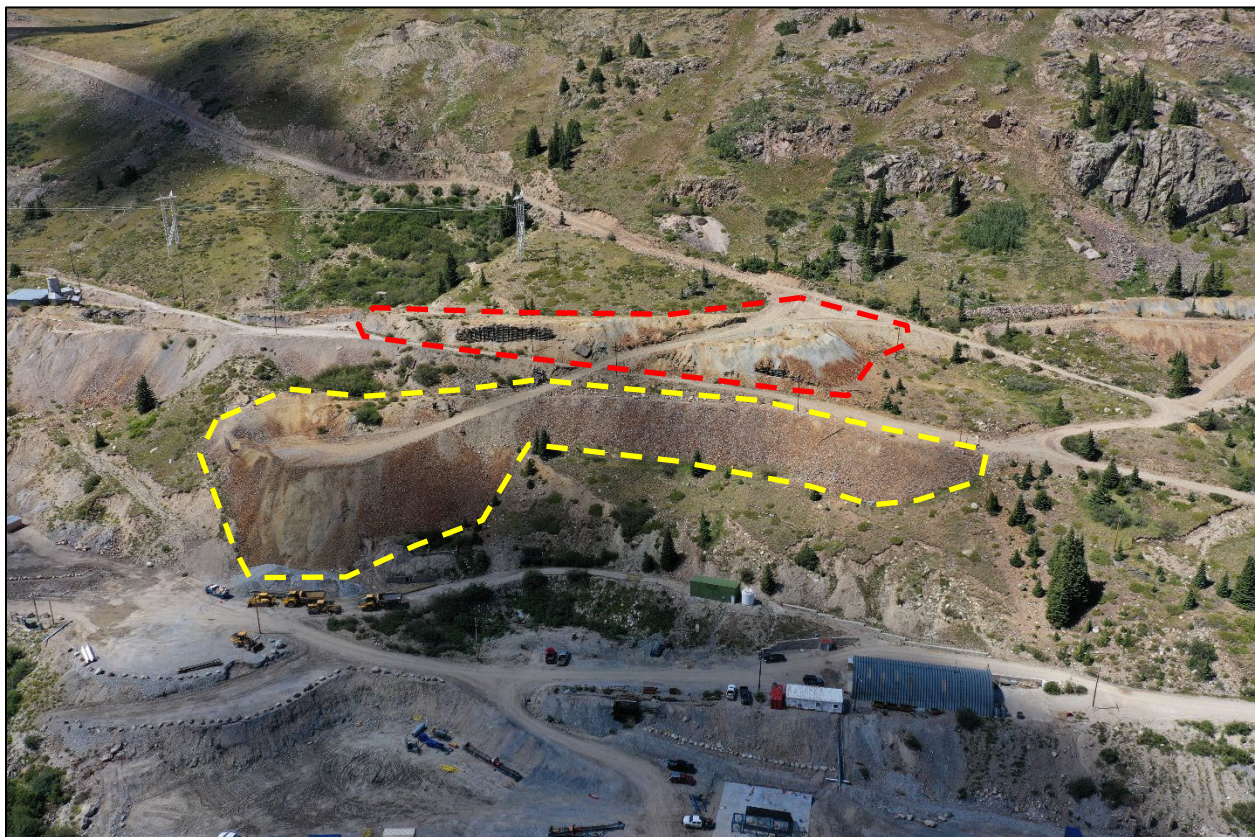
Photo 5. Overview of the Upper (red) and Lower (yellow) WR stockpiles; looking north.

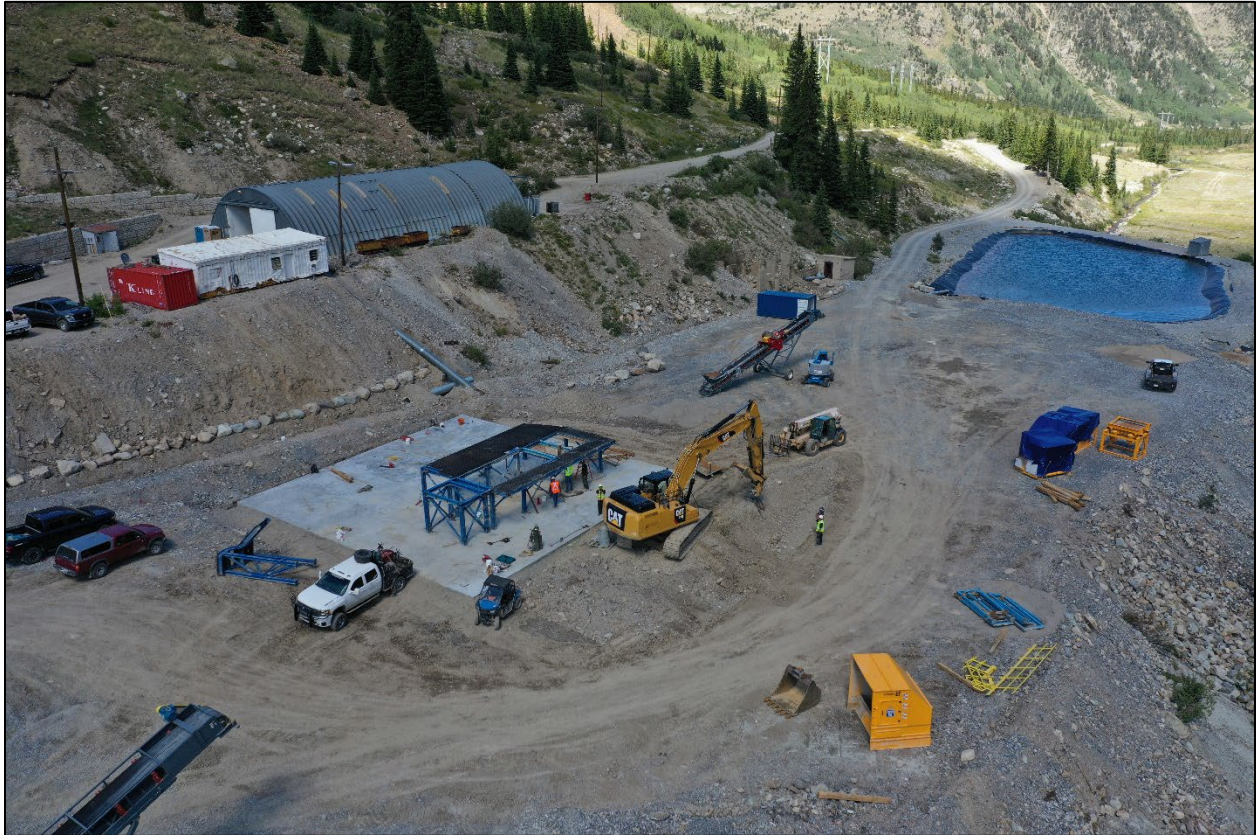
POSSIBLE VIOLATION: Failure to first obtain a reclamation permit from the Mined Land Reclamation Board before engaging in a new mining operation as required by C.R.S. 34-32-109(2).

During the inspection, the Division observed the construction of the facility that the sorter will be located. A concrete foundation and structure has been built before the permit has been approved/issued by the Division. An approximate 60' x 60' concrete pad on a 4' concrete foundation had been poured. At the time of the inspection, site personnel were constructing a metal structure on the concrete pad which will support the x-ray sorter. The application discusses the sorter will be located within a 30-foot tall air containment tent on this concrete pad. During the inspection, the Applicant stated that after getting confirmation from Park County that a building permit was not necessary for the sorting facility, they started the first of three concrete pours. Each pour cured for at least seven days before the next pour and that on the day of the inspection, it had been seven days since the third and final pour. It was unclear when activities commenced, but the Division estimates that activities started no later than July 24, 2023.

Photo 6. Concrete pad and metal structure for sorting machinery; looking northeast.

CORRECTIVE ACTIONS: This possible violation has been scheduled to be considered by the Mined Land Reclamation Board during the September 20-21, 2023 Board meeting. Official notice of the schedule and other details for the MLRB hearing will be provided under a separate document to be sent via certified mail to the Operator.

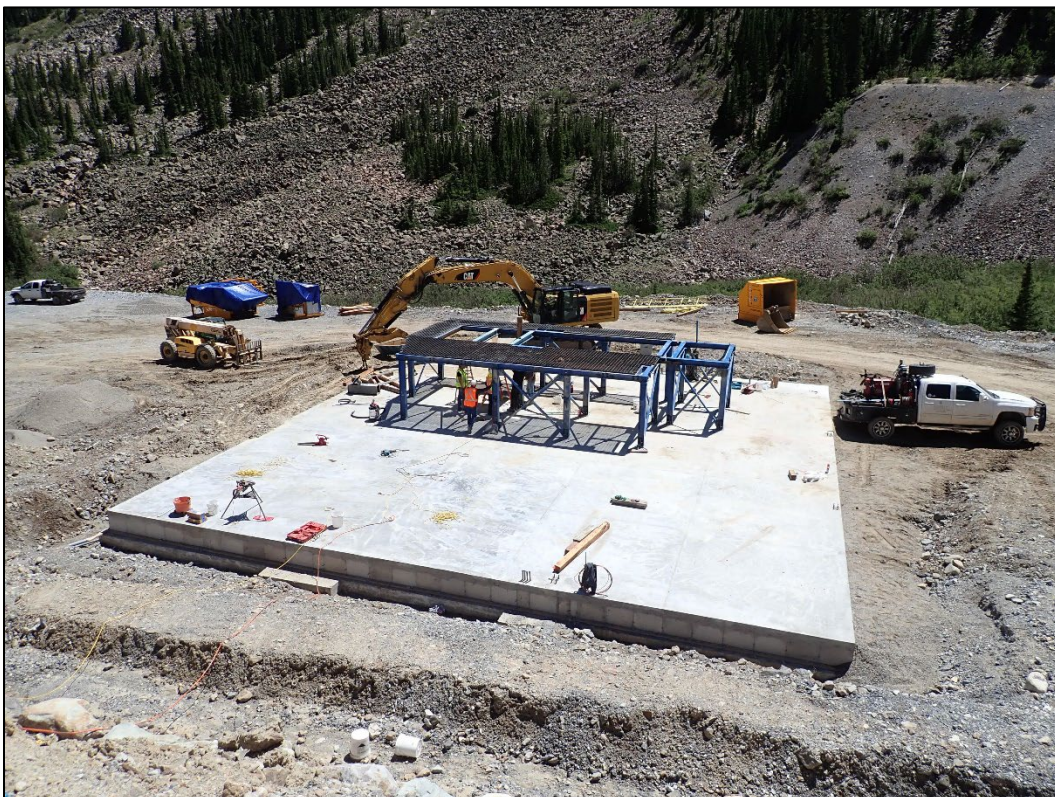
Photo 7. Concrete pad and metal structure for sorting machinery; looking south.
