Bowie #2 inspection report

Permit Number: C-1996-083 Mine Name: Bowie No. 2 Mine Operator: Bowie Resources, LLC Operator Address: Mr. Basil Bear P.O. Box 1488 Paonia, CO 81428	County: Delta Operation Type: Underground Permit Status: Active Ownership: Private
	Operator Representative Present: None
Operator Representative Signature: (Field Issuance Only)

Inspection Start Date: September 7, 2023 Inspection Start Time: 09:00 Inspection End Date: September 7, 2023 Inspection End Time: 10:30		Inspection Type: Coal Partial Inspection Inspection Reason: Normal I&E Program Weather: Clear	
Joint Inspection Agency: None		Joint Inspection Contacts:	
Post Inspection Agency: None		Post Inspection Contacts:	
Inspector(s): Robert Zuber, P.E.	Inspector's Signature:

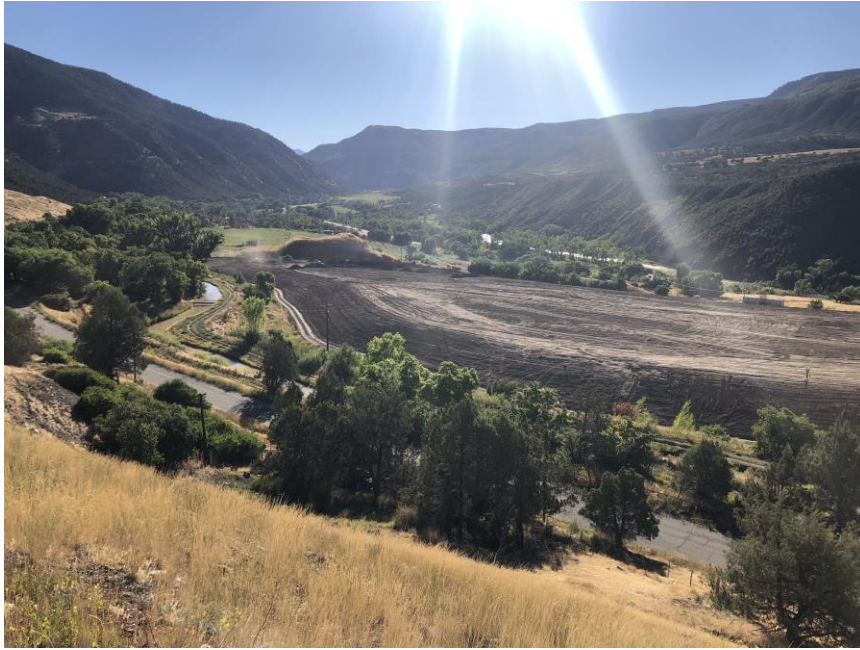
Gob Pile #3, east end

The work on Gob Pile #3 has progressed considerably in recent months. See photographs below.

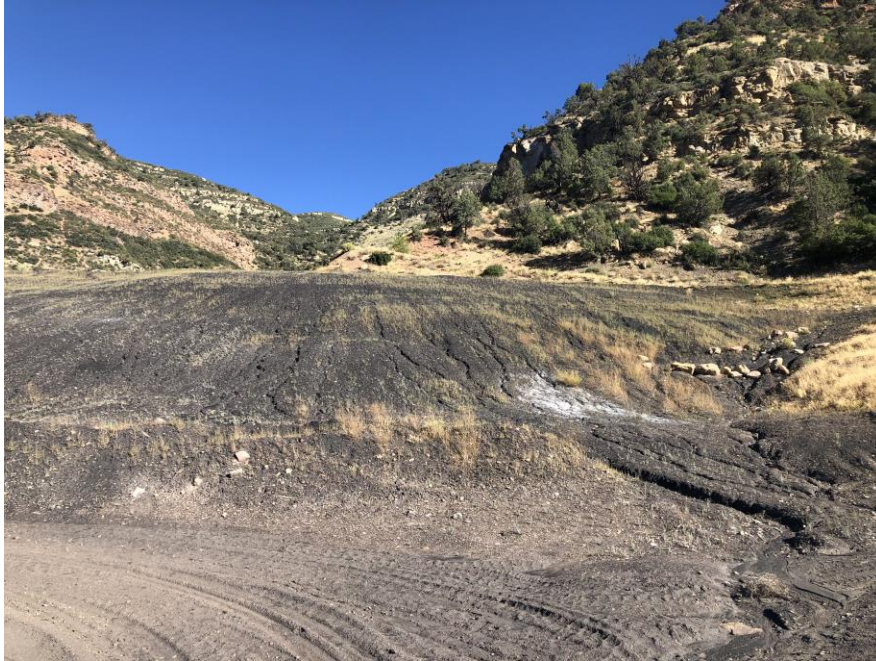
Gob Piles 1, 2, 3, and 4 appeared stable. Some rills are on the upper slope of Gob Pile #2, but appear no worse than in recent months.

Rills on Gob Pile #2

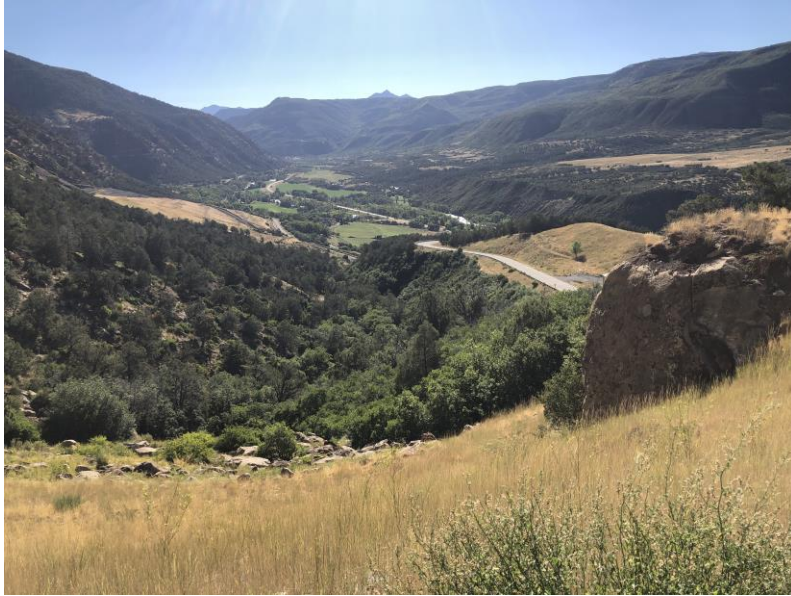
Watershed above Pond C

No problems with ditches were seen. This includes the undisturbed drainage that extends below riprap ditch C14 to Pond C.

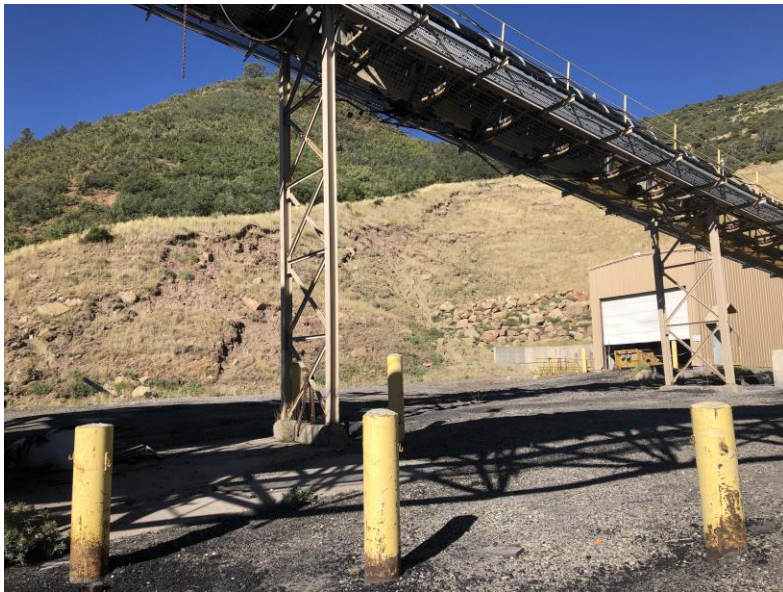
B Portal Bench – slide has continued to get worse

The slump above the west side of the B Portal Bench has moved in recent weeks. As noted before, it could be advantageous to improve the ditch above this area to limit further problems with this slope.

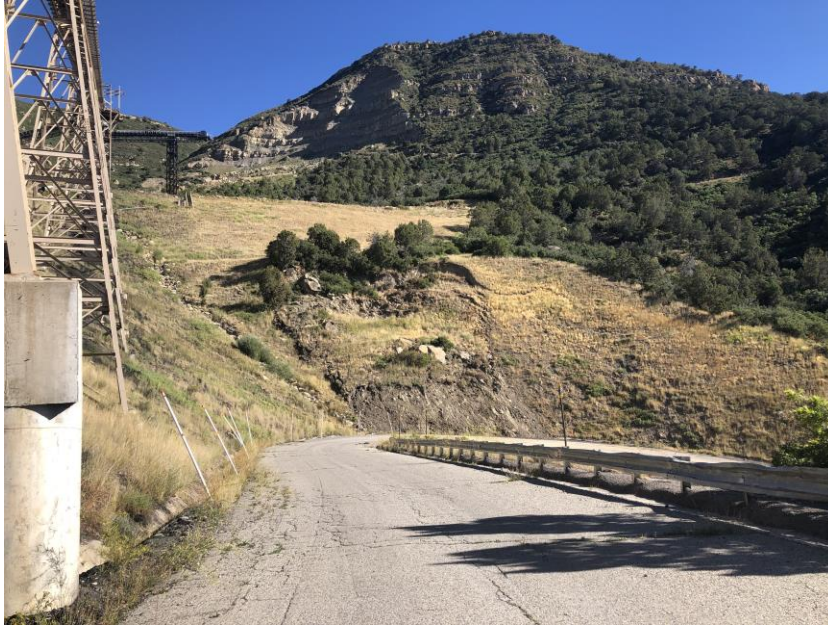
Slide above Curve 10

The road to the portals was in adequate condition. The majority of slopes adjacent to this road were stable, with the exception of the slide above Curve 10.

The slide above Curve Number 10 is an ongoing problem. The ground appears to have dropped more than five feet. It does not appear to be worse than during the August 2023 inspection.

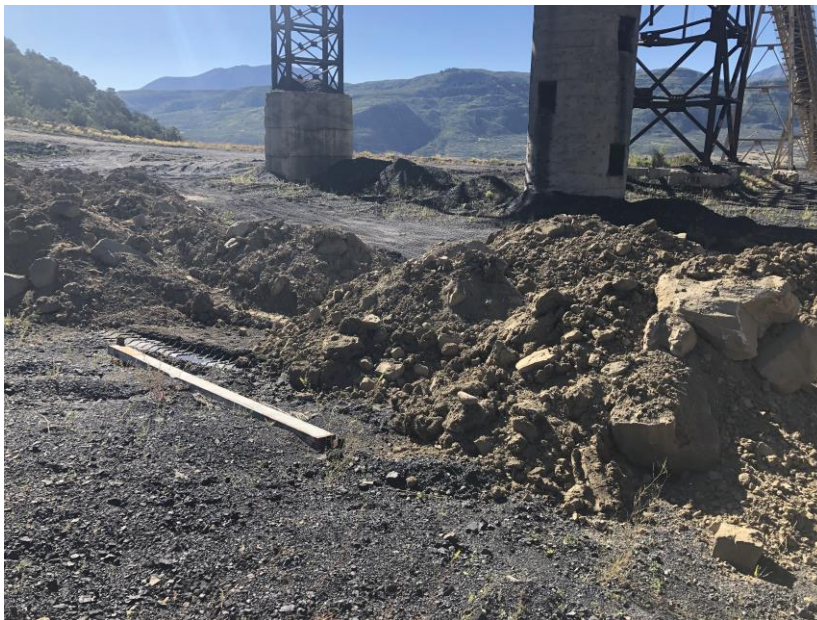
**Area on D Portal Bench where water could pond and infiltrate into bench
(Possible need for drainage improvement)**

Basil Bear has indicated that the source of water causing the slide above Curve 10 may be the D Portal bench. It appears that more work is needed regarding the drainage of runoff from the bench. The soil piles and general grade may need to be altered to get water to drain from the area and not infiltrate through the bench and to the slide area.
