MINERALS PROGRAM INSPECTION REPORT
PHONE: (303) 866-3567

MINE NAME: Henderson Mine	MINE/PROSPECTING ID#: M-1977-342	MINERAL: Molybdenum	COUNTY: Clear Creek, Grand
INSPECTION TYPE: Monitoring	WEATHER: Clear	INSP. DATE: August 22, 2023	INSP. TIME: 09:00
OPERATOR: Climax Molybdenum Company	OPERATOR REPRESENTATIVE: Geoff Niggeler	TYPE OF OPERATION: 112d-3 - Designated Mining Operation	
REASON FOR INSPECTION: Normal I&E Program	BOND CALCULATION TYPE: None	BOND AMOUNT: \$135,204,778.00	
DATE OF COMPLAINT: NA	POST INSP. CONTACTS: None	JOINT INSP. AGENCY: None	
INSPECTOR(S): Brock Bowles Amber Michels Joel Renfro	INSPECTOR'S SIGNATURE:

The focus of this inspection was the stormwater structures on the mine side of Henderson and the external facilities of the URAD water treatment plant.

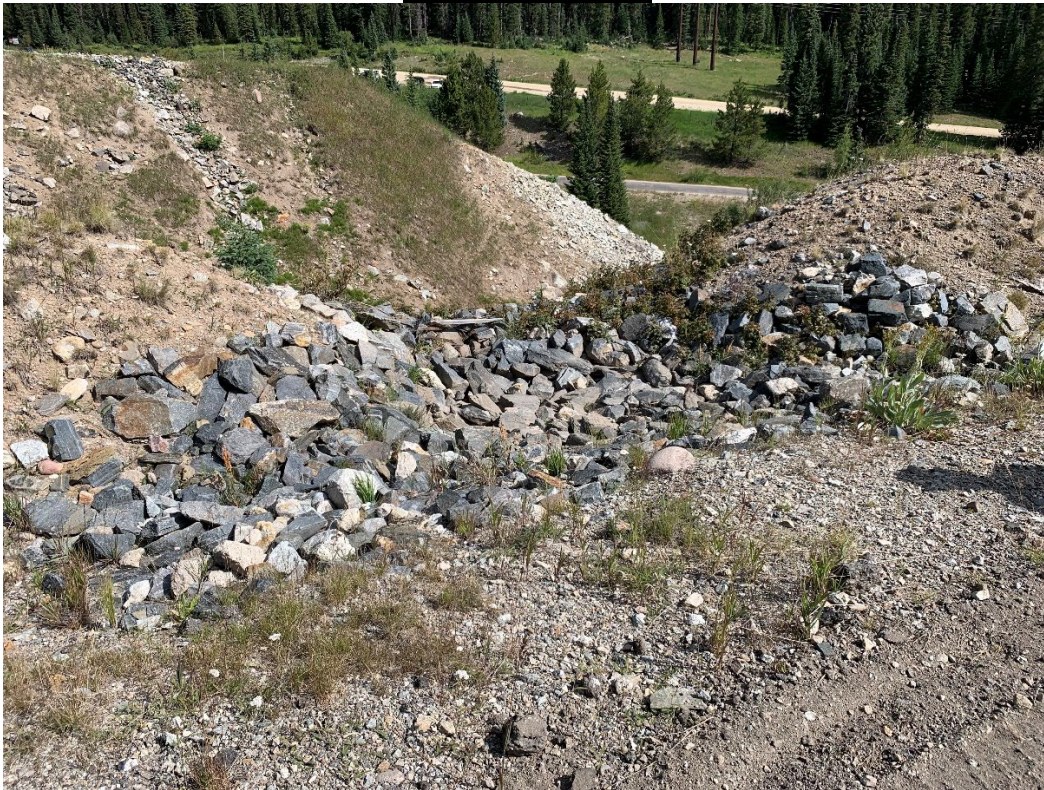
OF-7 is a rock check dam northwest of the laydown yard. It was in good condition (photo 1).

Photo 1 – OF7 check dam in working order.

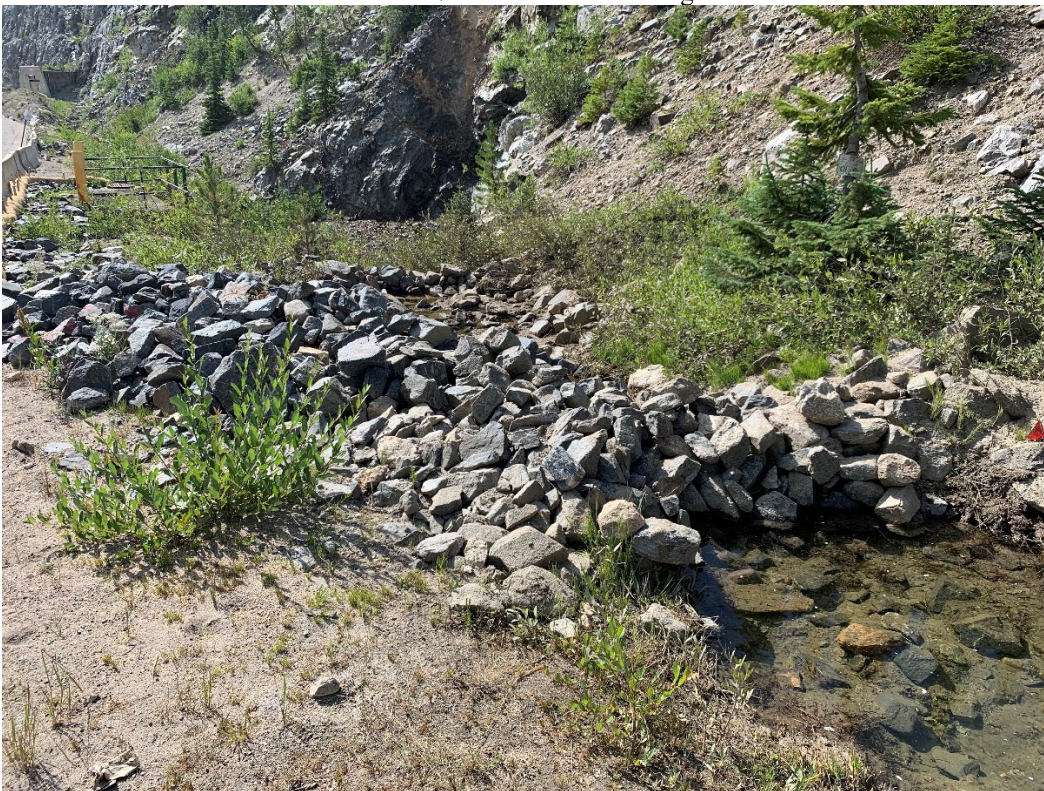
OF-8B Butler Gulch, Two rock check dams were in clean and operating properly (photo 2).

Photo 2 – OF8B, two check dams leading to Butler Gulch

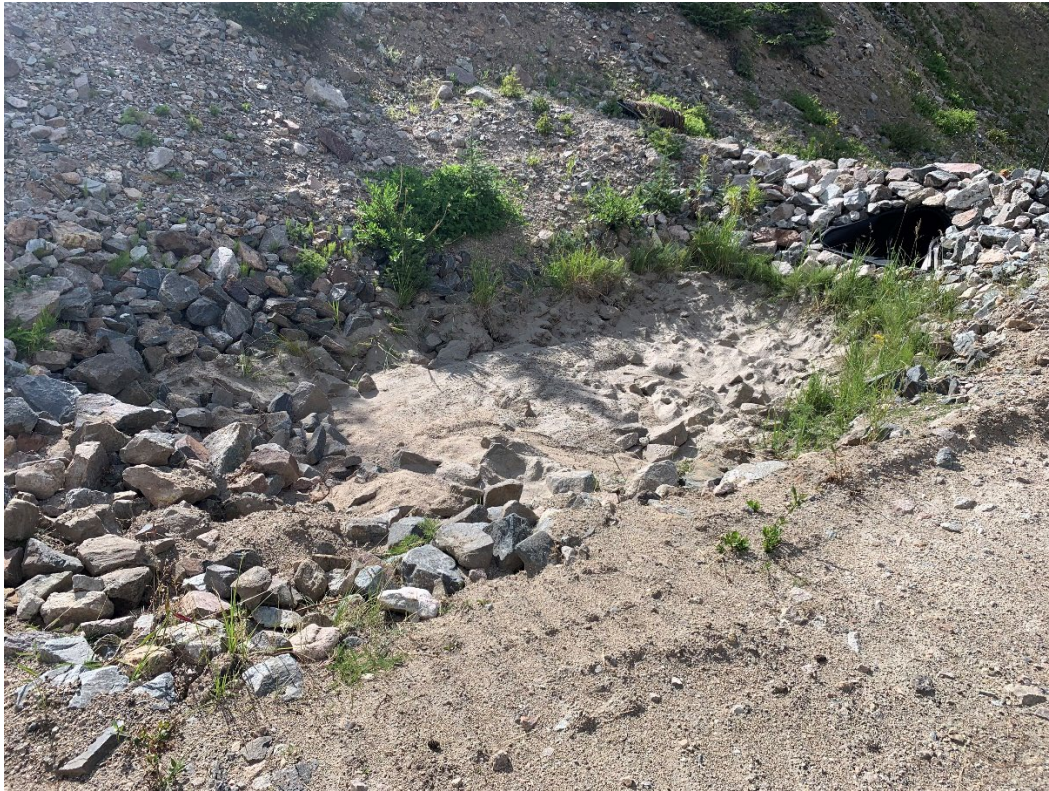
OF-15 The sediment pond above the discharge culvert was clean and free of obstructions (photo 3).

Photo 3 – OF15, clear of obstructions and appears stable.

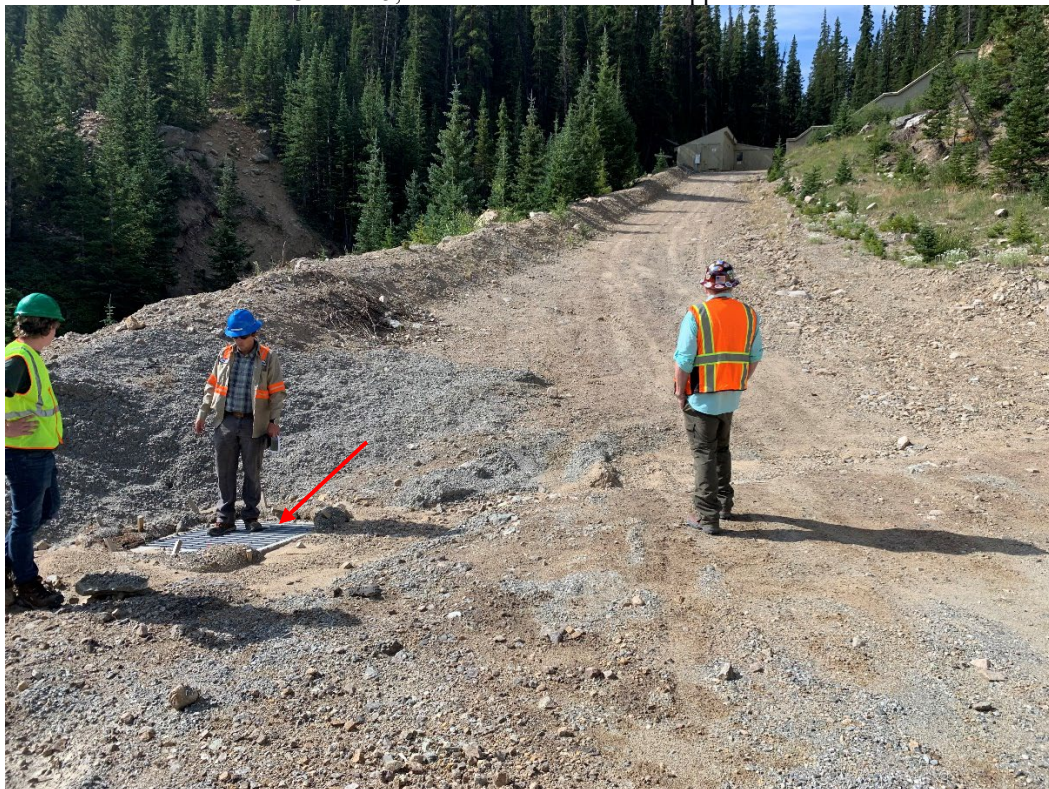
OF-18 Is located next to the potable water plant. It consists of a vault box buried in the ground. The top of the vault box has grate even with the ground surface (photo 4). Water is discharged from a culvert in the vault box to Butler Gulch. The vault is nearly full of sediment and needs to be cleaned.

Photo 4 – OF18, buried vault box with grate top catches sediment.

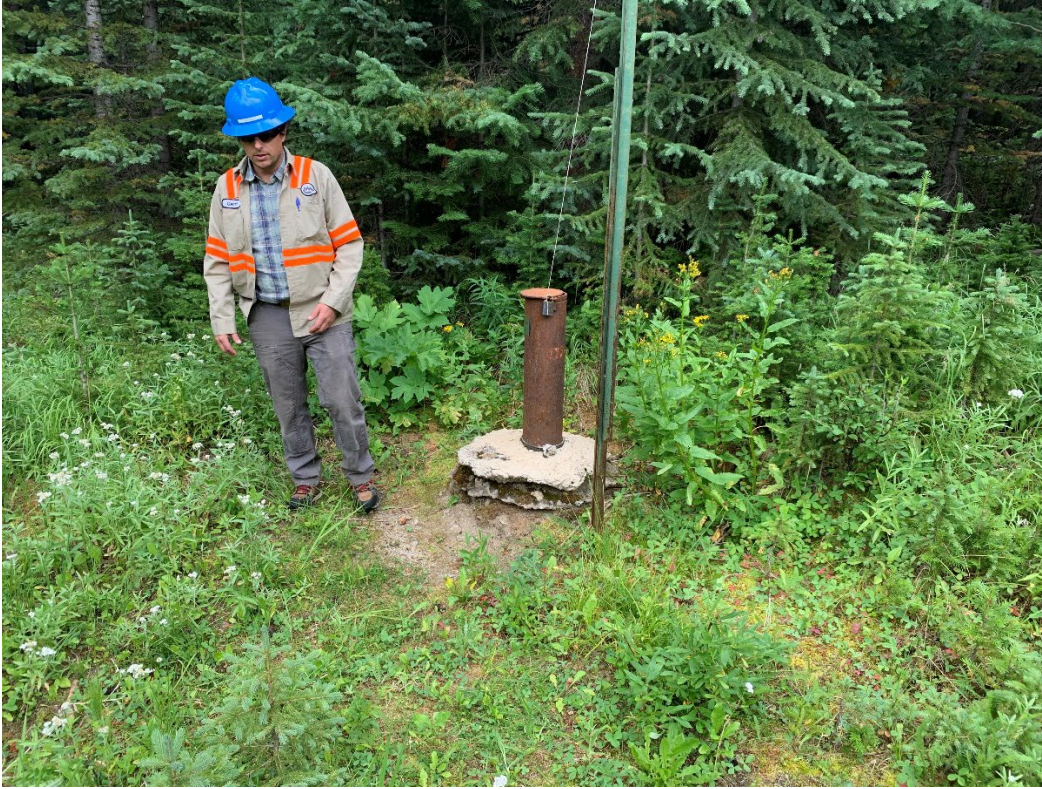
Photo 5 - groundwater well MNGW-1

The groundwater well MNGW-1 is the POC for the mine ground water monitoring program (photo 5).

Concrete was used to seal around the well casing when it was installed. Since then, the ground has settled around the casing and the concrete is probably no longer creating an effective seal.
