MINERALS PROGRAM INSPECTION REPORT
PHONE: (303) 866-3567

MINE NAME: West of Maybell Pit	MINE/PROSPECTING ID#: M-1979-142	MINERAL: Sand and gravel	COUNTY: Moffat
INSPECTION TYPE: Monitoring	WEATHER: Clear	INSP. DATE: August 30, 2023	INSP. TIME: 10:00
OPERATOR: Colorado Department of Transportation	OPERATOR REPRESENTATIVE: None	TYPE OF OPERATION: 112c - Construction Regular Operation	
REASON FOR INSPECTION: Normal I&E Program	BOND CALCULATION TYPE: None	BOND AMOUNT: \$0.00	
DATE OF COMPLAINT: NA	POST INSP. CONTACTS: None	JOINT INSP. AGENCY: None	
INSPECTOR(S): Zach Trujillo	INSPECTOR'S SIGNATURE:

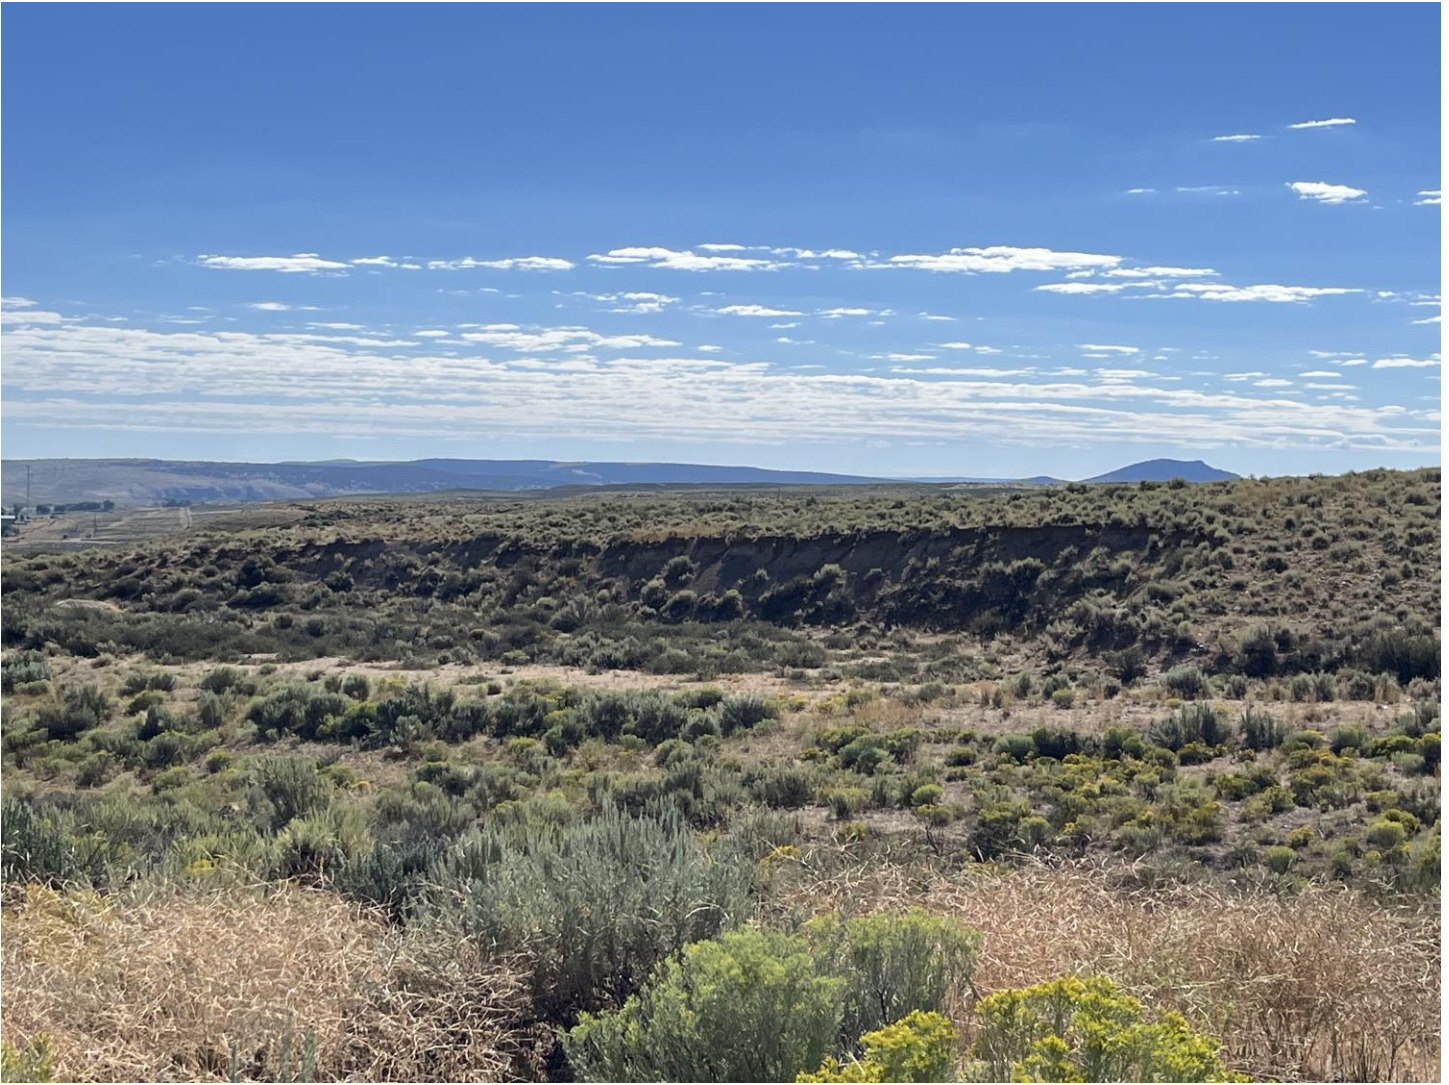
East Pit.
