# Keenesburg inspection report

# **PERMIT INFORMATION**

Permit Number: C-1981-028 Mine Name: Keenesburg Strip Mine Operator: Coors Energy Company Operator Address: Mr. Ben Moline	County: Weld Operation Type: Surface Permit Status: Permanent Cessation Ownership: Private			
P.O. Box 4030	Operator Representative Present:			
Golden, CO 80402	<b>F</b>			
00.000	None			
Operator Representative Signature: (Field Issuance Only)

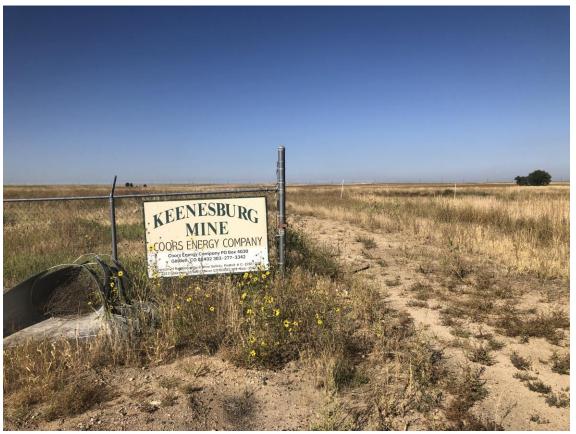
The entrance sign was seen beside the locked gate near the Dugout Pond, and it is in compliance.

**Entrance sign (recently installed at this location)**

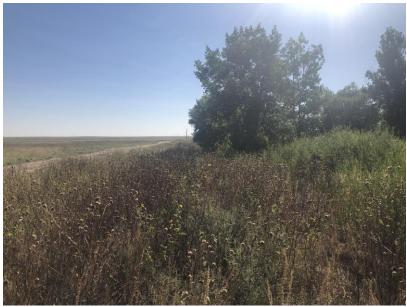
**Area below Sediment Pond 2**

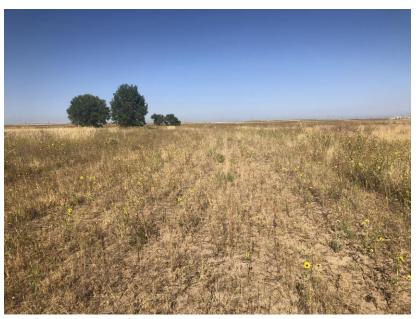
Poor vegetation growth was seen in some areas, including Areas 36, 37, and 38 (the reclaimed soil piles south of the facilities) and the reclaimed roads. In these areas, many sunflowers were seen, but grasses have not emerged well. In Area 25, tall grasses were seen (including, smooth brome and sand bluestem) in addition to the many sunflowers.

Reclaimed road near Sediment Pond 2

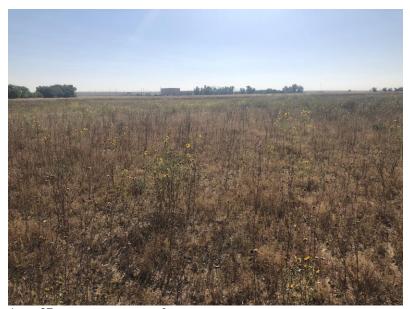
Area 37 – poor grass growth

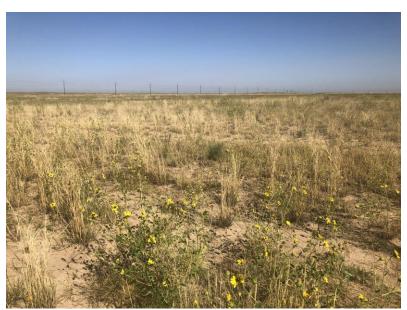
Area 44 – better grass growth than many of the other newly reclaimed areas

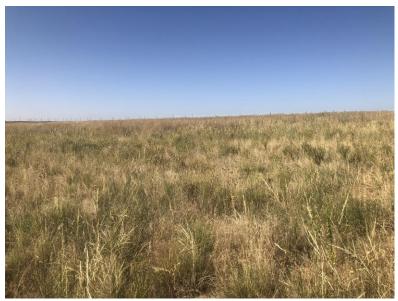
Area 31 – excellent grass growth

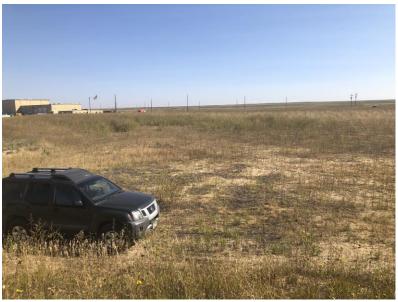
Area 38 – poor grass growth
