New Elk Mine, C-1981-012 Inspection Report

PERMIT INFORMATION

Permit Number: C-1981-012 Mine Name: New Elk Mine Operator: New Elk Coal Company, LLC Operator Address: Mr. Nick Mason 12250 Highway 12 Weston, CO 81091	County: Las Animas Operation Type: Underground Permit Status: Active Ownership: Private
	Operator Representative Present: Nick Mason
Operator Representative Signature: (Field Issuance Only)

Inspection Start Date: September 5, 2023 Inspection Start Time: 12:16 Inspection End Date: September 5, 2023 Inspection End Time: 15:00		Inspection Type: Coal Partial Inspection Inspection Reason: Normal I&E Program Weather: Clear	
Joint Inspection Agency: None		Joint Inspection Contacts: 	
Post Inspection Agency: None		Post Inspection Contacts: 	
Inspector(s): Jared Ebert Amber Michels	Inspector's Signature:

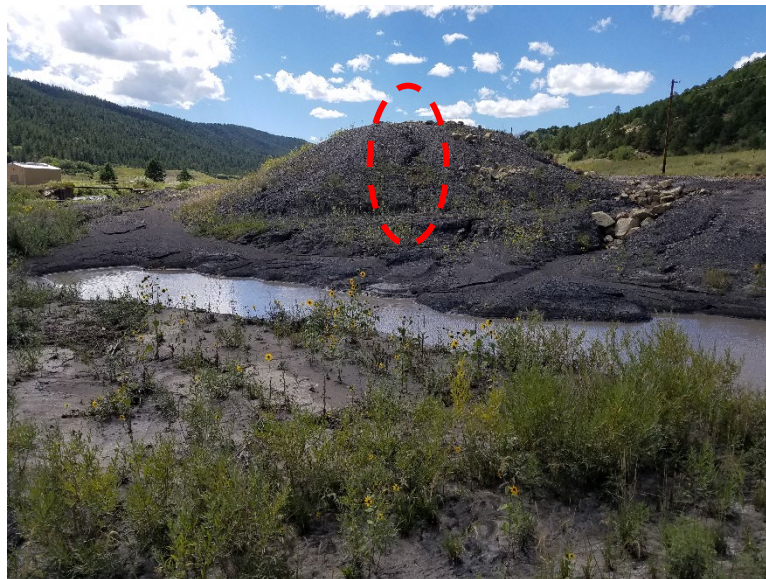
Development Waste Disposal Area (“DWDA”) #2 was observed. On the eastern face of the stockpile, a large rill is forming. NECC will need to monitor this rill closely and repair and stabilize this area should the rill deepen and continue to form. A sediment sump just above the inlet to culvert C13 was holding water. The berm around culvert C13 was in good repair.

Figure 1. Rill forming on eastern slope of DWDA #2 Stockpile.

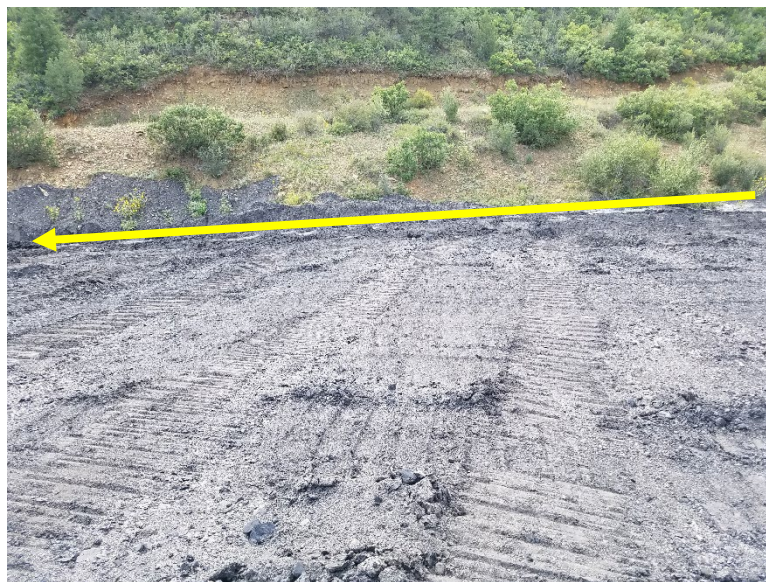
The Refuse Disposal Area (“RDA”) was observed. NECC has re-excavated a ditch on the northwest side of the RDA to help insure drainage is occurring and not pooling on top of the coal waste material. Mr. Mason indicated a surveyor would check the ditch positively drains.

Figure 2. Northwest corner of the RDA, ditch re-established.

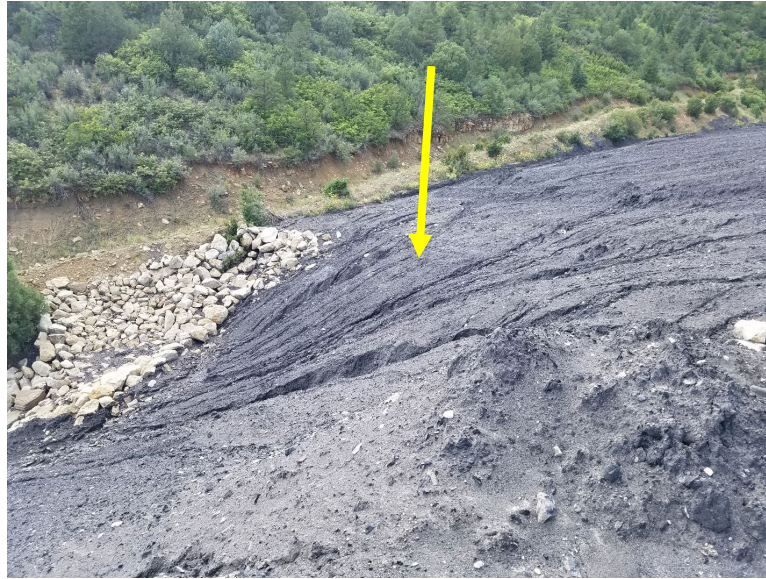
As indicated above, the mine was idle at the time of the inspection. Therefore, the wash plant was not processing coal at the time of the inspection. Several piles of coal waste were observed on the top bench of the pile waiting to be graded out. The western corner of the upper bench had several rills forming that NECC should monitor and stabilize should they continue to deepen and form.

Figure 3. Rills forming on the western side of the upper bench of the RDA.

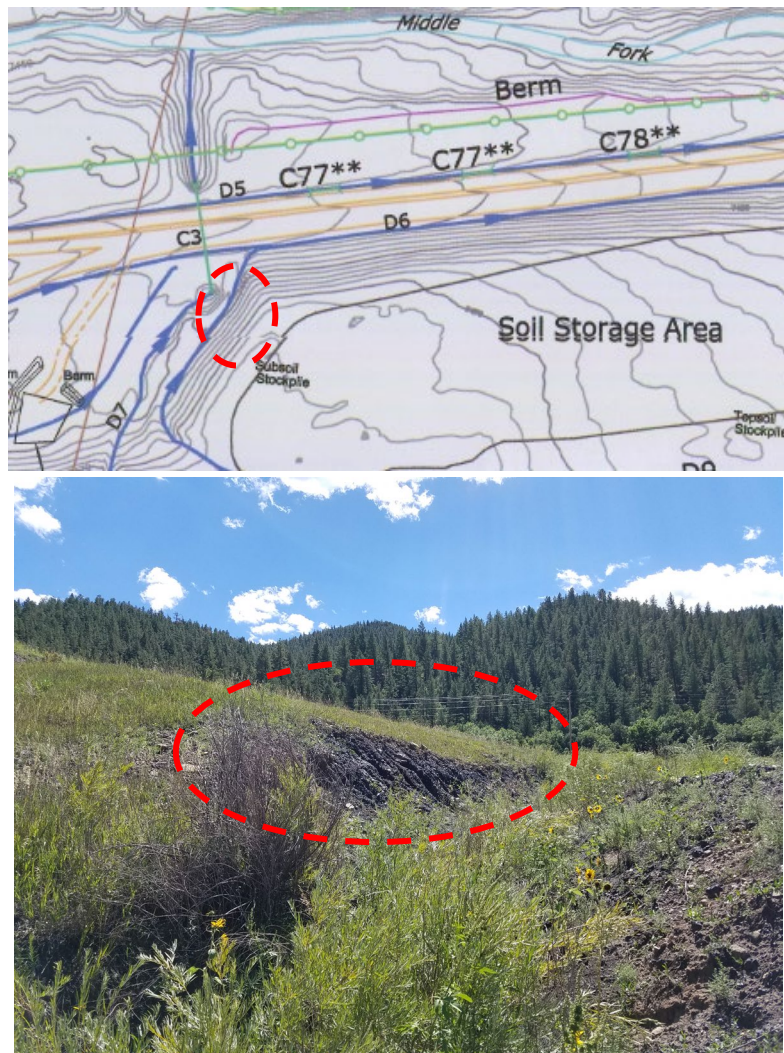
The embankment slope on the northwest side of the Soil Storage Area is eroding and sluffing into the ditch that discharges to ditch D6. NECC shall repair and stabilize this area. The ditch embankment separating the affected land drainage from the adjacent clear water ditch (D7) is very thin in areas. Failure of this embankment may overwhelm the ditch and cause sediment to discharge into the clean water ditch D7 that discharges to the river.

Figure 4. Soil Storage Area embankment on the west side. Slope failure highlighted above.

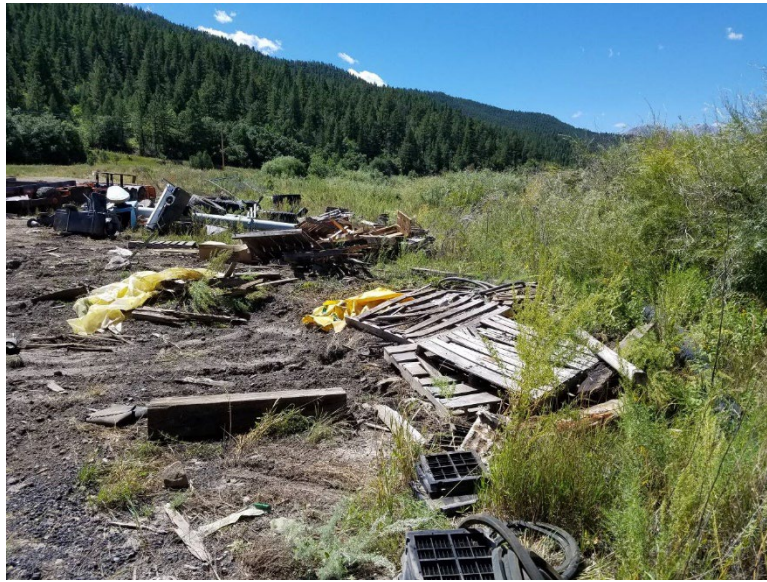
NECC has a salvage contractor onsite removing old equipment and metal. In addition, NECC had sold what appears to be a large amount of equipment, parts, etc. that has typically been stored in the yard area east of the C&W Train Shop. Equipment, parts, metal debris, wood pallets, and other debris was observed throughout this area. **A small berm separates this area from the Middle Fork of the Purgatoire River riparian area, this berm has been damaged by equipment running over the berm. NECC shall repair this berm. Trash, debris and equipment have been pushed in places up against this berm. NECC shall maintain this area to prevent environmental damages in accordance with Rule 4.04. NECC shall clean up this area and insure the trash and debris is disposed of in accordance with Rule 4.11.4.**

Figure 5. Trash and debris located adjacent to berm north of the C&W Train Shop

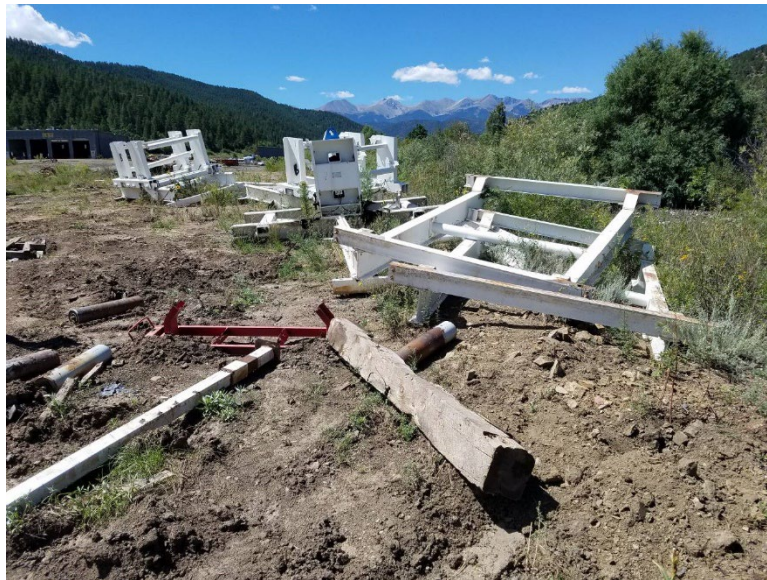
Figure 6. Debris and parts placed on top of the berm that is supposed to separate this area from the river.

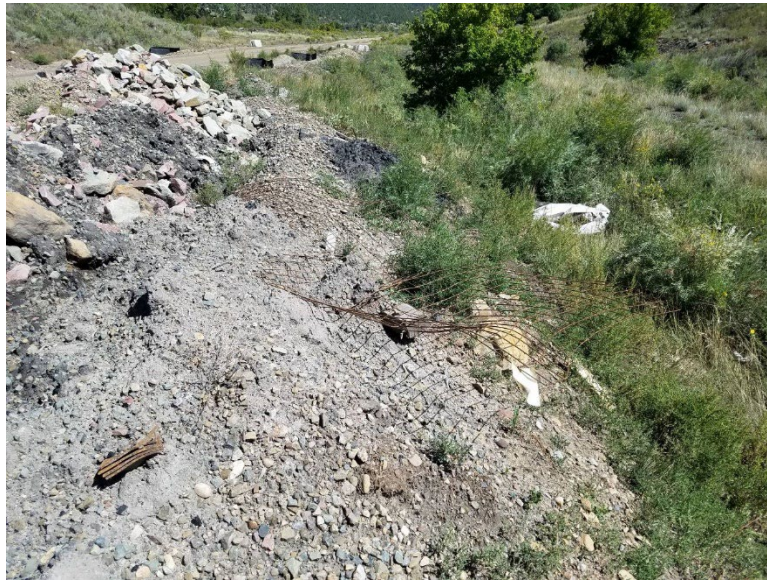
The SAE storage area south of Pond 007a was observed, equipment and material to support the mine operation are stored in this area. **It appears some dirt and rock have been pushed up against the berm separating the area from ditch D58. In addition, trash and debris has fallen into the adjacent ditch. NECC shall remove this material and keep it from overtopping the berm and remove the material that has fallen into the ditch.**

Figure 7. Rock and dirt pushed against berm above ditch D58. Trash and debris has fallen into the ditch.
