## Lorencito Canyon Mine, C-1996-084, Inspection Report

**PERMIT INFORMATION**

**INSPECTION INFORMATION**

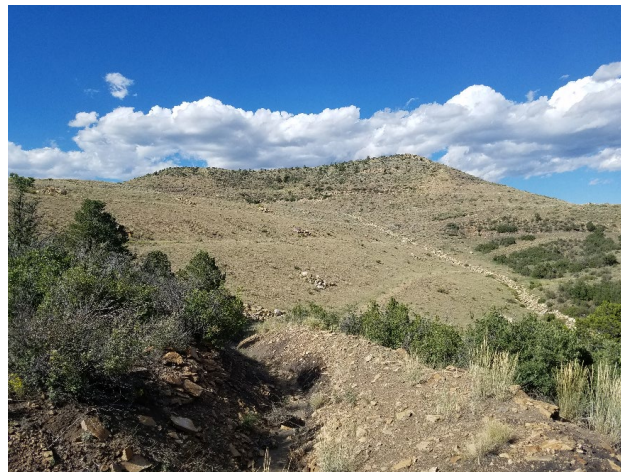
Fill 007 was observed. The face of the fill is well vegetated and appeared stable. Only minor rills were observed.

*Figure 1. Fill 007*

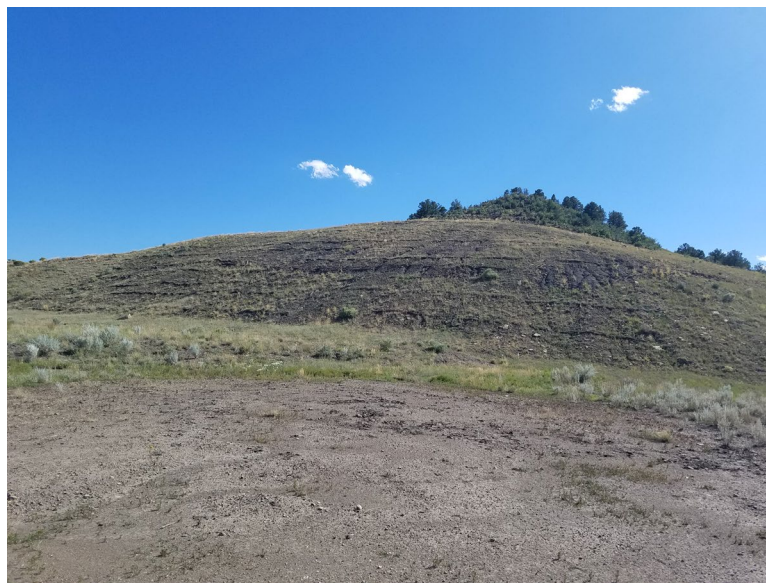
The area above where NECC stores pond and ditch cleanings consists of a steep slope. This slope was observed. Erosion rills and gullies were observed but the vegetation on this slope appears better established this year than previously observed by DRMS. NECC is encouraged to continue to monitor this area and conduct maintenance as needed.

*Figure 2. Reclaimed area above the sediment cleaning storage area.*
