## Roadside Mine, C-1981-041, August Partial Inspection Report

**PERMIT INFORMATION**

<b>Permit Number:</b> C-1981-041 <b>Mine Name:</b> Roadside Portals <b>Operator:</b> Snowcap Coal Company, Inc. <b>Operator Address:</b> MS Tonya Hammond P.O. Box 1430 Palisade, CO 81526	<b>County:</b> Mesa <b>Operation Type:</b> Underground <b>Permit Status:</b> Active <b>Ownership:</b> Private
	<b>Operator Representative Present:</b>  Tonya Hammond
<b>Operator Representative Signature: (Field Issuance Only)</b>

<b>Inspection Start Date:</b> August 31, 2023 <b>Inspection Start Time:</b> 09:10 <b>Inspection End Date:</b> August 31, 2023 <b>Inspection End Time:</b> 09:45		<b>Inspection Type:</b> Coal Partial Inspection <b>Inspection Reason:</b> Normal I&E Program <b>Weather:</b> Clear	
<b>Joint Inspection Agency:</b>  None		<b>Joint Inspection Contacts:</b>  None	
<b>Post Inspection Agency:</b>  None		<b>Post Inspection Contacts:</b>  None	
<b>Inspector(s):</b>  Clayton Wein	<b>Inspector's Signature:</b>  <i>Clayton Wein</i>		<b>Signature Date:</b>  9/13/2023

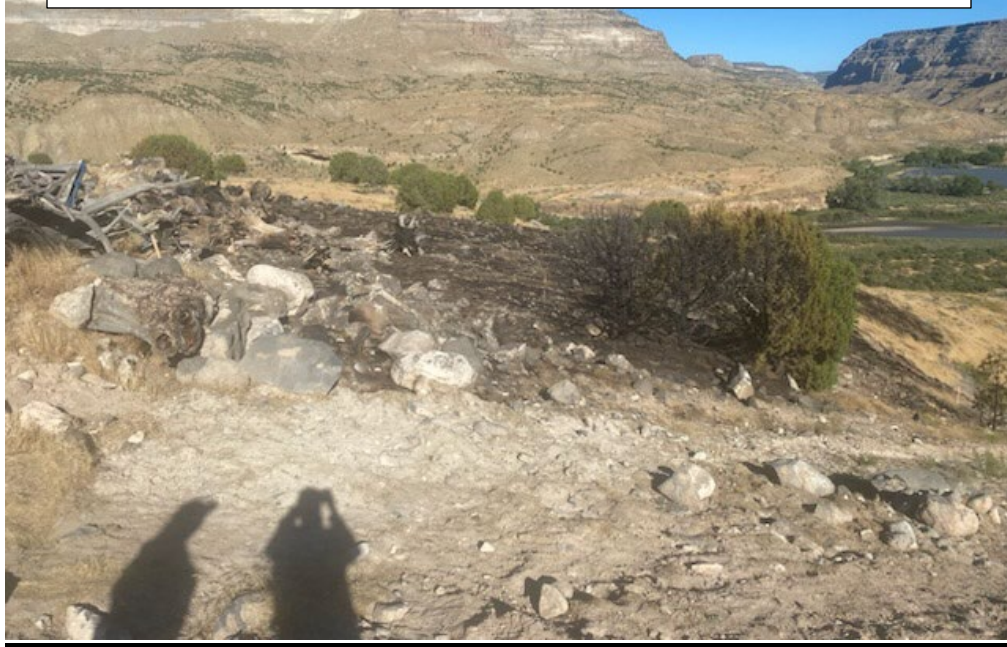
A small brush fire had occurred outside the permit boundary directly north of the TR-69 Repair Area (Photo 1). The fire occurred on the early morning of August 28<sup>th</sup>. The fire was quickly reported and put out. The cause of the fire was likely due to a lightning strike and not due to any mining or reclamation activities. The fire did not impact any portion of the reclaimed areas of the mine or any lands located within the permit boundary.

.Photo 1: The burn scar from the brush fire located just to the north of the Roadside Mine permit area. The photo was taken looking to the west/northwest towards I-70

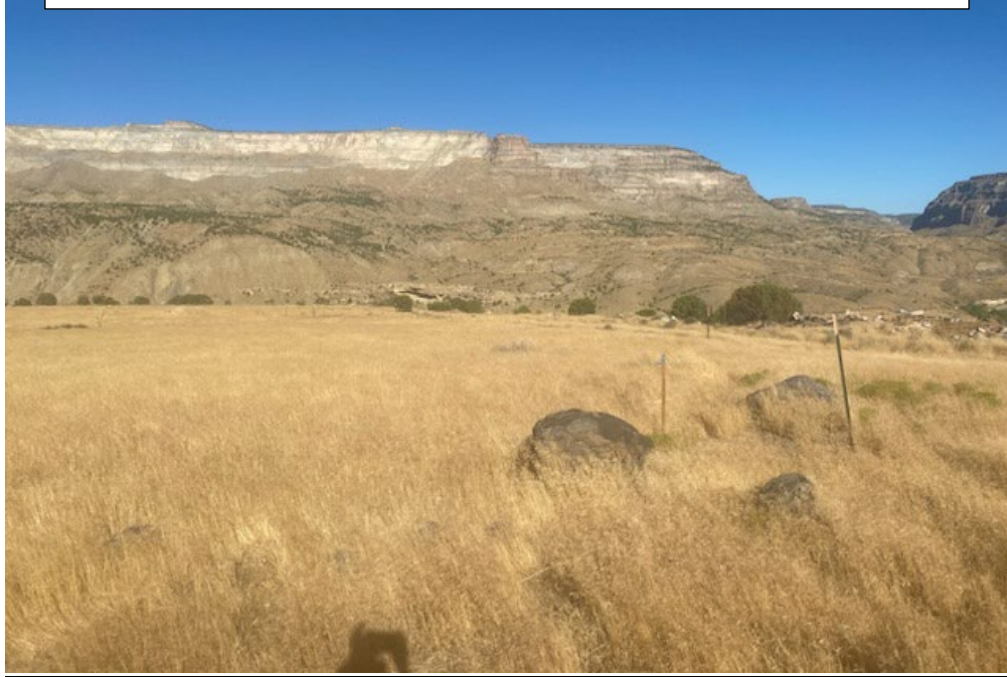
The TR-69 Repair Area was observed to be vegetated and stable (Photo 2 and 3). Most all of the vegetation on the site was dried out due to the late summer conditions. The disturbed area was marked by several T-posts and a mine identification sign. There were no erosional features identified. The landowner's ditch located adjacent to the TR-69 Repair Area was dry (Photo 4). There was no evidence of recent water application in the ditch. The TR-69 Repair Area is located in an area referred to as Tract 71. A landowner owned pit, referred to as the Carey Pit, is located by the southwest corner of Tract 71. The pit was dry and there was no evidence of recent water application through the landowner's pipeline into the pit (Photo 5).

Photo 2: The photo was taken at the northeast corner of the TR-69 Repair Area looking to the west.

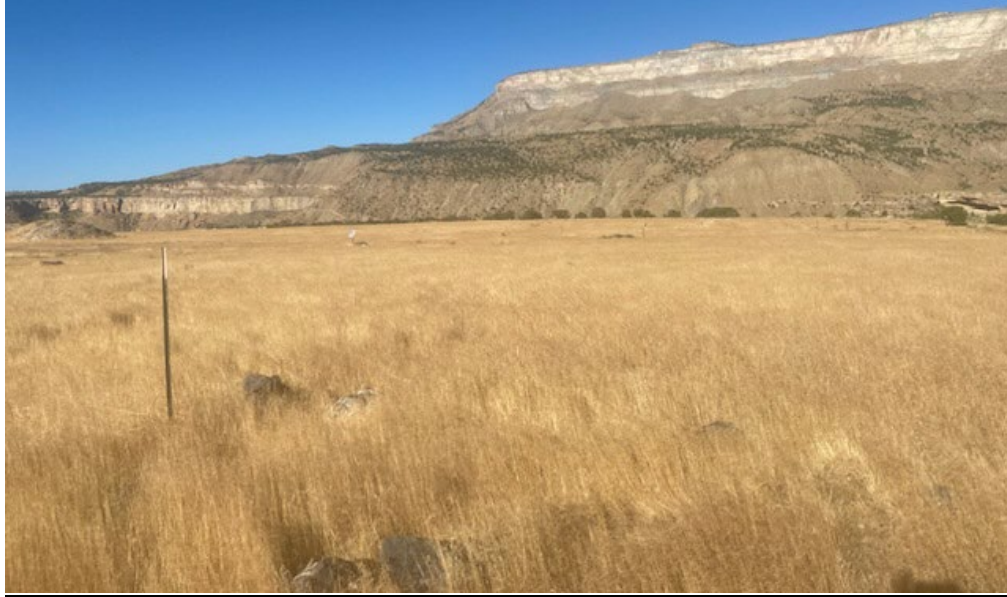
Photo 3: The photo was taken at the northeast corner of the TR-69 Repair Area looking to the southwest.

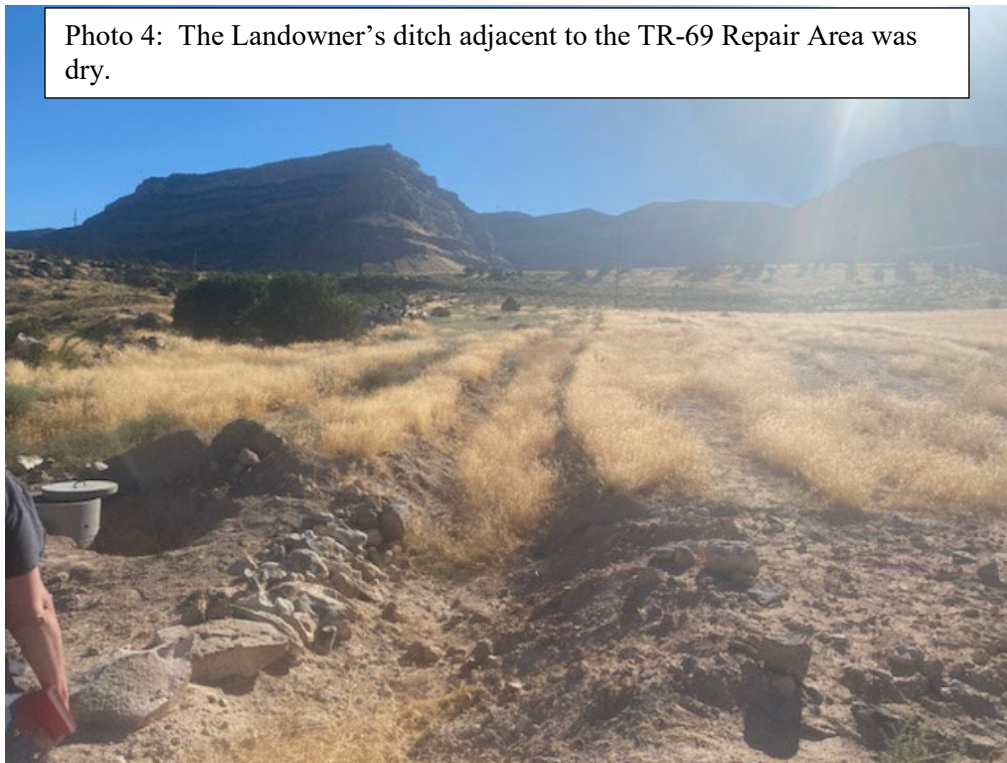
Photo 4: The Landowner's ditch adjacent to the TR-69 Repair Area was dry.

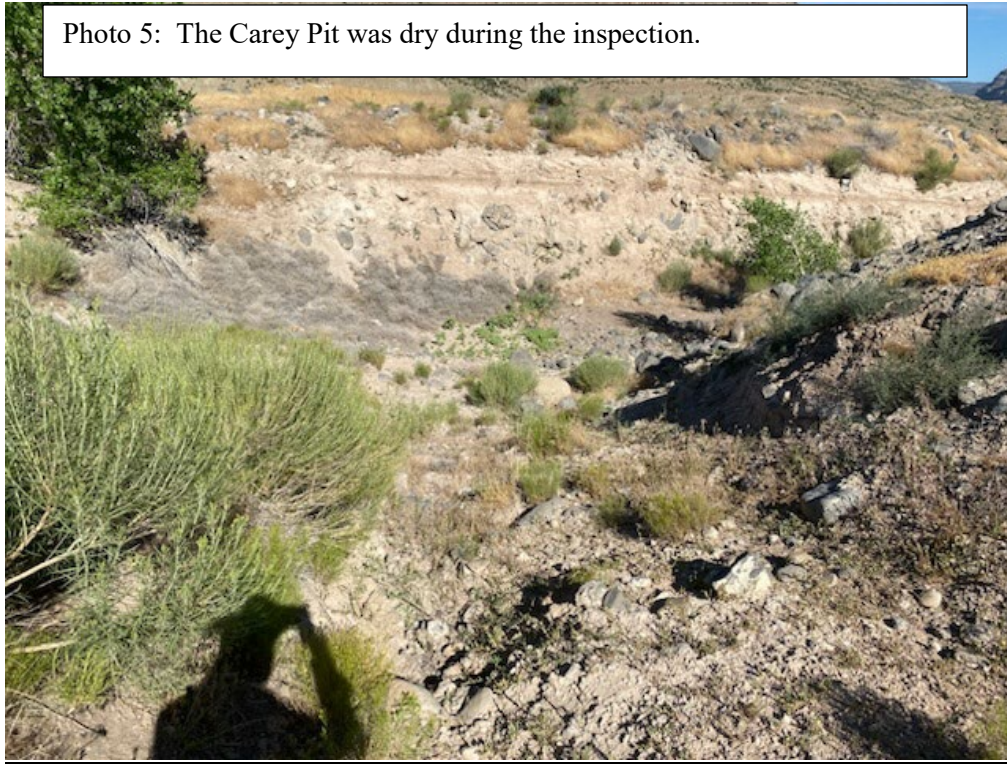
Photo 5: The Carey Pit was dry during the inspection.
