# **PERMIT INFORMATION**

# **INSPECTION INFORMATION**

The Bear mine permit is revoked, the site has been reclaimed, and the required inspection frequency has been reduced to quarterly. The weather was warm and dry. The site was accessible by vehicle from the West Elk Mine, and by foot from Somerset.

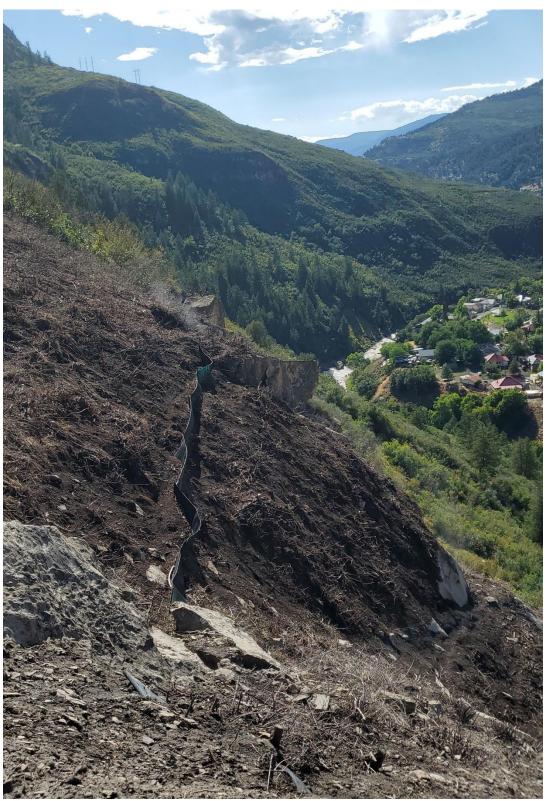
Staff from the Inactive Mines Program and their contractors from TetraTech and Authentic Drilling had resumed their investigation of the underground coal fire. Several new holes had been drilled and grouted with thermocouples. Drilling was expected to continue through mid-October.

Figure 1: Smoke/steam venting from western end of bench Number of Partial Inspection this Fiscal Year: 0 Number of Complete Inspections this Fiscal Year: 3

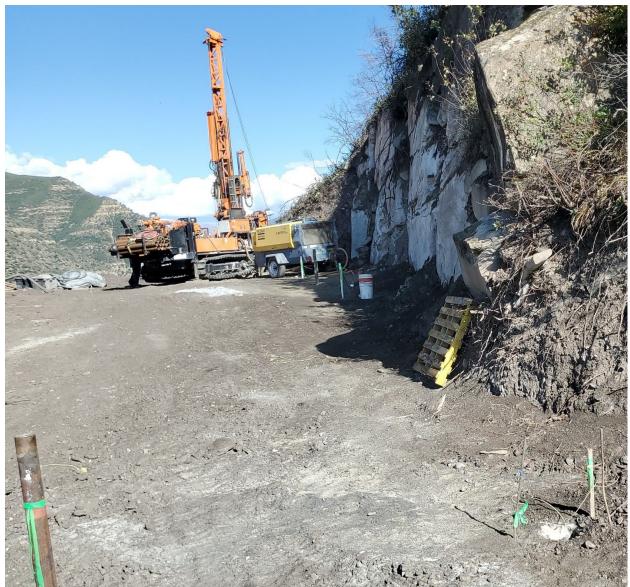
Figure 2: Drill rig on site

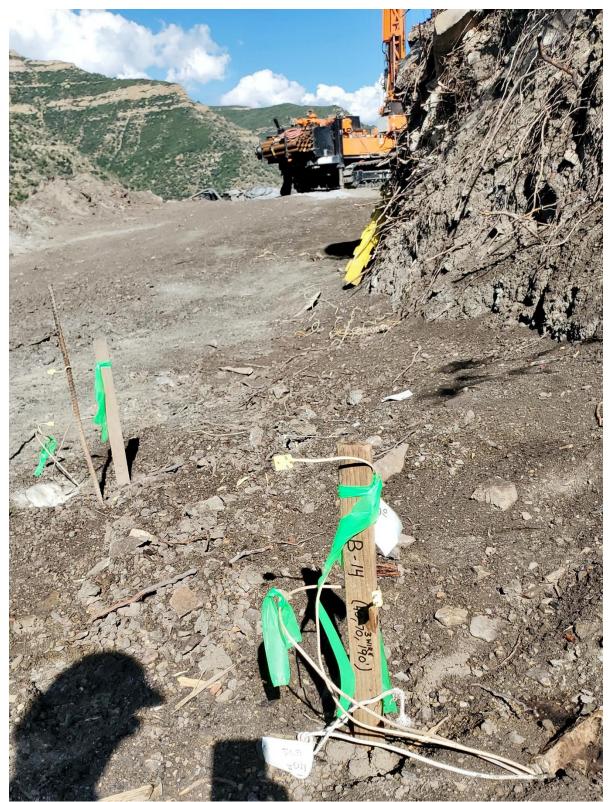
Figure 3: Thermocouples grouted into new holes

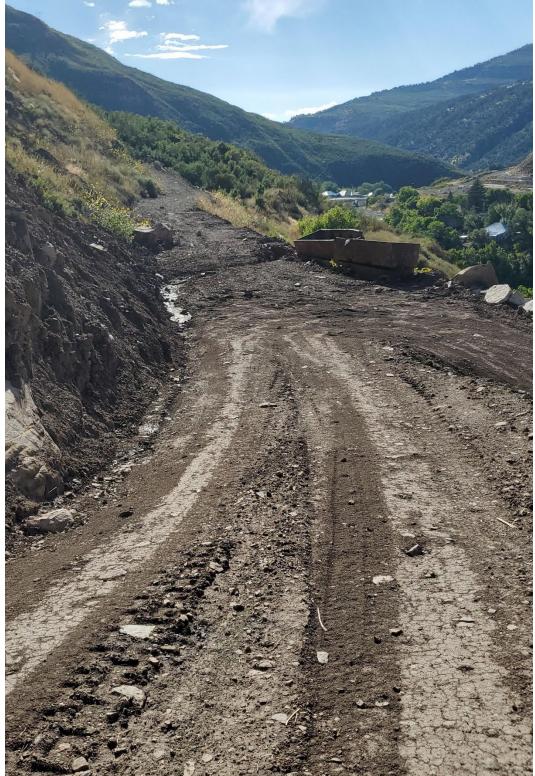
The temporary road to access the bench above the slide area was in much better shape than in recent months, and surface water diversions off the road seemed to be effective.

Figure 4: Surface water diversion at first hairpin on temporary road
