TRAPPER MINING INC.  
CRAIG, COLORADO

HORSE GULCH FILL  
QUARTERLY FILL CERTIFICATION

# **Horse Gulch Fill Quarterly Inspection Report**

**Third Quarter 2023**

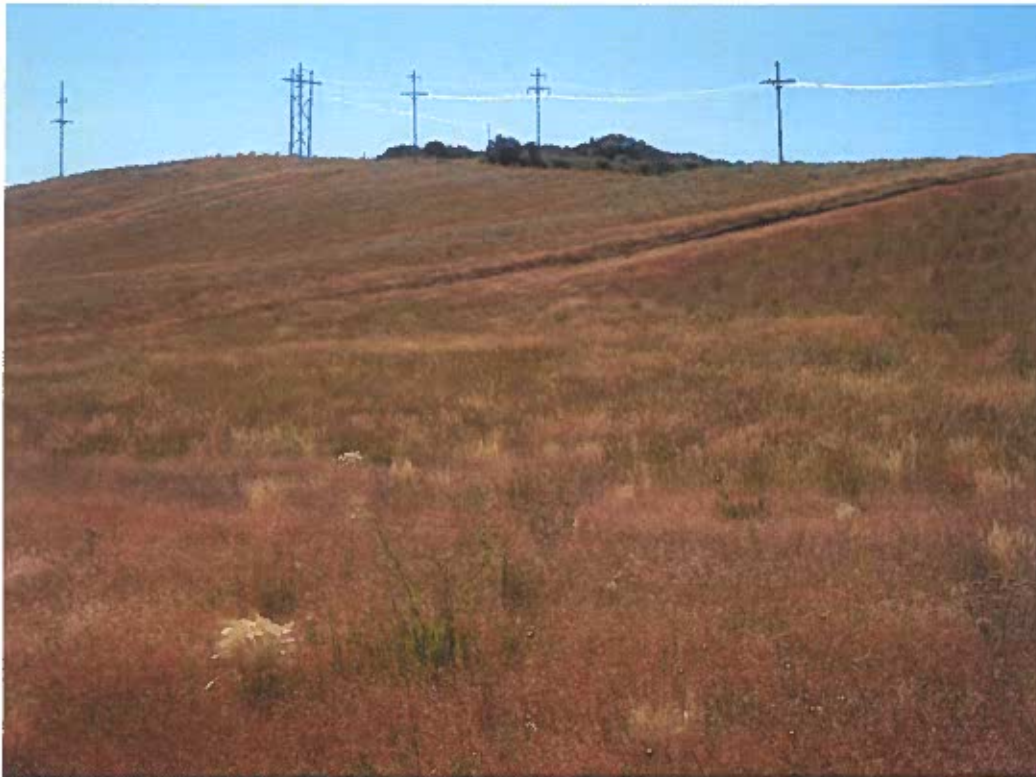
No appearances of instability, structural weakness, or other hazardous conditions were observed. Both the southeast side of the fill and the northeast side of the fill were inspected this quarter (Photographs 1 and 2). The area where cracks were detected on the top south portion of the dump during the first quarter of 2013 inspection was checked. There was no additional cracking found.

Photograph 1: East Side Looking South (9/12/2023)

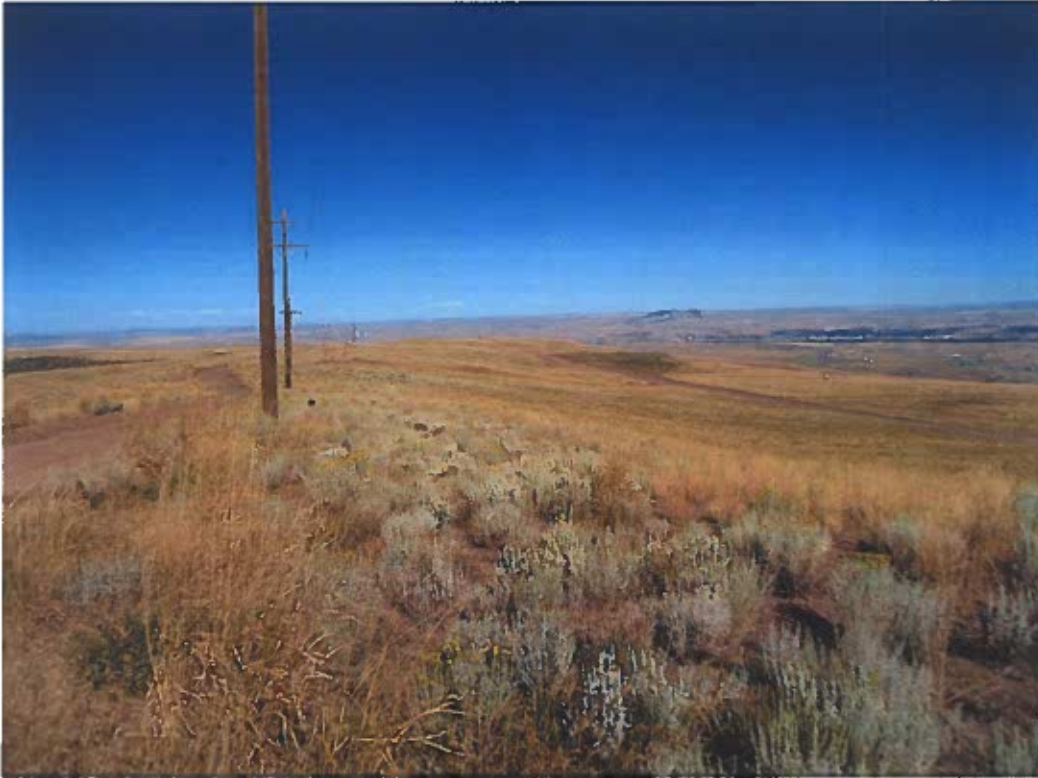
*Photograph 2: South Side Looking North (9/12/2023)*

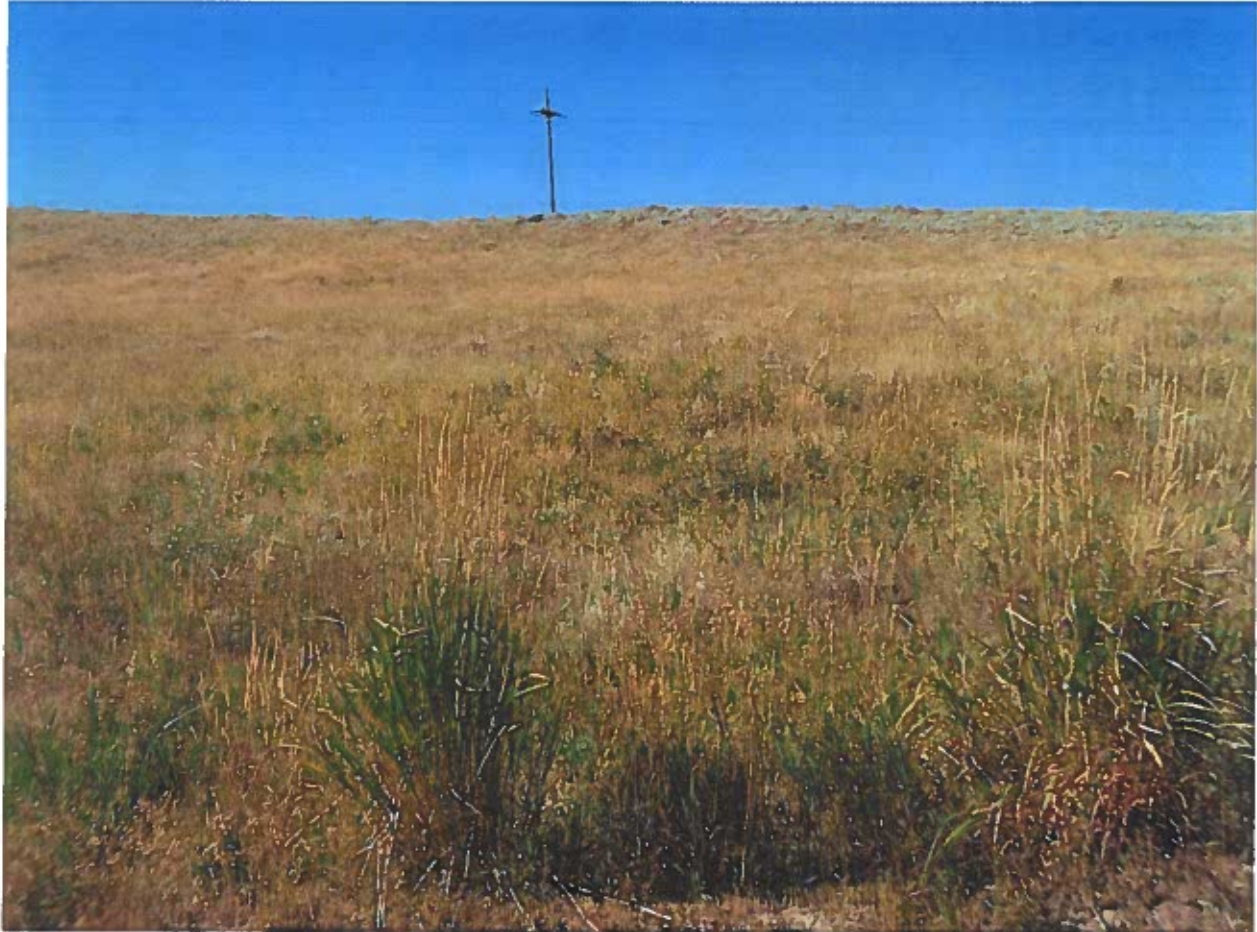
Photograph 3 depicts the east facing slope of the fill.

*Photograph 3: East Side of the Fill Looking West (9/12/2023)*
