September 5, 2023
Project No.: 19125

Regarding: Daniels Sand Pit 2, Permit No. M-1973-007-SG
Slope Stability Monthly Monitoring Report

Lithos Engineering (Lithos) visited the site on September 5, 2023. And notes the following observations.

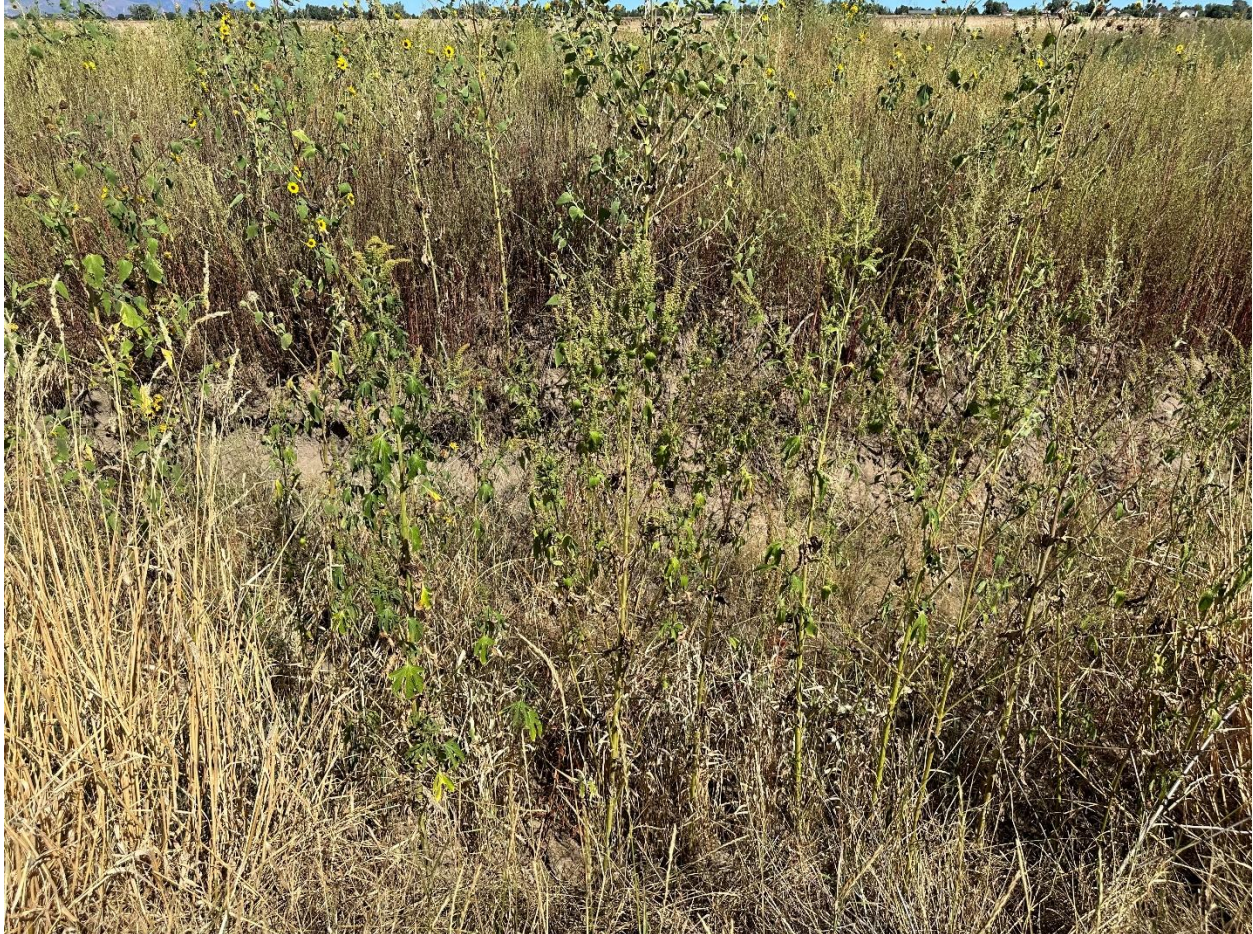
- 3) Weather: 50-79°, sunny, winds 10 - 15 mph
- 4) Visual observation of the Fountain Mutual Ditch and ditch road:
 - a) No tension cracks.
 - b) Vegetation growing on banks of ditch and on invert.

Photo 1. Dry ditch invert with vegetation

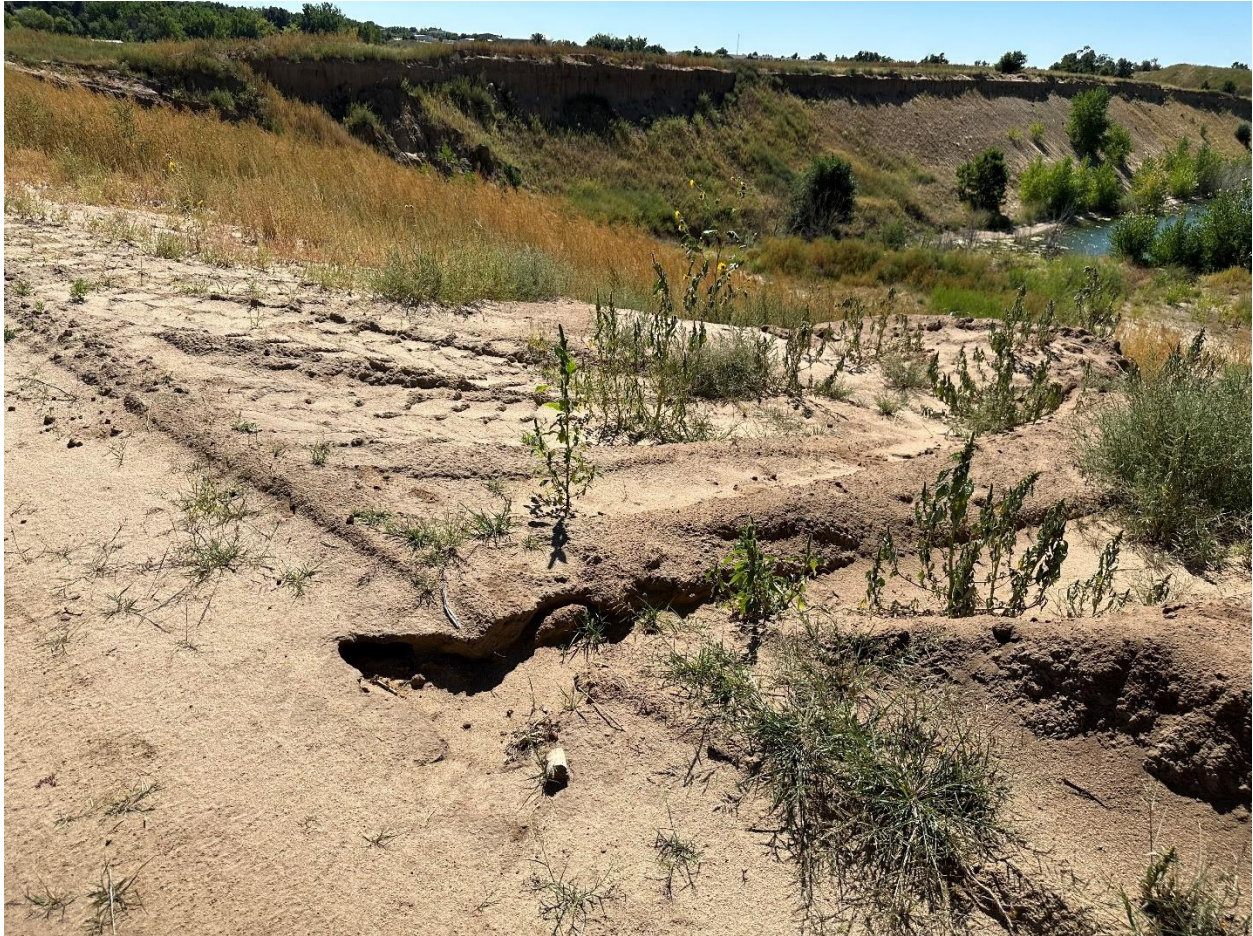
- 1) The majority of the ditch road has been repaired and the berm height between the access road and the ditch has been heightened. One erosion gully has reached the ditch road (eastern portion of the buttress).

Photo 2. Erosion gully on ditch access road

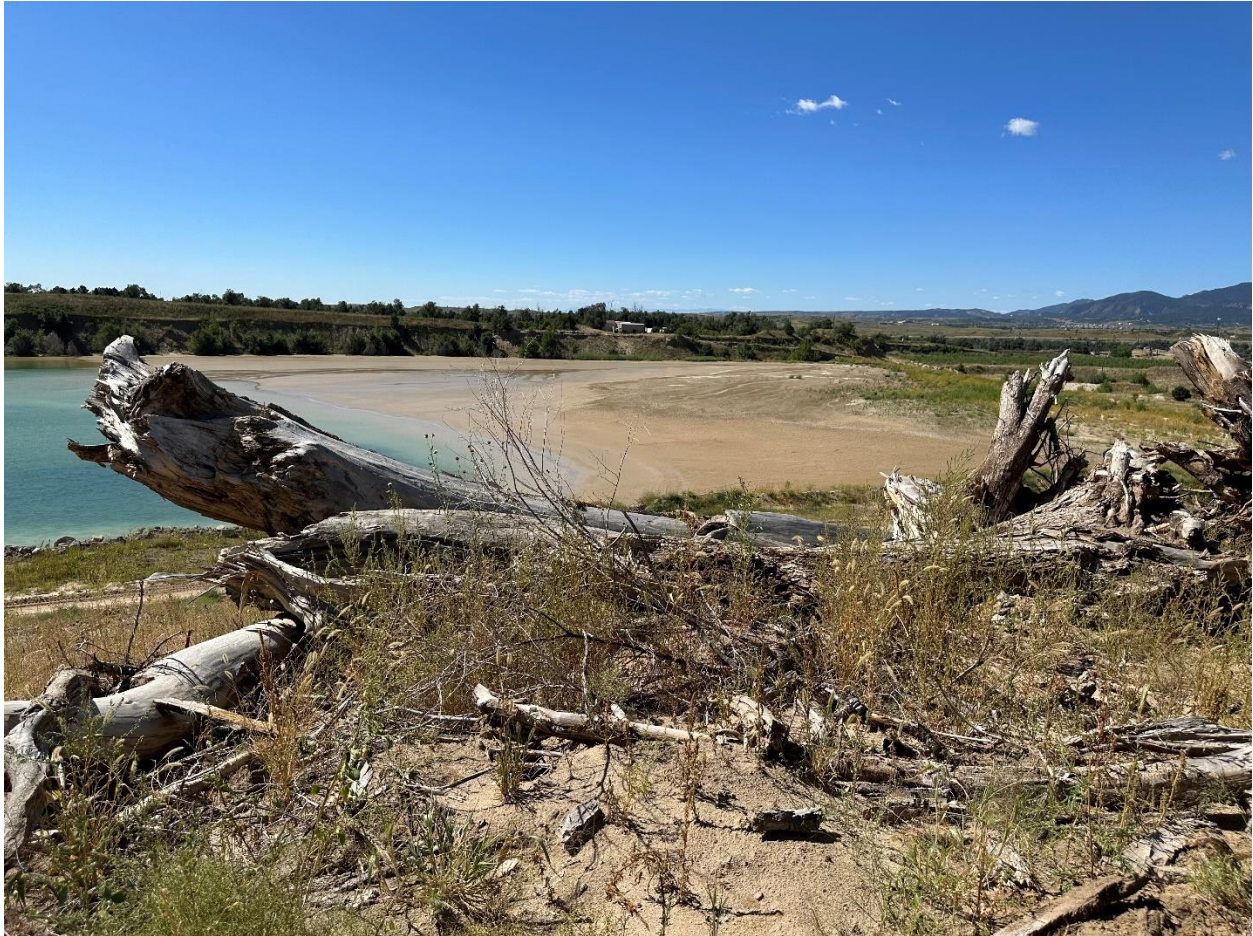
- c) Several locations show visible evidence of surface water runoff and expanding erosion gullies throughout the buttress.
- d) Several broken trees exist on the slope/buttress crest near the ditch access road.

Photo 3. Tree south of access road and on crest of buttress slope

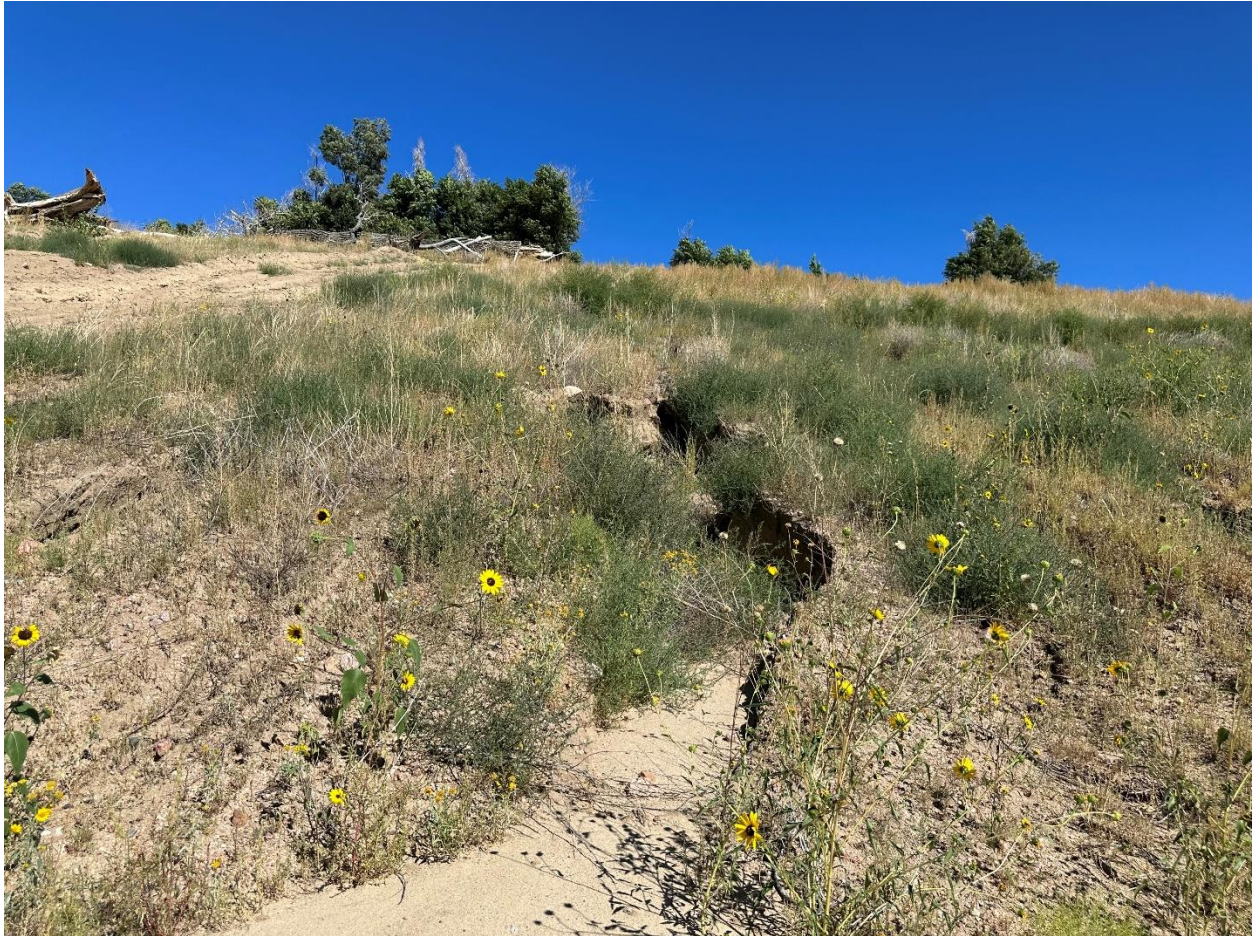
Photo 4. Erosion gullies in eastern portion of buttress

- 2) At several locations, erosion gullies have been repaired. However, erosion gullies still exist within the embankment slope. We recommend those areas be reconstructed ASAP and that the areas be seeded per the reclamation plan.

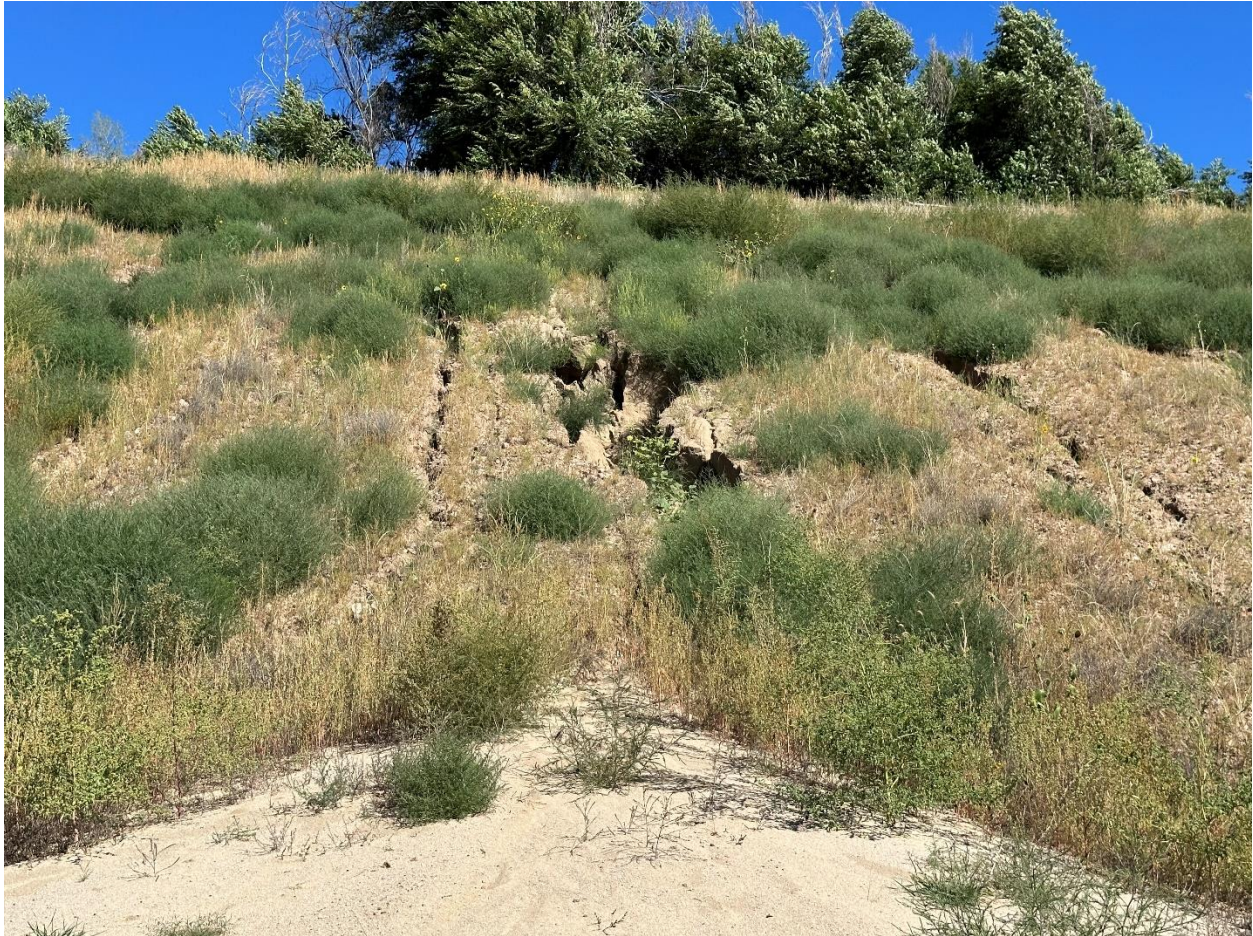
Photo 5. Erosion gullies in central area of buttress

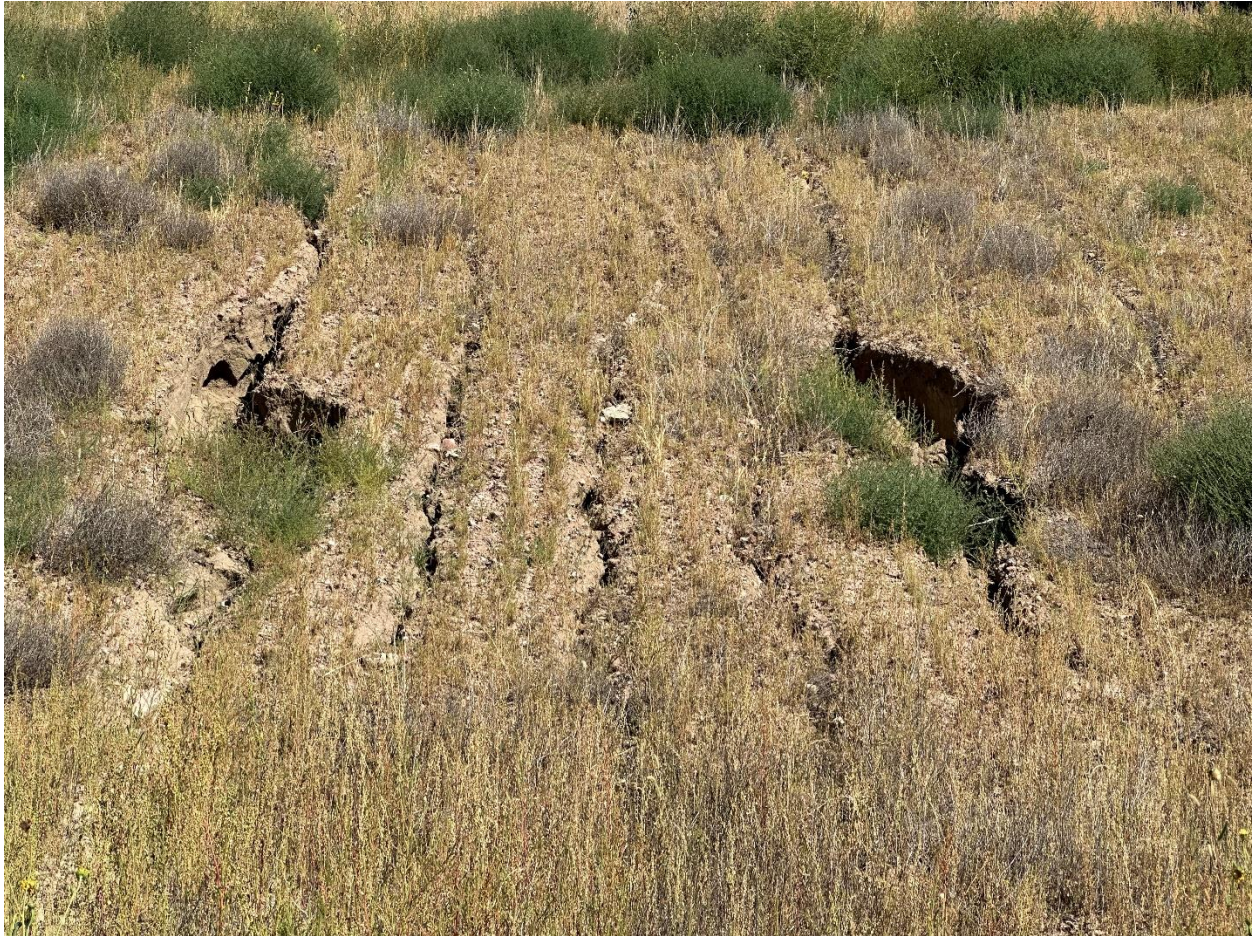
Photo 6. Erosion gullies in central area of buttress

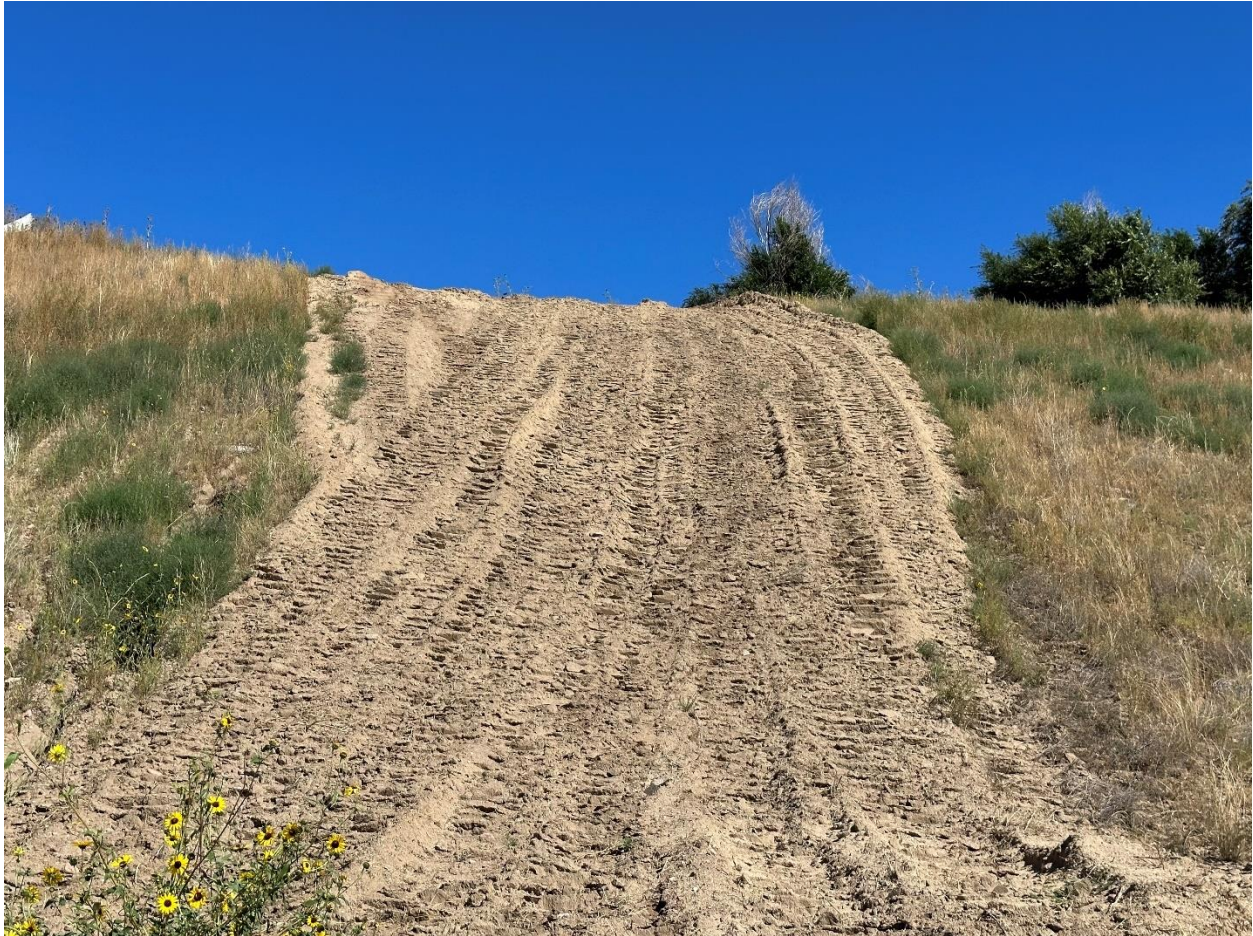
Photo 7. Recent repair on western portion of buttress

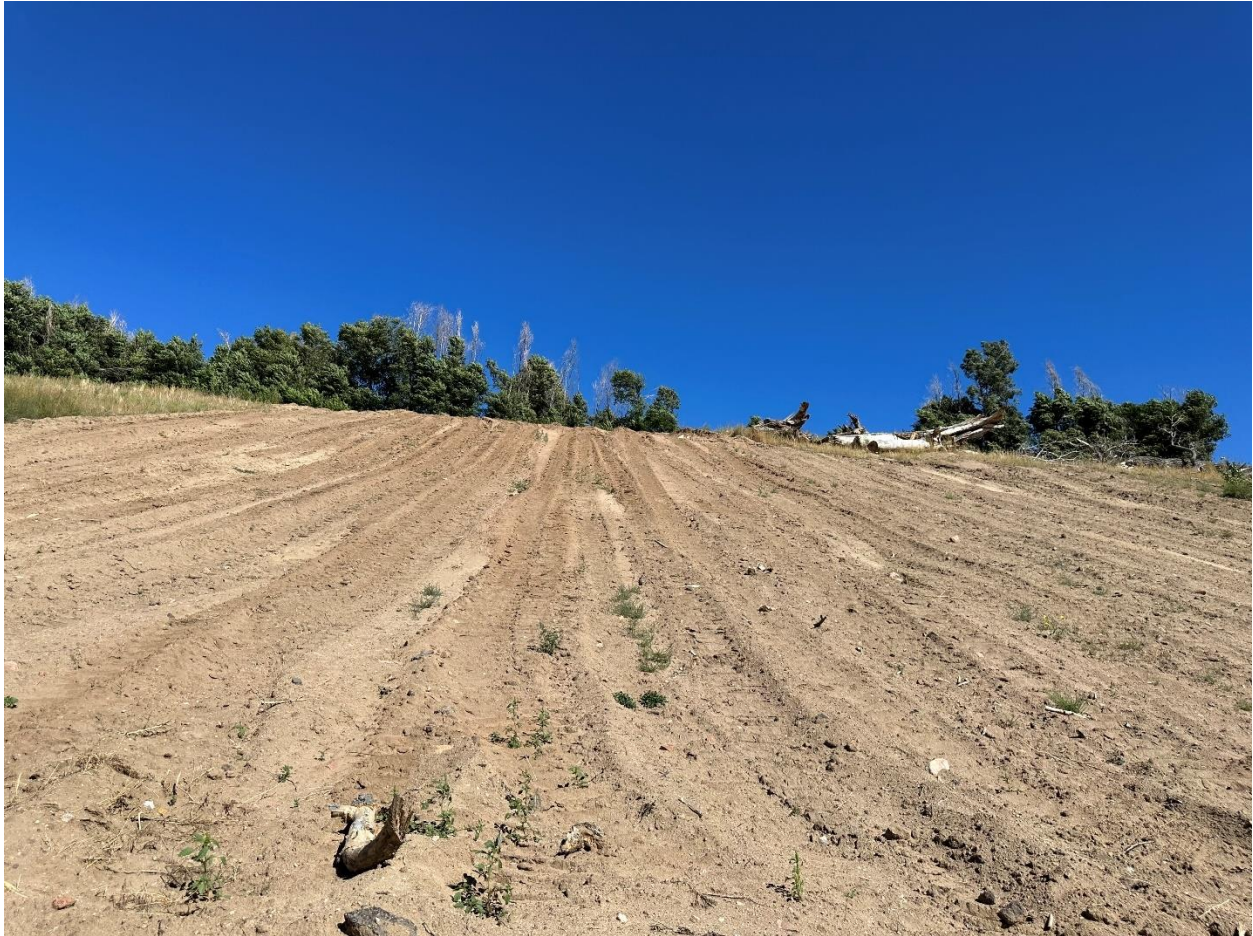
Photo 8. Repair on eastern portion of buttress

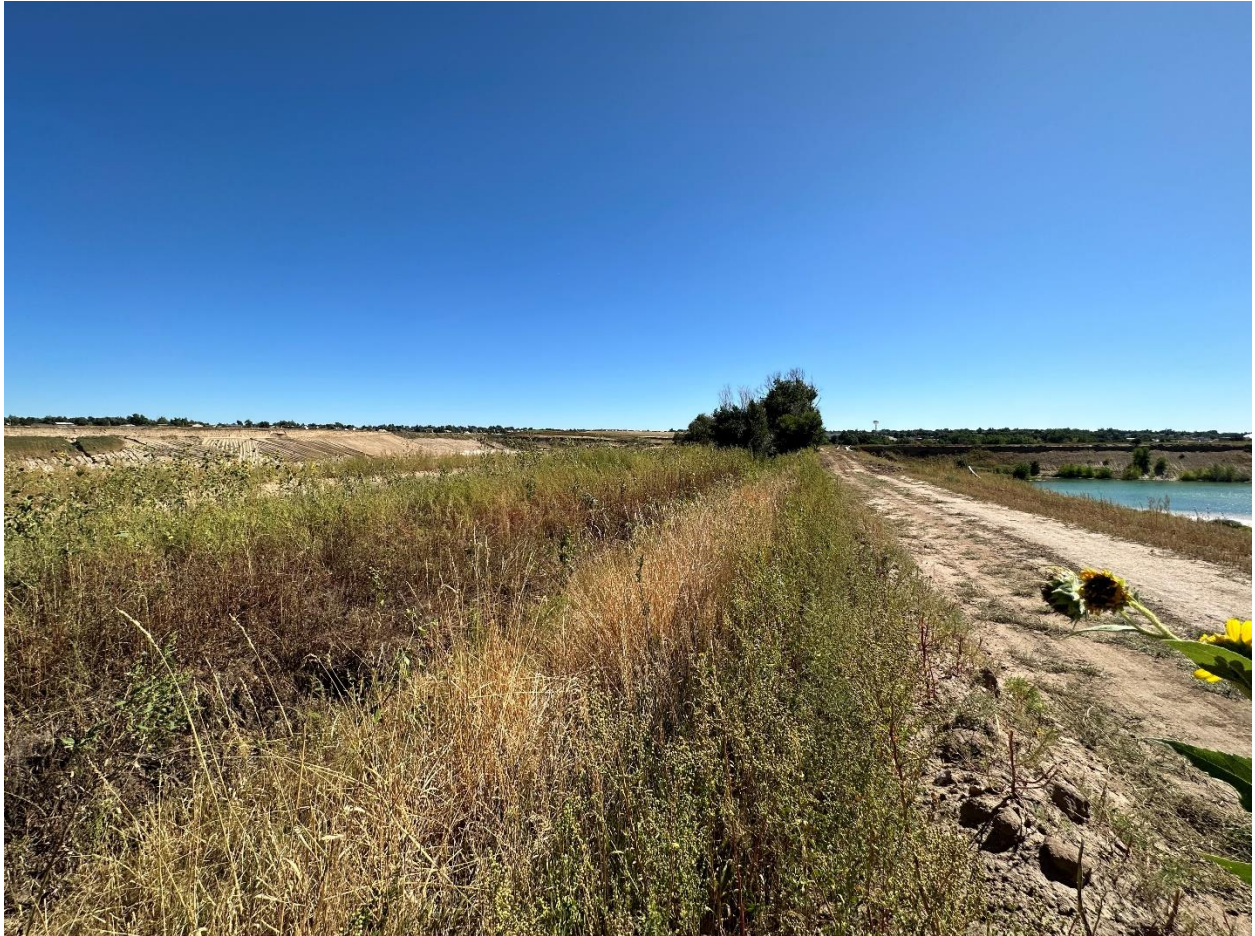
Photo 9. Ditch and access road looking east

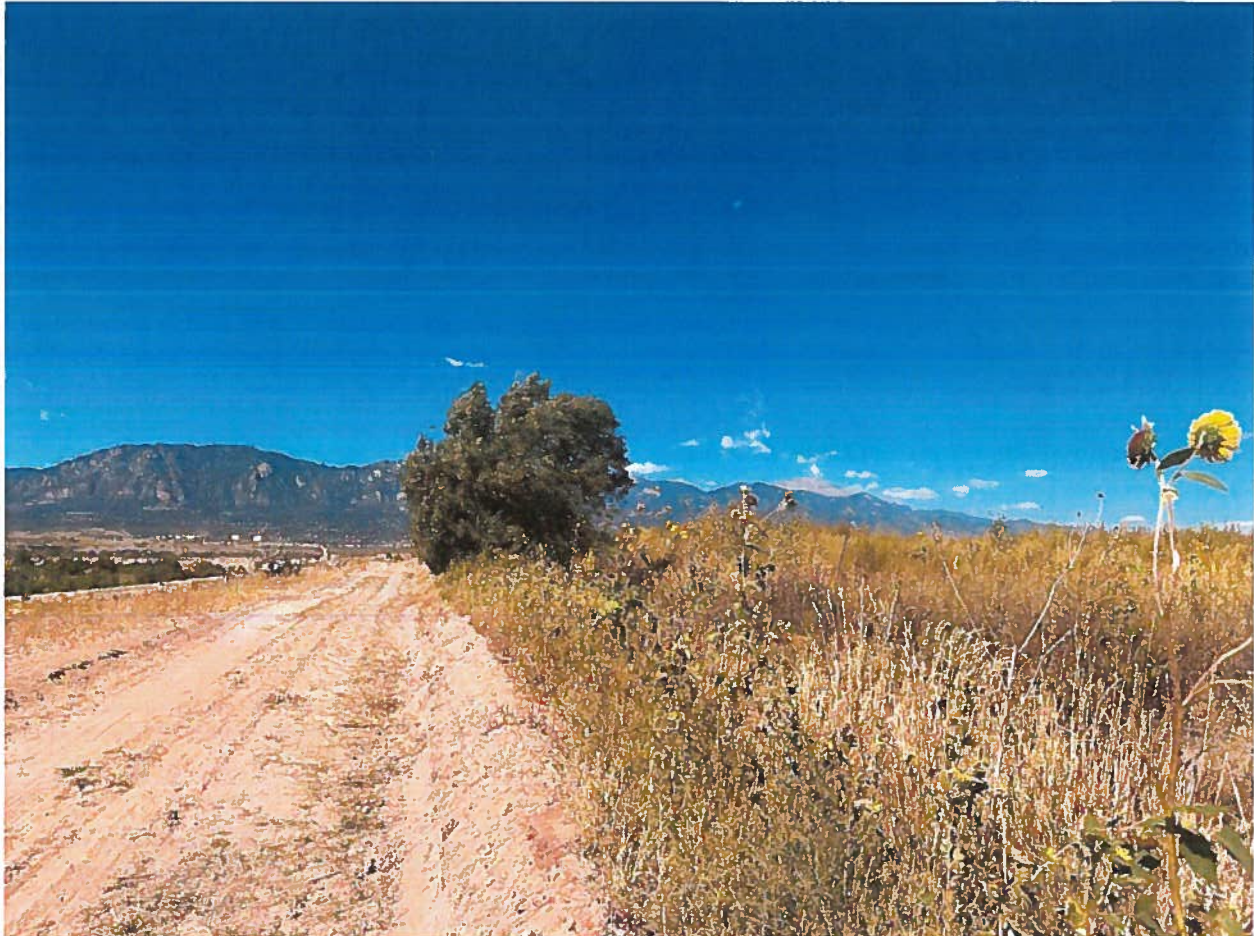
Photo 10. Ditch and access road looking west
