**MINERALS PROGRAM INSPECTION REPORT**  
**PHONE: (303) 866-3567**

<b>MINE NAME:</b> White Wolf Construction Borrow Pit	<b>MINE/PROSPECTING ID#:</b> M-2018-029	<b>MINERAL:</b> Borrow material for construction	<b>COUNTY:</b> Las Animas
<b>INSPECTION TYPE:</b> Monitoring	<b>WEATHER:</b> Clear	<b>INSP. DATE:</b> August 23, 2023	<b>INSP. TIME:</b> 11:00
<b>OPERATOR:</b> White Wolf Construction & Landscaping, LLC	<b>OPERATOR REPRESENTATIVE:</b> Bernard (Joe) Montoya	<b>TYPE OF OPERATION:</b> 111(1)(b) - Special One-Time Incidental	
<b>REASON FOR INSPECTION:</b> Surety Related	<b>BOND CALCULATION TYPE:</b> None	<b>BOND AMOUNT:</b> \$3,628.00	
<b>DATE OF COMPLAINT:</b> NA	<b>POST INSP. CONTACTS:</b> None	<b>JOINT INSP. AGENCY:</b> None	
<b>INSPECTOR(S):</b> Amber Michels Brock Bowles	<b>INSPECTOR'S SIGNATURE:</b>

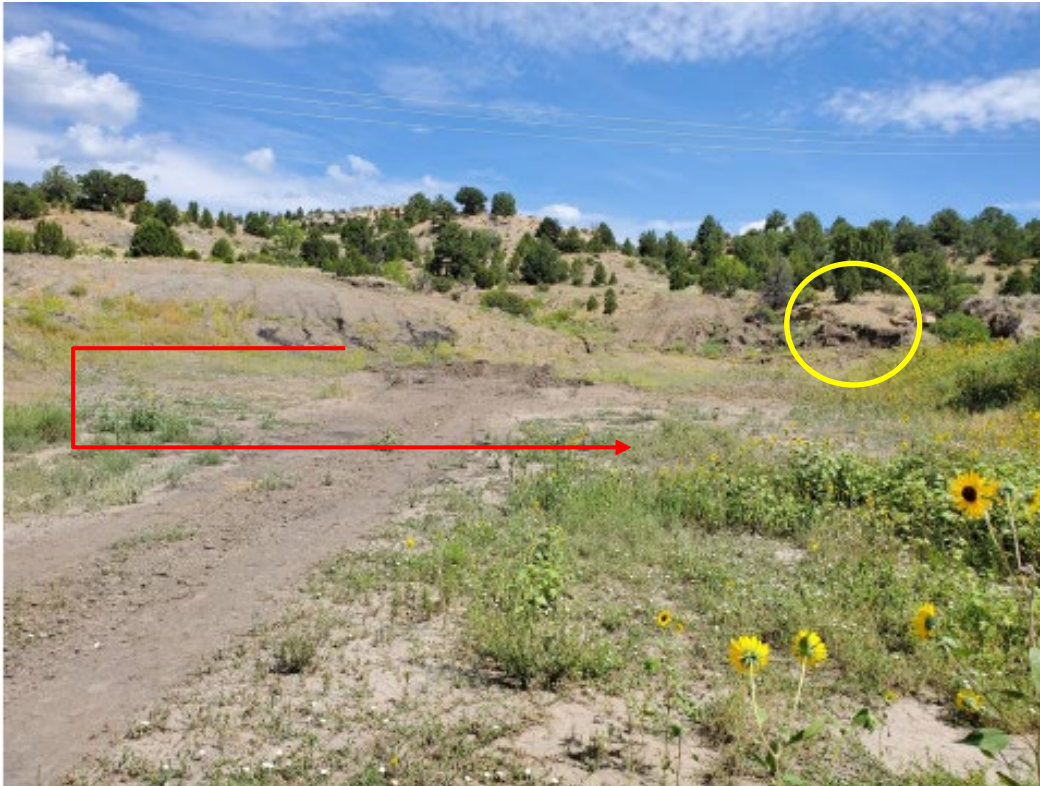
The initial backfilling and grading has been conducted at the site. The slopes on site have been returned to a 3H:1V configuration, except for a small (see Photo 1 and Map 1) area. Prior to spreading topsoil, the Operator shall do a small amount of additional grading on this slope to achieve 3H:1V.

**Photo 1:** Looking north-east at the mining disturbance on-site. Circle indicates a small area where the slope on-site is steeper than 3H:1V. Arrow indicates the flow of water on-site.

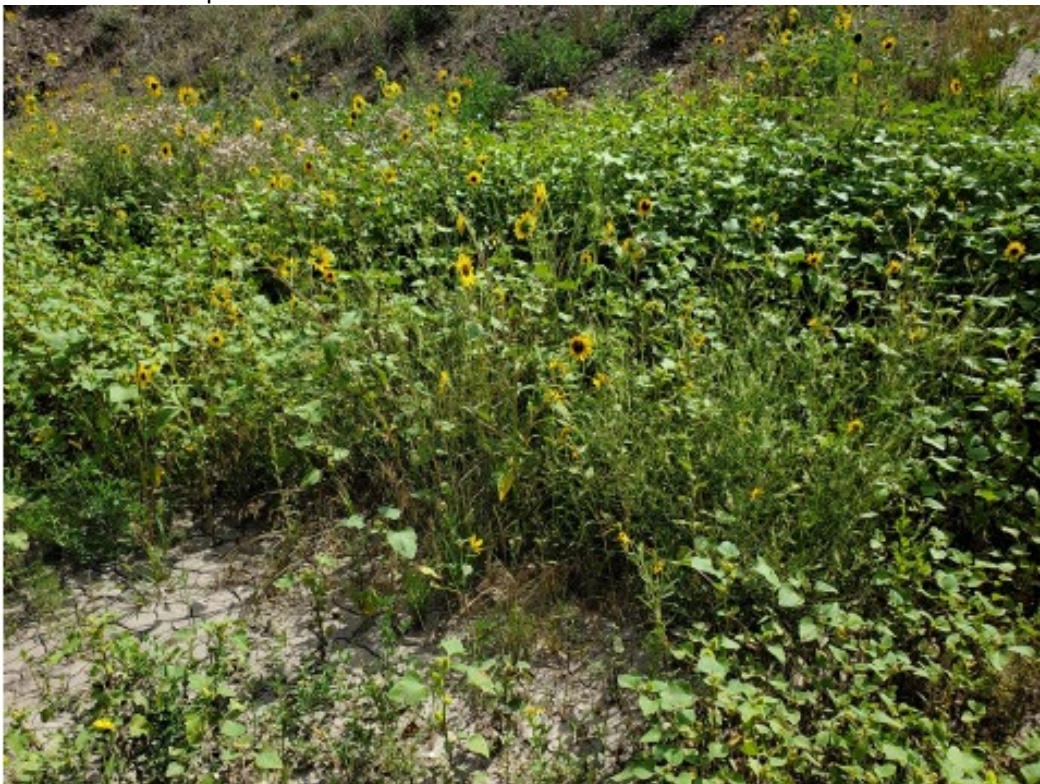
**Photo 2:** Looking east at the south end of the site where water and sediment are captured in a shallow heavily vegetated basin.

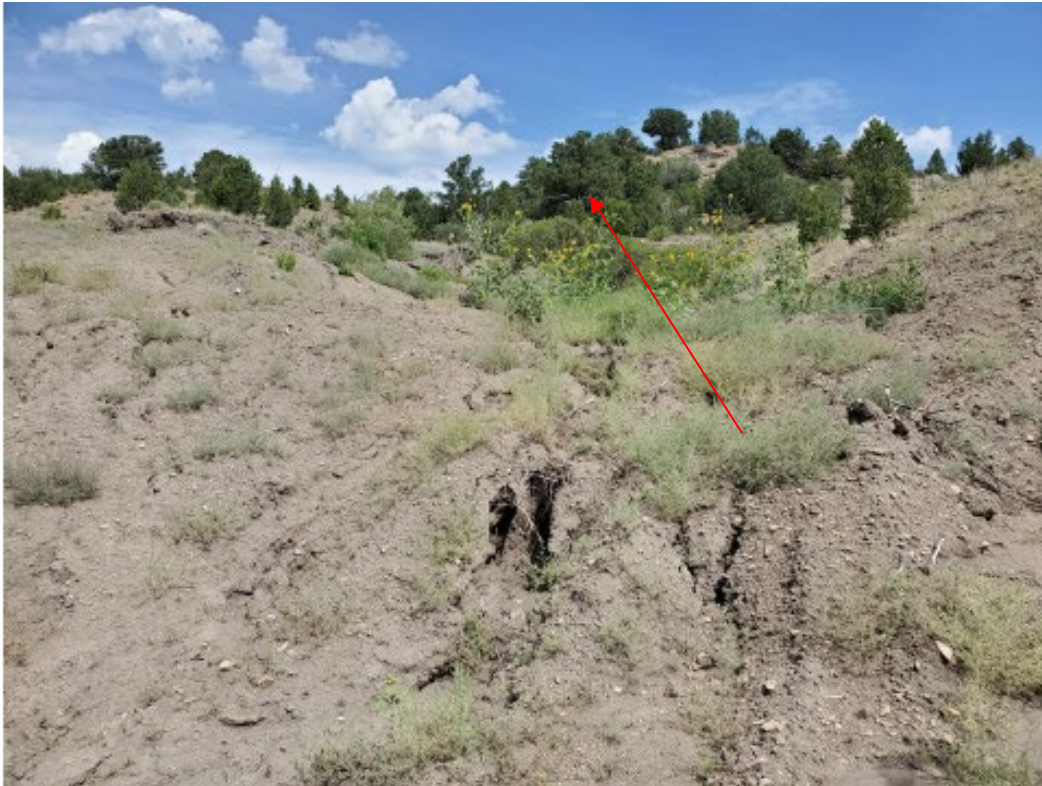
**Photo 3:** Looking north along a drainage beginning north of the disturbance that bisects the middle of the site from the eastern portion.

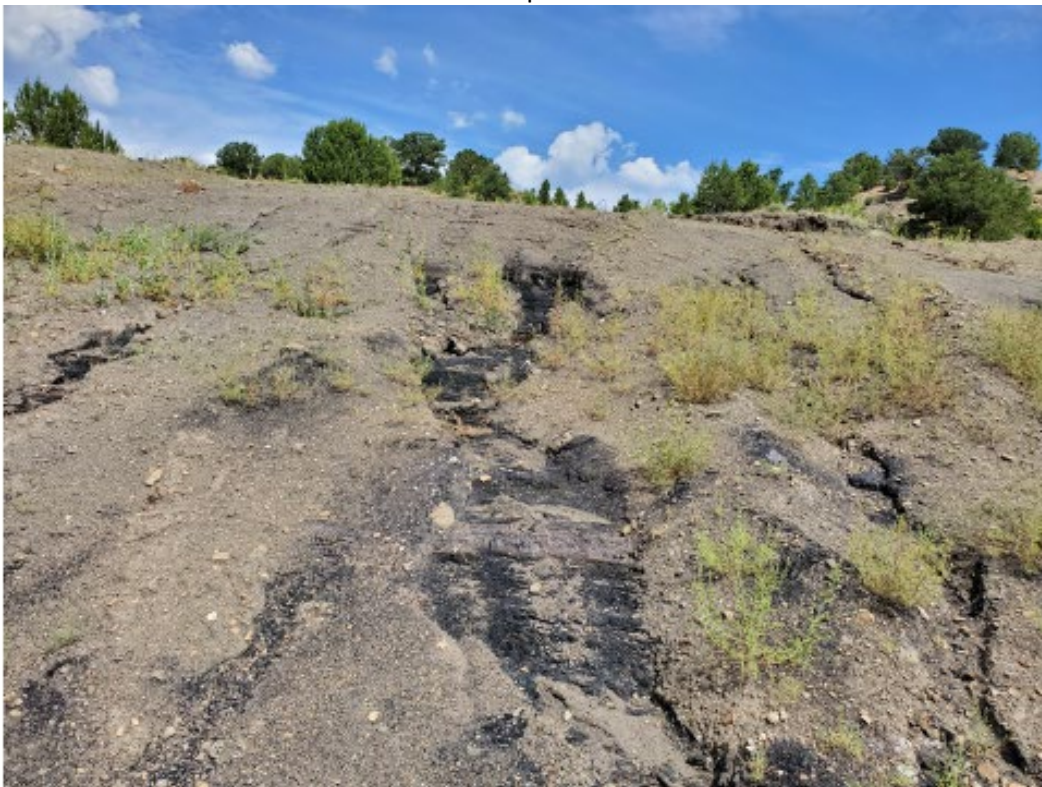
Some rilling was observed on the graded slopes (Photo 4: Map 1). Run-off appears to be contained on-site, running to a small heavily vegetated basin located along the south-east corner of the site (Photos 1 and 2: Map 1). Drainages bisect the site on the east and west side (Photos 3 and 6: Map 1). The drainages begin north of the site's boundary, and contribute to run-off entering the site and saturating the slopes. Prior to spreading topsoil and seed, the Operator shall stabilize the slopes to enable the establishment of a vegetative cover, and to reduce the probability of sediment leaving the site.

**Photo 4:** Looking north up the middle of the graded disturbance at minor riling. No topsoil is salvaged onsite. Very little to no topsoil is available on the adjacent undisturbed areas as well.

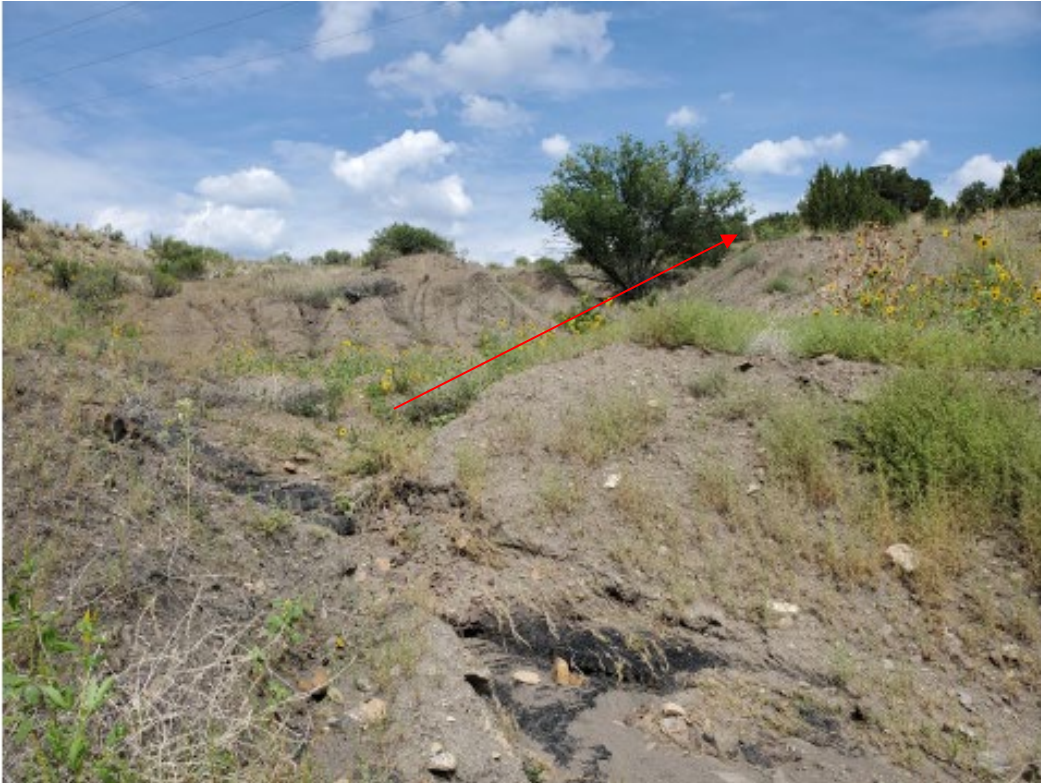
**Photo 6:** Looking north-west at another drainage that bisects and separates the middle of the site from the western portion.
