c1983059, Terror Creek Loadout, September Inspection Report

Permit Number: C-1983-059 Mine Name: Terror Creek Loadout Operator: Oxbow Mining, LLC Operator Address: Mr Doug Smith PO Box 535 Paonia, CO 81434	County: Delta Operation Type: Loadout Permit Status: Active Ownership: Private
	Operator Representative Present: None
Operator Representative Signature: (Field Issuance Only)

Inspection Start Date: September 12, 2023 Inspection Start Time: 14:00 Inspection End Date: Inspection End Time:	Inspection Type: Coal Partial Inspection Inspection Reason: Normal I&E Program Weather: Clear
Joint Inspection Agency: None	Joint Inspection Contacts:
Post Inspection Agency: None	Post Inspection Contacts:
Inspector(s): Leigh Simmons	Inspector's Signature:

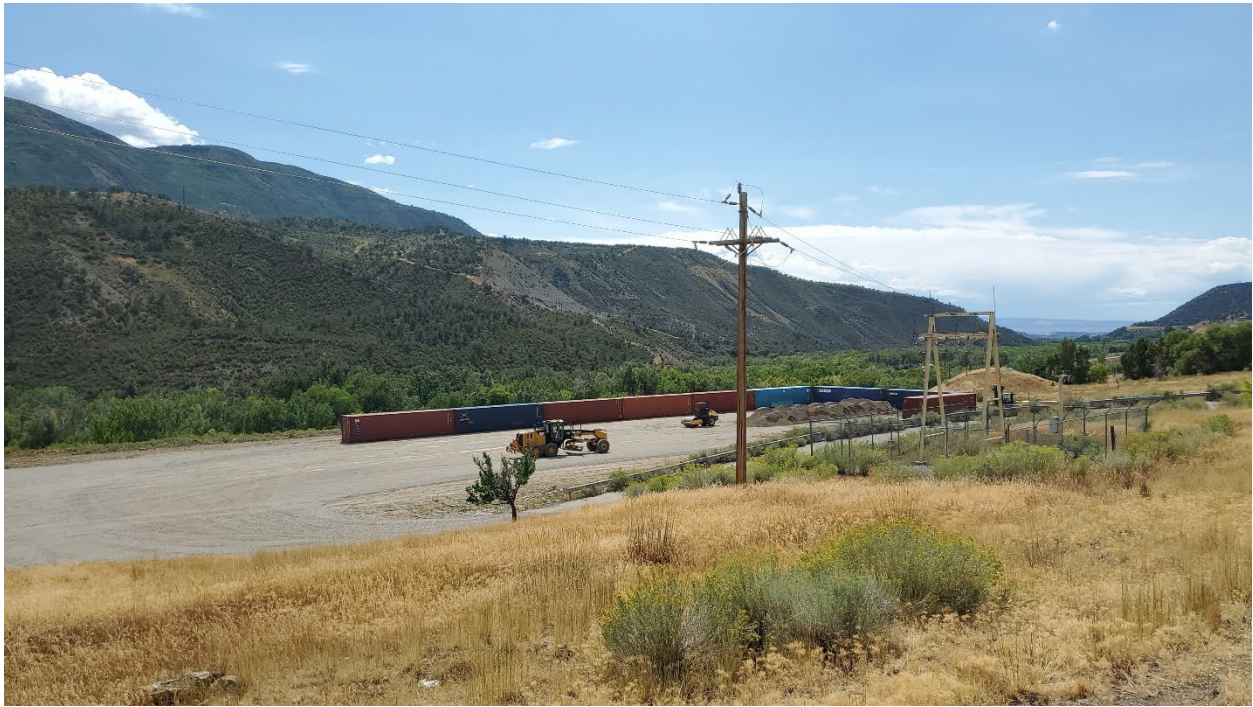
More than half of the lower pad had been leveled and compacted. Gravel had been spread and shipping containers had been placed. No asphalt had been placed and the erection of the temporary building had not begun. Minor Revision no. 33 (MR-33) was approved on August 29, 2023, but the Division has not received the rider to increase the reclamation bond, so the approved activity may not yet be implemented.

Figure 1: Overview of lower pad (west)

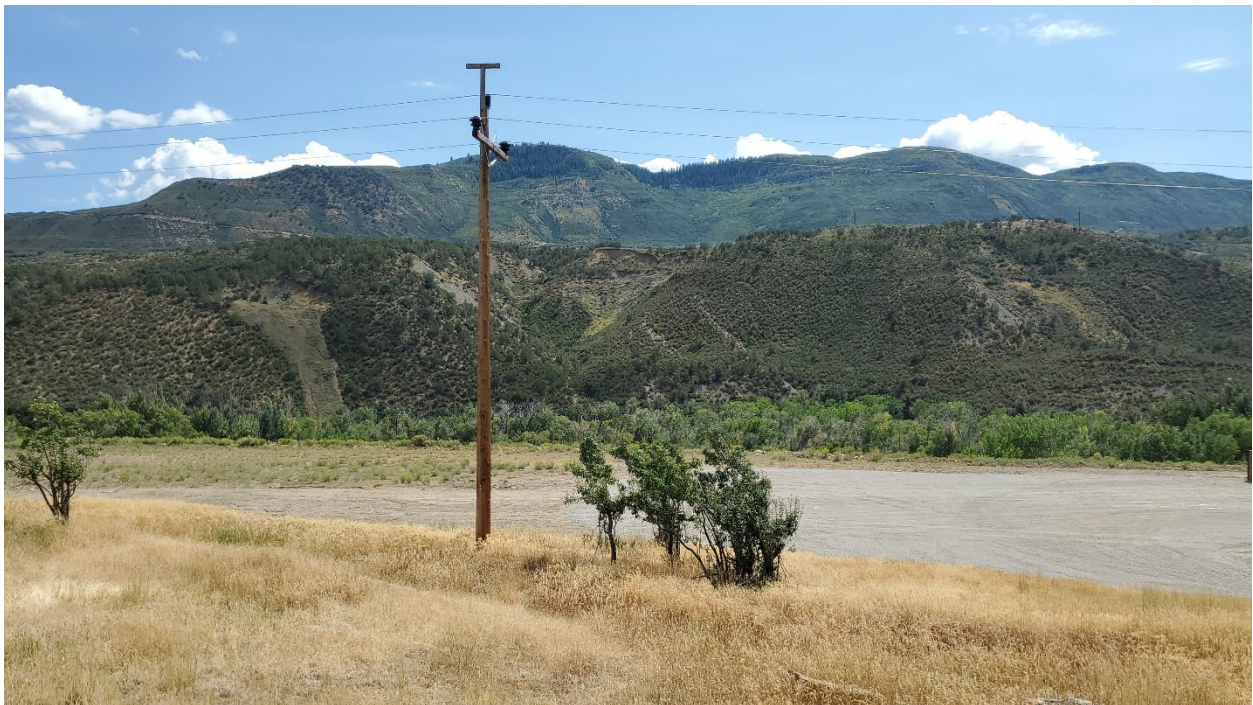
Figure 2: Overview of lower pad (east)

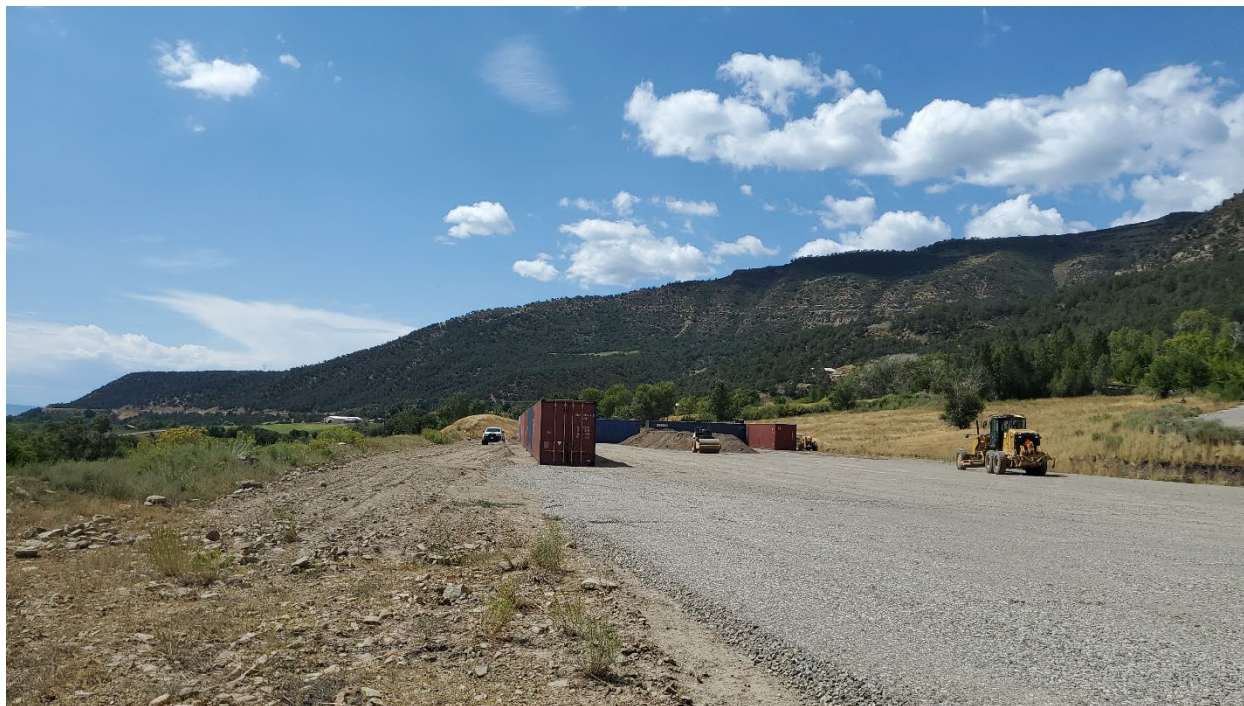
Figure 3: Pad has been leveled, compacted and graveled

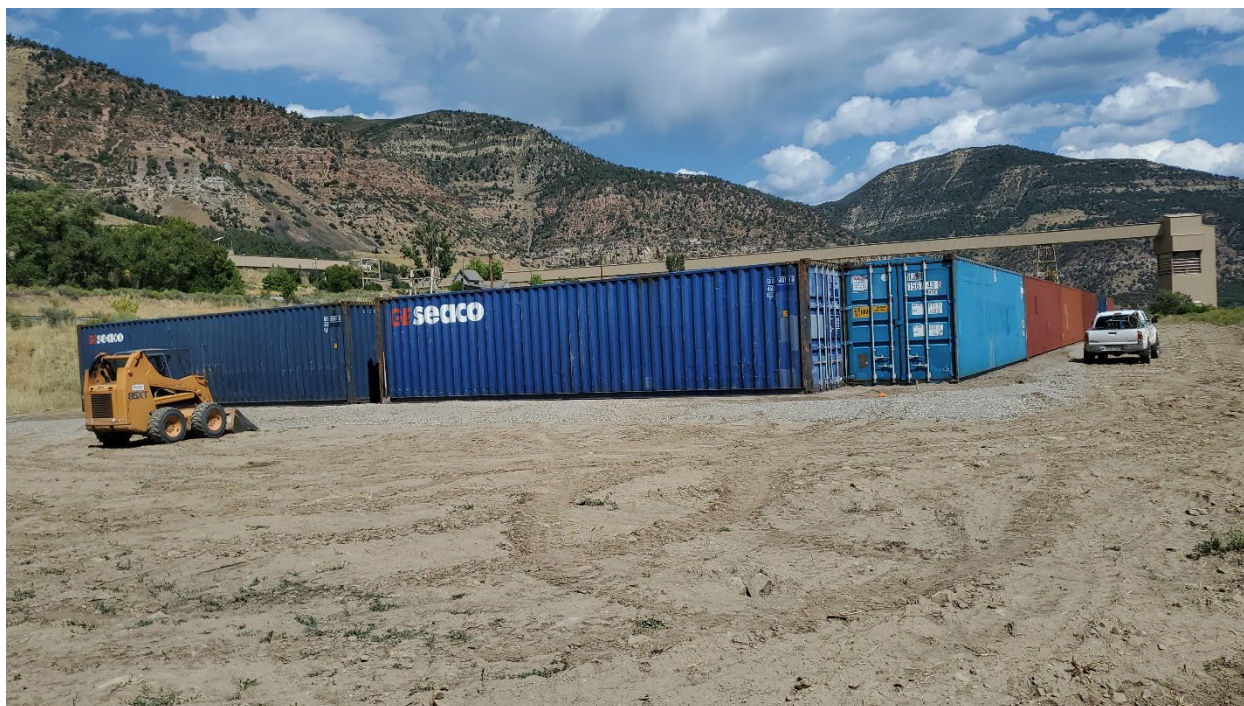
Figure 4: Shipping containers placed
